Request for Conditional Closure
Salt Lagoon Diesel Seep, NOAA Sites 34 and 35/TPA Sites 13a and 13b
St. Paul Island, Alaska

Request for Conditional Closure

Site: Salt Lagoon Diesel Seep, also known as National Oceanic and Atmospheric Administration (NOAA) Sites 34 and 35/Two-Party Agreement (TPA) Sites 13a and 13b). NOAA designated the Salt Lagoon Diesel Seep as Site 34/TPA Site 13a (the uplands portion) and Site 35/TPA Site 13b (the channel portion). The site will be referred to herein as the Salt Lagoon Diesel Seep.

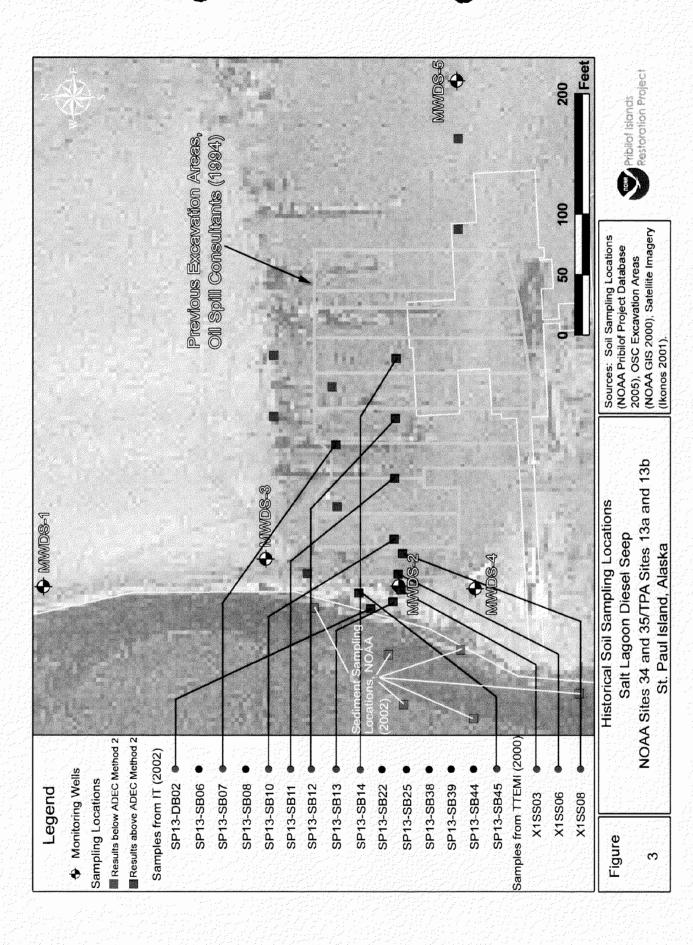
Oil Spill Consultants Removal Action – 1994: Oil Spill Consultants (OSC) performed a PCS removal from the uplands portion of the Site in 1994 (OSC 1995). They removed approximately 9,000 yd³ of PCS from the vadose zone and upper saturated zone (Figure 3). OSC stockpiled PCS at the Blubber Dump Site where it was treated using NOAA's enhanced thermal conduction system during 2000, 2001, and 2002. Excavation did not extend significantly deeper than the top of the water table. The shoreline along the Salt Lagoon Channel was not removed during the 1994 work to allow for a 5 to 15 foot wide soil barrier to prevent tidal channel water intrusion to the upland excavations. OSC encountered floating oil (diesel fuel and suspected animal fat) atop the groundwater that seeped into the excavations. OSC used a skimming system to remove the floating oil, and an oil-water separation process to collect approximately 150 gallons of oil. The

IT Site Characterization—2001: In 2001, IT Alaska Corporation (IT) performed a comprehensive site characterization on behalf of NOAA (IT 2002a). IT collected 231 soil samples from 57 sampling locations, and 65 sediment samples from 14 locations using a direct-push exploration rig (Figure 3). IT collected samples at each location in 2-foot depth intervals and sent samples for analysis to an off site laboratory for DRO, gasoline-range organics (GRO), residual-range organics (RRO), benzene, toluene, ethylbenzene, total xylenes (BTEX), and semi-volatile organic compounds (SVOCs), including select polynuclear aromatic hydrocarbons (PAHs). Of the 65 sediment samples taken from in the Salt Lagoon Channel only six detected DRO; concentrations varied from 19 to 470 milligrams per kilogram (mg/kg). In addition, IT collected three surface water and five groundwater samples. The surface water samples did not reveal detectable levels of DRO, GRO, BTEX, or SVOCs. Only monitoring well MWDS-2* had an exceedance above the ADEC Table C cleanup levels with DRO at 2,500 μg/L. No other analytes tested exceeded Table C levels.

NOAA Sediment Characterization—2002: In 2002, NOAA collected sediment samples from within the Salt Lagoon Channel to supplement the characterization work performed previously by IT (Figure 3). Sediment sampling results indicated that concentrations of DRO varied from <13 mg/kg to 80 mg/kg (NOAA 2002).

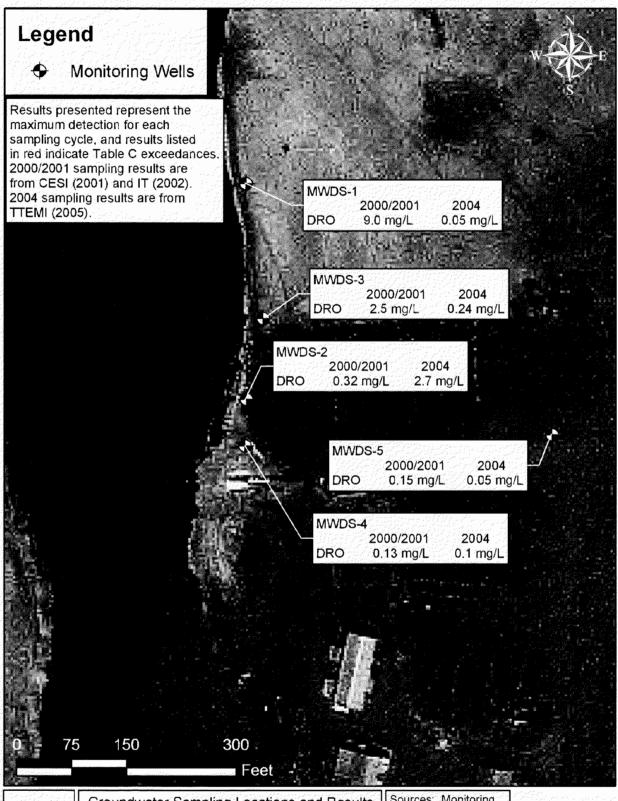
4

<u>TTEMI Groundwater Monitoring – 2004/2005</u> In April and July 2004, Tetra Tech collected groundwater samples from the five Salt Lagoon Diesel Seep Site monitoring wells. Analytical data for groundwater samples indicated the presence of DRO at a maximum concentration of 2,900 μ g/L in monitoring well MWDS-2*, exceeding the ADEC Table C cleanup level; no other groundwater samples contained analytes at concentrations above the cleanup levels (Tetra Tech 2005).

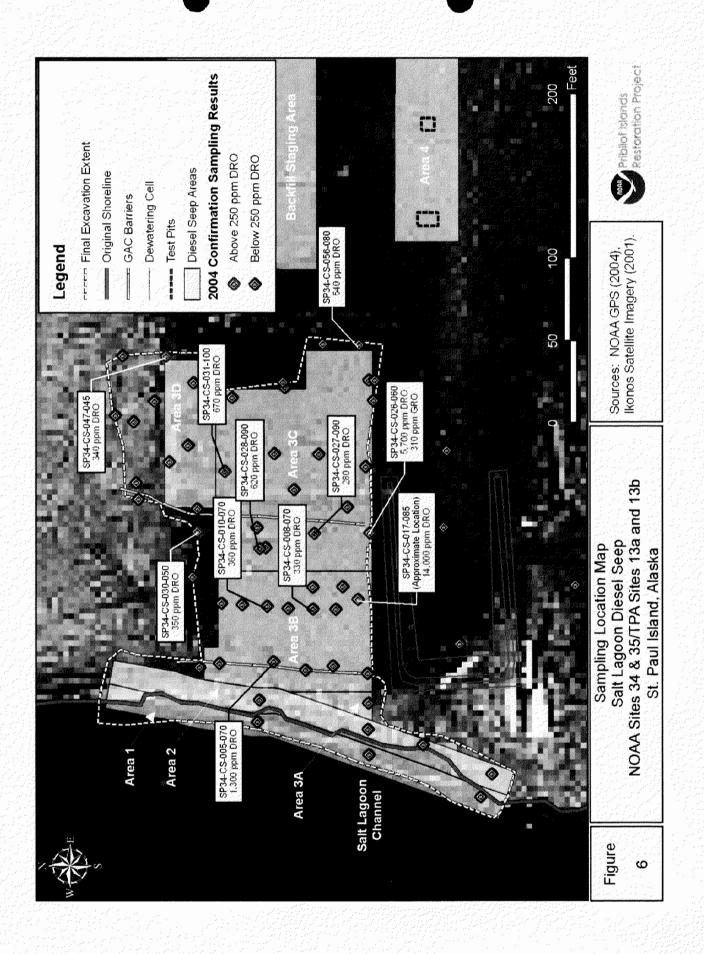
TTEMI removed approximately 9,234cubic yards of PCS and sediments from the Salt Lagoon Diesel Seep Areas 1, 2, 3A, 3B, 3C, and 3D, (Figure 6) according to the corrective action report, (NOAA 2005). They removed PCS down to elevations that varied from -1 ft mean lower low

water (MLLW) to -4 ft MLLW. They removed sediments extending approximately 15 feet out into the channel along the east shoreline of the Salt Lagoon Channel (Figure 6). Excavation efforts continued in these areas until either no petroleum sheen was observed, or until further excavation was impracticable because of groundwater and sloughing of excavation sidewalls. NOAA attempted to investigate potential contamination in Area 4 by excavating two test pits. Subsurface debris prevented NOAA from completing this investigation and no soil was removed from Area 4. Past site characterization data (CESI 2001, IT 2002) indicate Area 4 soil is contaminated at depths ranging approximately +4.5 ft MLLW to +0.0 ft MLLW (*i.e.*, approximately 3.5 ft bgs to 8.0 ft bgs), which includes both the vadose and saturated zones. Concentrations of DRO were found during the past site characterizations of Area 4 as high as 17,000 mg/kg.

Two underground granular activated carbon (GAC) barriers were installed at the Diesel Seep Site to provide treatment of potentially contaminated groundwater flowing toward the Salt Lagoon Channel (Figure 6). The GAC trench was designed to allow the groundwater to flow through sandbags filled with GAC, which are expected to absorb petroleum migrating along with the groundwater.
