Department of Environmental
Conservation

RE: Decision Document: Delta Western Tank Farm Haines
Cleanup Complete Determination -- Institutional Controls

Delta Western Tank Farm Haines
56 Haines Highway
Haines, Alaska 99827
Tract A Lot 1 Mission Subdivision

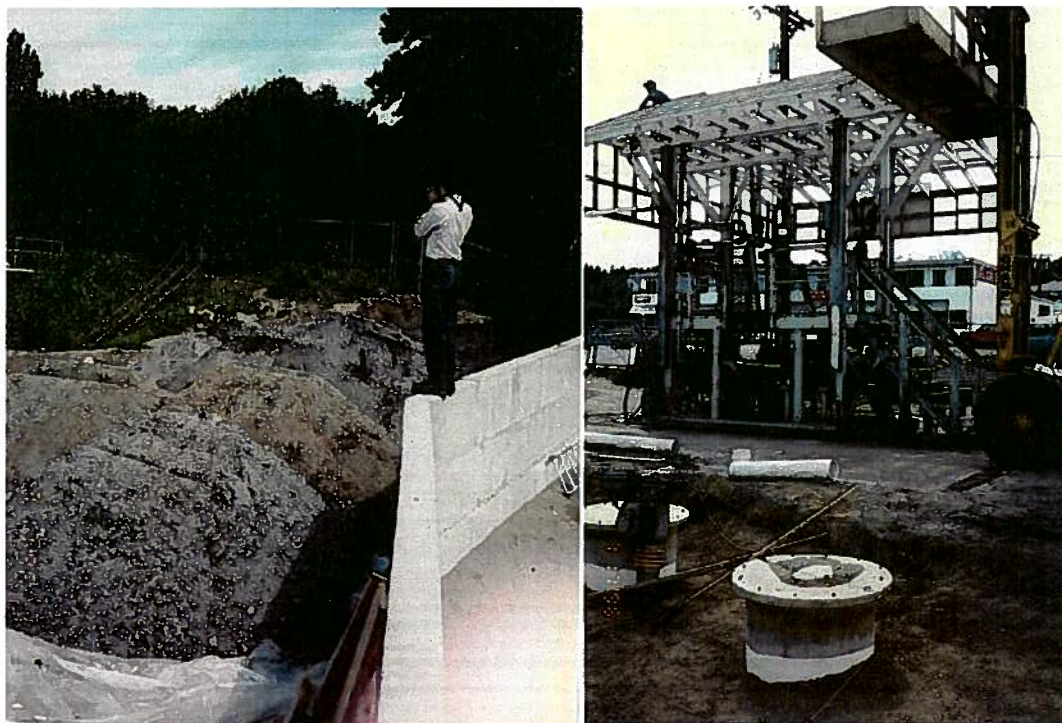
Figure 2. Soil stockpiles and installation of the OWS system near truck rack in 1996

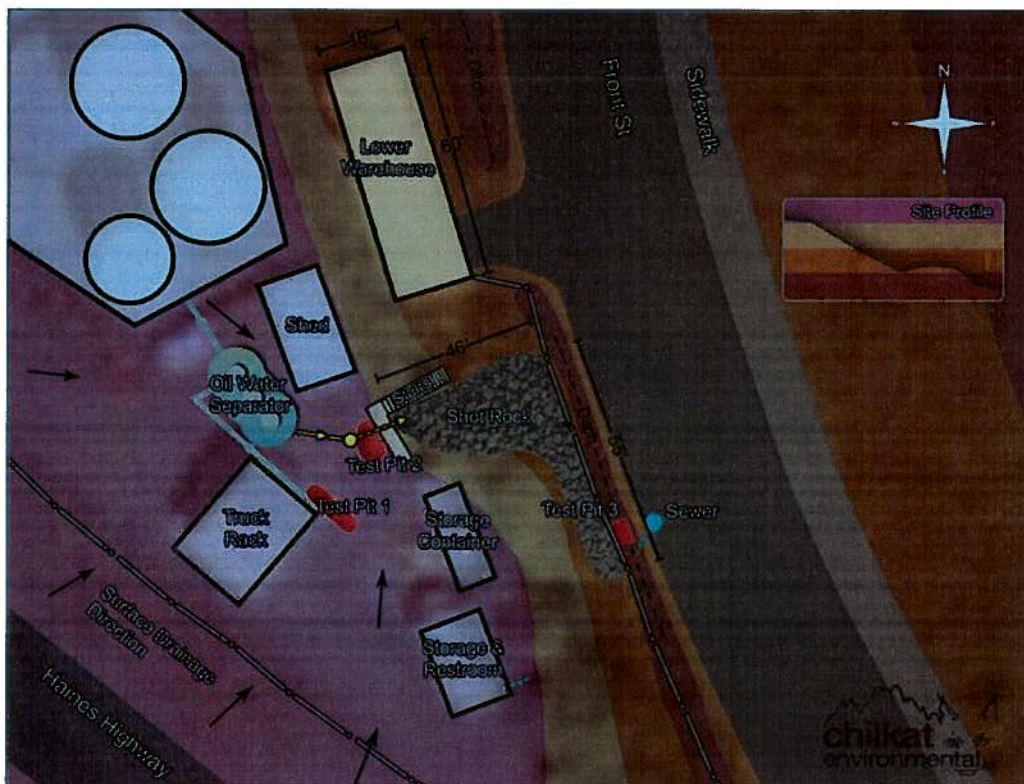
Figure 3. Bold red identifies contaminated subsurface soil in the upper and lower operations areas

During the 2011 site activity, DW emptied free product from water in the OWS system tanks and CE advanced trenches in the upper and lower operations areas to observe subsurface soil conditions and to collect soil and water samples. When CE excavated the rock-filled embankment between upper and lower operations areas, they discovered an outfall consisting of a slotted four-inch pipe. The source of the mystery oil seep in the ditch is presumably an unpermitted drain field in the embankment for the OWS system which was installed during the PM facility upgrades between 1996 and 2002.

samples from the trench in the lower operations area DRO was detected above soil cleanup levels. Based on results, CE concluded that DRO and VOCs in soil were the contaminants of concern. In accordance with a DEC-approved work plan in July 2012, DW pumped the tanks dry and permanently decommissioned the faulty OWS system in the upper operations area and ChemTrack Alaska (ChemTrack) advanced 13 Geoprobe borings to collect soil samples at varying depths in two locations around the facility. Workers advanced eight soil borings adjacent to the truck rack and five soil borings in the ditch below the embankment. Analytical sample data indicates that both sample areas had concentrations of DRO that exceed M2 MTG soil cleanup levels. Sample results also confirm that DRO is the only contaminant of concern in the sample areas as GRO, VOC and BTEX analytical results were below M2 MTG cleanup levels. The DRO contamination is stabilized in a distinct layer beginning approximately between three and five feet below ground surface (bgs). It does not exceed a depth of 14 feet bgs in the upper operations area, and eight feet bgs in the lower operations area.

- 2) An estimated volume of fifty cubic yards or less of soil contamination remains in the subsurface between the truck rack and the oil water separator at the facility and as described and displayed in bold red in Figure 3 in this document.

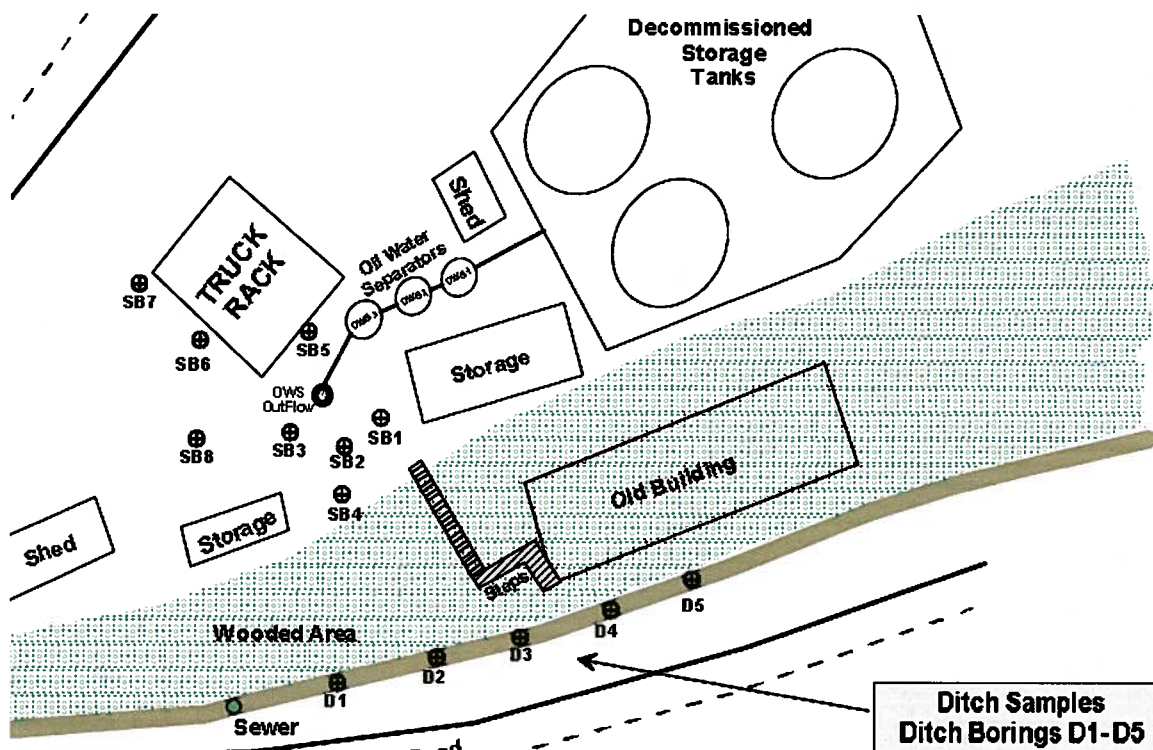
Figure 4. 2012 Soil boring locations to define the extent of subsurface contaminate soil.

ChemTrack concluded the soil boring results indicated that the fuel impacted soil is localized to a distinct layer under an average thickness of three feet of clean fill. This cap of clean fill above the impacted layer in both the Upper and Lower sampling areas, minimizes the risk of off-site migration. The OWS System that was identified as a likely source contributing to the contamination on site was decommissioned in July 2012. Therefore, any threat of continued contamination on site from that system has been removed.

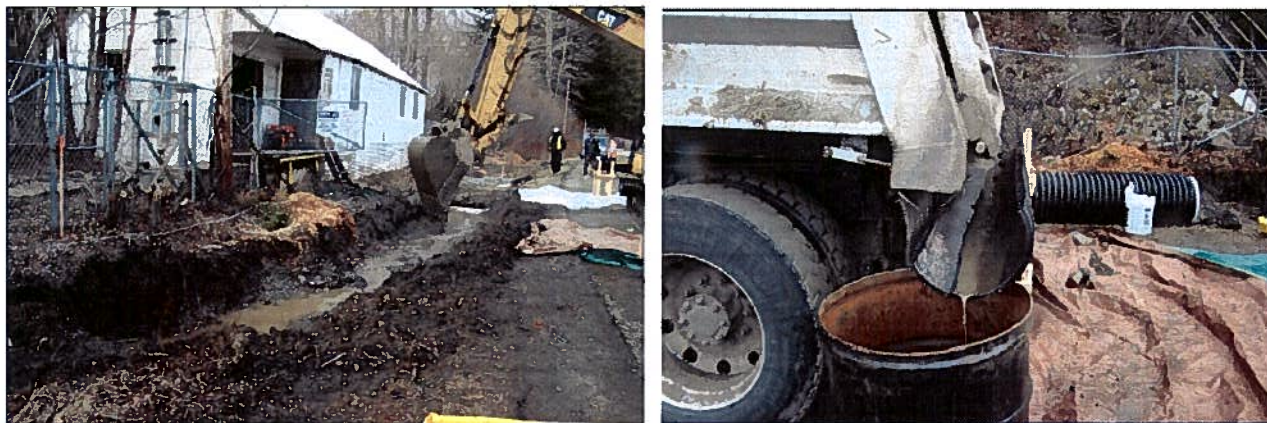
DOT workers encountered a 6-inch diameter vertical steel casing located in the ditch that was slowly discharging water and causing the soil to become saturated. The water discharging from the steel casing under hydraulic pressure was observed to be free of petroleum indicators, but sheen was observed after the water came in contact with the soil in the ditch. Field measurements report that the casing depth was approximately 26-feet deep below top of casing (TOC) and was assumed to be an old water well.

Figure 6. Front Street ditch at the warehouse; draining water from the contaminated soil into containers.

Based on field screening observations (i.e. visual staining, sheen, odor), clean soil was segregated from contaminated soil. A total of 6 field screen samples were collected and 2 samples were selected for laboratory analysis based on visual comparison of the sheen test results.

Approximately 50 cubic yards of contaminated soil was staged in the parking area of facility. After collecting waste characterization samples the contaminated soil was loaded into waste management bins and transported by Waste Management barge to a recycling facility in WA for disposal.
