Department of Environmental
Conservation

Re: Decision Document; Petro Marine Ketchikan
Cleanup Complete Determination with Institutional Controls

Petro Marine Ketchikan
100 Stedman Street
Ketchikan, Alaska 99901
Parcel 011542000500
Amended USS 1100

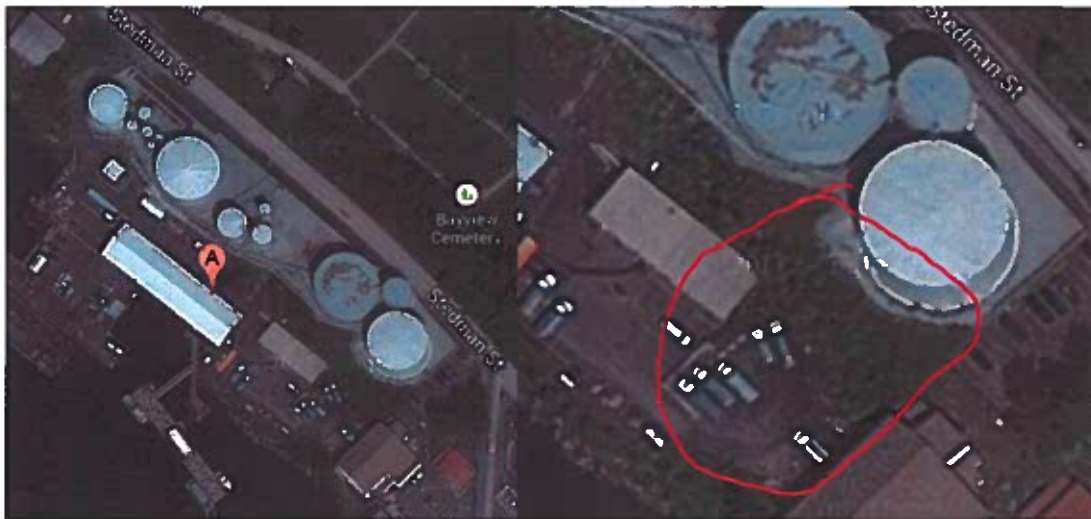
In November 1999, diesel contaminated soil from a residential property (North Residence - Hazard ID 3138) at 399 Salmonberry Circle in Ketchikan was approved by CS for transport to and later biocell treatment at the Petro Marine Ketchikan property. By May 2006, levels of DRO had been reduced from 4,400 ppm to concentrations averaging about 500 ppm. DEC's Contaminated Sites Program (CSP) authorized PM to land spread the last of the 200 cubic yards of contaminated soil on the AST containment berm hillside and apply seed.

Figure 2. The area in the red circle is where the biocell was assembled in 2000.

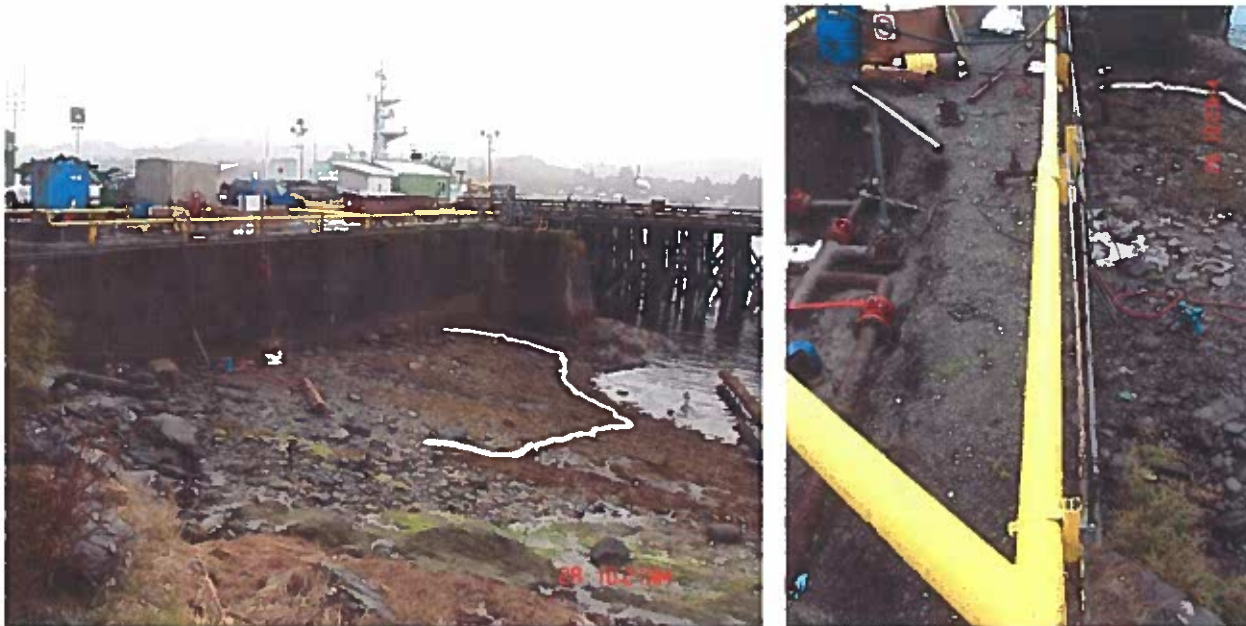
On May 1, 2010 PM reported to PERP that oily water was discharging from two vertical tidal exchange pipes within the seawall facing Tongass Narrows. The tidal exchange pipes provide critical structural support by draining seawater from behind the seawall at a rate similar to that of receding tidal waters. PM deployed sorbent boom along the waterfront to recover floating fuel during high tide, and at low tide installed one-way valves on the ends of the pipes to hold in the seawater backwash. As the tide receded, PM transferred the oil/seawater mixture from the seawall pipes into a containment area. Floating oil and water with sheen was transferred to drums for off-site treatment and the remaining water was processed through the permitted on-site OWS before release into Tongass Narrows.

Figure 3. West facing seawall and sorbent boom

South facing seawall and sorbent pads

PM contracted environmental consultant R&M Engineering Ketchikan (R&M) to install monitor wells to bedrock depth behind the seawall to provide additional ports to pump out subsurface water and screen for sheen. When PM observed sheen along the west seawall, the tidal exchange pipes were also retrofitted with valves to hold seawater on receding tides. These pipes were also drained into containment for screening before transfer into the OWS for final treatment. By June 25th 2010, PM had recovered 22,909 gallons of seawater from the tidal exchange backwash pipes and monitor wells, and 2,208 gallons of “oily waste” had been transported off-site and remediated.

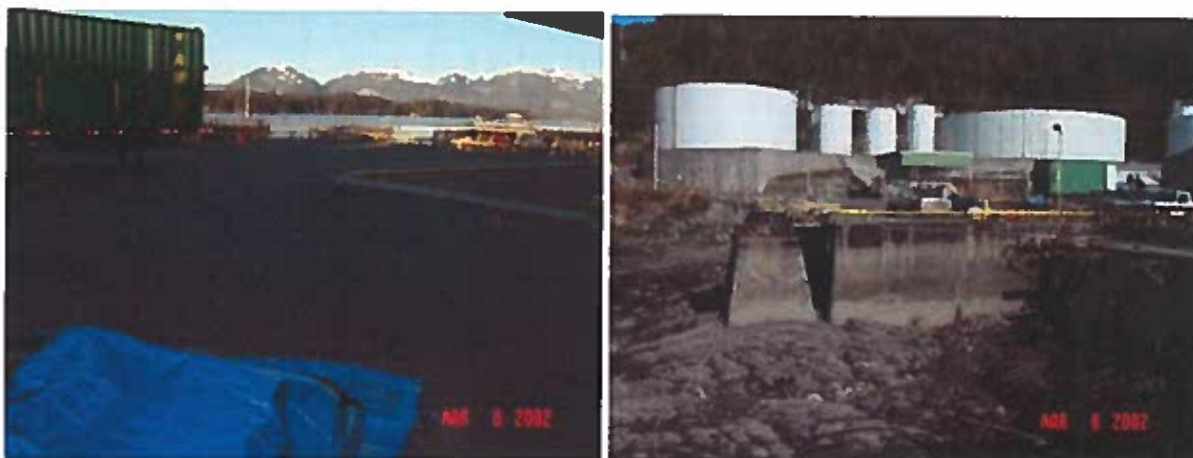
Figure 4. 2002 Site Assessment photos show the excavation site and its distance from the bulkhead.

TECS-AK concluded the excavation site aligned with the former marine shoreline. The toe of the bulkhead contacts a beach comprised mostly of bedrock. The fill and cap insulates the contaminated soil from rainfall; groundwater flow, if any, is most likely through fractured bedrock. TECS-AK observed the bulkhead and found a seep with barely perceptible flow in a seam directly beneath the marine end of the fuel fill lines. Located somewhat downhill from the contaminated soil excavation, water from the seep had no sheen or petroleum odor.

DEC concurred with the conclusion of TECS-AK that the remaining soil contamination consisted of bunker C fuel that has not been stored at the facility for many years and the extent is limited for lack of native soil. DEC entered the PM facility as a new site on the Contaminated Sites Database with inactive status pending additional site characterization by PM when the removal of structures allowed access to underlying soil. DEC approved a plan by PM to back-fill the excavation with clean soil, reinstall the asphalt cap and submit a plan for enhanced biological remediation of the excavated petroleum contaminated soil on-site.

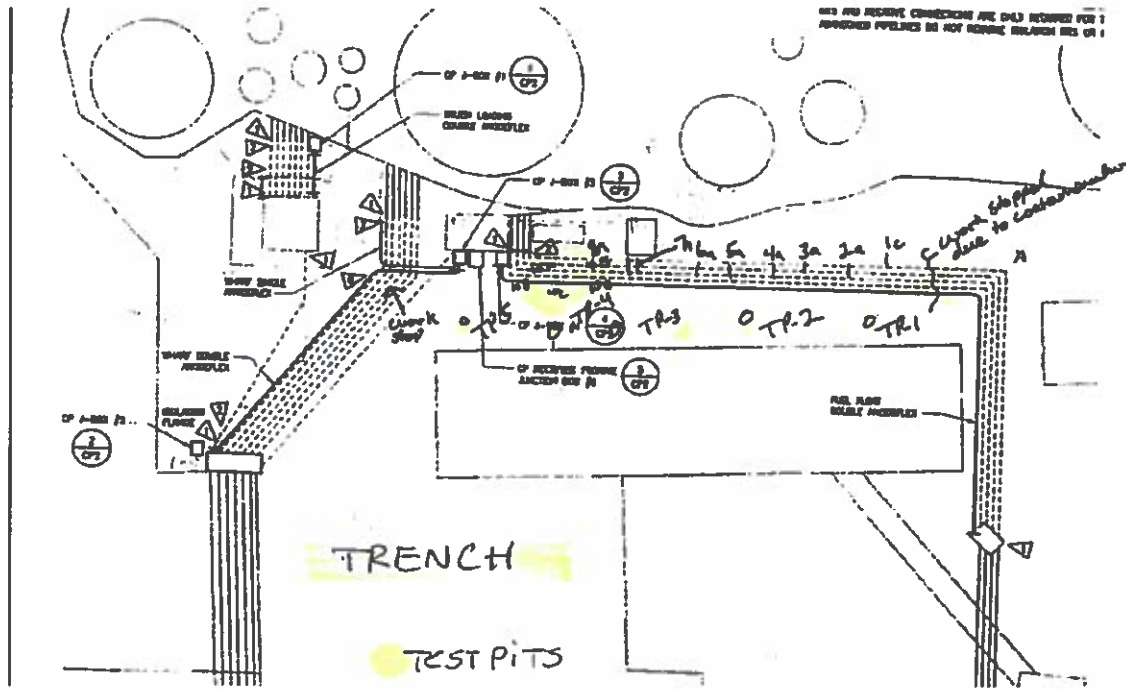
Figure 5. Numbered confirmation soil sample locations in the trench and in test pits

R&M advanced five test pits to further characterize down gradient soil over the full length of the first trench where contaminated soil was excavated. The average depth to bedrock below asphalt surface grade in the test pits was ten to twelve inches except for pit TP-5 south of the pump house that reached a depth of two and one half feet. No soil staining was observed and PID petroleum vapor readings were zero in each of the test pit soil samples. Seventeen soil samples were collected in the first trench.

Hydrocarbon range & compounds of concern	Greatest level in soil mg/kg	Sample name, sample location in the trench displayed in Figure 5, and depth below ground surface	M2 MTG Cleanup Levels mg/kg
GRO	637	Sample 4 from mid trench at 3.0 feet	260
DRO	4,030	Sample 10A from north end at 2 feet	230
RRO	330	Sample 4 from mid trench at 3.0 feet	9700
Benzene	0.245	Sample 10A from north end at 2 feet	0.025
Ethylbenzene	0.614	Sample 10C from north end at 2 feet	6.9
Total Xylenes	5.89	Sample 4 from mid trench at 3 feet	63

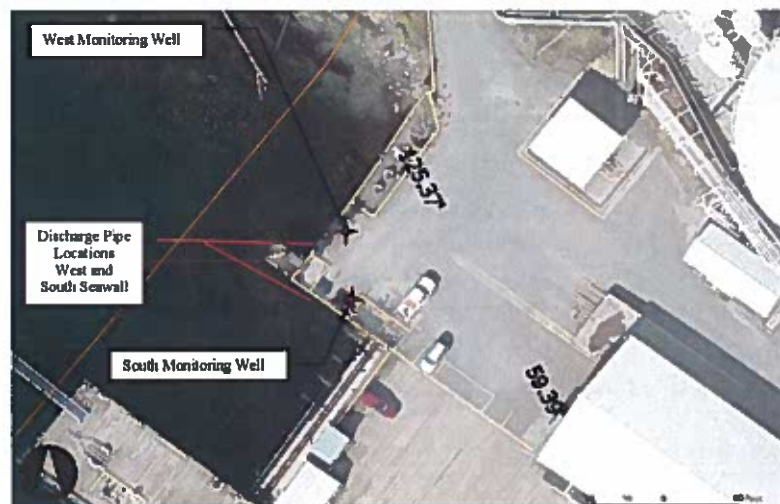
Figure 6. Seawall tidal exchange pipes and monitor well locations

Based on the consistent concentrations of PAH and BTEX compounds as TAH and TAqH in the analytical samples of pre-treatment water, CSP approved reducing the sampling frequency from bi-monthly to 90 days (quarterly) and only from the Port E on the south wall facing Tongass Narrows. The modified sampling protocol continued through the second and third quarters of 2012, with results indicating the concentrations of TAH and TAqH in samples of untreated water exceed Water Quality Standards in 18 AAC 70.020 (b) (17) (A).

1. Monitoring is required to ensure that contaminant of concern (COC) concentrations previously detected above regulatory levels in seawall subsurface waters have declined and are not increasing. Once COC concentrations are, by sampling and analysis monitoring and trend analysis reporting in accordance with the approved Site Monitoring Plan (Plan) by a third party qualified professional, determined to be consistently below regulatory levels for four sampling events, monitoring will be reduced to visual observation as a precautionary measure and ICs 1 and 2 listed in this determination letter will be suspended.
