Department of Environmental
Conservation

DIVISION OF SPILL PREVENTION AND RESPONSE
Contaminated Sites Program

RE: Decision Document; Mitkof Sales & Service
Corrective Action Complete Determination – Institutional Controls

Mitkof Sales & Service
Sing Lee Alley
Petersburg, Alaska 99827
Lots 12, 13, and 14 Block 26 Petersburg

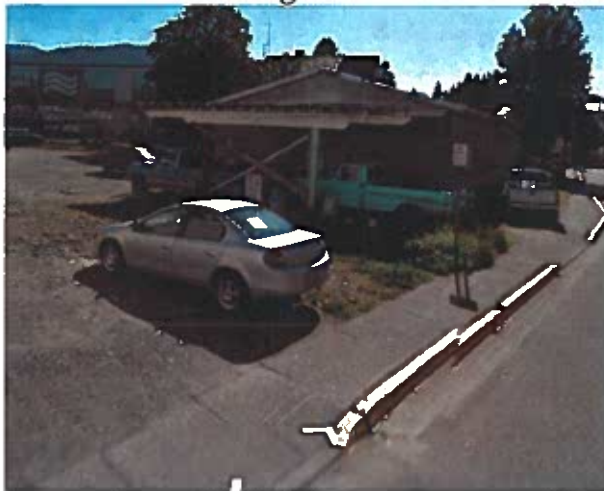
Investigation of subsurface soil by CDI was constrained by a utility corridor on the west side of the property and a concrete driveway. Analytical samples from four test holes, advanced in accessible locations, documented hydrocarbon soil contamination in the gasoline range (GRO) hydrocarbons and benzene, toluene, ethylbenzene and total xylene (BTEX) hydrocarbon compounds above DEC Method Two migration to groundwater soil cleanup levels. The CDI Report stated that groundwater was not encountered during any of the excavations, although soil appeared saturated at a depth of four feet below the ground surface (bgs).

View south from Sing Lee Drive

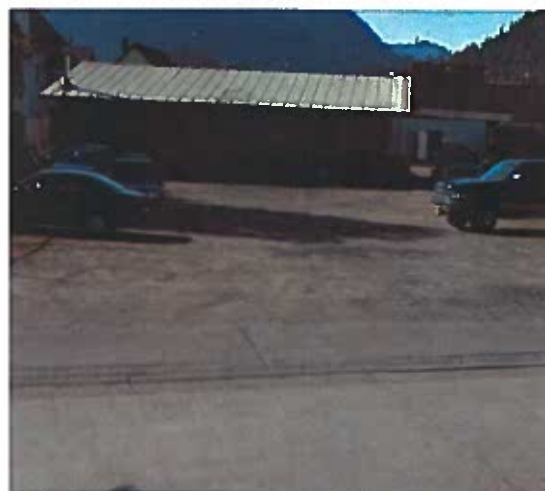
View west from Main Street

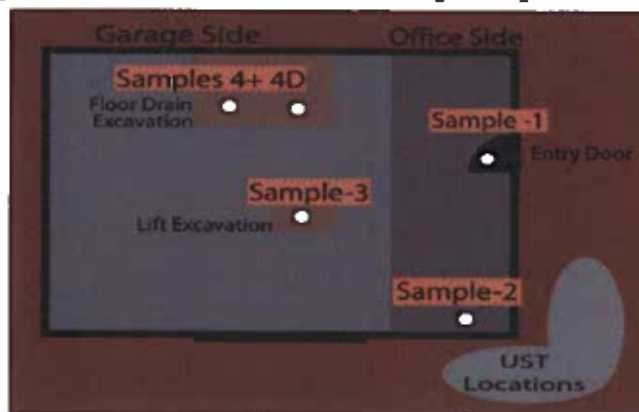
Figure 1. Vehicle Maintenance Shop Sample Locations

During installation of the hydraulic lift, the clay soil layer was removed, resulting in a collection point for water infiltrating surface soil on the property. Samples 1, 2 & 3 were collected from the clay layer two feet bgs and samples 4 and 4D were collected at the soil/water interface less than one foot bgs. The results for analytical soil confirmation samples found that concentrations of VOC compounds (including BTEX), GRO, DRO and RRO were all below laboratory the reporting limits and the soil cleanup levels. Although these samples were not collected from the same deeper depths below ground surface where the UST removal excavation confirmation soil samples were collected, the only analyte concentration above soil cleanup levels is arsenic. The highest arsenic concentration of 1.53 mg/kg in Sample 4 is attributable to natural occurring soil conditions in the Petersburg area.

Chilkat concluded that soil beneath the building was not an environmental concern. Subsurface contamination from the UST did not appear to have migrated the short distance from the former UST site to the shop. The shop is located south of the former UST site which is the most direct path of migration to marine waters of Hammer Slough. The planned future land use by the Petersburg Borough as a paved parking lot is an excellent institutional control measure for any remaining contamination.

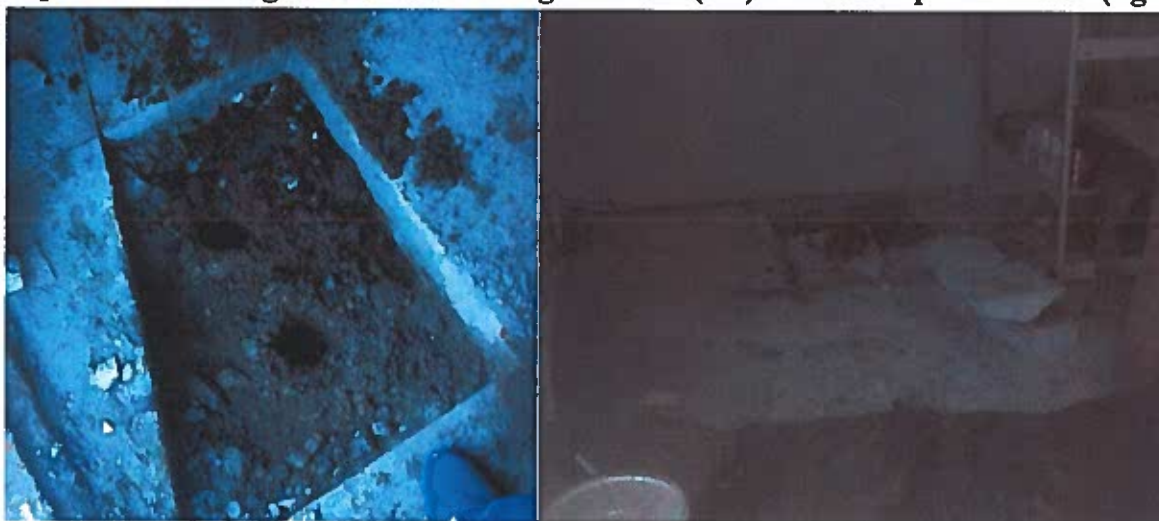
Shop floor soil borings nearest the leaking UST Site (left) and the dispenser island (right)

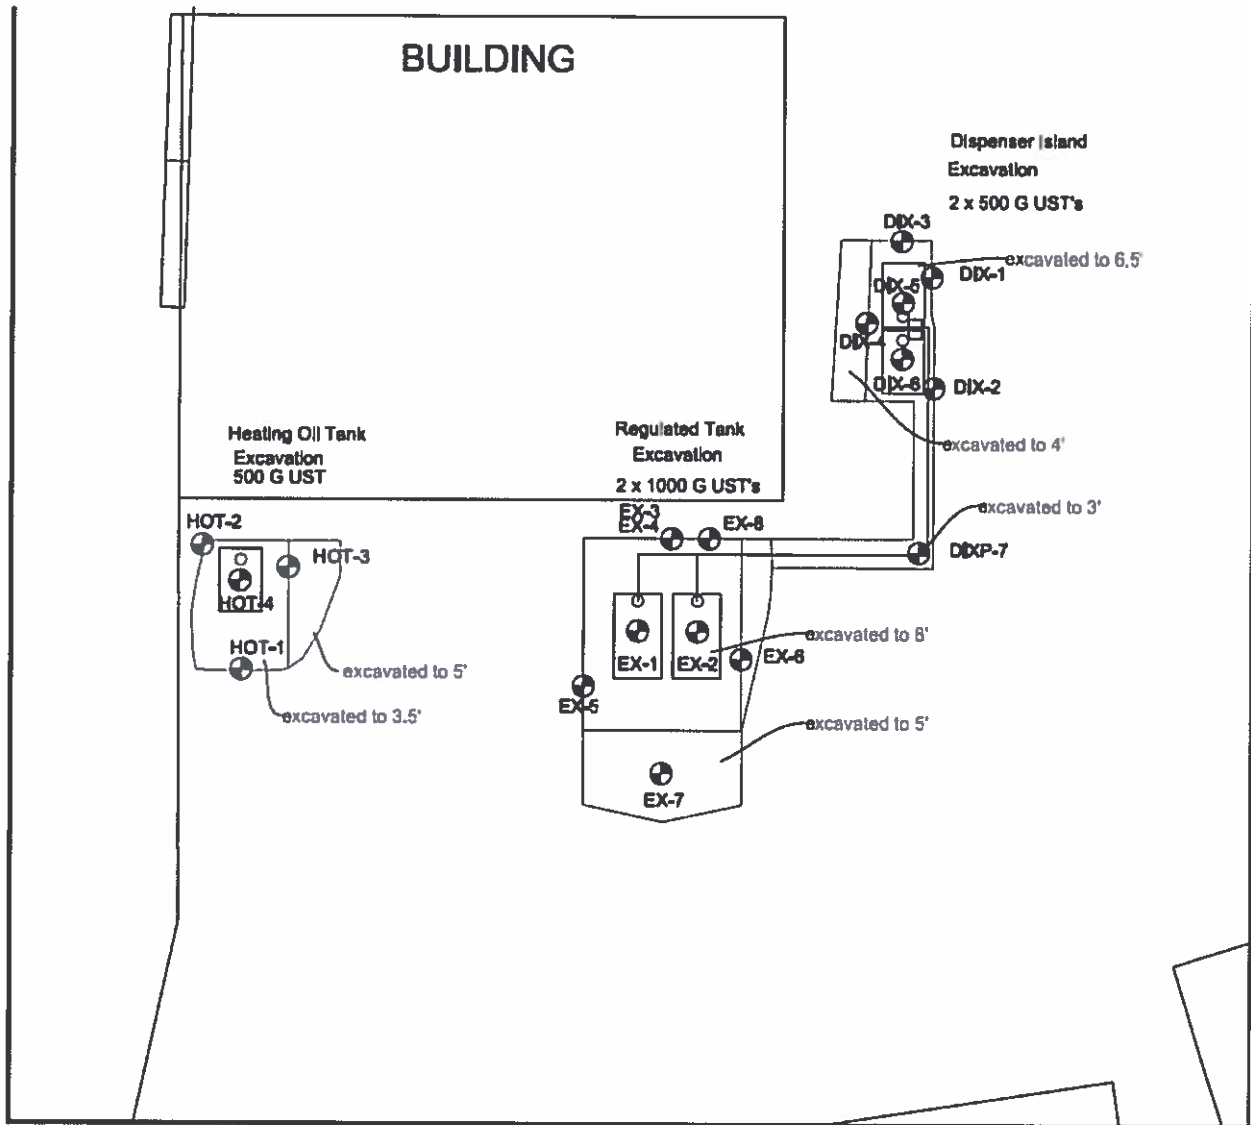
Figure 3. Sample Locations and UST Removals

Nortech collected a total of 19 confirmation samples and two field duplicates from the UST and dispenser island piping excavations. The samples were analyzed for GRO, diesel (DRO) and residual range (RRO) hydrocarbons, and BTEX compounds. The depth bgs of excavation ranged between five and eight feet and the depth that analytical samples were collected from ranged from three to eight feet. Samples EX1-1 through EX1-9 were collected at the twin USTs, samples DIX1-1 through DIX1-8 were collected under the dispenser piping, and HOT1 through HOT4 were collected at the heating oil tank. Groundwater was not encountered in the UST release investigation, but soil saturated with water began to appear at a depth of four feet bgs. Figure 3 from the Nortech Site Assessment Report is included in the decision document as Attachment C.

All but four of the 21 confirmation samples collected by Nortech had benzene concentrations above the Method Two soil cleanup level and the mean concentration was 0.264 milligrams per kilogram (mg/kg). Each of the other analytes, GRO, DRO, and RRO petroleum ranges and toluene, ethylbenzene, and total xylene compounds were below laboratory reporting limits or Method Two cleanup levels.

4. Soil contamination is present in subsurface soil surrounding the former twin UST and fuel dispenser locations located west of the center of the property as shown in Figure 3, included with this agreement as an attachment. If disturbance is planned in the areas of the property described in this letter as having residual contamination, a work plan must be submitted for DEC approval prior to any such site activity begins.

1. The shop building will be removed from the property.
2. The property will be covered by asphalt cap to limit exposure routes. The cap will be installed within 15 months of receipt of this letter (by October 3, 2016). When implemented, the Borough of Petersburg shall submit an Initial Cap Maintenance (ICM) Report with photographs documenting the condition of the asphalt cap. Every five years after the Initial Report is submitted, the Borough of Petersburg will submit new ICM report to the DEC. Reports may be sent the Juneau DEC office by regular mail or electronic mail to DEC.ICUnit@alaska.gov.
