**Department of Environmental
Conservation**

DIVISION OF SPILL PREVENTION AND RESPONSE
Contaminated Sites Program

Re: Decision Document for BLM Maclaren Glacier Mine Dump Site
Cleanup Complete Determination

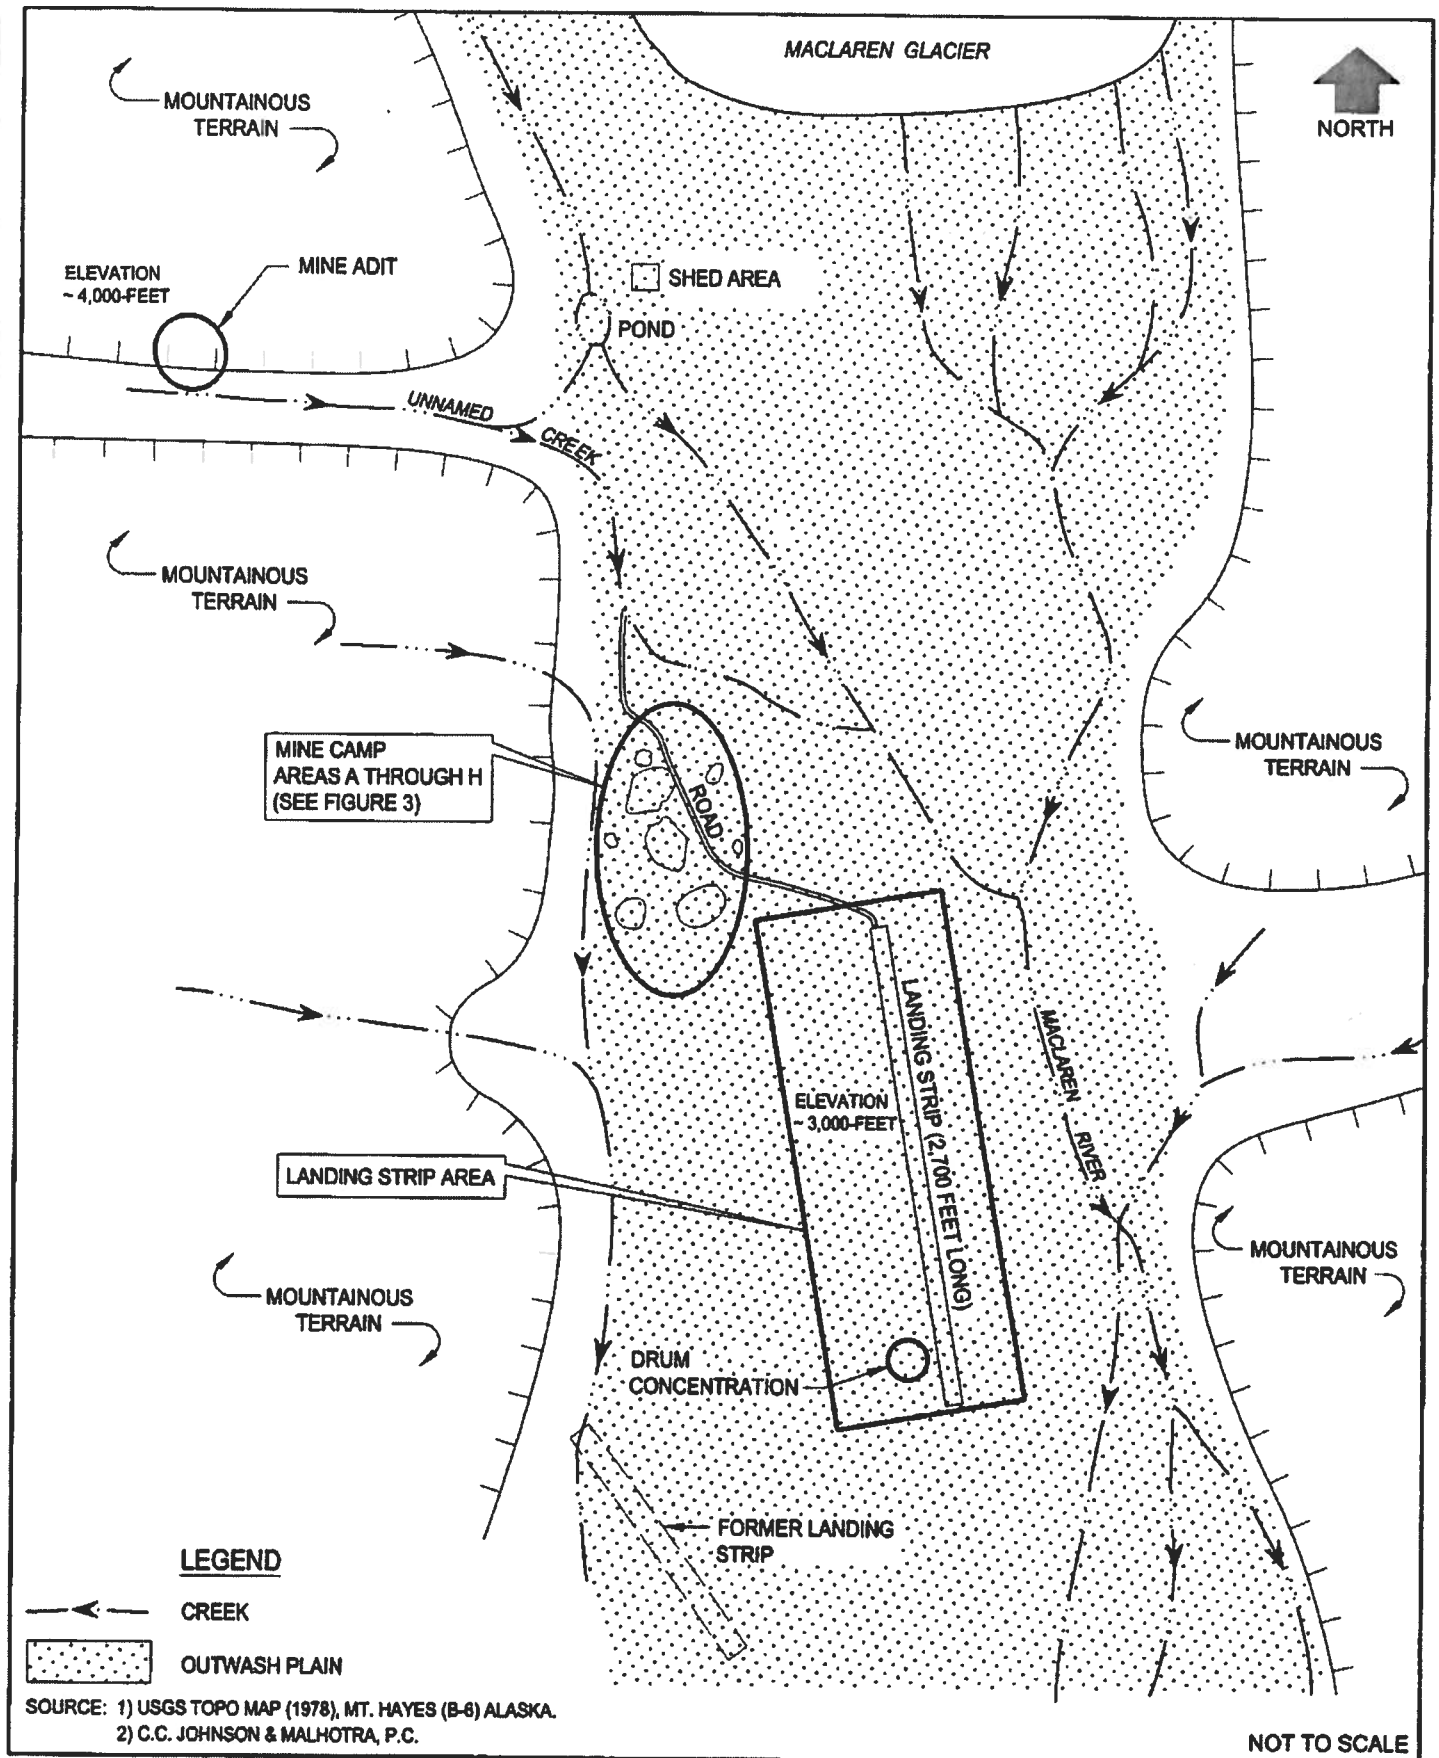
Site Map

In 1990, C.C. Johnson and Malhortra, P.C. conducted a preliminary assessment of the site for BLM. During the preliminary assessment, the contractor identified over one hundred 55-gallon drums at the site. Drums and debris were concentrated at the mine camp area, the shed area, the mine adit, and the landing strip. Stained soil and a petroleum odor were observed at the mine camp.

Harding Lawson Associates/Wilder Construction (HLA/Wilder) performed debris removal and site characterization activities at the site in 1999. They removed and properly disposed of 220 drums, 18.5 tons of metallic debris and construction material, and 800 gallons of drum liquids. Wood debris was burned and the ash buried on site.

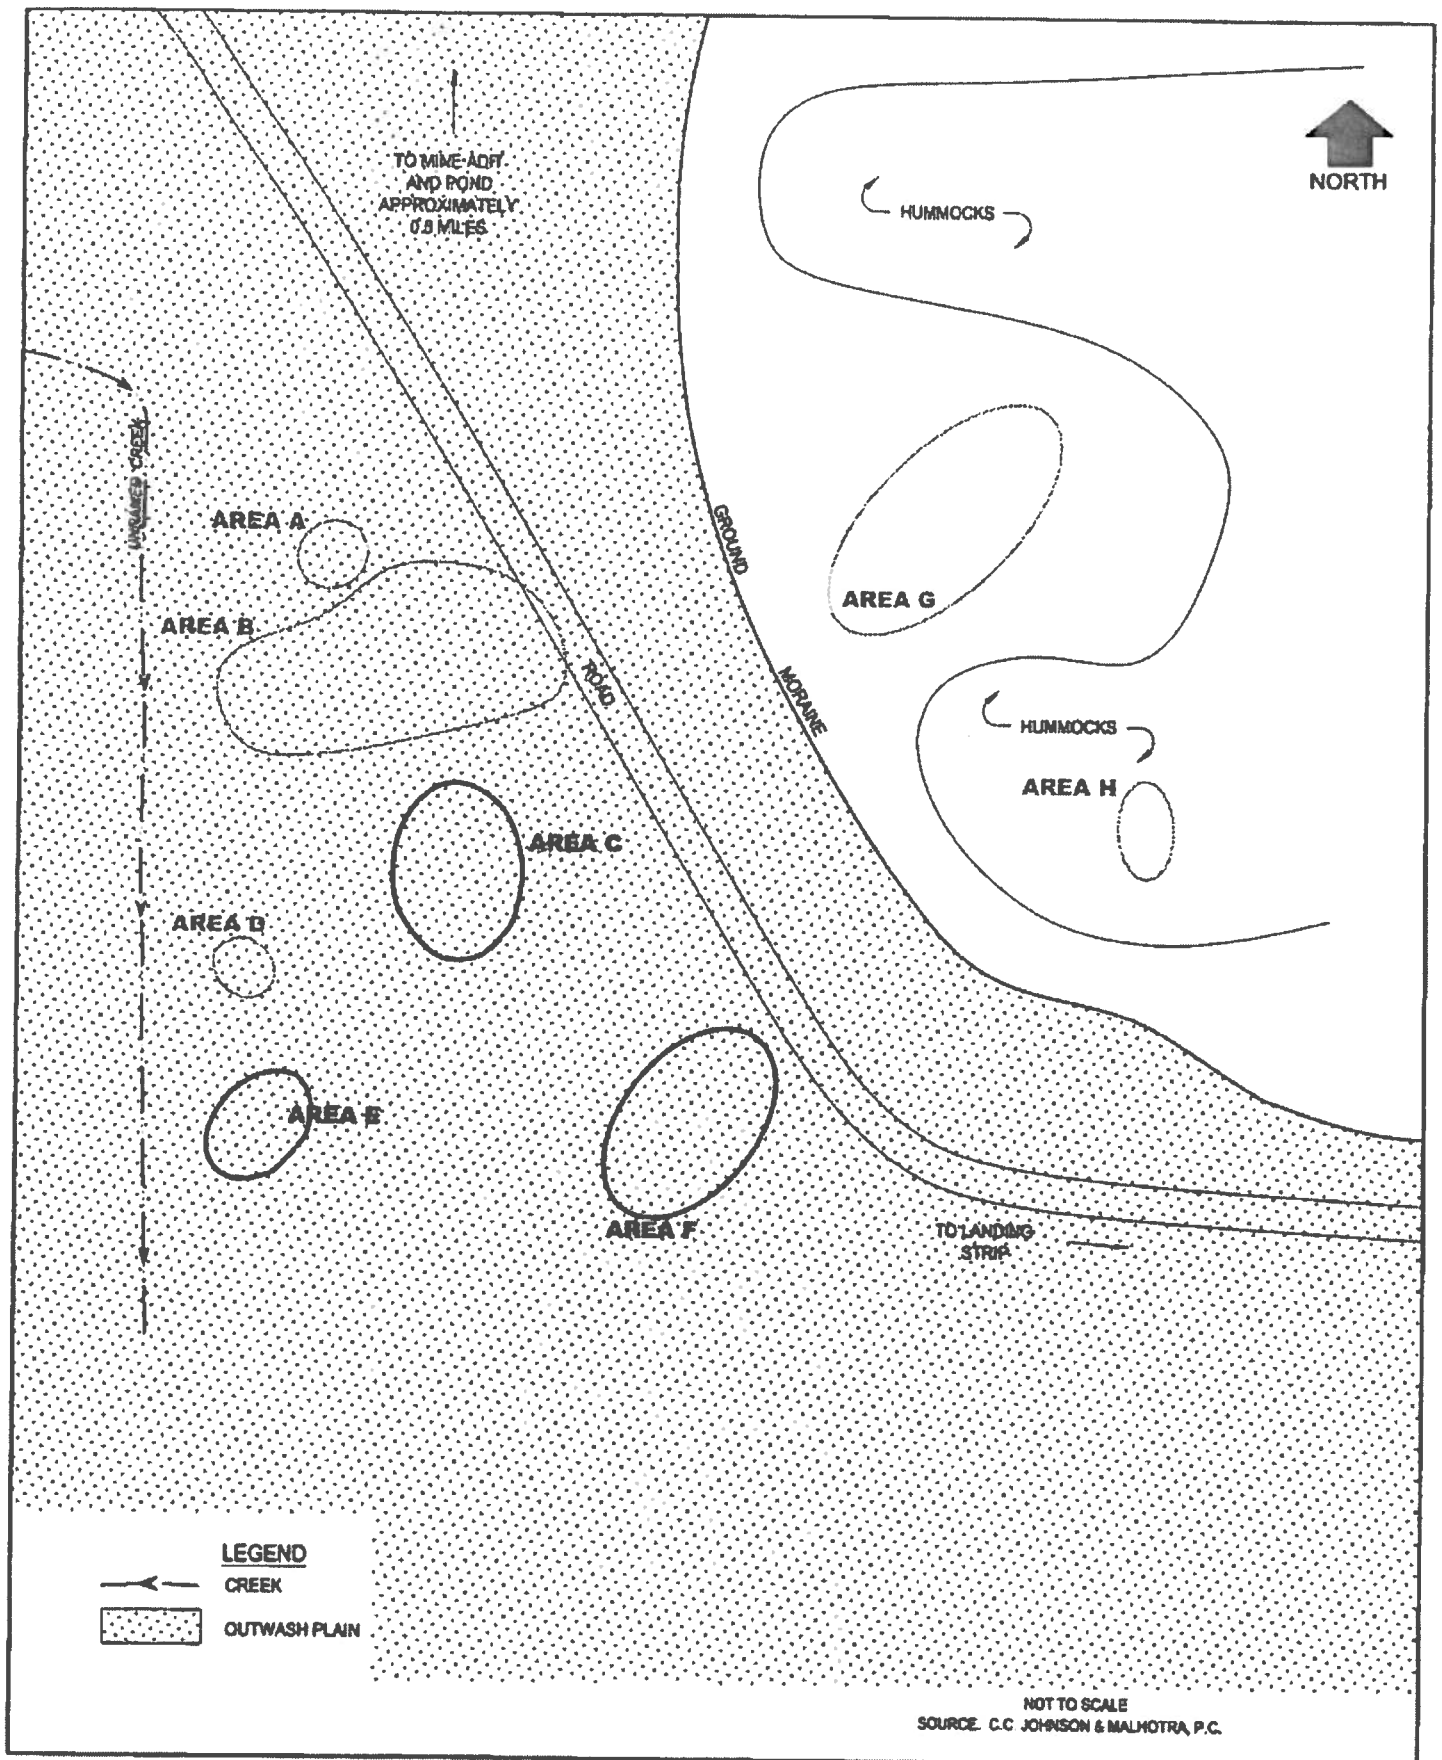
**Proposed Excavation Areas
Mine Camp Areas C, E, and F**

Contaminant	Minimum Detected Concentration (mg/kg)	Maximum Detected Concentration (pmm)	Method 2, Migration to GW Cleanup (mg/kg)	Location of Maximum Concentration
DRO	20	17,000	250	Mine Camp Area E
Benzene	0.07	0.1	0.02	Mine Camp Area E

The contaminants of concern associated with this site include DRO and benzene; all other petroleum related constituents sampled for were below a Method Two, migration to groundwater, cleanup levels. The maximum concentration of DRO found in the soil was 17,000 milligrams per kilogram (mg/kg) and benzene was 0.1 mg/kg.

HLA/Wilder returned to the site in to perform remedial actions in 2000. Approximately 730 cubic yards of petroleum impacted soil was removed from 5 areas of concern at the mine area. Soil samples were collected from the limits of the excavations and analyzed for GRO or DRO,

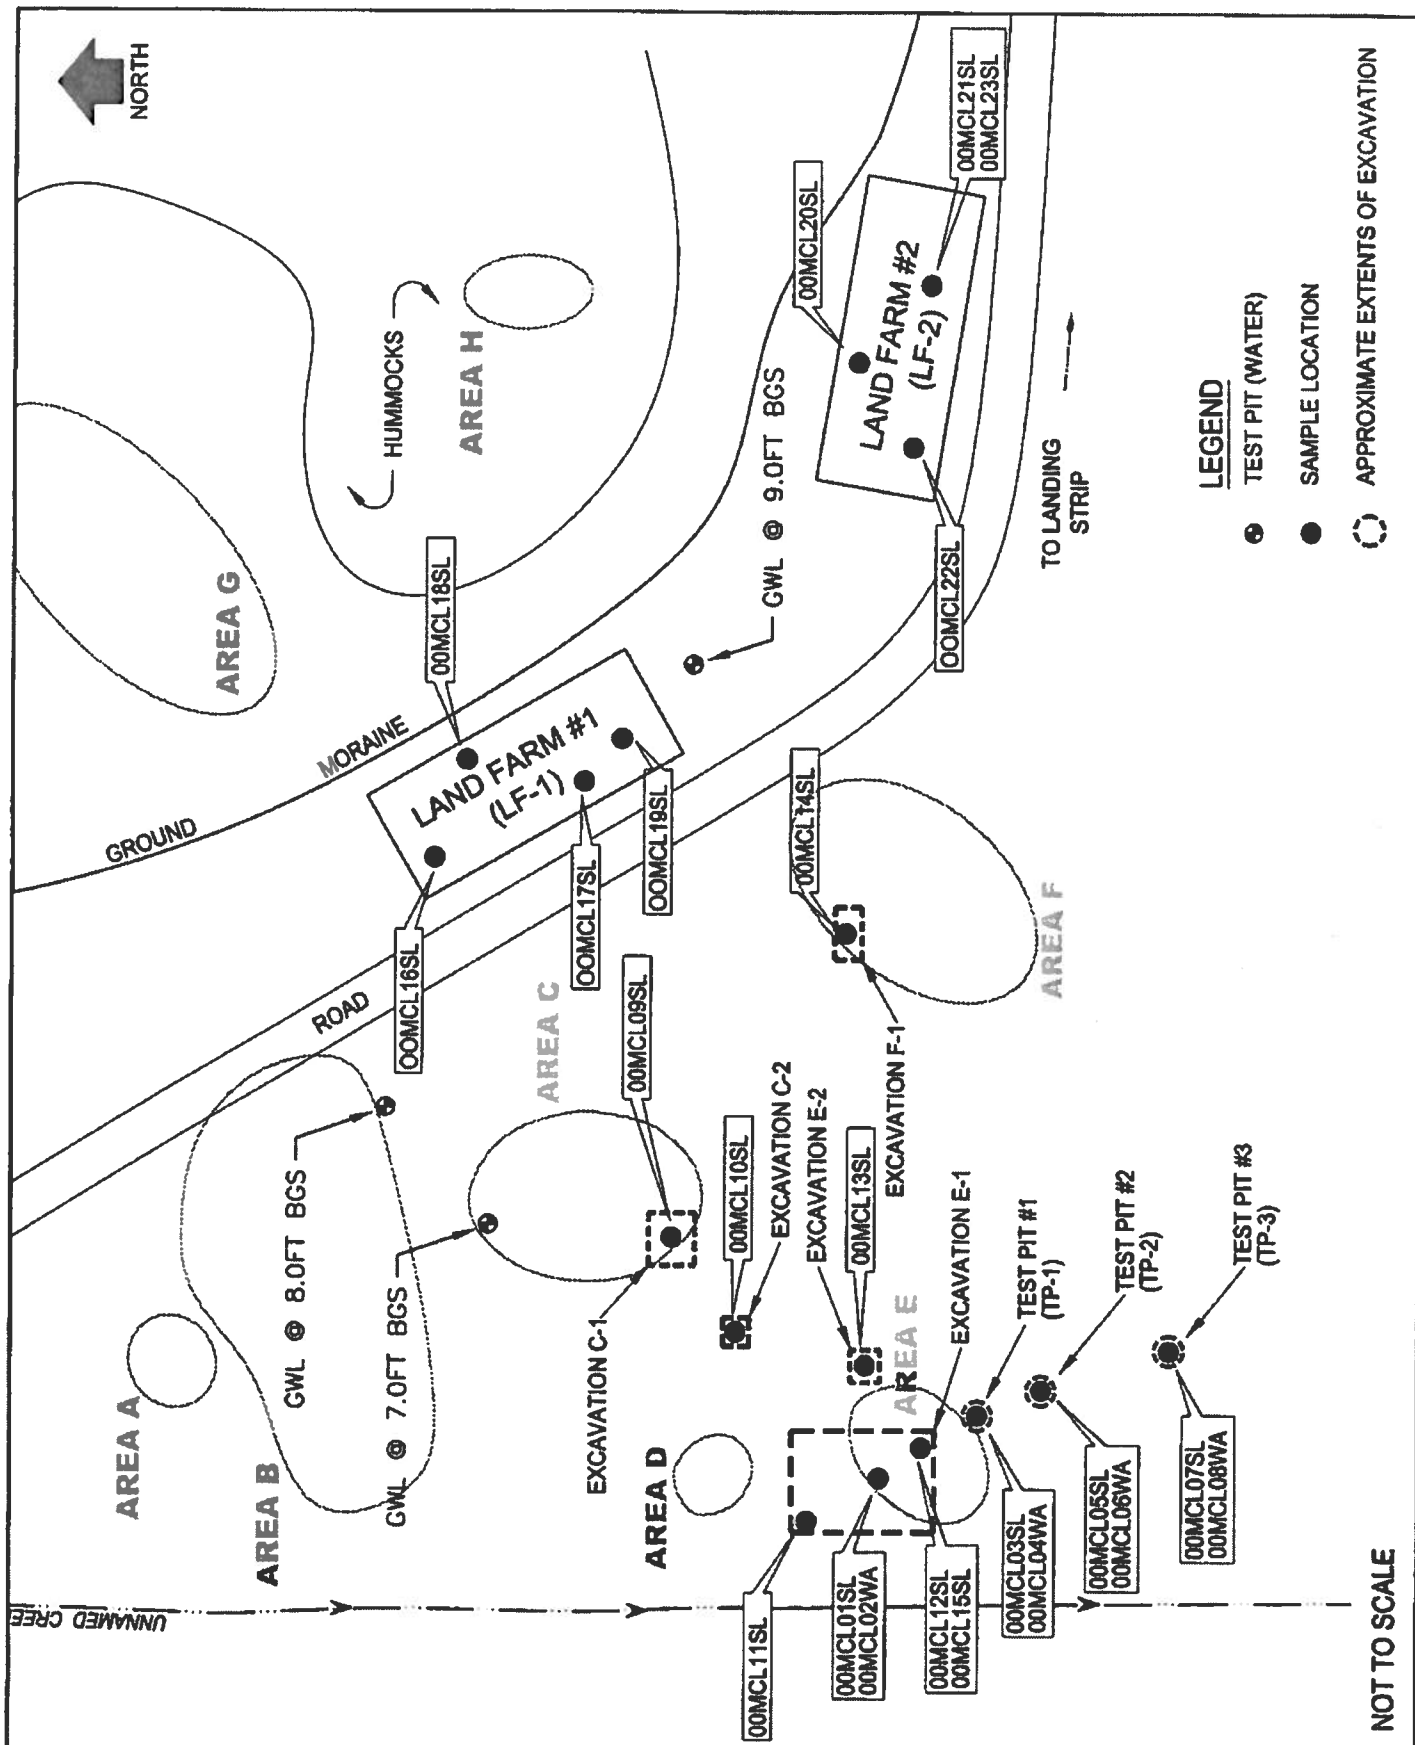
Excavations, Land Farms, and Sample Locations

depending on the area of concern, and BTEX. All results were below the cleanup levels. A sheen was observed on 40% – 50% of the groundwater encountered at the bottom of excavation E-1. Three downgradient test pits were excavated to determine the lateral extent; no sheen was observed in the downgradient test pits. Soil and water samples were collected from the smear zone of each test pit and excavation E-1 and analyzed for GRO and BTEX. Results were non-detect for all analytes.

The excavated soil was treated with 450 pounds of fertilizer and placed in two landspread areas for treatment. Soil samples from the landspread soil were collected and analyzed for DRO, with a maximum result of 13,100 mg/kg. In October 2001, the contractor returned to the site and collected additional samples from the landspread soil. The maximum result for DRO was 3,900 mg/kg.

In 2013, BLM contracted Marsh Creek, LLC to conduct soil sampling at the landspread areas. Marsh Creek collected multi-incremental soil samples from the two landspread areas and submitted the samples for analysis of DRO. Results are below the migration to groundwater cleanup level of 250 mg/kg.
