**Department of
Environmental Conservation**

DIVISION OF SPILL PREVENTION AND RESPONSE
Contaminated Sites Program

Subject: Decision Document: Galena AFS/Airport - Former Aircraft Refueling Pads (PADS / CSS005)
Cleanup Complete Determination

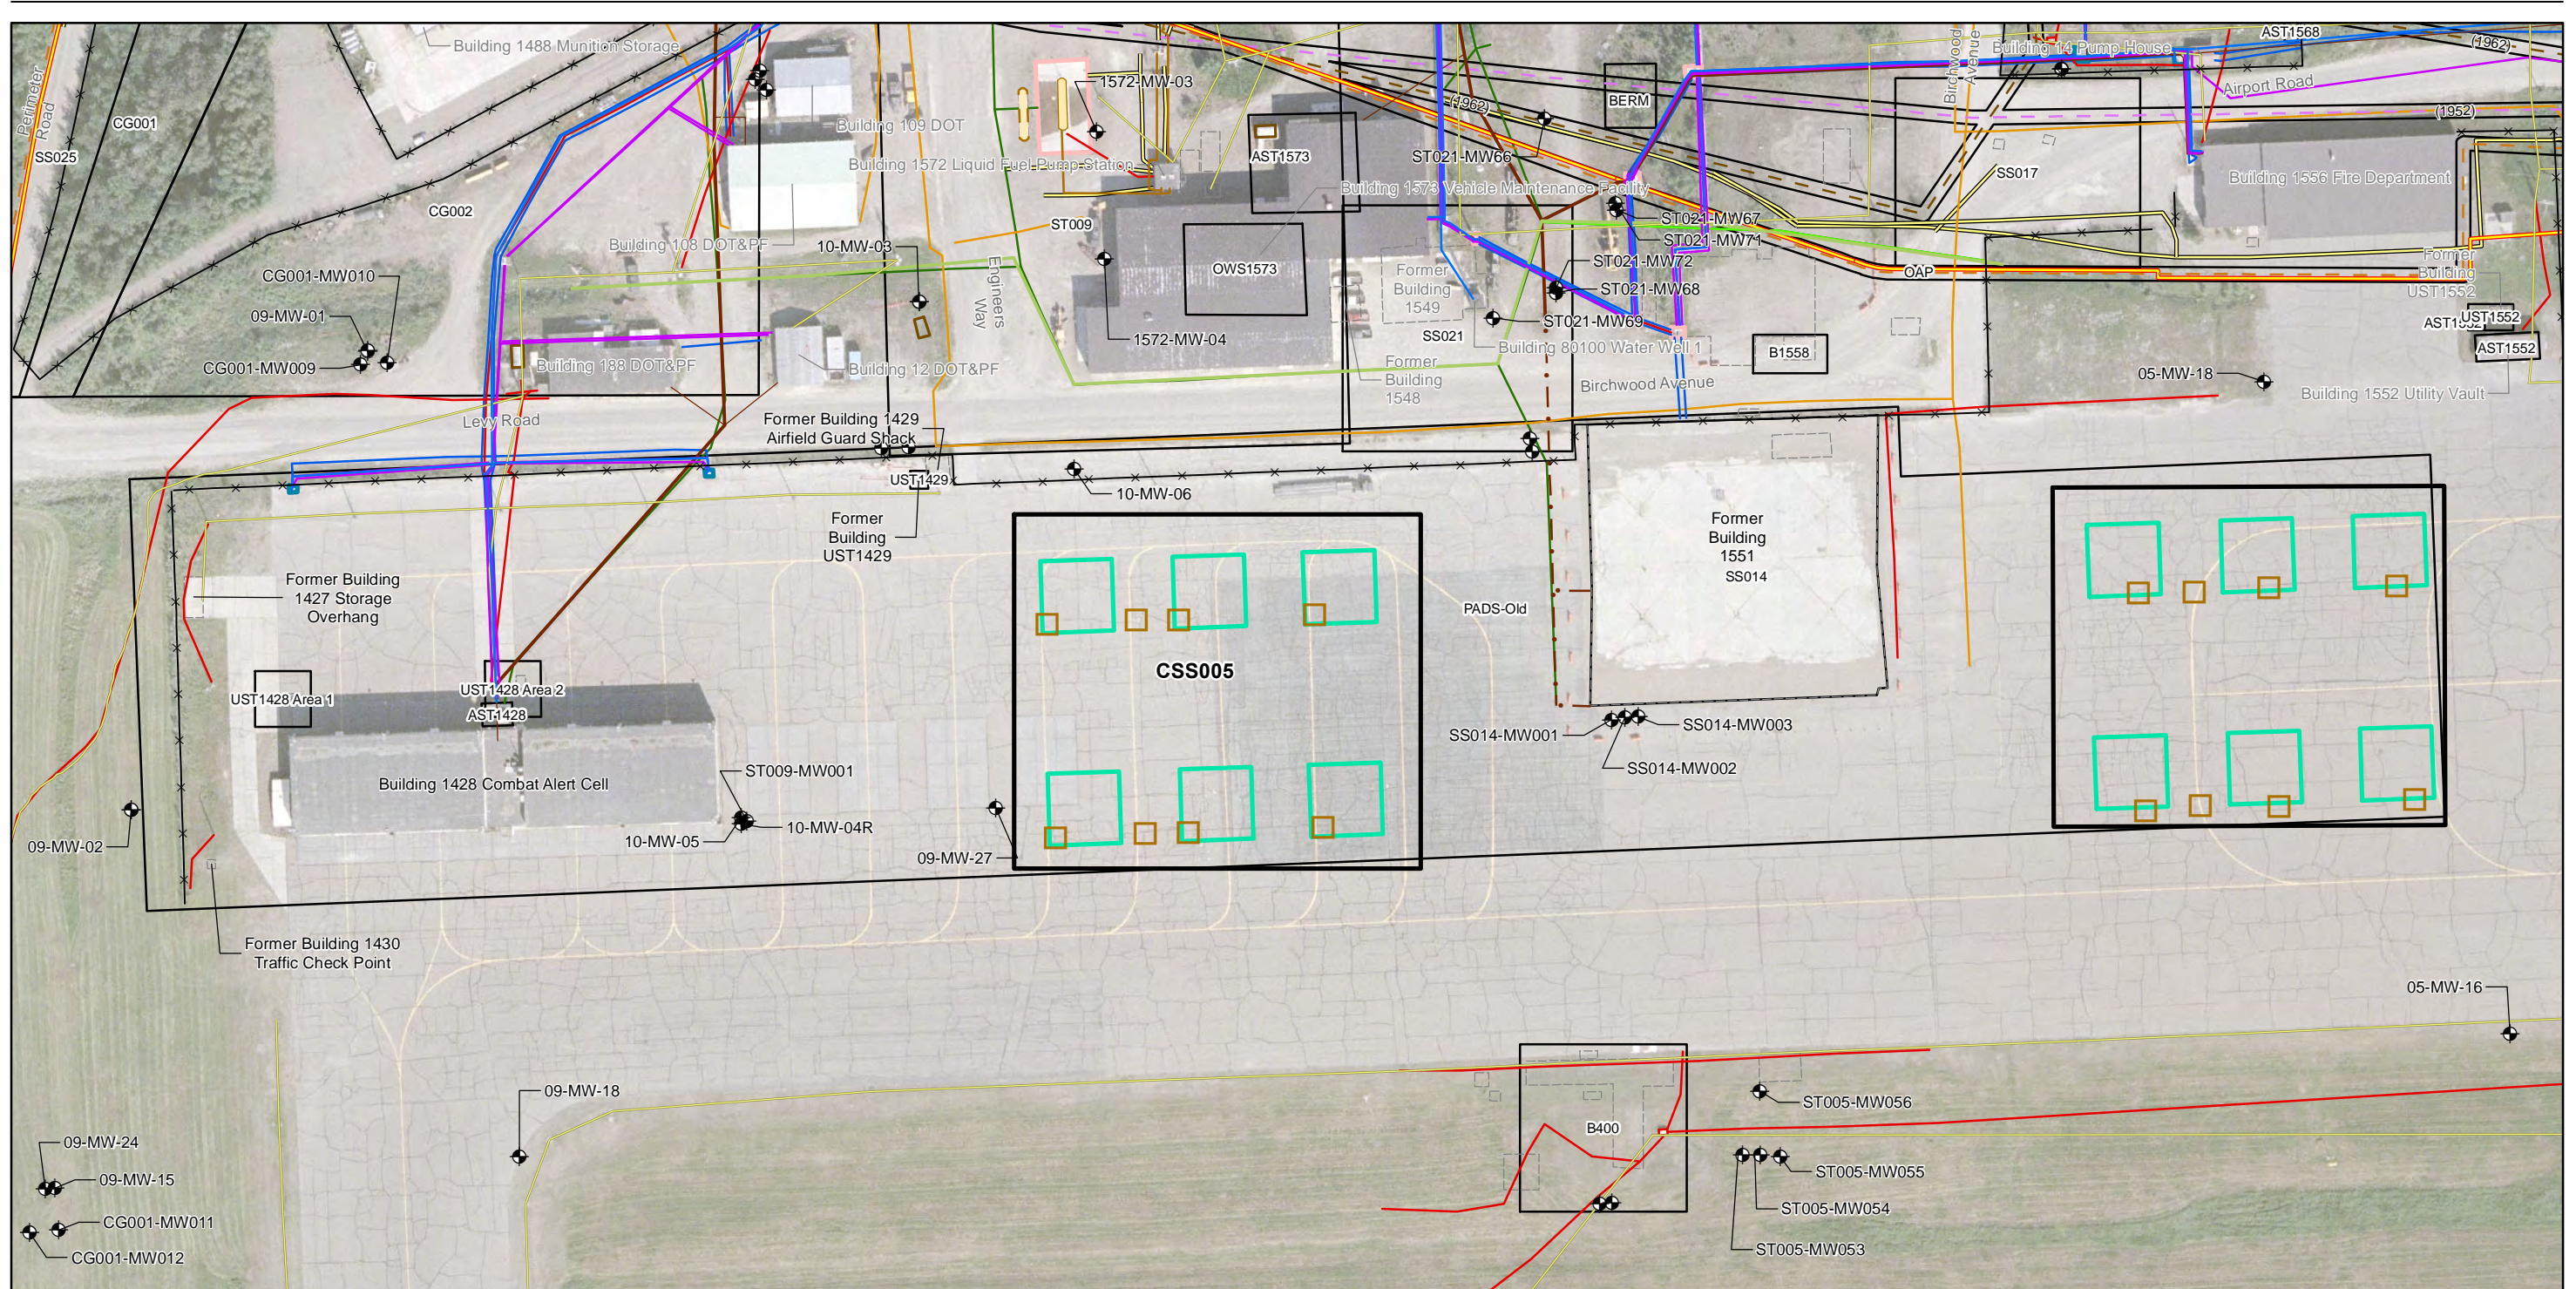
FIGURE 1
Site CSS005 Layout
 ADEC Method Three Risk Evaluation
 Former Galena Forward Operating Location. Alaska

The former Aircraft Refueling Pads (Site CSS005, formerly known as Site PADS) is located within the airfield, south of the Former Galena FOL cantonment triangle, as shown on Figure 1.

Site CSS005 consists of 12 former aircraft refueling pads, outlined in green on Figure 1. The dimensions of each former refueling pad is approximately 50 feet by 50 feet. The former refueling pads have been covered over by more recent pavement and are no longer visible. The source of contamination is suspected surface releases associated with aircraft refueling.

Excluding the asphalt-related surface soil samples, the fuel-related contaminated subsurface soil area is approximately 7 feet by 7 feet, and extends from approximately 5 to 9 feet bgs within the vadose zone (approximately 7.25 cubic yards). The 1,1,2-trichloroethane contamination in surface soil is approximately 3 feet by 3 feet and extends from approximately 0 to 2 feet bgs within the vadose zone.
