United States Department of the Interior

NATIONAL PARK SERVICE

January 3rd, 2018

Re: Documentation of Institutional Controls at the Denali Bus Barn Site, ADEC File Number 220.38.042

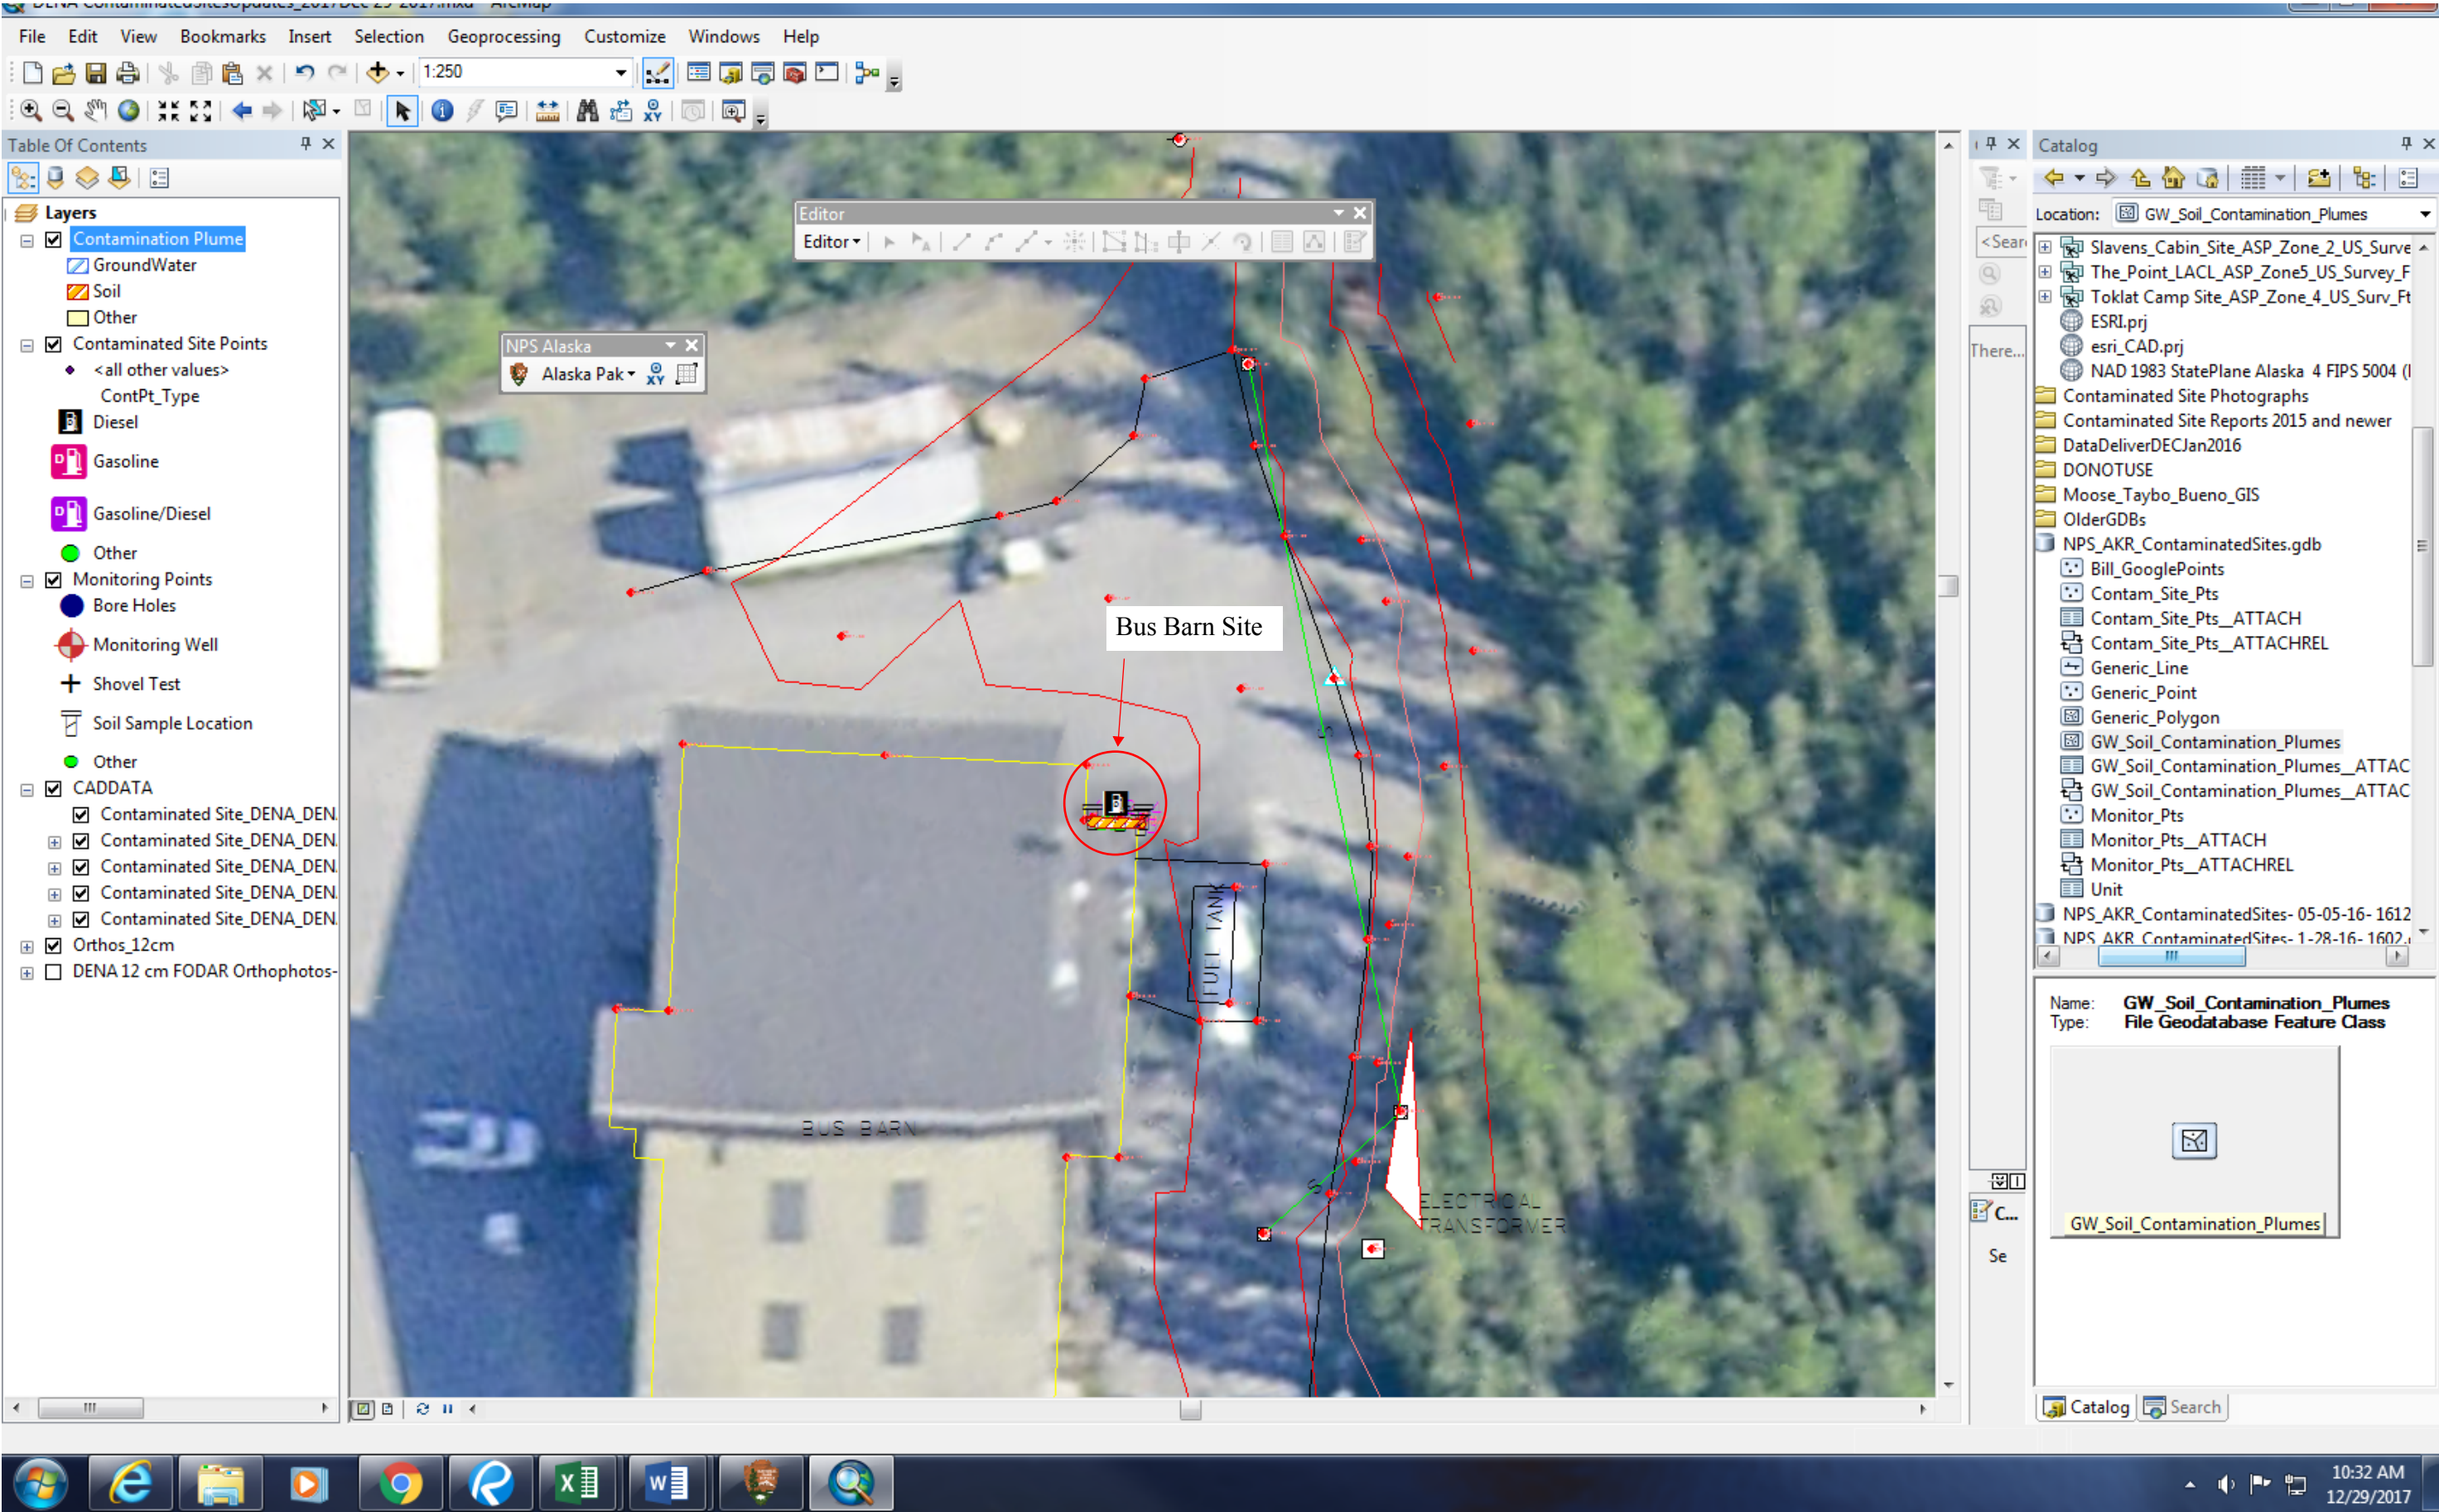
Figure 1- Screen Shot of Overall Bus Barn Site in NPS GIS Database

Figure 1. An overall screenshot of the Bus Barn site in GIS is provided on this figure. The colored lines that are not part of the aerial photographic image are from a drawing in Autocad Civil 3D, based on the site survey, which is more positionally accurate than the aerial photography.

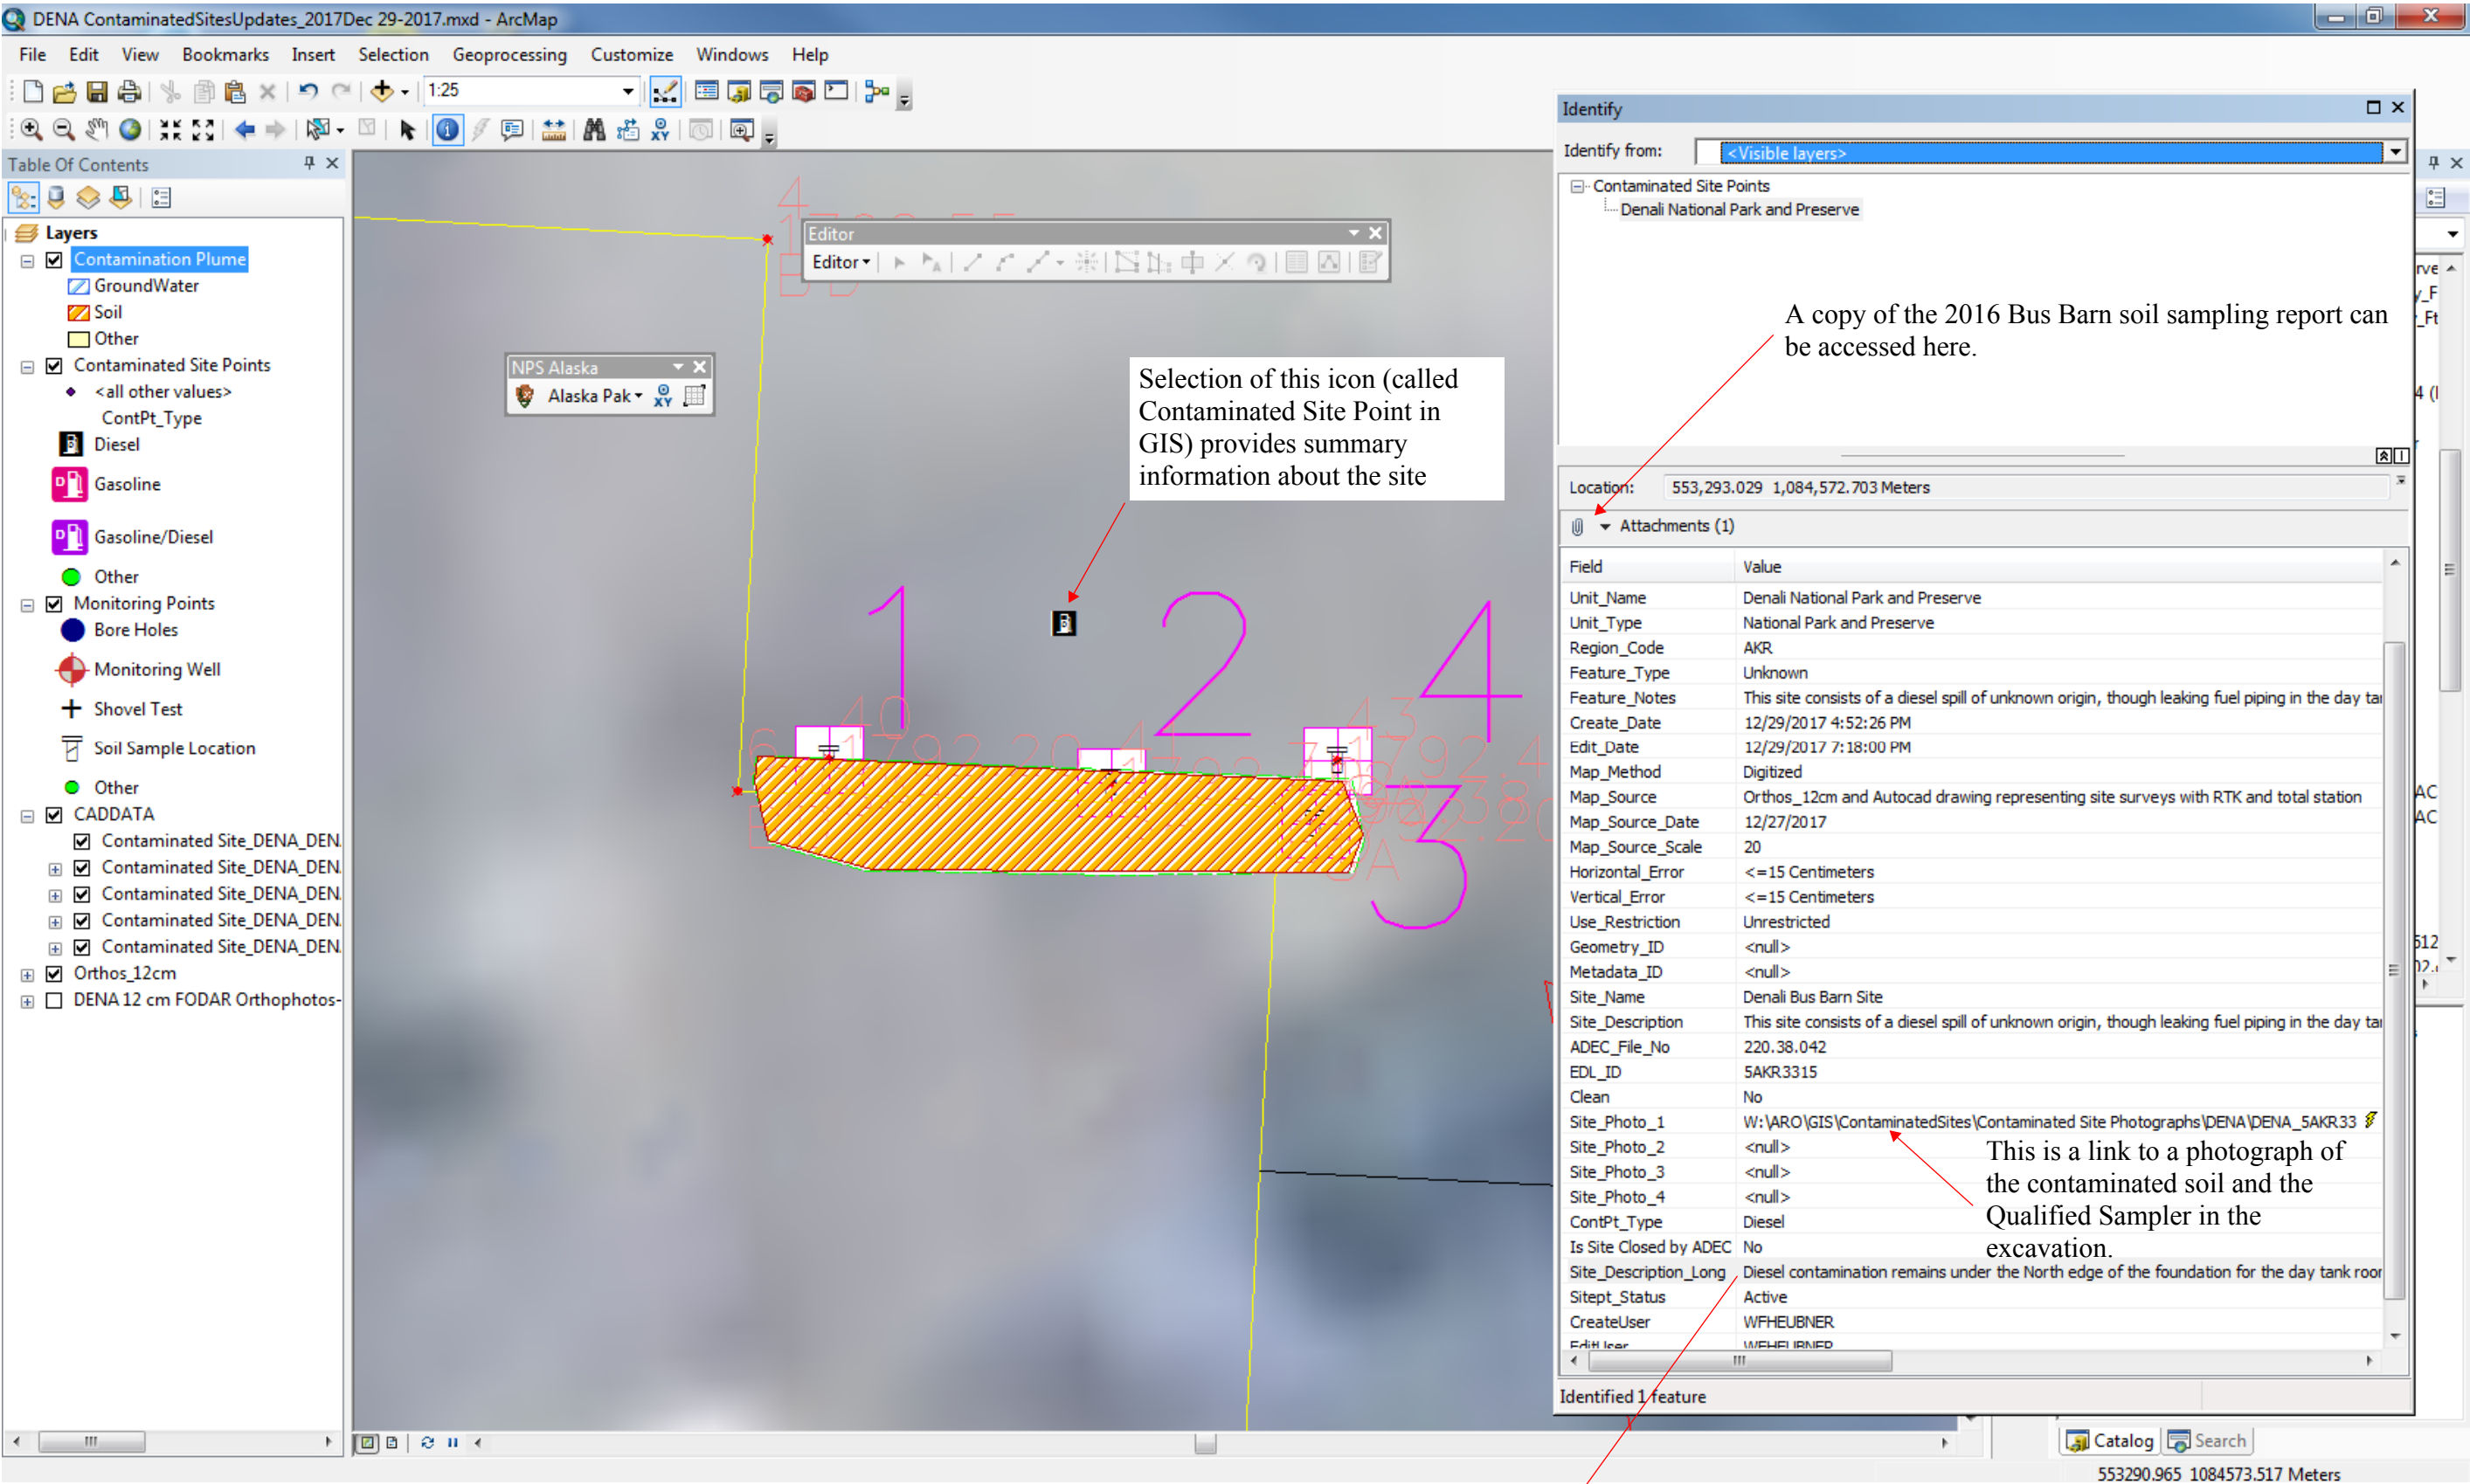
Figure 2- Screen Shot of Contaminated Site Summary Data in NPS GIS Database

Figure 2. On this figure, a black fuel pump icon is used to denote the Contaminated Site Point in the GIS database for the Bus Barn Site. The data entered for the Bus Barn Site is displayed in this printscreen. The red arrows and associated text on these printouts are not part of the database, but added to the printscreen to help clarify what is being displayed.

Full text for Site Description-Long: “Diesel contamination remains under the North edge of the foundation for the day tank room. This soil must be removed by workers with PPE if the building is removed. No drinking water well shall be drilled in this vicinity.”

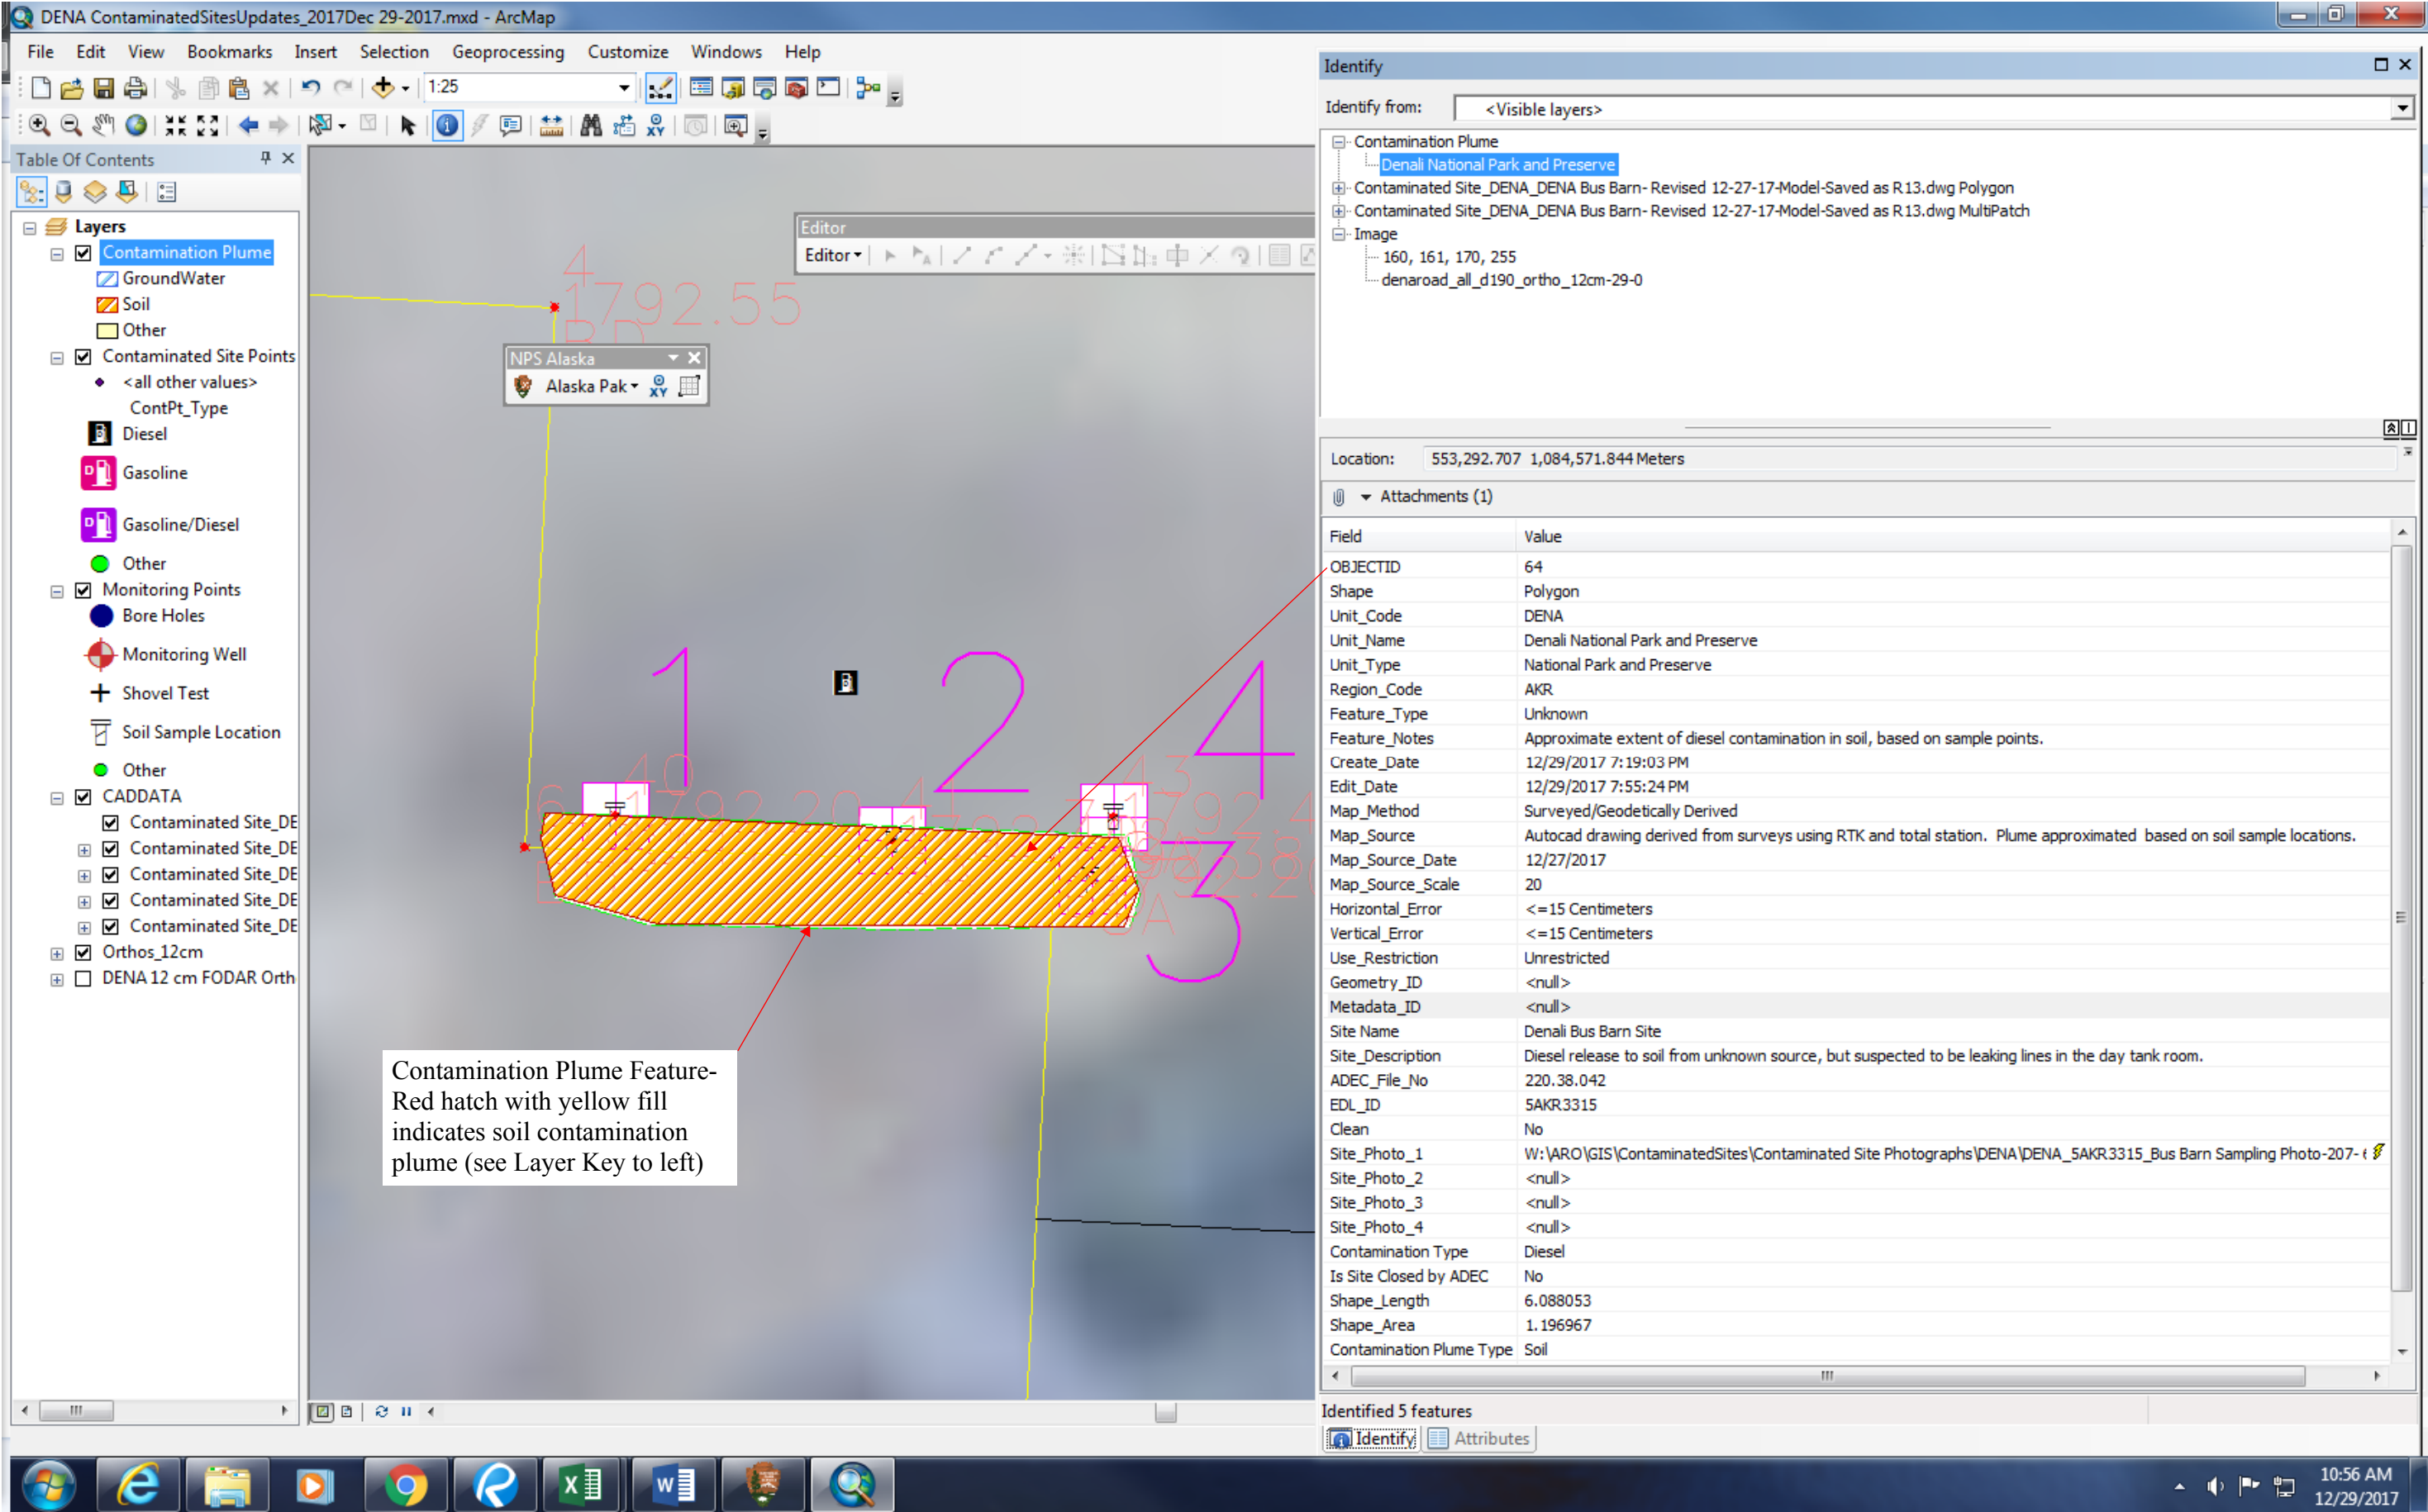
Figure 4- Screenshot of Soil Contamination Plume Data in the NPS GIS Database

Figure 4. This figure is a printscreen of the approximate extent of the contamination plume (in this case, soil contamination plume) for this site. The red arrow shown on this this screenshot is not part of the database. The plume extent shown on this figure is approximated, since there is no information on the extent of contamination under the floor slab.

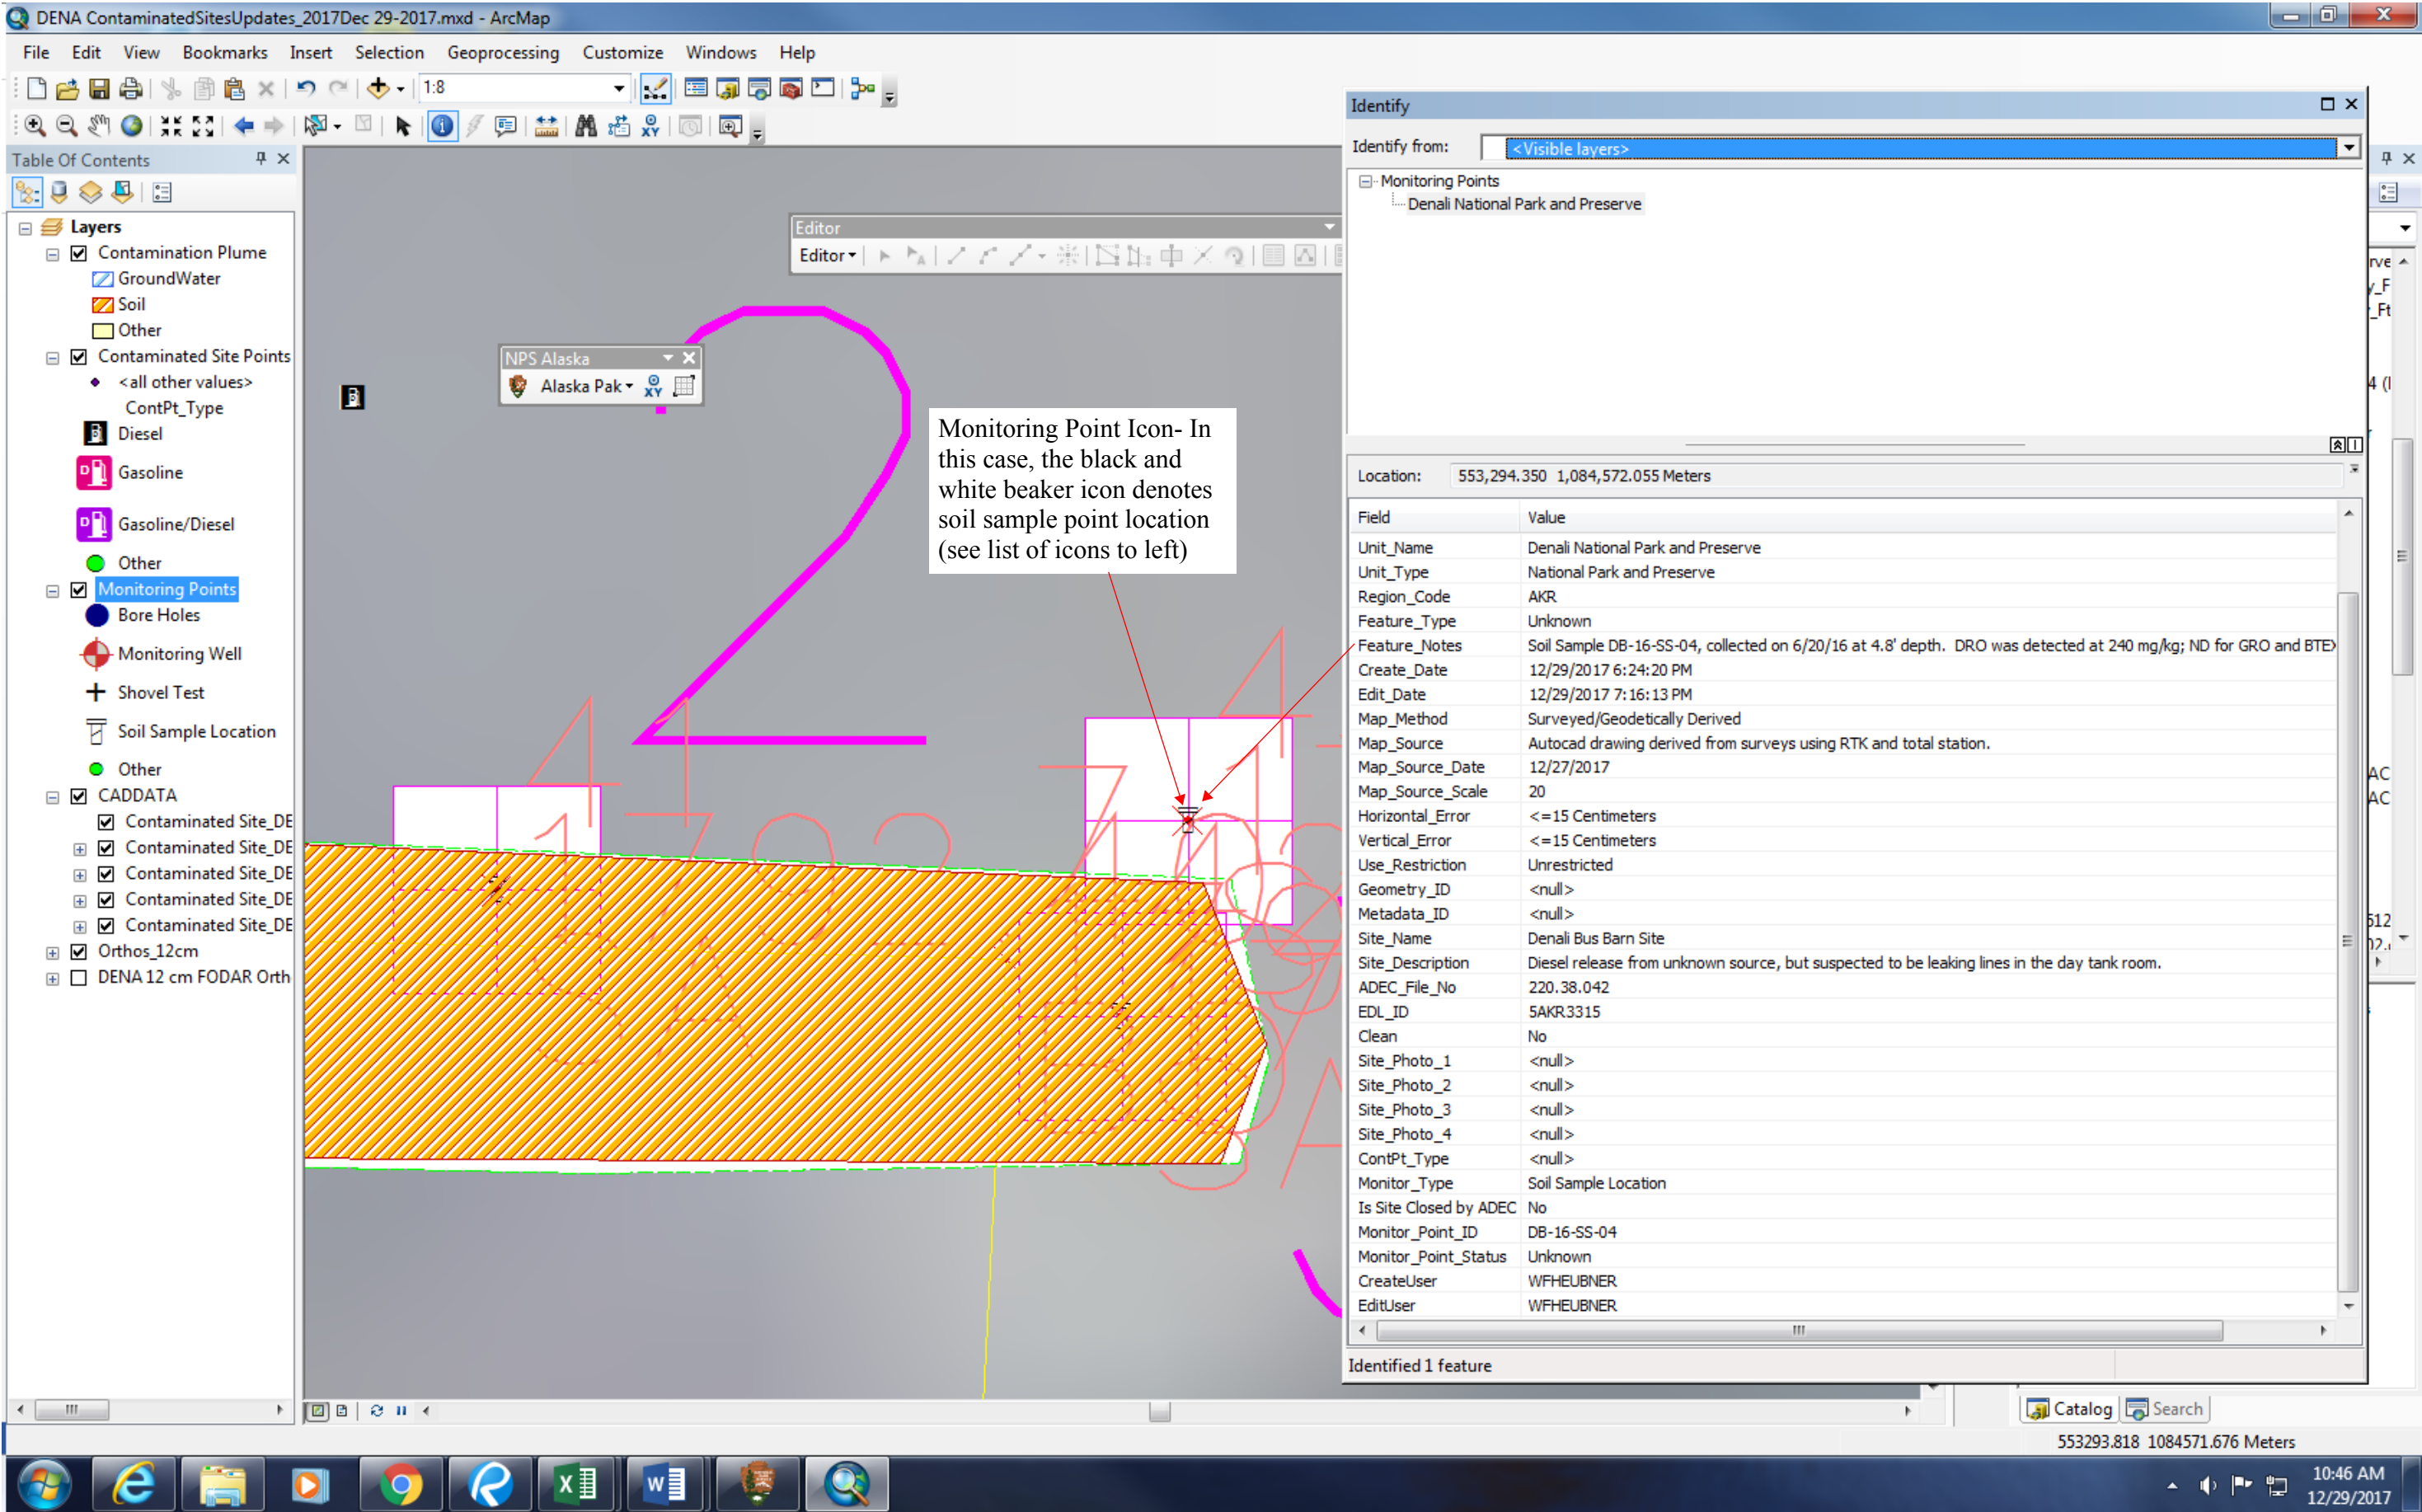
Figure 3- Screen Shot of Soil Sample Point Data (Data shown is for Sample DB-16-SS-04) in NPS GIS database

Figure 3. Example data for a Contaminated Site Point (in this case, soil sample DB-16-SS-04, found in the 2016 sampling report) is displayed in this figure. Locations where soil samples were collected are identified by a black and white icon that looks like a laboratory beaker in this figure. The red arrow pointing to the soil sample location is not part of the database, but identifies which soil sample location corresponds to the data shown.
