STATE OF ALASKA

DEPARTMENT OF ENVIRONMENTAL CONSERVATION DIVISION OF SPILL PREVENTION AND RESPONSE CONTAMINATED SITES PROGRAM

Re: Decision Document; FIA – Empire Airlines
Corrective Action Complete – Institutional Controls Determination

FIA- Empire Airlines (#4)
Block 3 Lot 9
Fairbanks International Airport, Fairbanks, Alaska

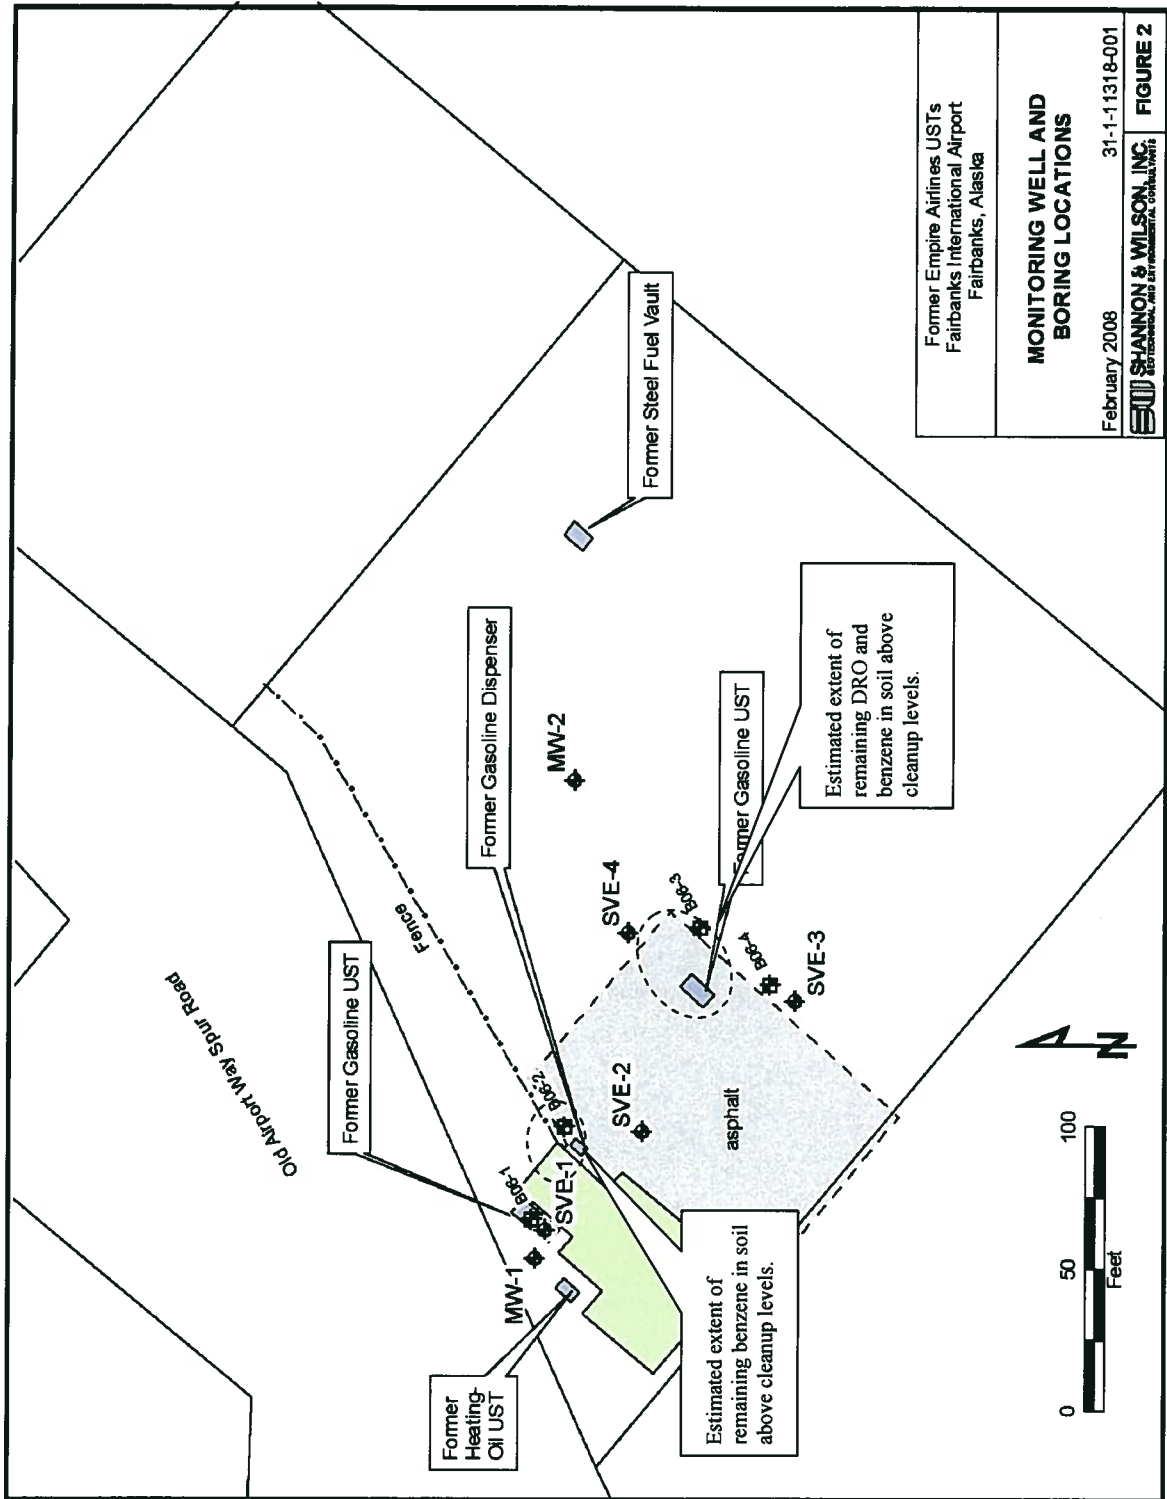
Attachment B: Site Figure

3. Installation of groundwater wells will require approval from ADEC and the FAI DOT&PF Leasing Office.
4. Any proposal to transport soil or groundwater off site requires ADEC approval in accordance with 18 AAC 78.600(h). A “site” [as defined by 18 AAC 75.990 (115)] means an area that is contaminated, including areas contaminated by the migration of hazardous substances from a source area, regardless of property ownership. (See attached site figure).
