SITE CHARACTERIZATION AND CORRECTIVE ACTION REPORT

**NAPA FACILITY
1937 VAN HORN ROAD
FAIRBANKS, ALASKA**

JANUARY 22, 2013

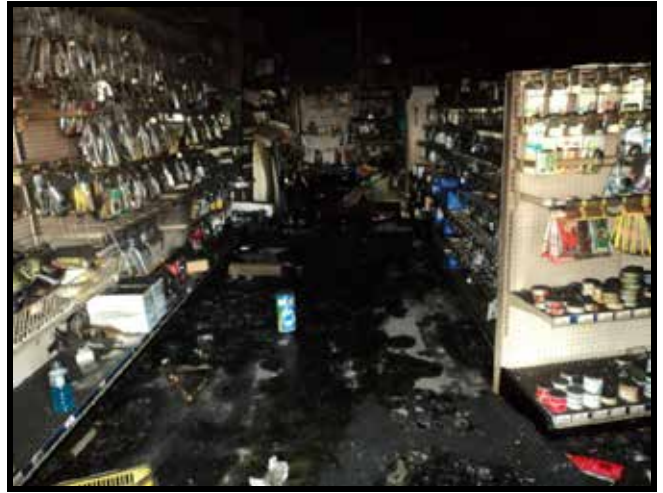
Photo 1: 5/27/2011 - South side of NAPA facility during initial visit.

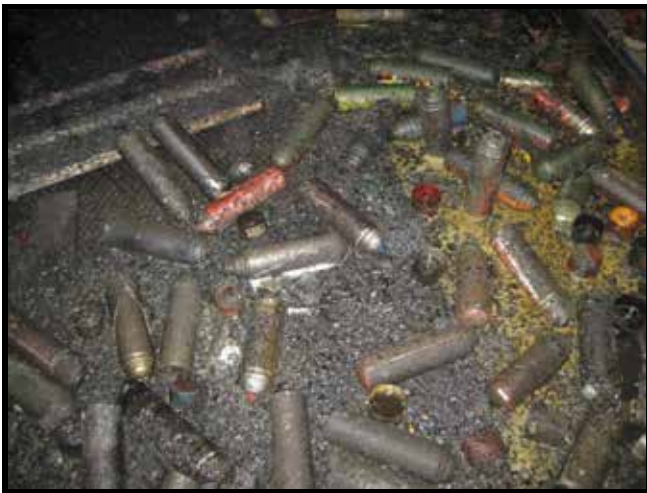
Photo 2: 5/27/2011 – Typical retail conditions.

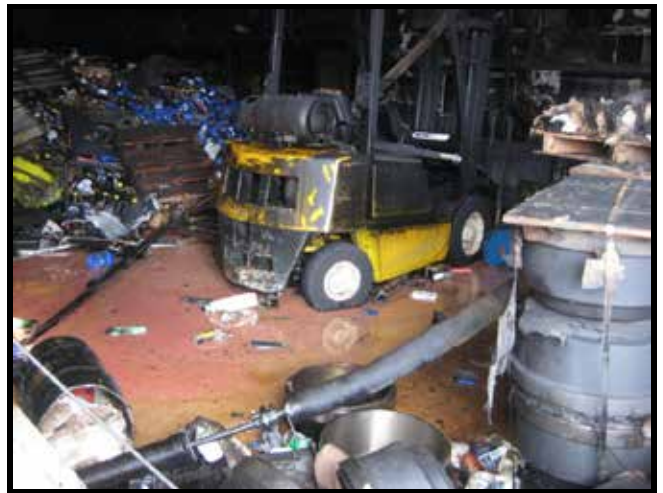
Photo 3: 5/27/2011 – West side area conditions.

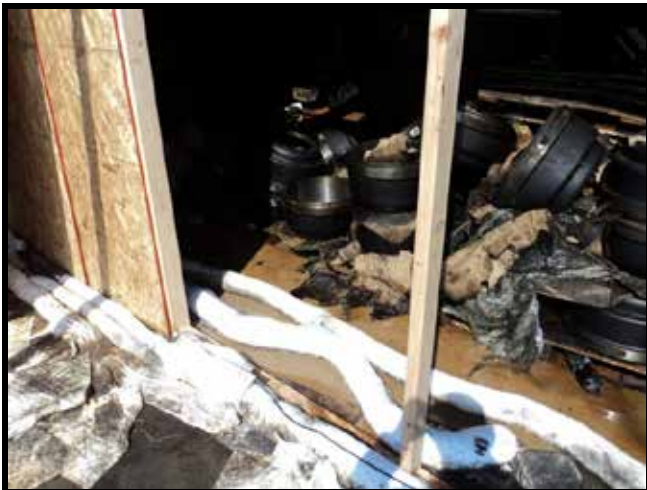
Photo 4: 5/29/2011 – South end warehouse conditions.

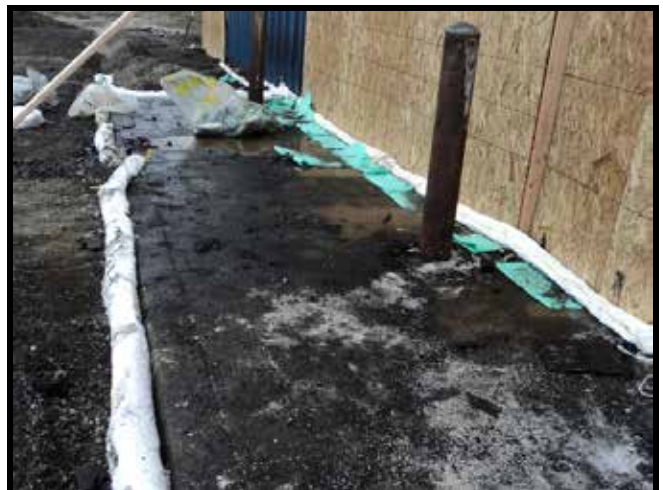
Photo 5: 5/27/2011 – South warehouse door sludge containment.

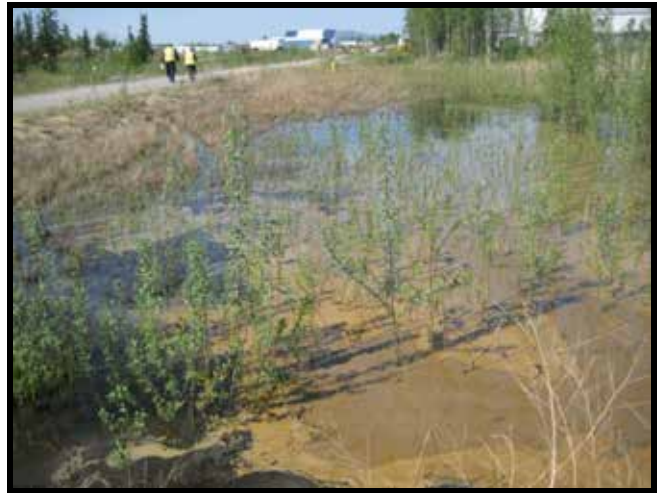
Photo 7: 5/27/2011 – Impacted ground from firefighting water release on the south side of the property.

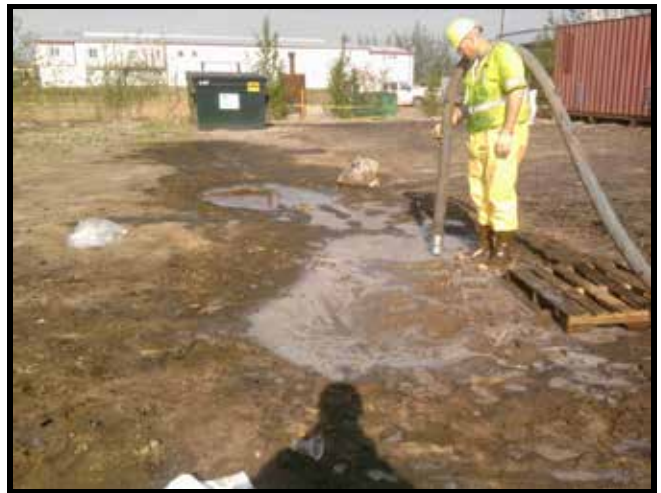
Photo 9: 5/28/2011 – “Stinger” collecting floating phase contaminants from the South Ditch.

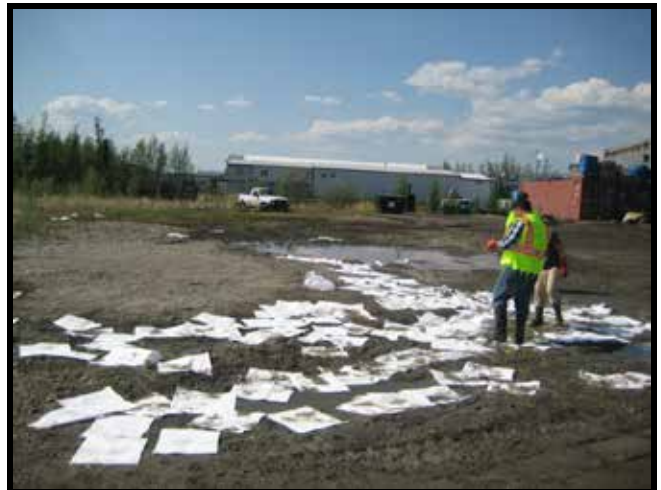
Photo 11: 5/29/2011 – Southeast perimeter Ditch surface contaminant absorption.

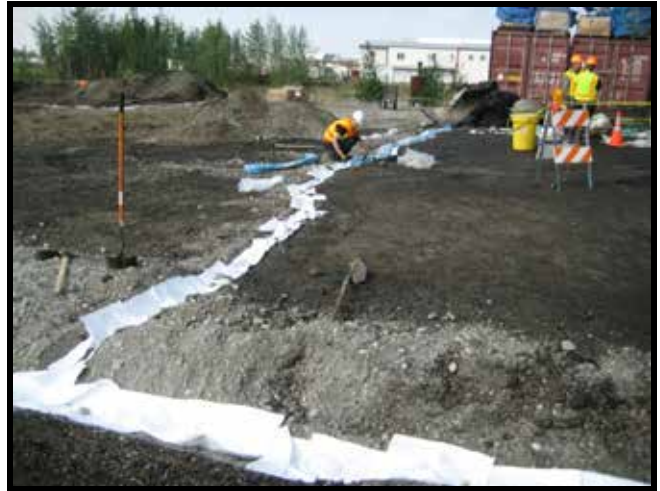
Photo 13: 5/29/2011 – West building perimeter sludge and surface migration control.

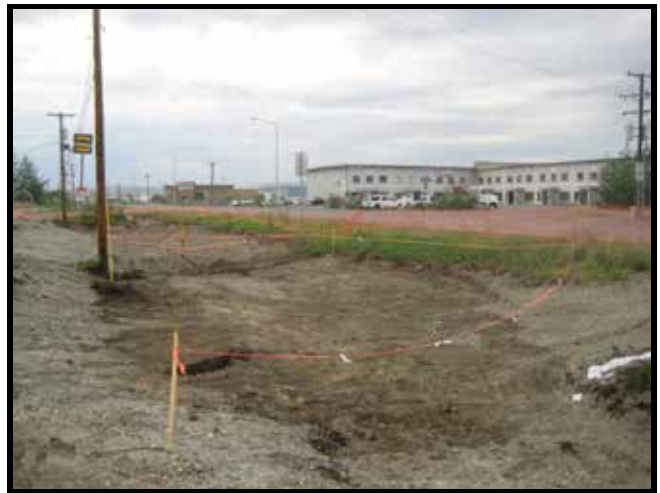
Photo 15: 6/2/2011 – Southern soil stockpile construction.

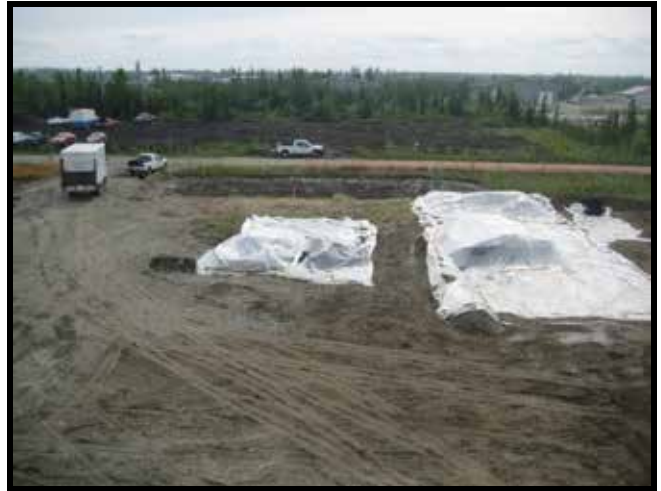
Photo 19: 6/3/2011 - Eastern stockpile excavated from perimeter ditches.

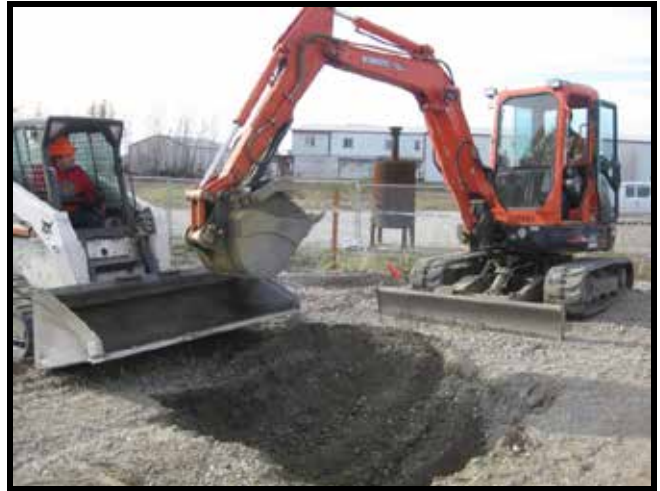
Photo 31: 9/22/2011 – Typical surface stain corrective action.

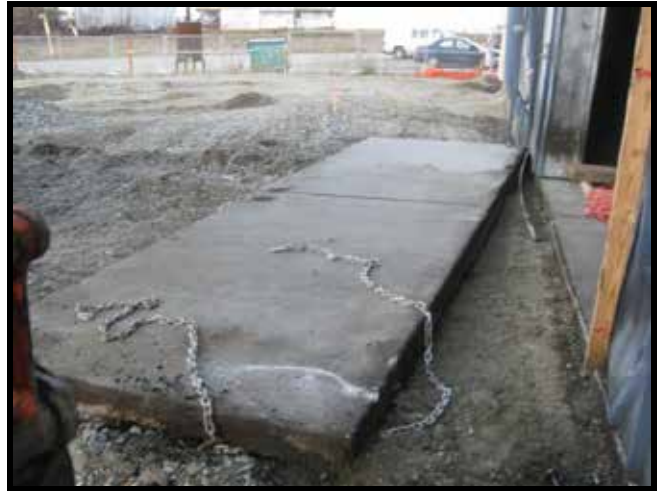
Photo 37: 10/6/2011 – Surface impacts from oily sludge at southern overhead door.

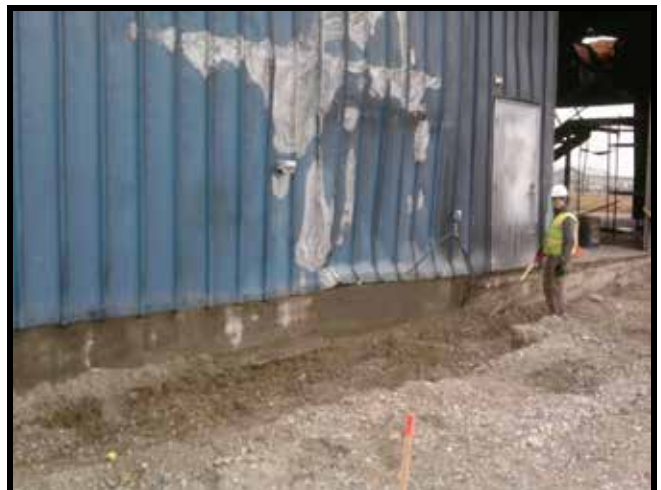
A shallow lens of contaminated soil remains within the structural prism below the concrete foundation at the southern end of the building. This lens extends south from the overhead door on the east side of the building, across the south side of the building, and approximately 30 feet north on the west side of the building. The lens extends approximately five feet radially from the base of the grade beam near the southeast corner and tapers down to the west, extending approximately three feet radially from the grade beam near the southwest corner of the building. DRO concentrations are typically between 597 mg/kg and 7,190 mg/kg, and PCE concentrations on the east side are around 105 to 216 mg/kg and decrease to 0.482 to 0.77 mg/kg on the west side. Benzene and ethylbenzene also exceed the ADEC cleanup level near the southeast corner of the building. In addition to DRO and PCE, RRO also exceeds the ADEC cleanup level near the southwest corner of the building.

Photo 42: 10/12/2011 – Visible stained soils remaining within structural prism.

Perforated piping and a vapor barrier were installed around the foundation in this area prior to backfilling. These items, along with the concrete slab and impervious RAP surfacing, prevent infiltration, direct contact with the soil, and reduce the potential for vapor migration to both the indoor and outdoor air. The perforated piping can be used to evaluate the potential for vapor intrusion and provide access for vapor mitigation or remediation if necessary. The existing data is expected to be adequate to develop a vapor intrusion assessment plan and complete a risk evaluation to identify the appropriate remediation and long-term management strategy.

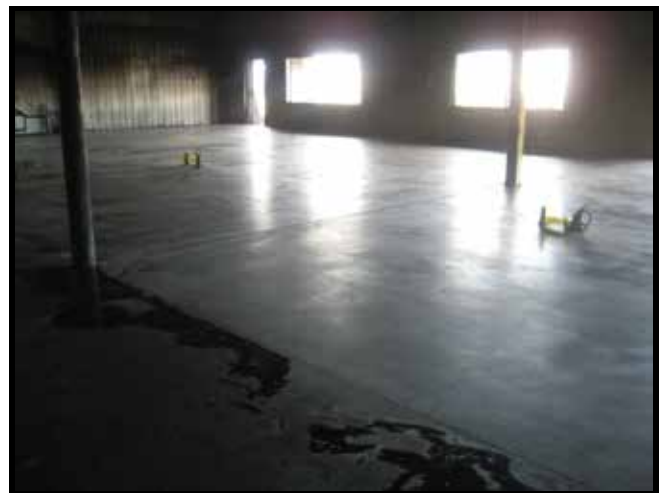
The top of the concrete slab was cleaned prior to building demolition to remove the remaining oily residue. The slab was observed to be intact with no cracks and minimal other damage from the fire or heavy equipment operations. Floor drains were cleaned and appeared intact. These were winterized to prevent additional damage. Dye testing is recommended to verify integrity after new construction.

Photo 46: 9/29/2011-Typical concrete floor section after cleaning.

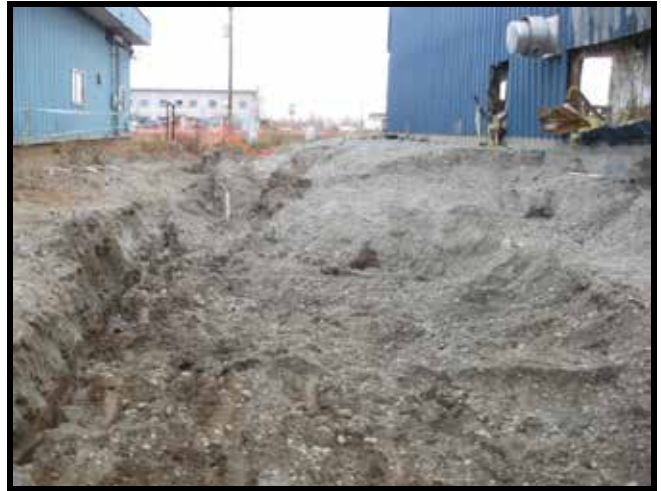
Photo 49: 10/11/2011 – Corrective action at 1:1 slope toward the West Ditch.

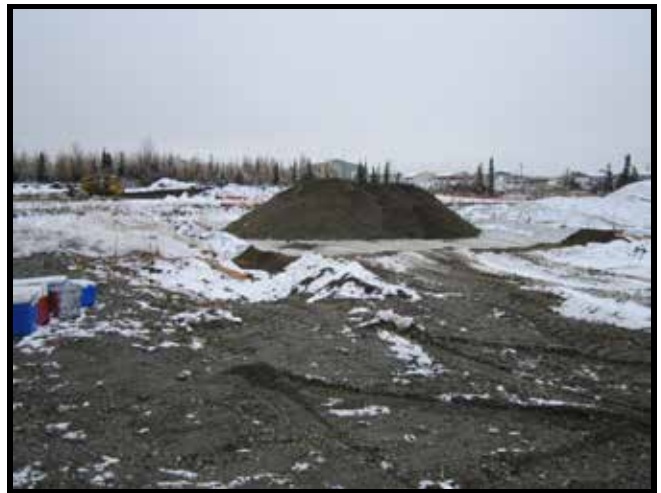
Photo 51: 10/13/2011 – Corrective action near the south end of the West Ditch.
