Department of Environmental
Conservation

DIVISION OF SPILL PREVENTION & RESPONSE
Contaminated Sites Program

RE: Cleanup Complete with Institutional Controls
Juneau Airport Travelodge Hotel Contaminated Site

Juneau Airport Travelodge UHOT
9200 Glacier Highway
Juneau, Alaska 99801
Airport Acres Block E Lots 6, 7 & 8

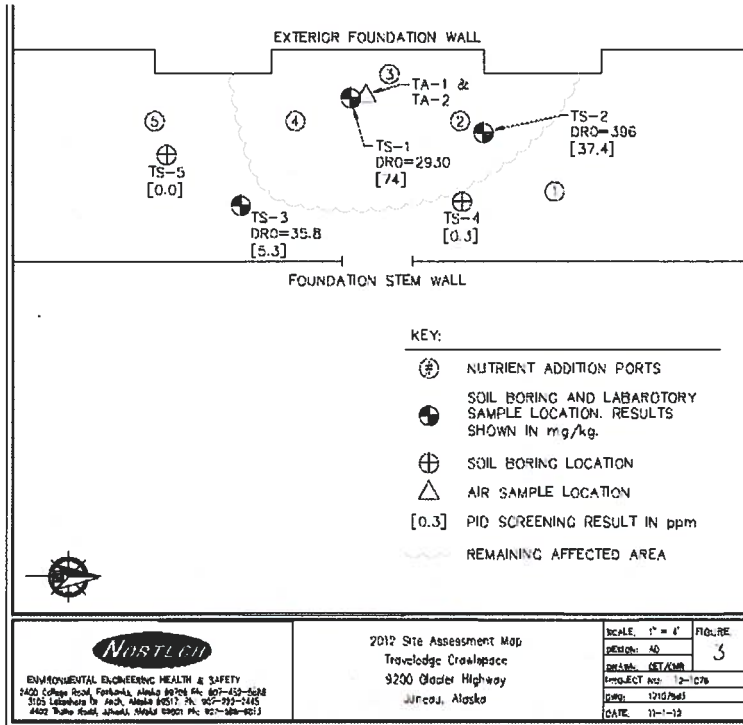
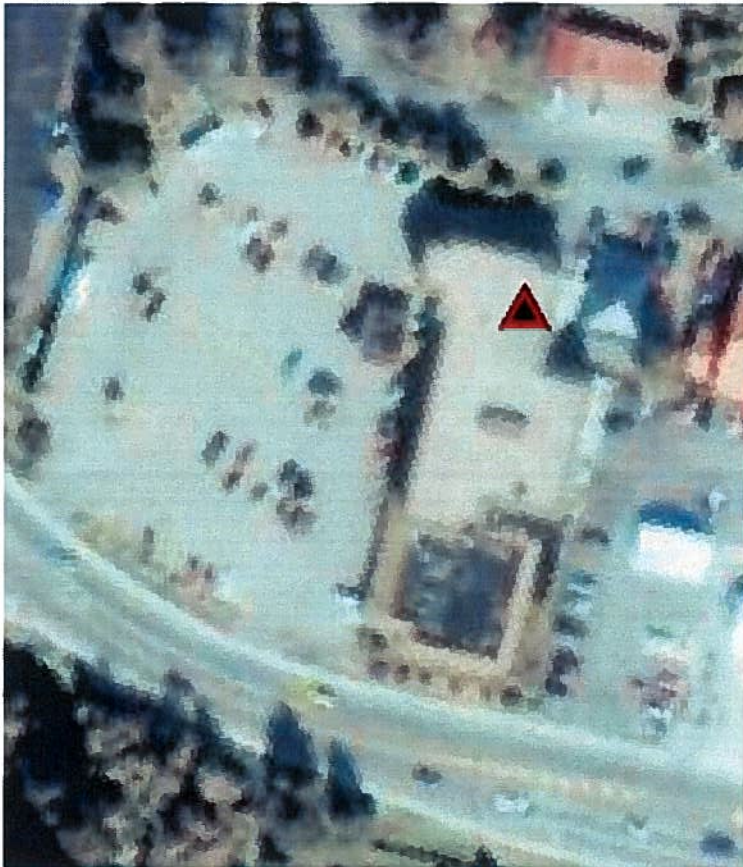
Attachment C: Site Figure

- 1) Soil contamination remains in a layer at the water table in the crawlspace of the north end of the building. Attached is a diagram of the property, with location of the former UST in relation to existing structures, the area that has been cleaned up, the approximate location and extent of remaining soil contamination and the locations where confirmation soil samples were collected.
- 2) A Notice of Environmental Contamination (deed notice) shall be recorded in the State Recorder's Office that identifies the nature and extent of contamination at the property and any conditions that the owners and operators are subject to in accordance with this decision document.
