RE: Valdez Petroleum Terminal Ground Water Monitoring Well Identification and Inspection

**Petro Star VPT Well Inspection**  
Valdez, Alaska

**Petro Star, Inc. VPT Monitoring Well Investigation: Photo Log – April, 2015**

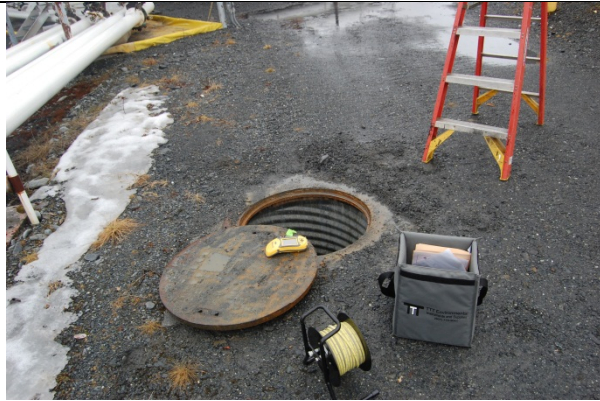
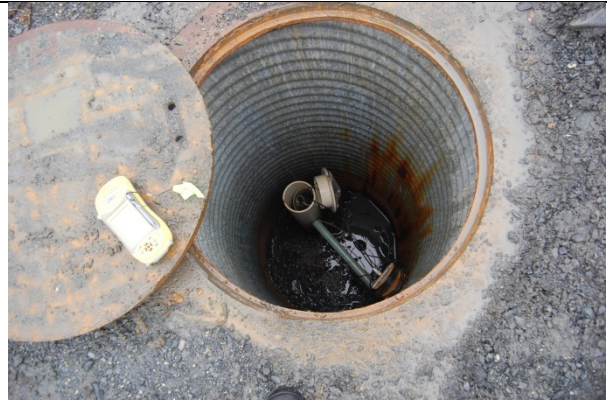
MW4.

Condition: The well appears to be in good condition. The pump system blocks access down the well casing for anything larger than a water level meter or flexible pump tubing. The well cap does not fully seal the well head. It is possible, though unlikely, that surface water could penetrate the manhole cover and drain into the well casing.

Contamination: A strong hydrocarbon odor was observed. A hydrocarbon sheen was visible on the water, but the sheen was light and thin. Measurable free product was not present.

Wells MW21 and BH1 require minor repairs to allow for sampling to occur. Sampling efforts would be simplified if the pump systems were removed from MW4, BH1, and BH3. All wells should be given new, locking well caps to ensure no surface contamination or vandalism occurs. Well MW1 is no longer functional and will need to be decommissioned when facility conditions allow.

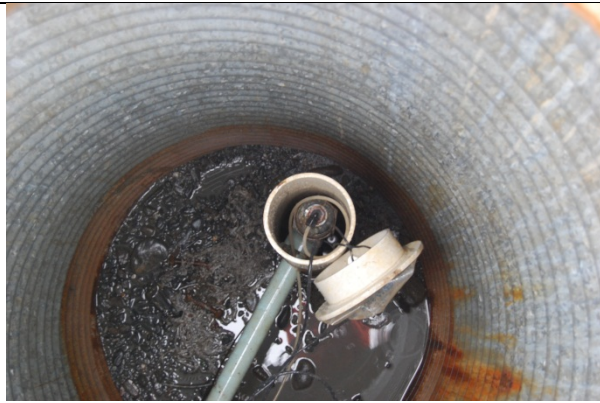
MW4 highlighting the pump system.

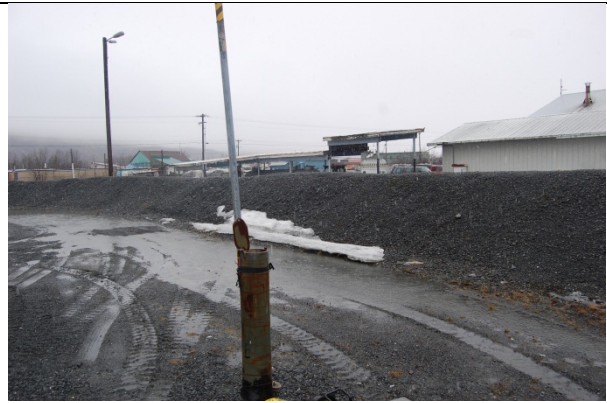
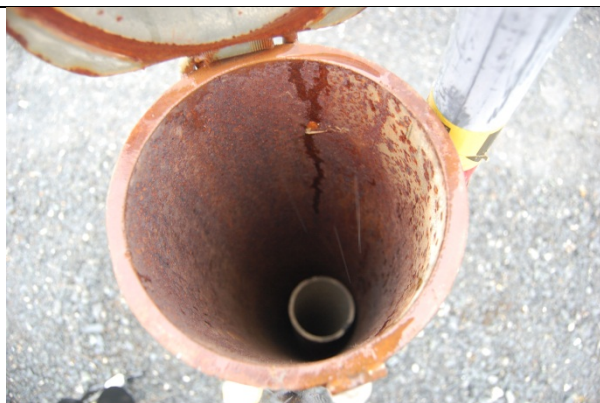
Condition: The well appears to be in good condition with no damage to the stand pipe or the well casing. Due to corrosion and weathered rubber, a new well cap should be installed.

MW13 inside containment area.

Inside MW13.

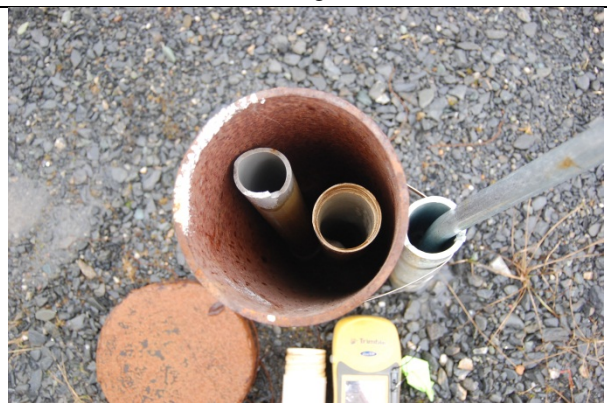
Condition: The PVC casing was crushed and broken. The casing was impassible for water level monitoring or other tubing at a depth of approximately 4.6 feet. TPECI was unable to access ground water. The well was not functional for future monitoring and should be decommissioned. Decommissioning of this well may not be possible while the facility is operational due to the location within the containment cell.

Inside damaged MW1.

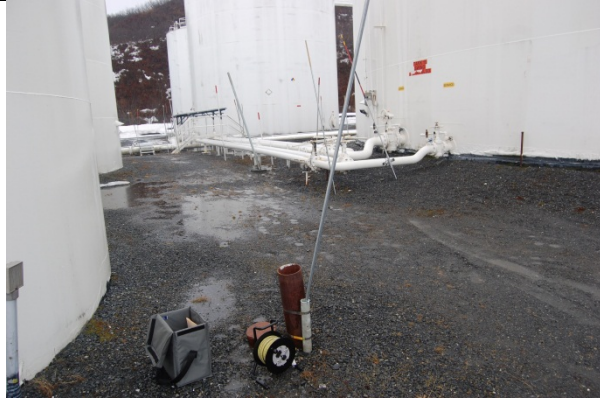
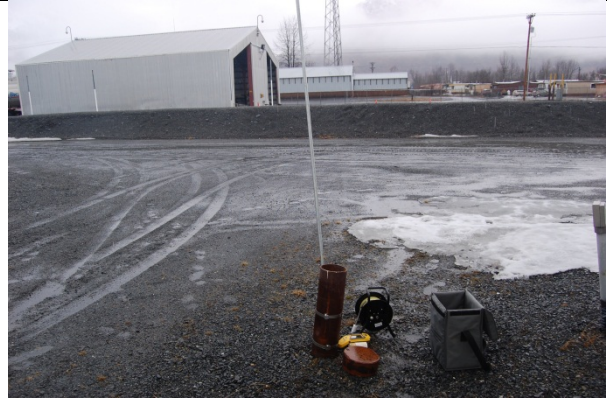
MW1 between tanks within the containment area.

MW1 looking north.

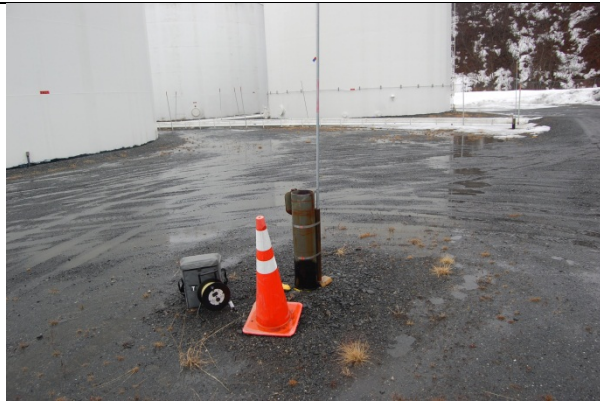
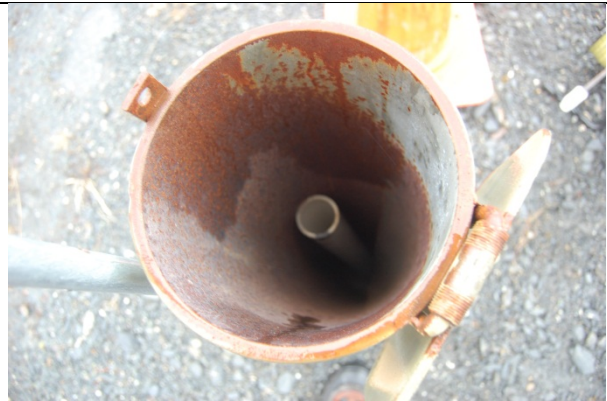
Condition: The well appears to be in good condition with no damage to the stand pipe or the well casing. Due to corrosion and weathered rubber, a new well cap should be installed.

MW12 within the containment area.

Inside MW12.

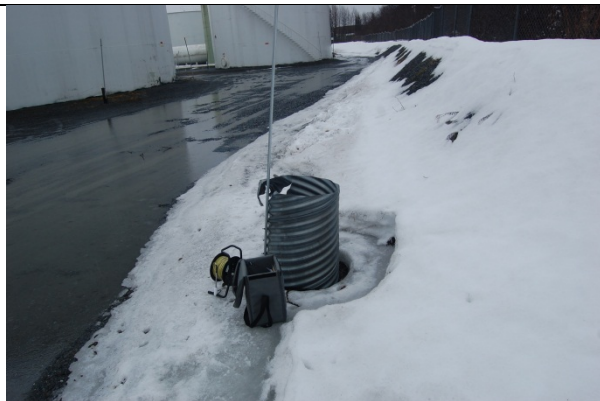
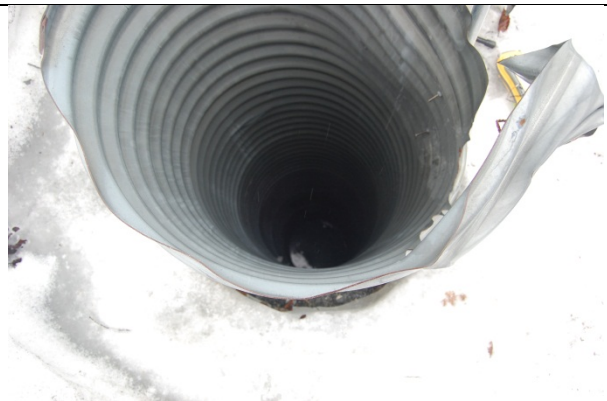
Two possible dry wells were located on the property. Both wells were approximately 15 feet deep and constructed of 24" corrugated steel pipe. Both pipes were damaged with large tears and dents in the metal. Neither well had a cap or cover. Snow, ice, and standing water were located at the bottom of each dry well. The dry well coordinates are 61.1287°N, -146.3654°W and 61.1284°N, -146.3630°W.

One dry well on the south side of the containment area.

Inside the possible dry well.

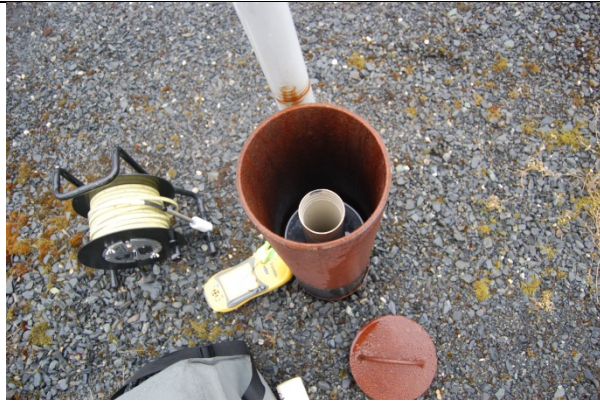
Condition: The well appears to be in good condition with no damage to the stand pipe or the well casing. Due to corrosion and weathered rubber, a new well cap should be installed.

Inside MW2.

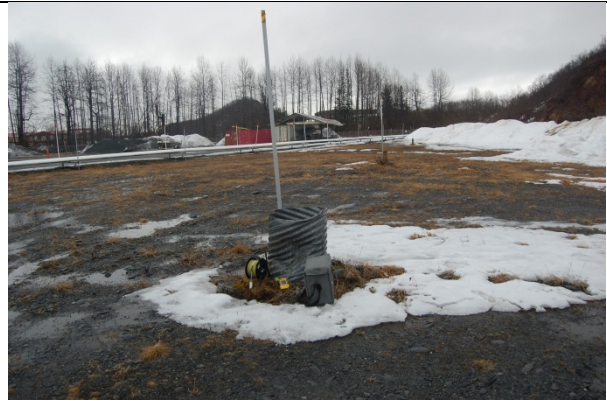
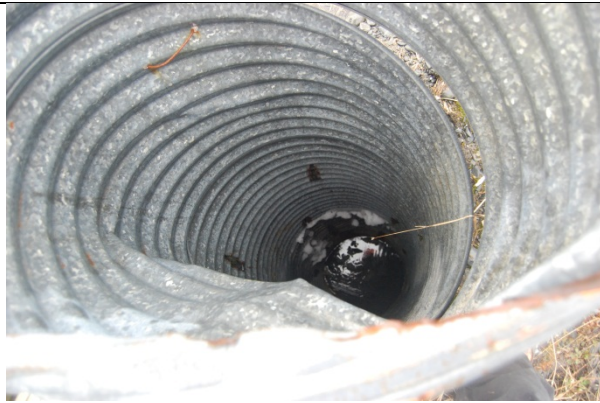
Second possible dry well.

Inside second possible dry well.

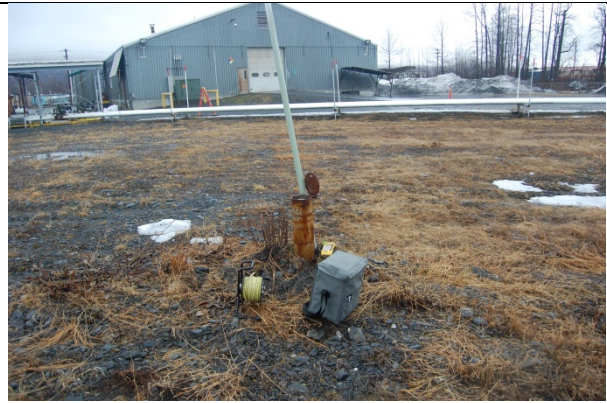
Condition: The well appears to be in good condition with no damage to the stand pipe or the well casing. Due to corrosion and weathered rubber, a new well cap should be installed.

MW19 looking north towards warehouse.

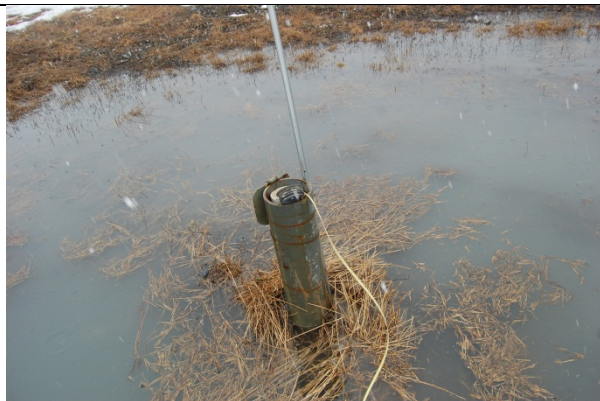
Condition: The well appears to be in good condition with no damage to the stand pipe or the well casing. Due to corrosion and weathered rubber, a new well cap should be installed.

MW14 in a snowmelt puddle.

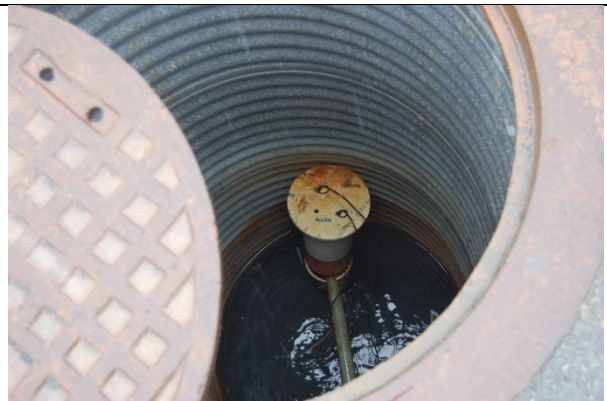
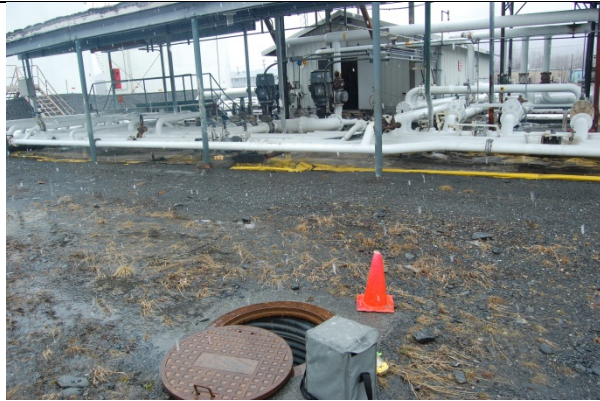
Condition: The well cap and casing were damaged along with the pump unit blocking all access into the well. The manhole vault was partially filled with water, but below the height of the top of the well casing.

Inside BH1. Cap damaged and immovable.

BH1 looking north.

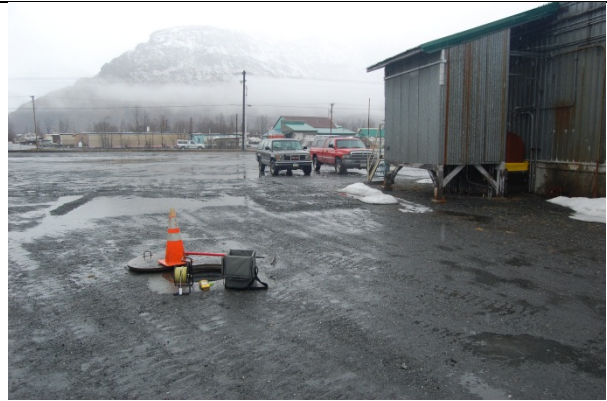
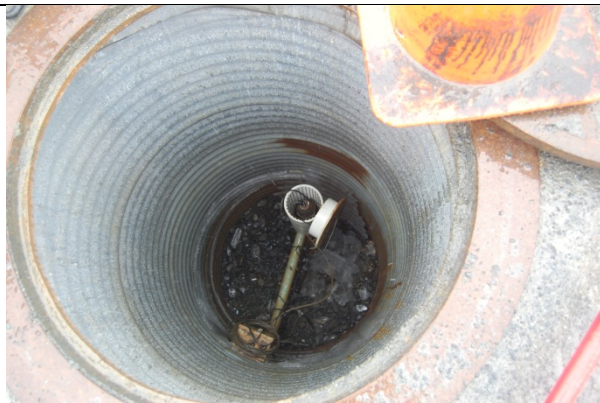
Condition: The well appears to be in good condition. The pump system blocks access down the well casing for anything larger than a water level meter or flexible pump tubing. The well cap does not fully seal the well head. It is possible, though unlikely, that surface water could penetrate the manhole cover and drain into the well casing.

BH3 looking north.

Inside BH3.

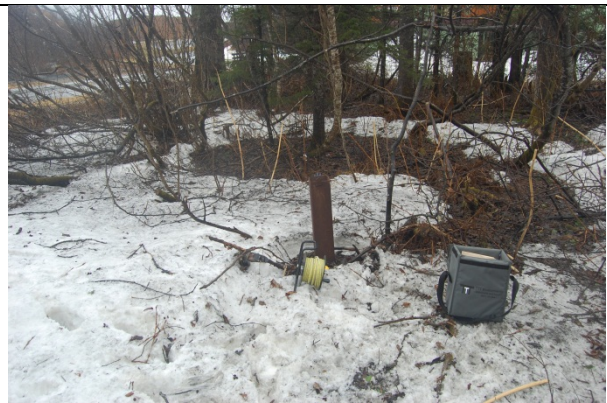
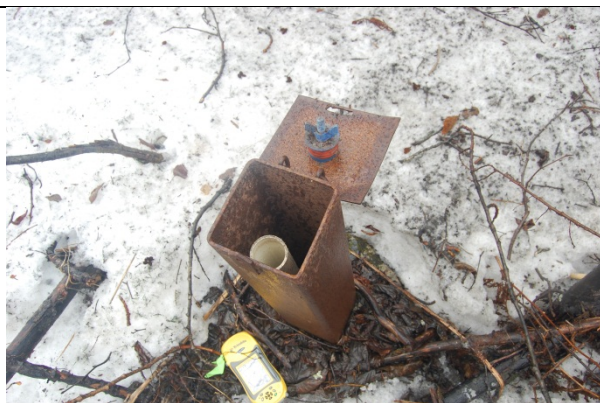
Condition: The well appears to be in good condition with no damage to the stand pipe or the well casing. Due to corrosion and weathered rubber, a new well cap should be installed.

MW22 looking south.

Inside MW22.

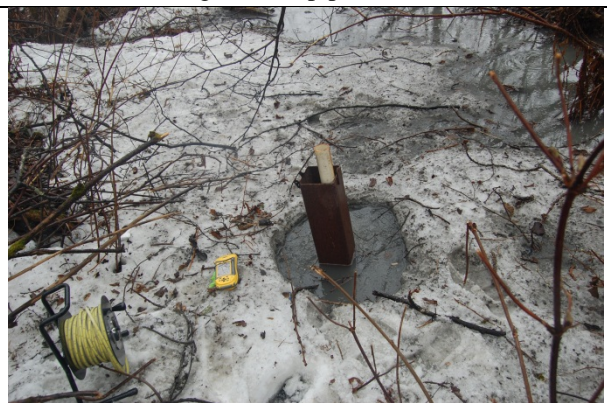
Condition: The stand pipe casing was heavily damaged and no longer covered the well casing. TPECI attempted to adjust the stand pipe, but it was immobile. No well cap was on the casing and the well was open to the elements. A new well cap should be installed and a new stand pipe should be constructed around the casing if this well is to be used in the future.

Damaged stand pipe on MW21.
