September 20, 2013

Wells Fargo Data Center  
6831 Arctic Boulevard  
Anchorage, Alaska 99518

**RE: MONITORING WELL DECOMMISSIONING, 6831 ARCTIC BOULEVARD,  
ANCHORAGE, ALASKA, ADEC FILE ID 2100.38.492**

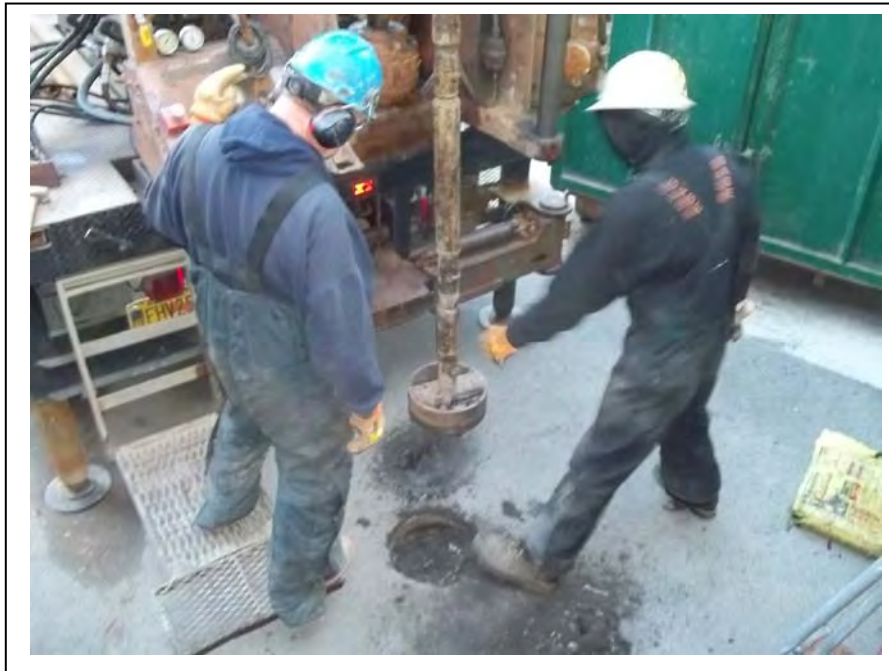
Photo 1: Discovery making two asphalt cuts in an attempt to locate Well B6MW. (September 16, 2013)

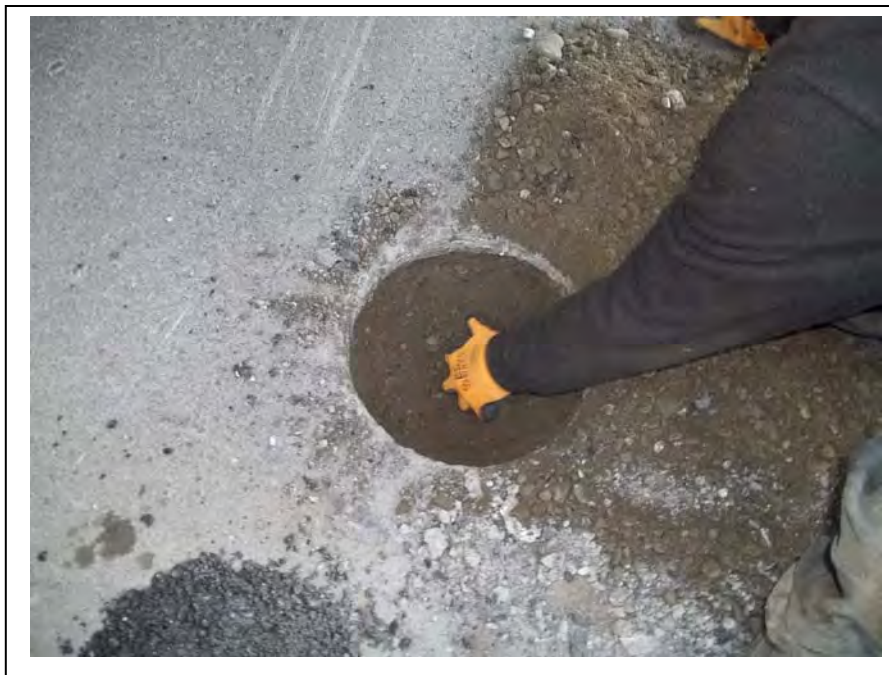
On September 16, 2013, Monitoring Wells B2MW, B7MW, B8MW, B9MW, B10MW, and B11MW were decommissioned. A Shannon & Wilson representative was on-site to document decommissioning activities. In an attempt to locate Wells B4MW, B5MW, B6MW, and B7MW, Discovery cut the asphalt up to two times at each well location and hand dug about 6 inches (Photos 1 and 2) to determine if the well casings were present under the asphalt. Only Well B7MW was located (Photo 3). The asphalt cuts were repaired using asphalt cold-patches (Photo 4).

Photo 2: Discovery hand-dug down to approximately 6 inches bgs to locate casings of Wells B4MW, B5MW, B6MW and B7MW. (September 16, 2013)

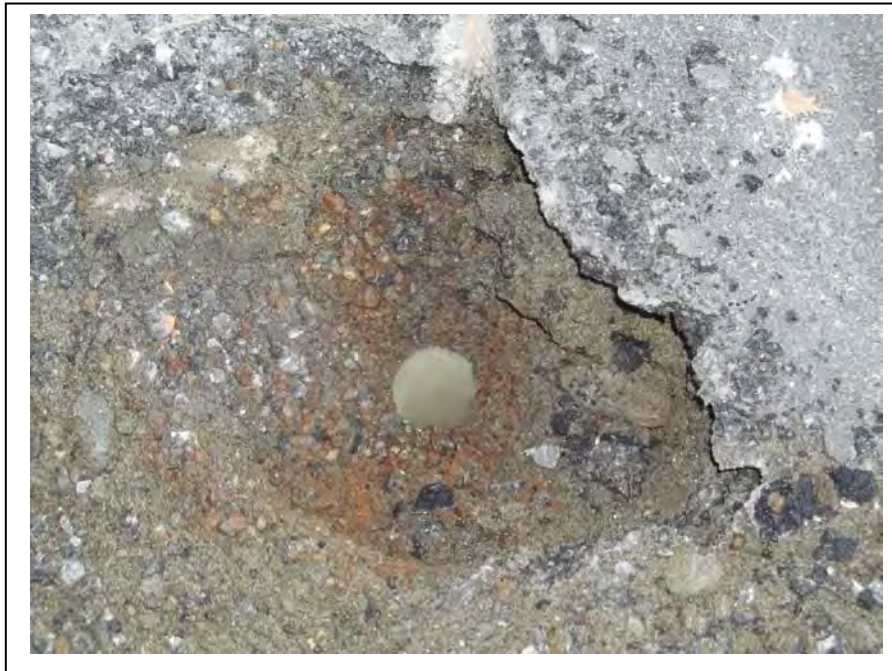
- 945 Same process as MW-4. After two cuts, casing not found.
- 1005 Encountered well MW-7. The monument sleeve was damaged (caved in). Pryed out monument w/ bar.

Photo 3: Well B7MW casing after damaged monument sleeve was removed. (September 16, 2013)

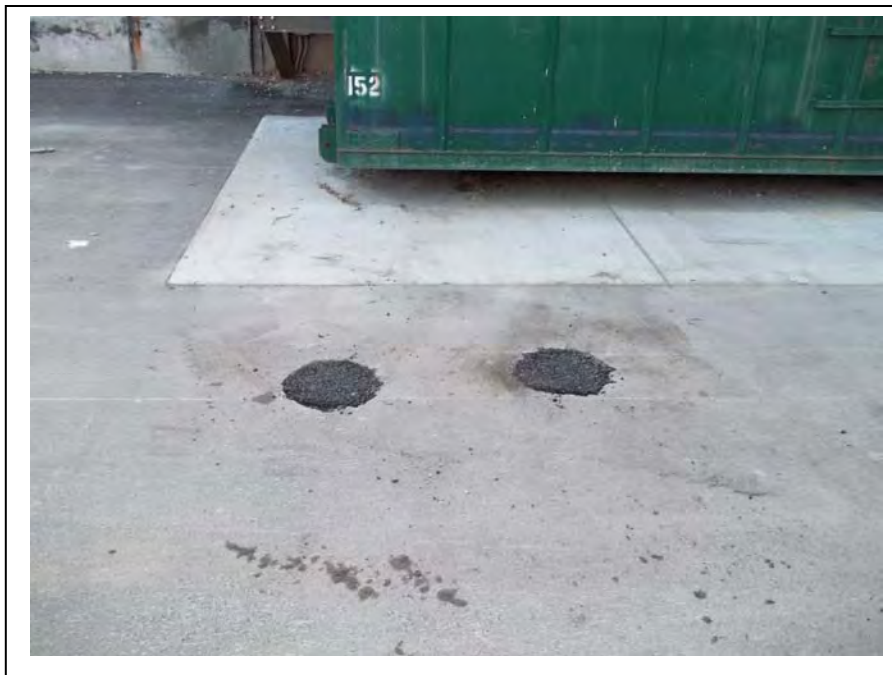
Photo 4: Asphalt cuts were finished with cold patch asphalt. (September 16, 2013)

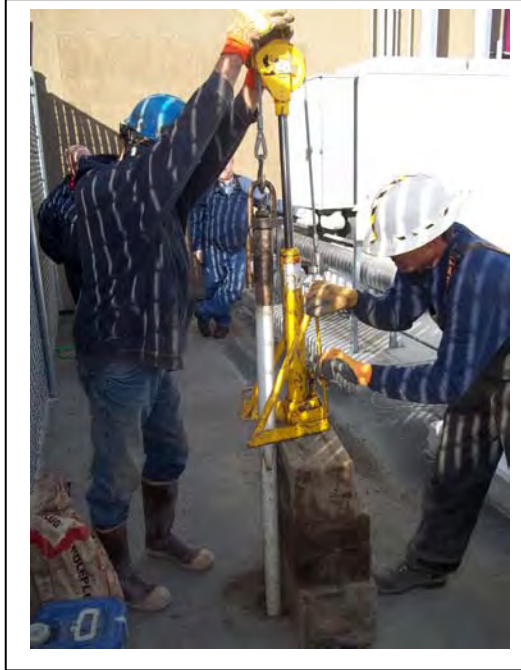
With the exception of Well B10MW, which was pulled up with a hydraulic jack due to the location within the fenced area (see Photo 5), the Monitoring Wells were decommissioned using a CME-75 drill rig. Due to the shallow groundwater at the site, the well casings were removed to allow the aquifer material to collapse in the borehole and then backfilled with bentonite chips (Photo 6). While decommissioning Well B2MW, the casing broke at approximately 5 feet bgs so that the bottom 2.5 feet of the screened interval remained in the ground. If the hole collapsed in on itself (Well B7MW and B8MW), the hole was re-opened by driving a metal rod down the pre-existing hole to about 5 feet bgs and then backfilled with bentonite chips to about 3 feet bgs. Pea gravel was used to backfill each hole to about 0.25 feet bgs. The surface of each well was finished with an asphalt cold patch.

Photo 5: Monitoring Well B10MW was pulled up with a hydraulic jack. (September 16, 2013)

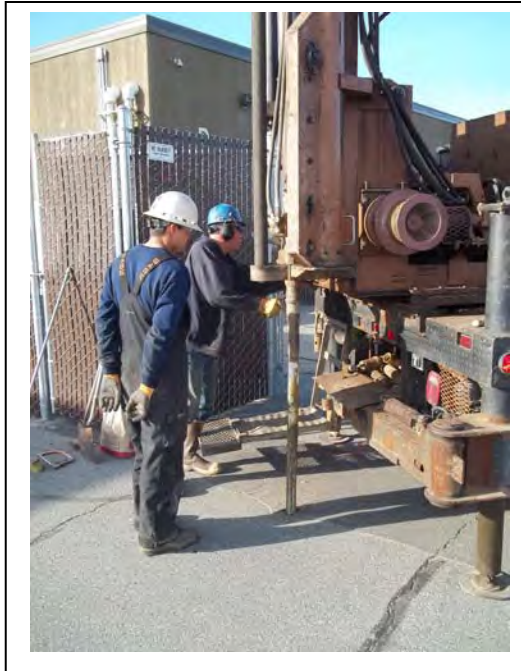
Photo 6: A CME-75 Drill Rig was used to pull the casings of Monitoring Wells B2MW, B7MW, B8MW, B9MW, B10MW, and B11MW. (September 16, 2013)

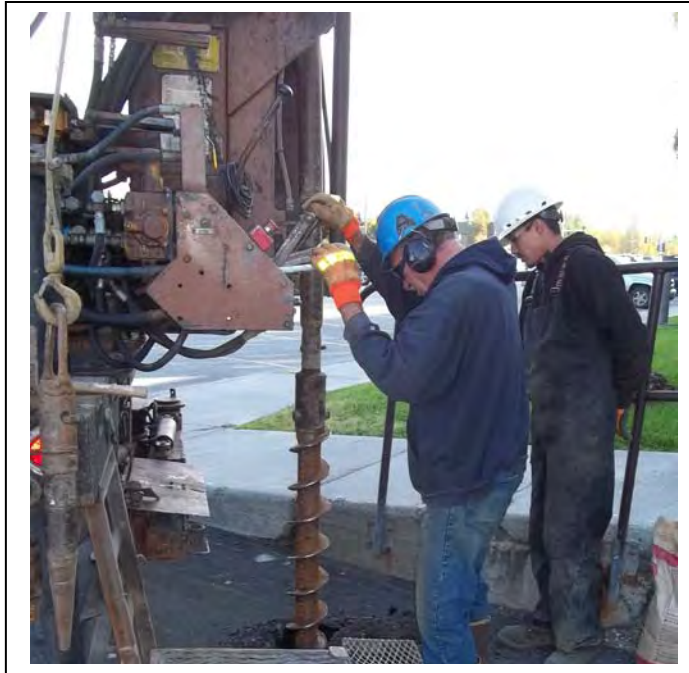
- Pulled casing but top of hole collapsed  
- Augered down about ~~25~~ 5 ft bgs until existing bentonite was encountered. Poured chips down auger to 3 ft bgs.

Photo 7: An auger was advanced down to 5 feet bgs to re-open the collapsed hole of Well B7MW. Bentonite chips were backfilled while the auger was retracted. (September 16, 2013)
