SMS Environmental

TO: Mark Peterburs
Project Manager
Alaska Railroad Corporation

RE: Summit Siding Field Observations and Sampling
ARRC MP 312.5

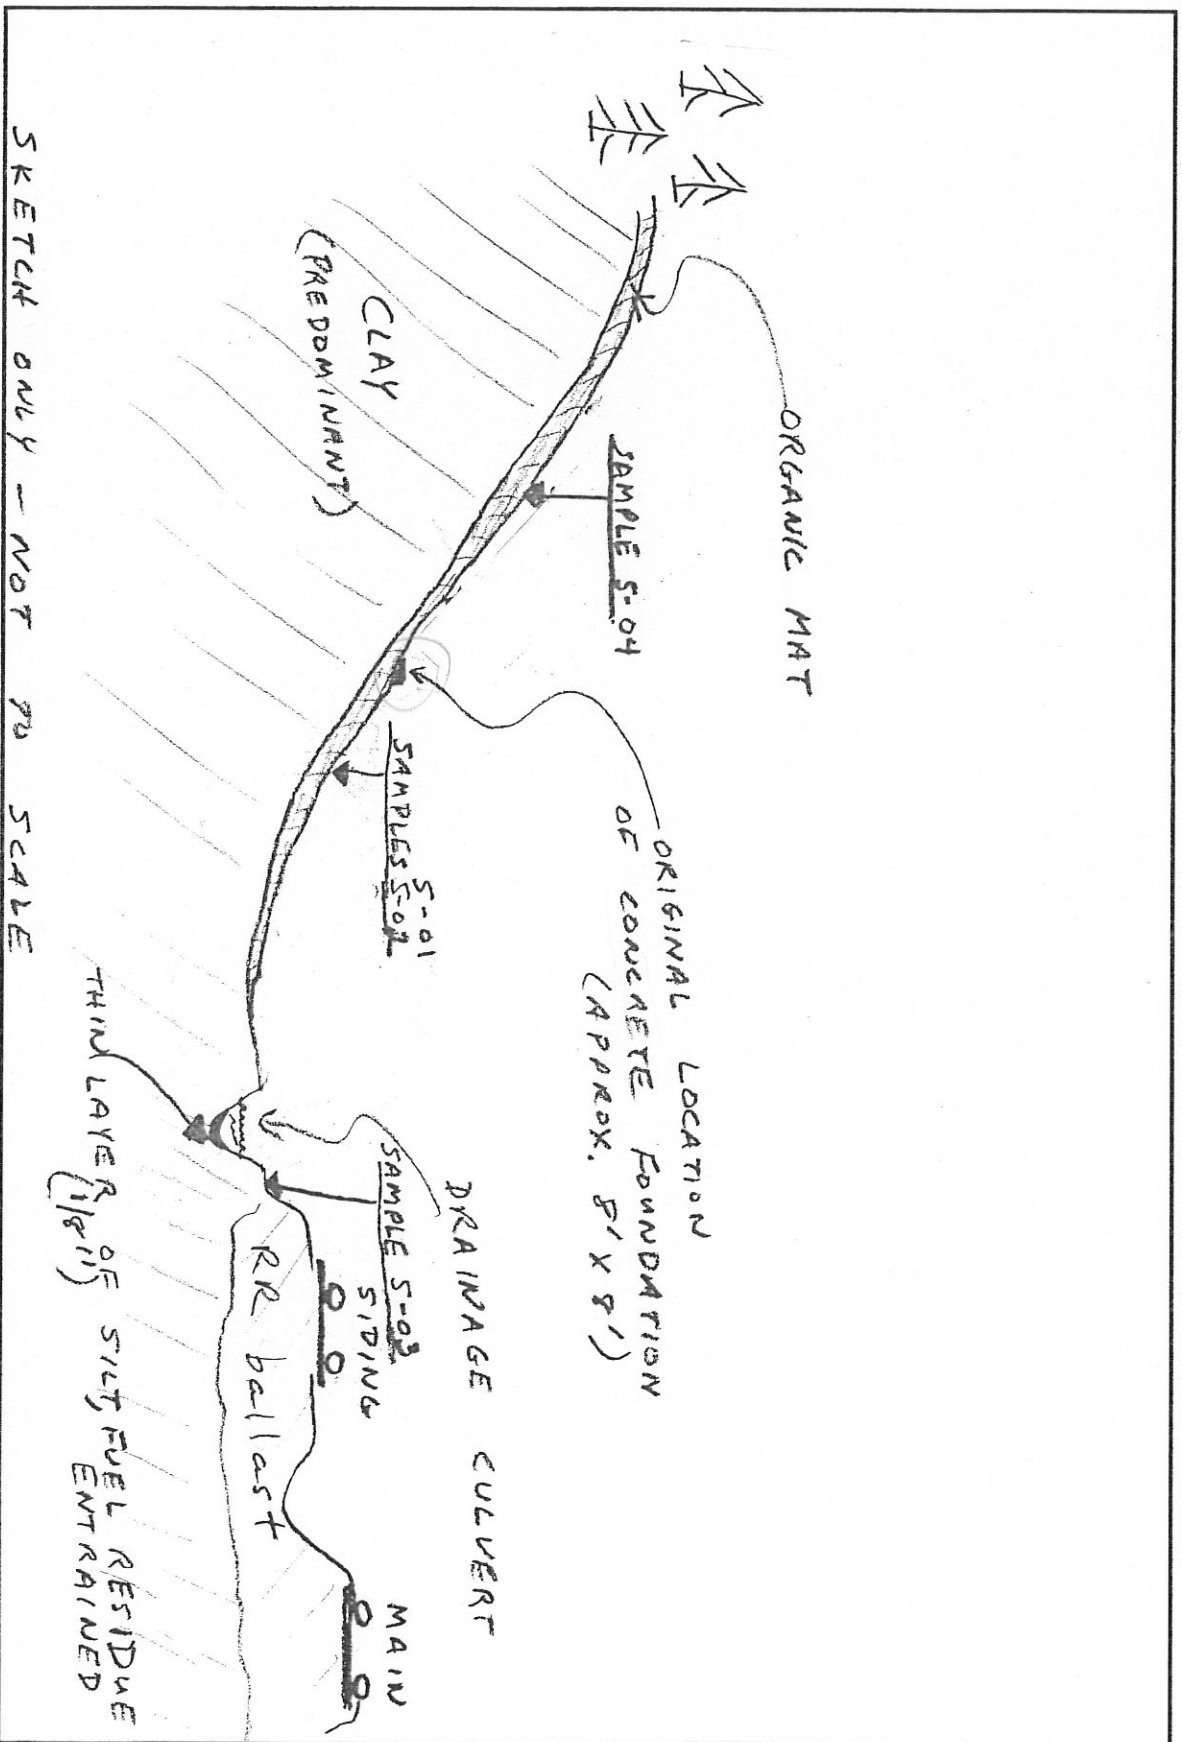
Figure 2
Cross Section
Summit Siding
8/12/02

Figure 1 presents a layout of the site, and Figure 2 provides a sketch of the cross section shown on Figure 1. The cross section goes through the former location of the concrete foundation that supported the fuel pump house and represents the area where the fuel odors were originally observed. Other than a short 3-inch section of rusty pipe, there was no evidence of the above ground piping system that used to carry fuel to the airstrip from the fuel pump.

1. The fuel residue is confined to an area topographically downgradient of the former location of the fuel pump house. Pits were excavated upgradient and cross gradient of this area and no evidence of fuel residue was observed. The fuel residue appears to be from surface spills that occurred during fuel pumping operations over 35 years ago. The fuel spills were apparently absorbed by the thick organic mat and were prevented from entering the subsurface by the underlying clay. The fuel odor noted during and after grooming of the ditch resulted after the organic mat was disturbed by the excavating equipment, releasing the more volatile fuel fraction into the air and the less volatile fuel fraction into the water that seeped out of the disturbed peat.

pump house
Foundation -
fuel is seeping
through road track, it is
a sham on the surface
Soil drainage ditch is
along and above
drainage ditch is
organic mat, sand/silt
beneath. Fuel
unknown.

I understand that the staging of materials for the track extension is planned for this week (August 15-16), and that the work required for the siding extension is largely done by on-track equipment. I recommend that the organic mat in the entire area be disturbed as little as possible to minimize the clay silt accumulation in the drainage ditch and to prevent further release of fuel residue from the affected area below the former concrete foundation location.
