PRELIMINARY ASSESSMENT REPORT

GOOSE BAY SITE

GOOSE BAY, ALASKA

DECEMBER, 1992

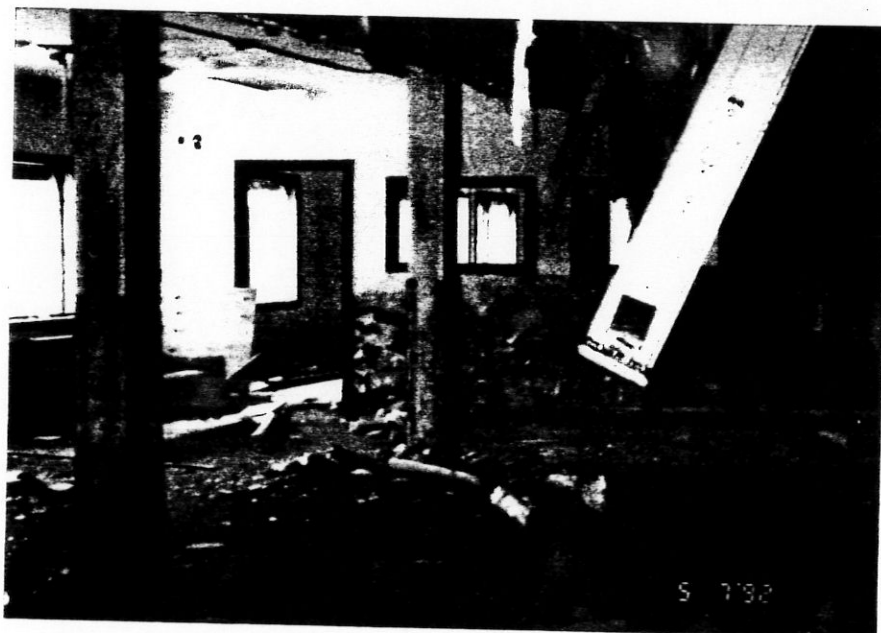
PHOTO # 2  
INSIDE MAIN BUILDING

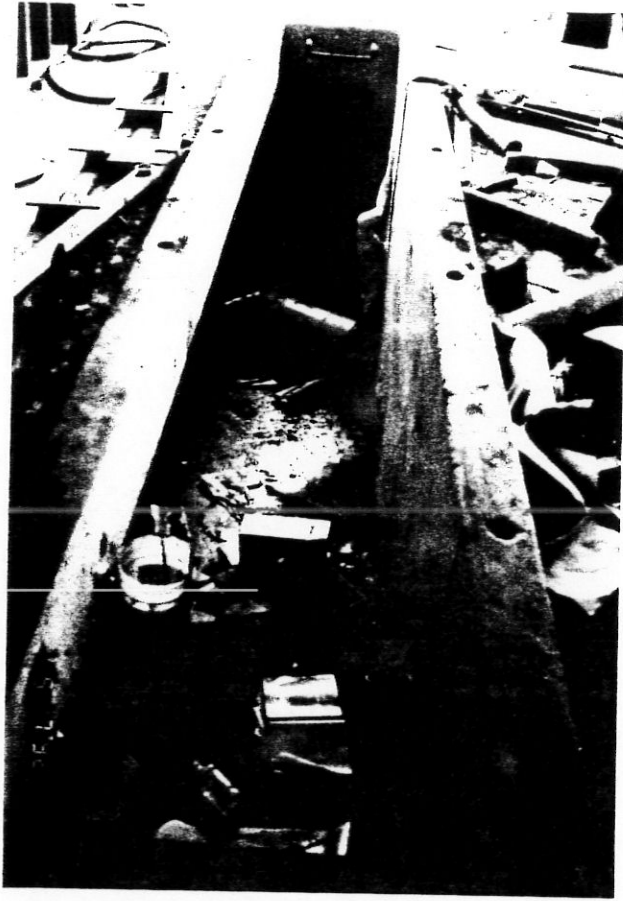
A site inspection of both the launch site and the correctional facility was conducted by ADEC personnel and a representative of the University of Alaska on May 7, 1992. The buildings at the correctional facility have been heavily vandalized. Asbestos is present for the most part in the form of pipe insulation which was noted in all of the buildings. The pipe insulation is mostly in a deteriorated state. Asbestos wall board and flooring is also present. Underground storage tanks which have been emptied, are present at the site. In the mechanic's shop (See map 2) there is spilled oil in a mechanic's well (ADEC, 1992).

PHOTO # 3  
OIL SPILL IN SHOP - GOOSE BAY CORRECTIONAL FACILITY

1. Removal of all friable asbestos that began in the 80s should be completed.
2. Areas of Petroleum Hydrocarbon contamination should be remediated.
3. The contents of the dump site should be investigated.
4. Transformers remaining on site should be removed.

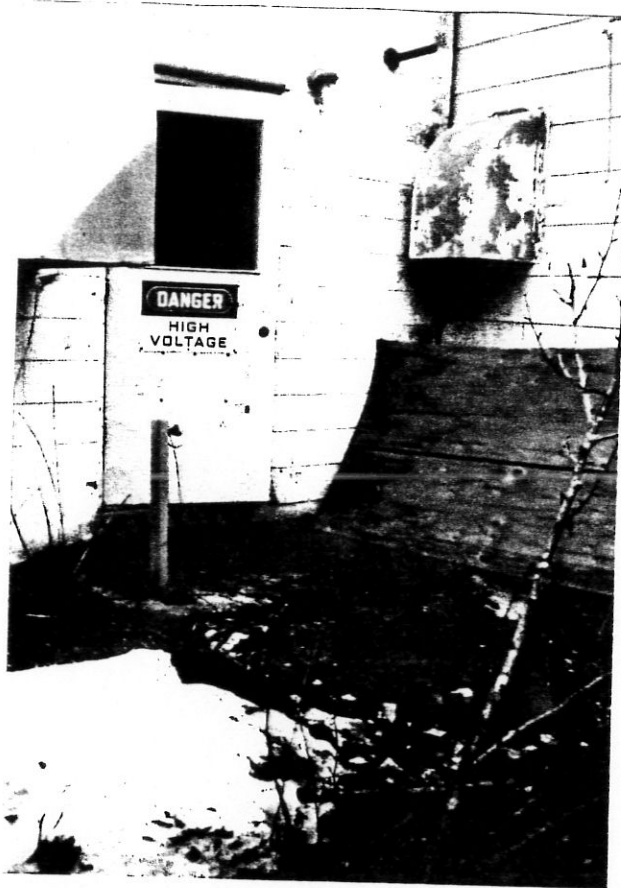
In the spring of 1992, vandals broke into the generator building at the launch site and took parts from the generator causing an oil spill on the cement floor and outside the door in the soil. The spill was reported to the ADEC Mat-Su District Office. Evidence of the spill was still present at the time of the site visit (ADEC, 1992).

PHOTO # 5  
GOOSE BAY NIKE MISSILE SITE  
OUTSIDE DOOR TO GENERATOR BUILDING-OIL SPILL

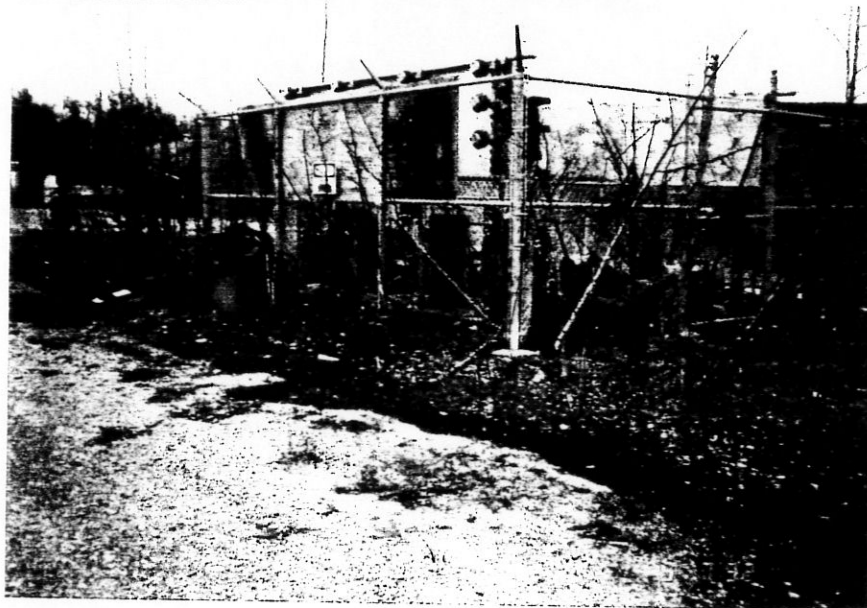
In another study of the launch site, samples were taken on August 2, 1991 by Dave Moll, Manager of Environmental Health & Safety at the University of Alaska. Results showed total petroleum hydrocarbons concentrations of 44,000 mg/dry kg in a soil sample taken near the Launch Control building. PCBs (Aroclor 1260) were detected in transformer oil collected from two transformers at the launch site at concentrations of 3.5 mg/kg and 2 mg/kg.

PHOTO # 6  
GOOSE BAY NIKE MISSILE SITE  
OIL SPILL AREA-TRANSFORMERS
