Building Condition Assessment/Materials Investigation

Torpedo Bombsight and Utility Shop, Unalaska Airport, Dutch Harbor, Alaska

**Alaska Department of Transportation
& Public Facilities
Anchorage, Alaska**

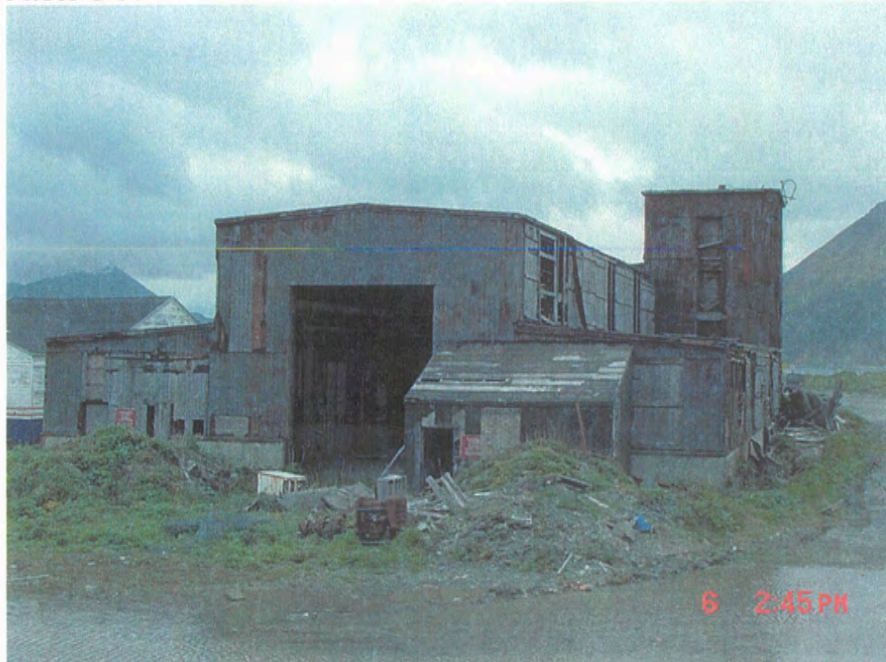
Photo S-01

Southwestern exterior elevation, June 2003

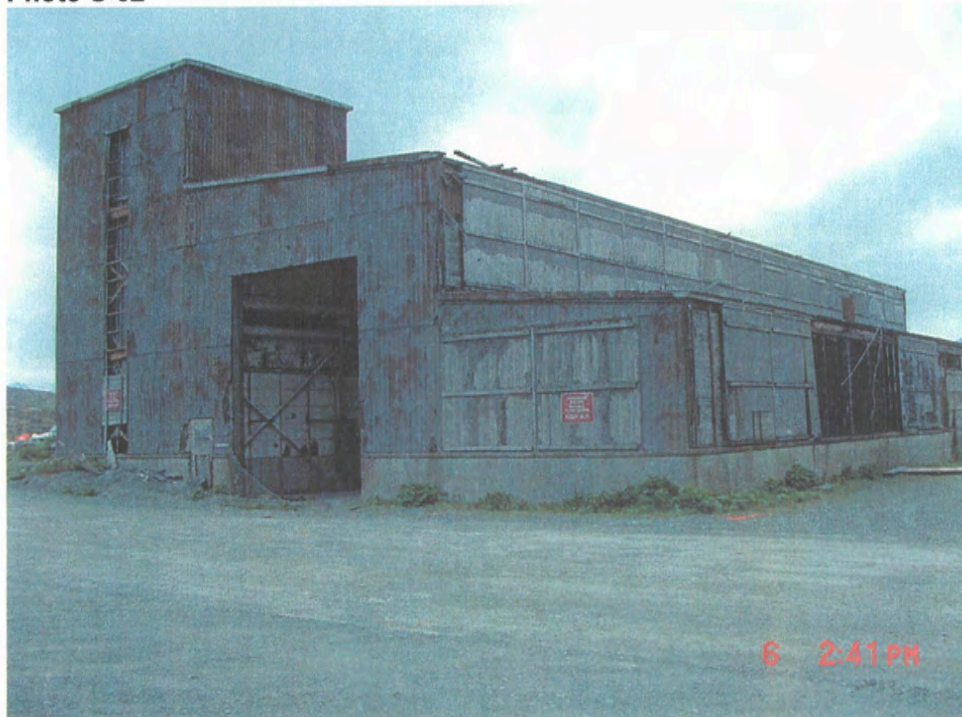
Photo S-02

Northeast exterior elevation, June 2003

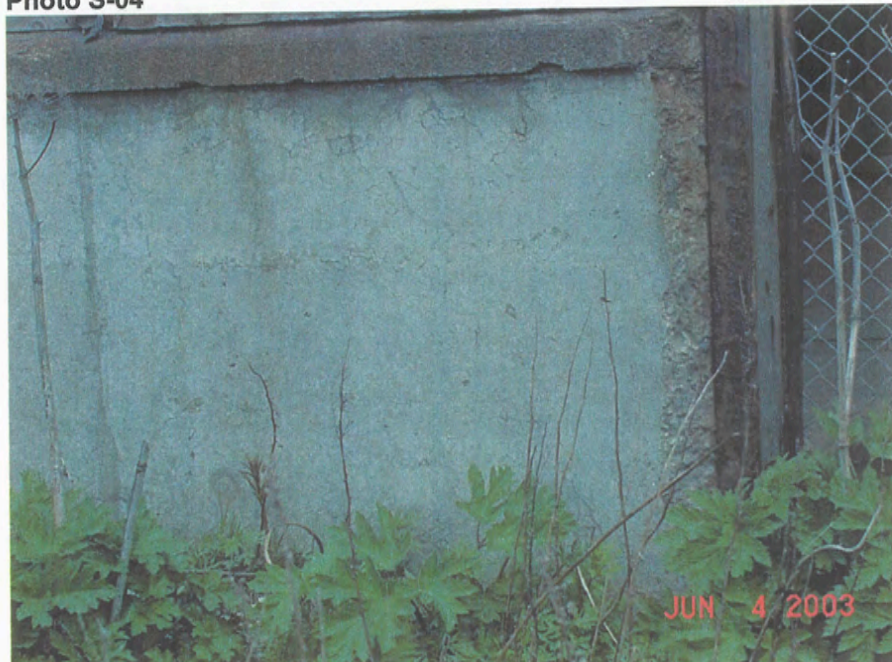
Photo S-04

Grid 1/C – exterior concrete wall, damaged corner , June 2003

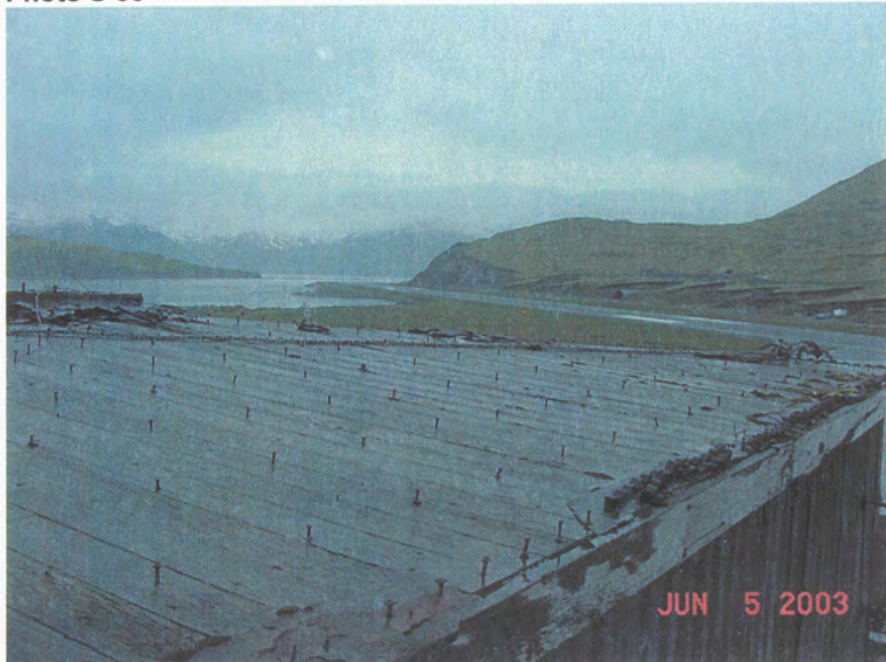
Photo S-05

Grid 7/A – parachute loft roof deck from above, June 2003

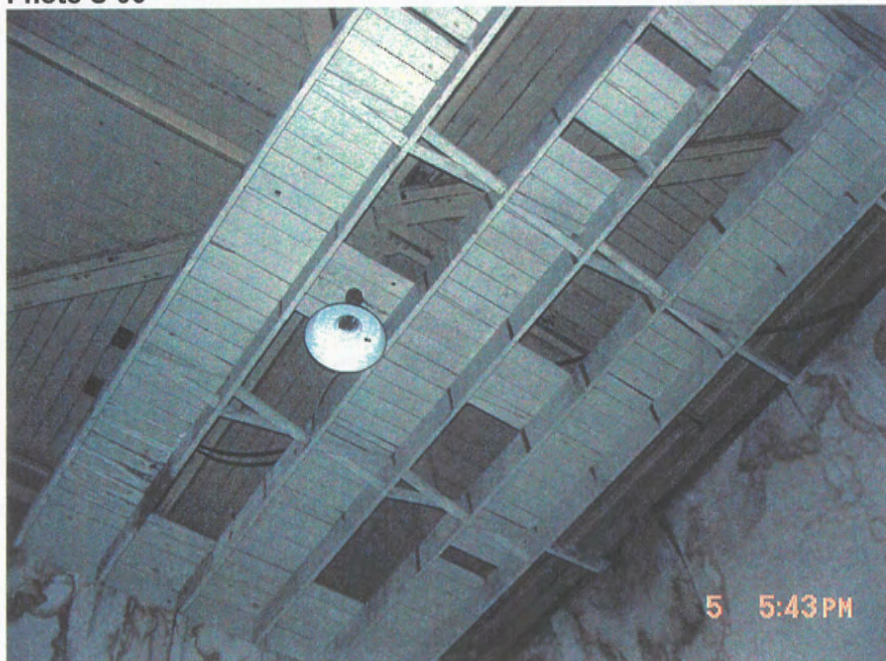
Photo S-06

Grid 6-7/A-B – parachute loft roof deck/framing from below, June 2003

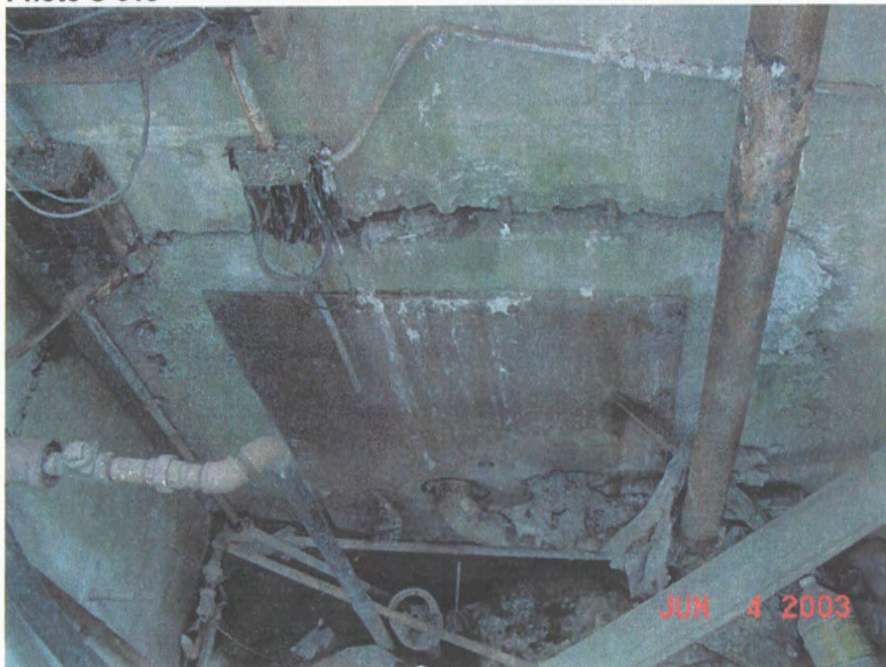
Photo S-018

Grid 2.5/D – pit, hole through outside wall below outside grade, patched, June 2003

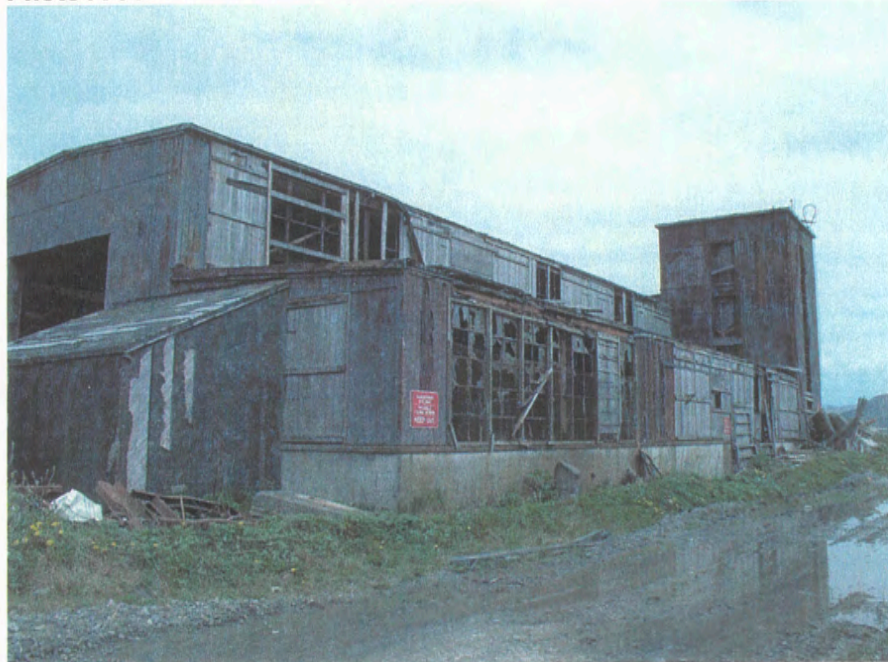
Photo A-01

In 1980, the building was deeded to ADOT & PF and continued to function as a storage facility until 2001, when an environmental cleanup was undertaken to eliminate accumulated solid waste, petroleum products, and sediment within the building. Testing confirmed the presence of various asbestos-containing materials and lead-based paints (Shannon & Wilson 2001). The Torpedo Building is currently vacant and has endured nearly sixty years of weather deterioration and lack of proper maintenance (Appendix, Photo A-01).

Southwestern corner of building, June 2003

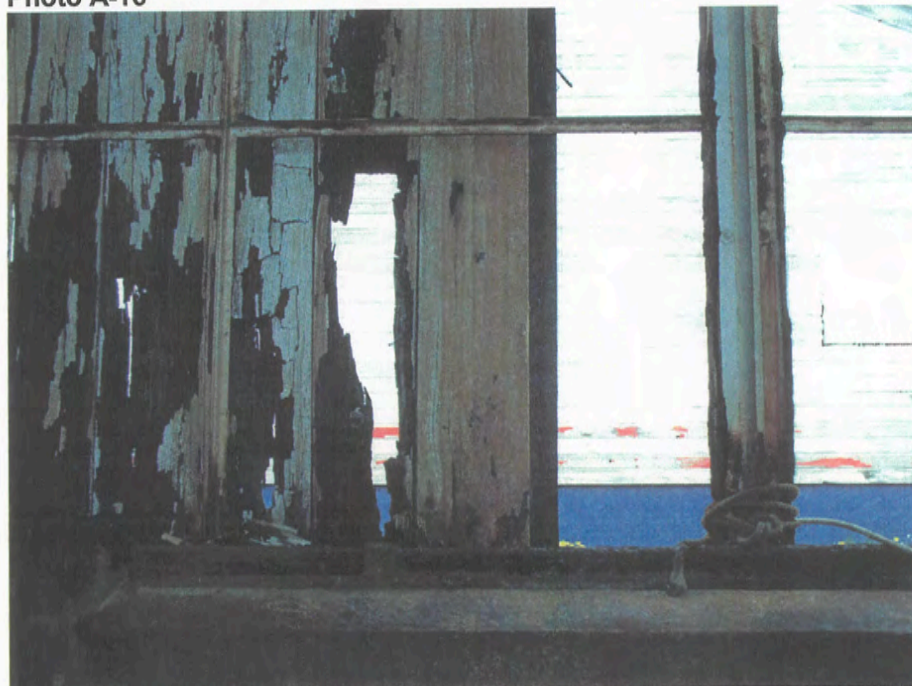
Photo A-16

North elevation detail, looking through metal sash window frames to exterior wood decking of Room 106-Torpedo Rack, June 2003
