Project 793842.08G00000

Re: Second Operational Status Report Under, Task 8G, Vapor Extraction System
Building 986 Remedial Action, Fort Richardson, Alaska

FORT RICHARDSON
BUILDING 986 REMEDIAL ACTION
Anchorage, Alaska

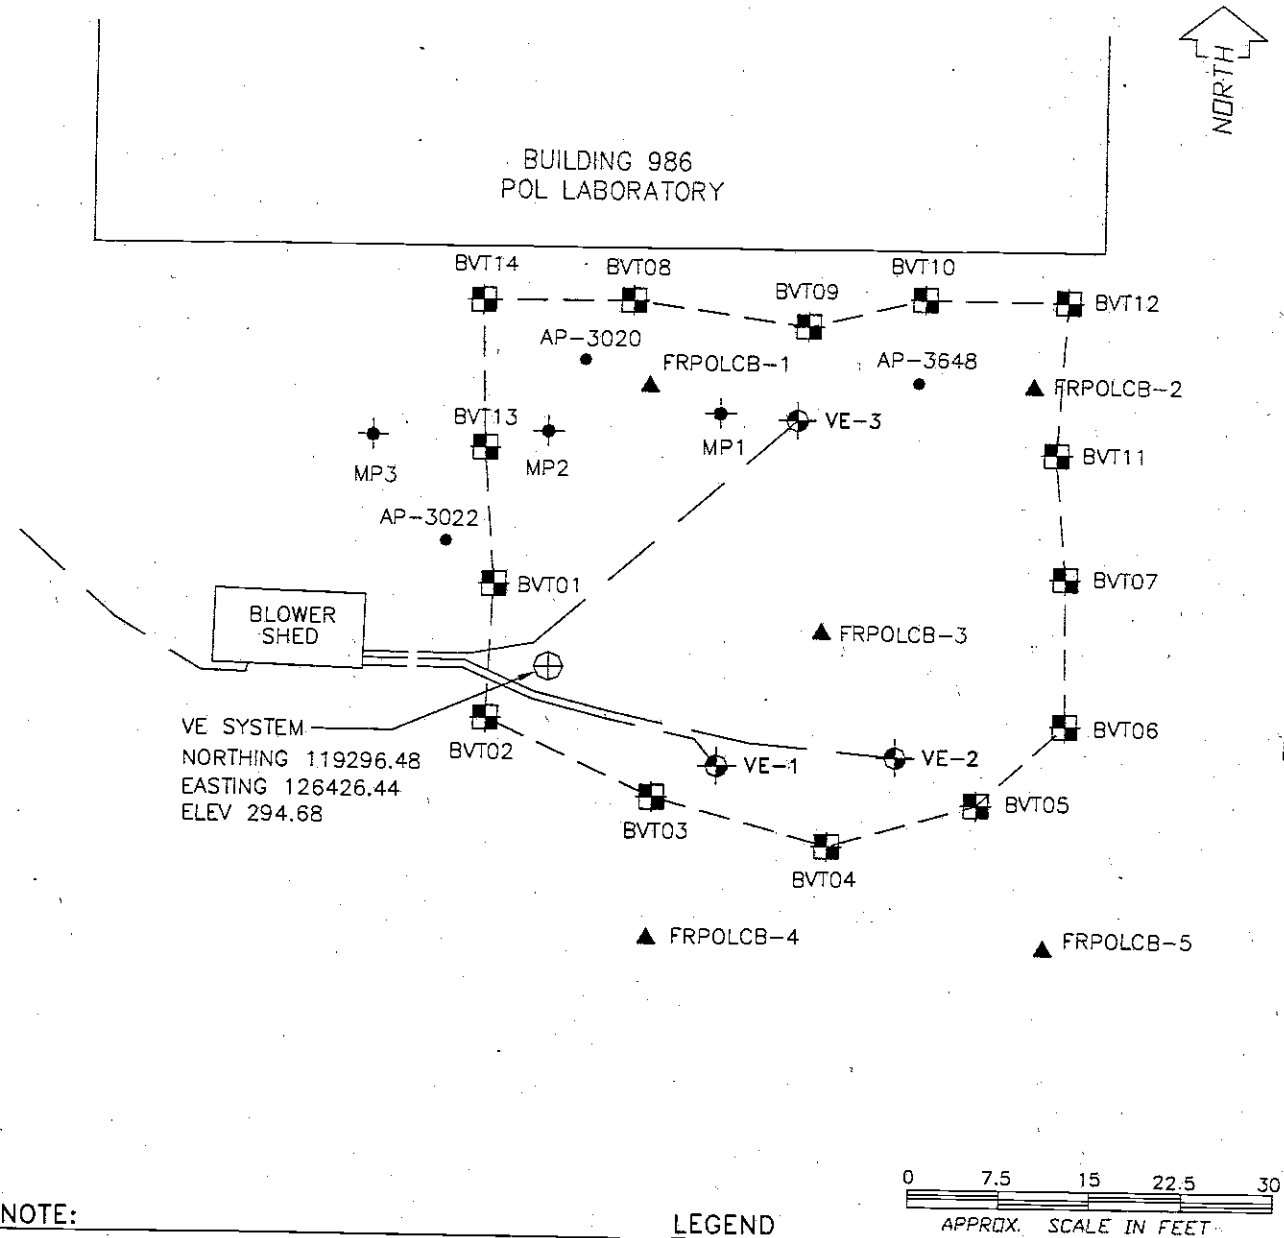
SITE LAYOUT

Since installation of the passive bioventing system after one year of VE system operation EMCON has performed monthly checks on the system operation. Currently the system is extracting soil gas from only the No. 3 VE well. This well is located in the former dry well location, which is surrounded by the 14 passive bioventing wells, as shown on the figure.

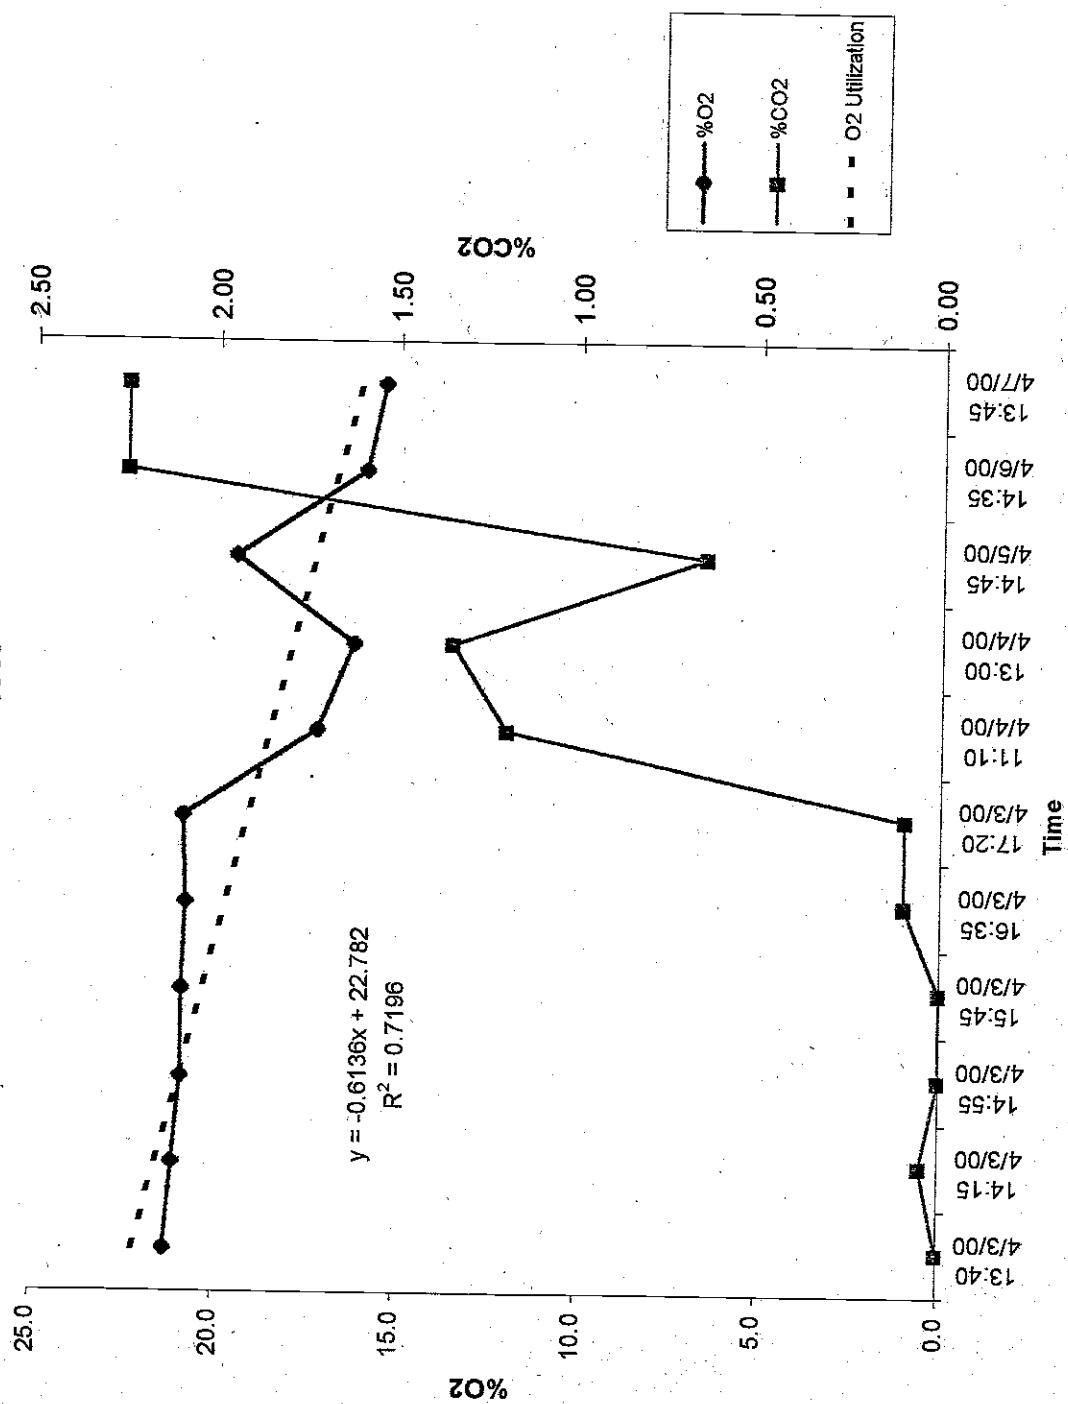
April 2000
MP1 - 10 feet

The results of the three respiration tests are presented in the attached charts. The readings for monitoring point MP1 (near the location of the former dry well) show that oxygen is being utilized at a linear rate and that carbon dioxide (the byproduct of biological activity) is increasing at a nonlinear rate, at both the 10-foot and 20-foot depth zones. These results indicate that biological activity is occurring in the area around MP1.

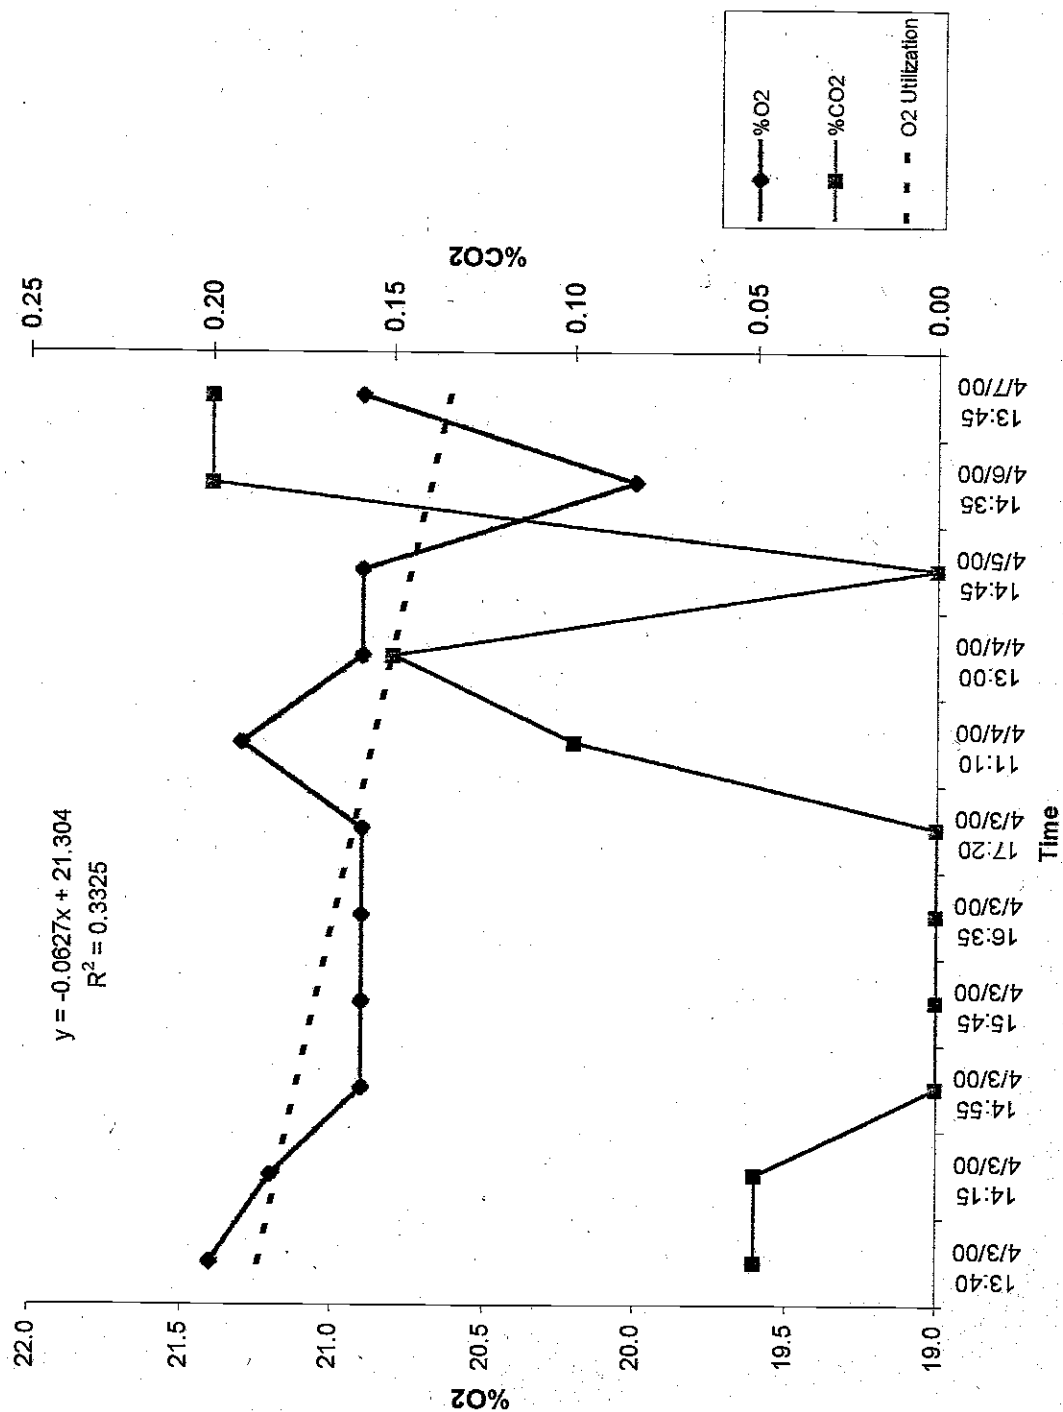
April 2000
MP2 - 10 feet

The readings from MP2 show that oxygen utilization and carbon dioxide concentrations were nonlinear in October 1999 at 10 feet but were linear at 20 feet. The results of the January and April 2000 monitoring at this location were similar. Due to the fluctuations seen in both oxygen and carbon dioxide concentrations for the 10-foot depth at MP2, it can be surmised that biological activity is sporadic due to the lack of nutrients or food (i.e.

petroleum) for the microorganisms. There appears to be biological activity at the 20-foot depth at the location.

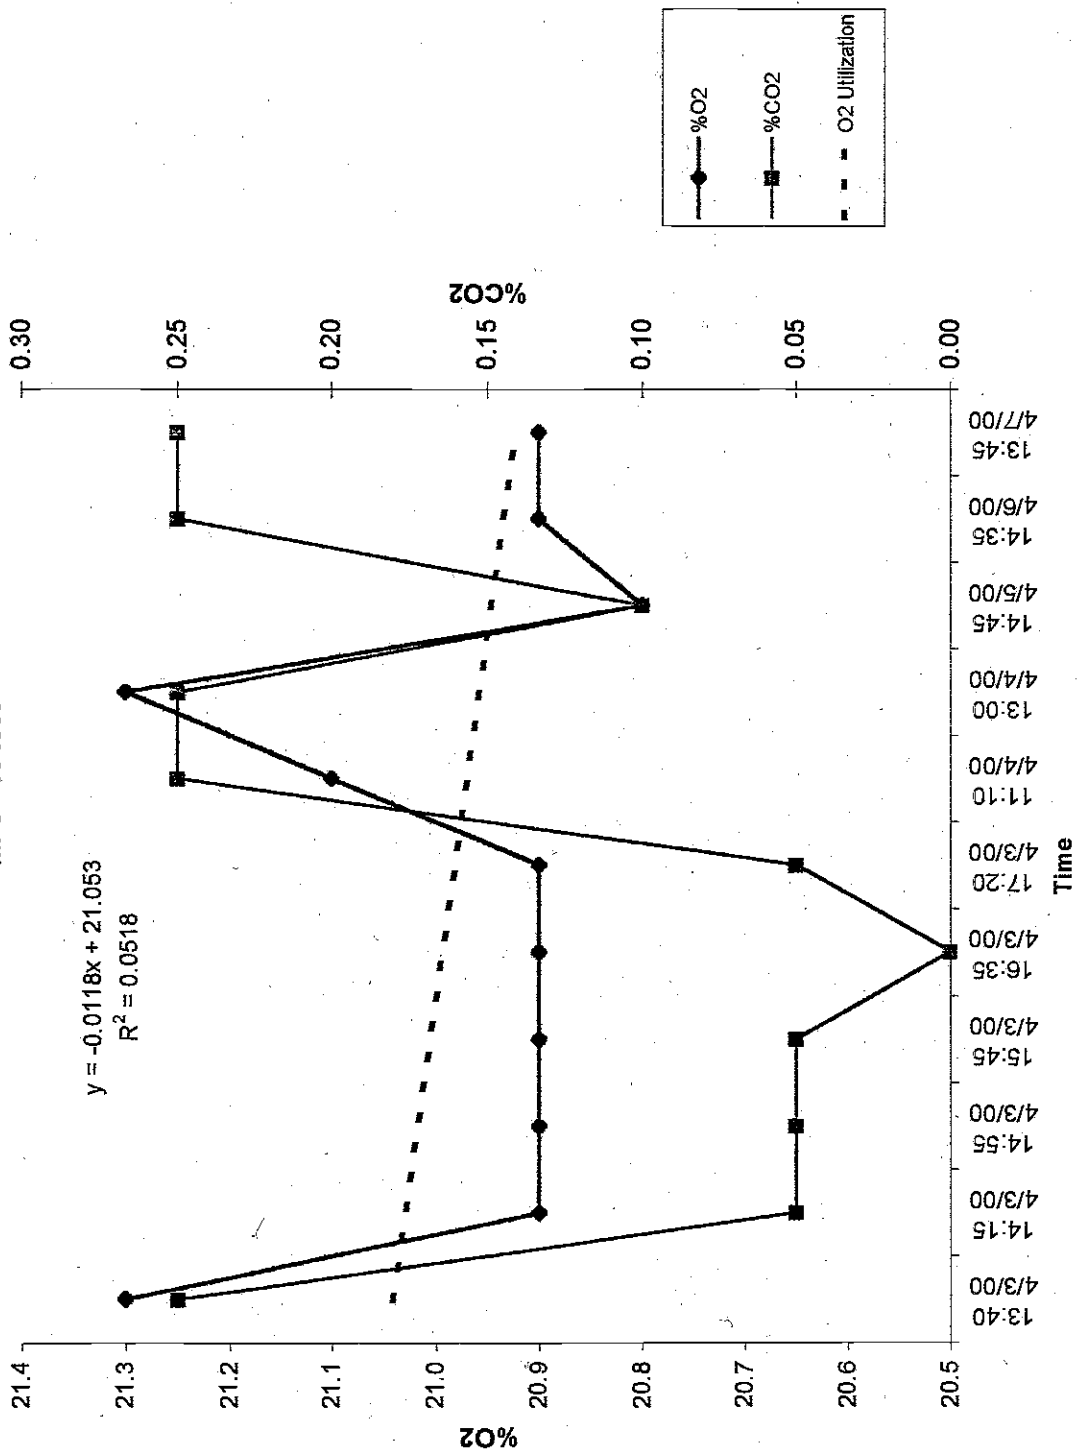
April 2000
MP3 - 10 feet

MP3 is away from the main area of contamination at the former dry well location. The concentrations of oxygen and carbon dioxide fluctuated significantly during both respiration tests. It appears that biological activity is minimal at this location. MP3 can be used to provide possible background information on the subsurface biological activity in areas where there is no significant amount of contamination.
