UST Release Investigation Report

**ML&P Operations and Dispatch Center
1201 East First Avenue
Anchorage, Alaska**

November 2009

Hoefler Consulting Group
3401 Minnesota Drive
Suite 300
Anchorage, Alaska 99503
(Project Manager: Bret Berglund,
Environmental Scientist: Brent Veltkamp)

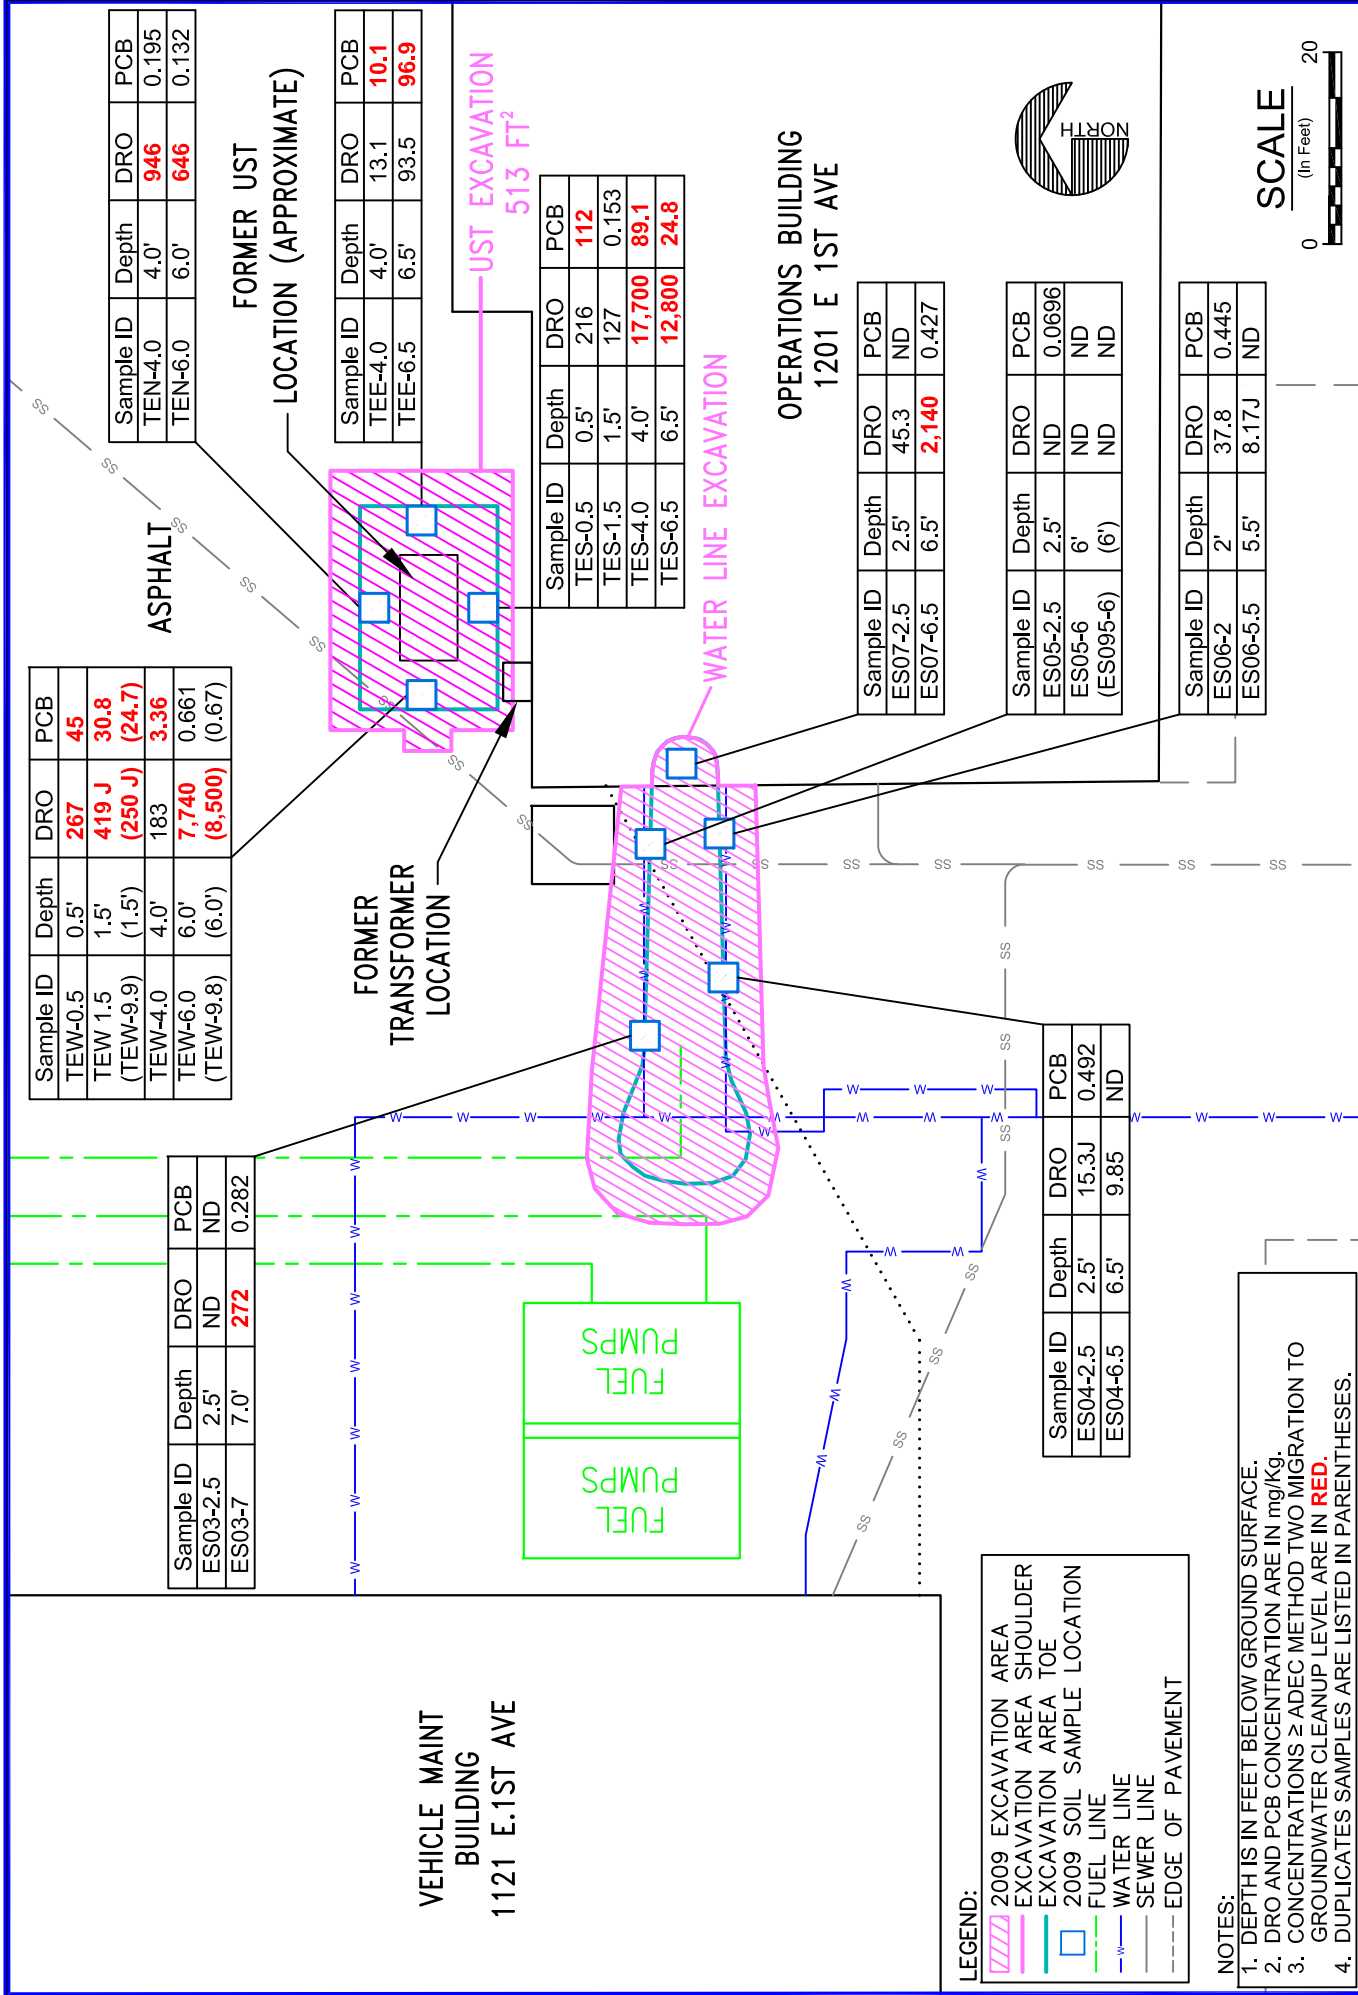
Detailed Site Map with Sample Results - Water Line and UST Excavation, Sept. 2009

The soil sample results from the completed Water Line Excavation are presented on Table 3-3 and Figure 2-1. Analytical data reports are included in Appendix D (on CD). Samples were collected prior to installation of the water line and backfill of the excavation. Ten samples and one replicate were collected in locations distributed along the bottom of the excavation and sidewalls. The samples were analyzed for GRO/BTEX, DRO/ RRO, and PCBs; two samples from the most likely areas of contamination were analyzed for VOCs.

No sample concentrations exceeded the ADEC Method Two cleanup level for the under 40-inch zone. However, DRO and two chlorinated solvents (tetrachloroethene and trichloroethene) exceeded the most stringent ADEC Method Two cleanup level (Migration to Groundwater). DRO exceeded this cleanup level in two locations along the floor of the excavation. The highest concentration (2,140 mg/Kg) was detected within a small excavation within the building (Sample ES07-6.5). This is the same location where the two chlorinated solvents exceeded the Migration to Groundwater cleanup level. PCBs were detected in 5 of 10 samples but no sample concentrations exceeded the ADEC Method Two cleanup level of 1 mg/Kg. Aroclor 1260 was the only PCB detected.

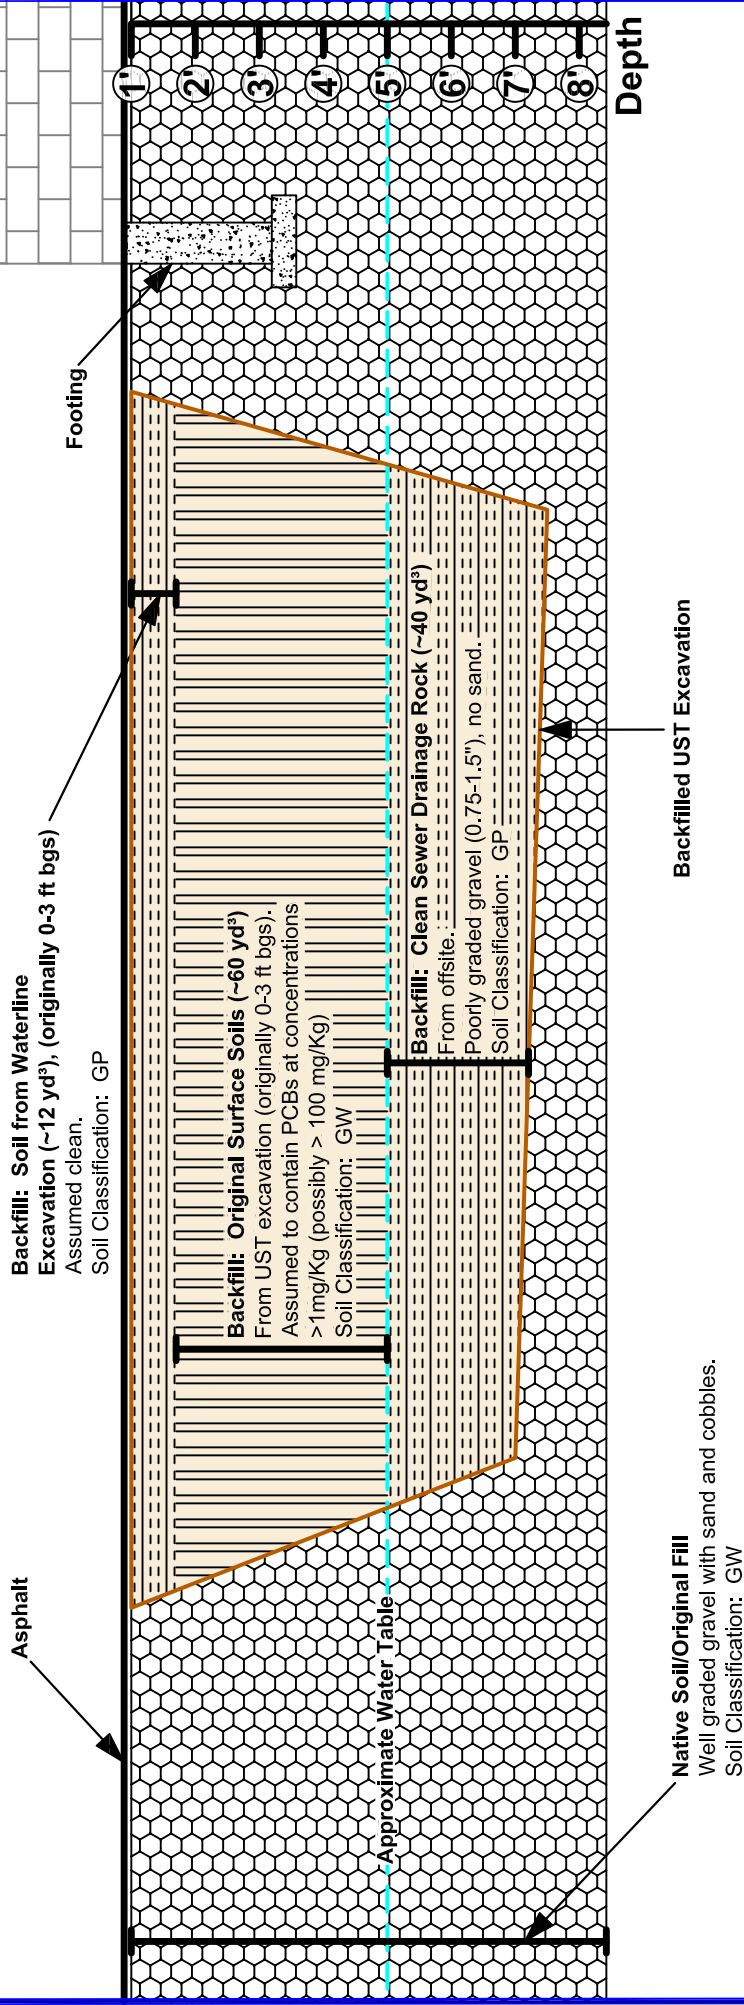
FIG.
2-2

The excavation was backfilled after the completion of soil sampling. Backfill material consisted of three types: (1) From the bottom of the excavation to the estimated water table depth (4 feet bgs), backfill material consisted of approximately 40 yd³ of clean sewer rock (coarse gravel with no sand or fines); (2) Stockpile SP04 soil was placed over the sewer rock to a depth of 0.5 to 1 foot bgs. The SP004 soil (approximately 60 yd³) was originally removed from the upper 3 feet of soil within the excavation; (3) Approximately 12 yd³ of surface soil (0-3 bgs) from the Water Line excavation area was used to fill the remainder of the UST excavation. The area was paved approximately one week later. A cross section of the backfilled excavation is shown on Figure 2-2.
