Re: OMS 35-1.2 Reconnaissance Report

Reconnaissance of Operations Mining Site (OMS) 35-1.2 was completed on July 7, 2019 by SLR International Corporation (SLR) on behalf of Alyeska Pipeline Service Company (Alyeska). The reconnaissance was requested by the Alaska Department of Environmental Conservation (ADEC) to assess the area for the presence of petroleum stained gravel and to document the condition of the entrance gate. In addition, ADEC requested a review of mining records to evaluate whether mining activity has occurred since 2003. Alyeska retained SLR International Corporation (SLR) to complete this work. Site activities were conducted in accordance with the ADEC-approved work plan dated June 20, 2019 (SLR, 2019).

Report
 OMS 35-1.2 RECONNAISSANCE REPORT

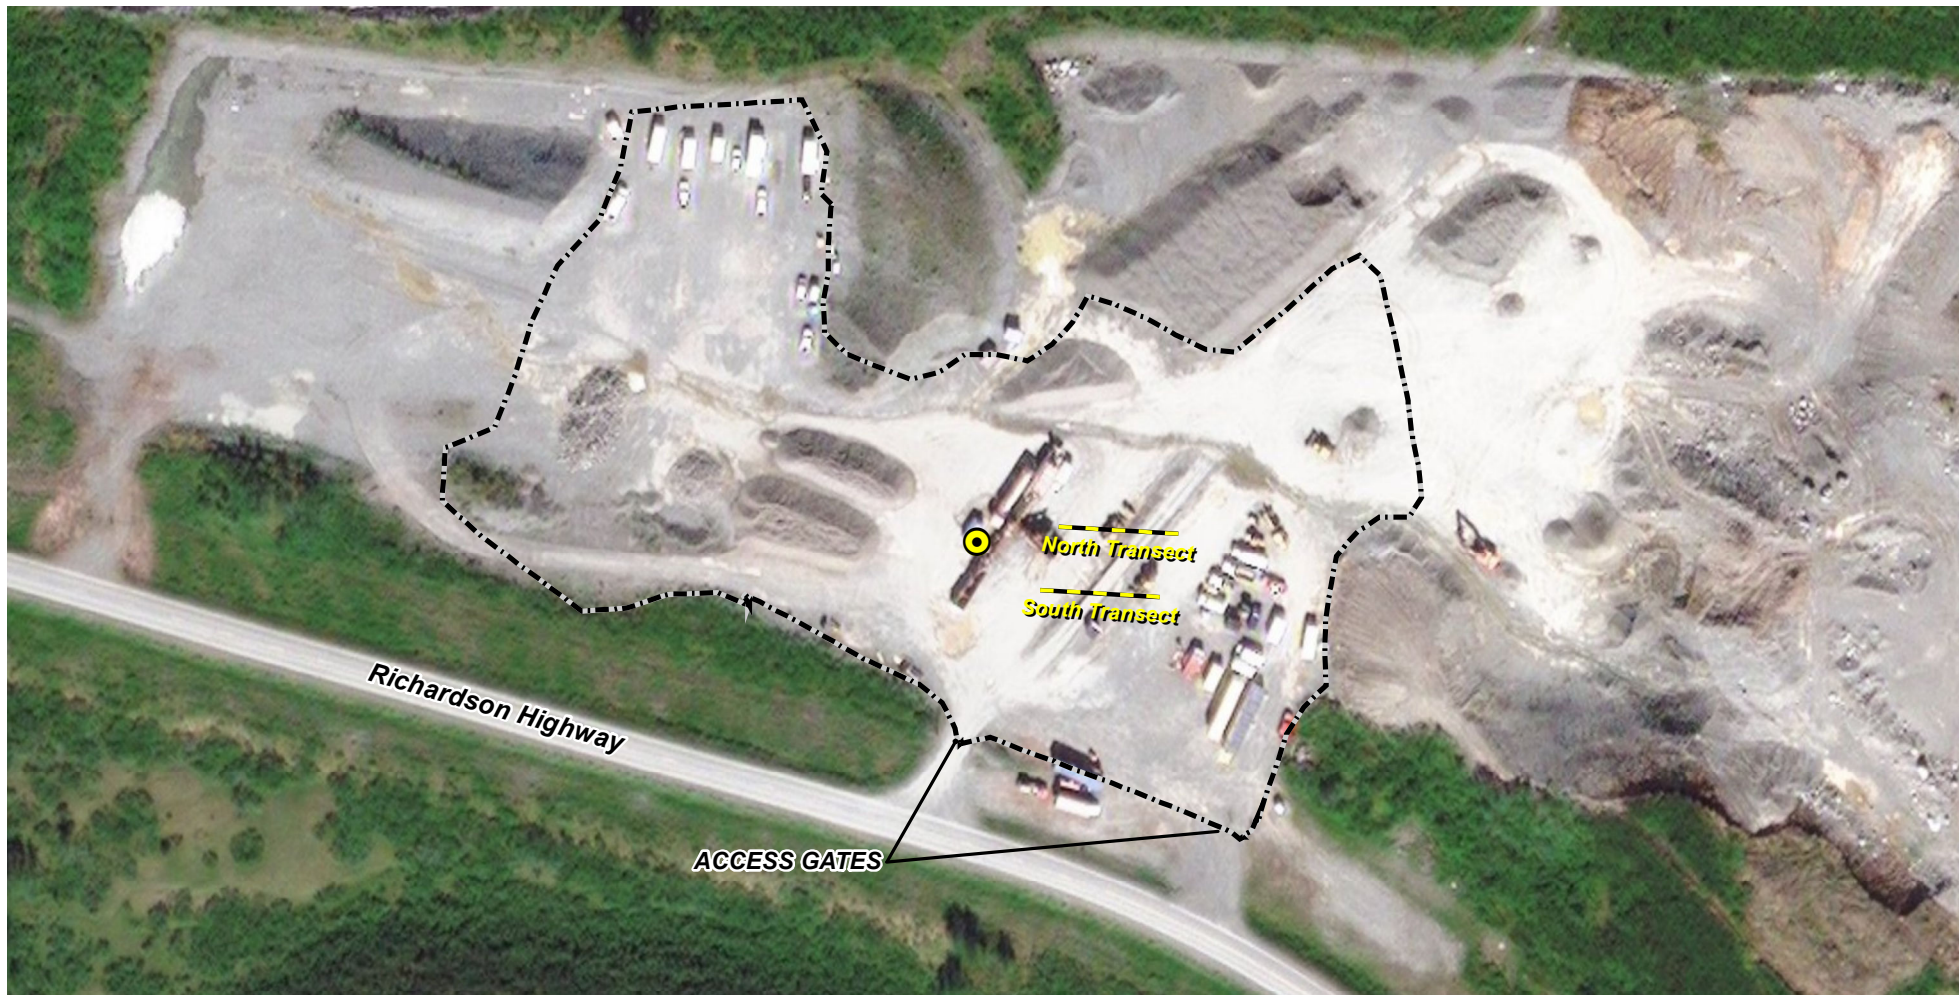
SITE VICINITY MAP

Visual inspection included mapping the current site perimeter with a handheld global positioning system (GPS) unit (Figure 2), and a visual inspection of the ground surface within the perimeter. Observations included the following:

Soil screening for VOCs was conducted along two long transects established in the approximate center of the OMS site, near the ADEC site coordinate and the location of machinery observed in an aerial photograph taken in 2014. The transects were spaced approximately 50 feet (ft) apart and ran 100 ft from east to west, as shown in Figure 2. Soil samples were collected every 20 ft along each transect from a depth of approximately 0.5 ft for heated headspace screening using a photoionization detector (PID). Heated headspace PID readings for the north and south transects ranged from 0.0 to 0.3 parts per million, well within the typical VOC background range for uncontaminated soils. The location of screening transects were mapped by GPS.

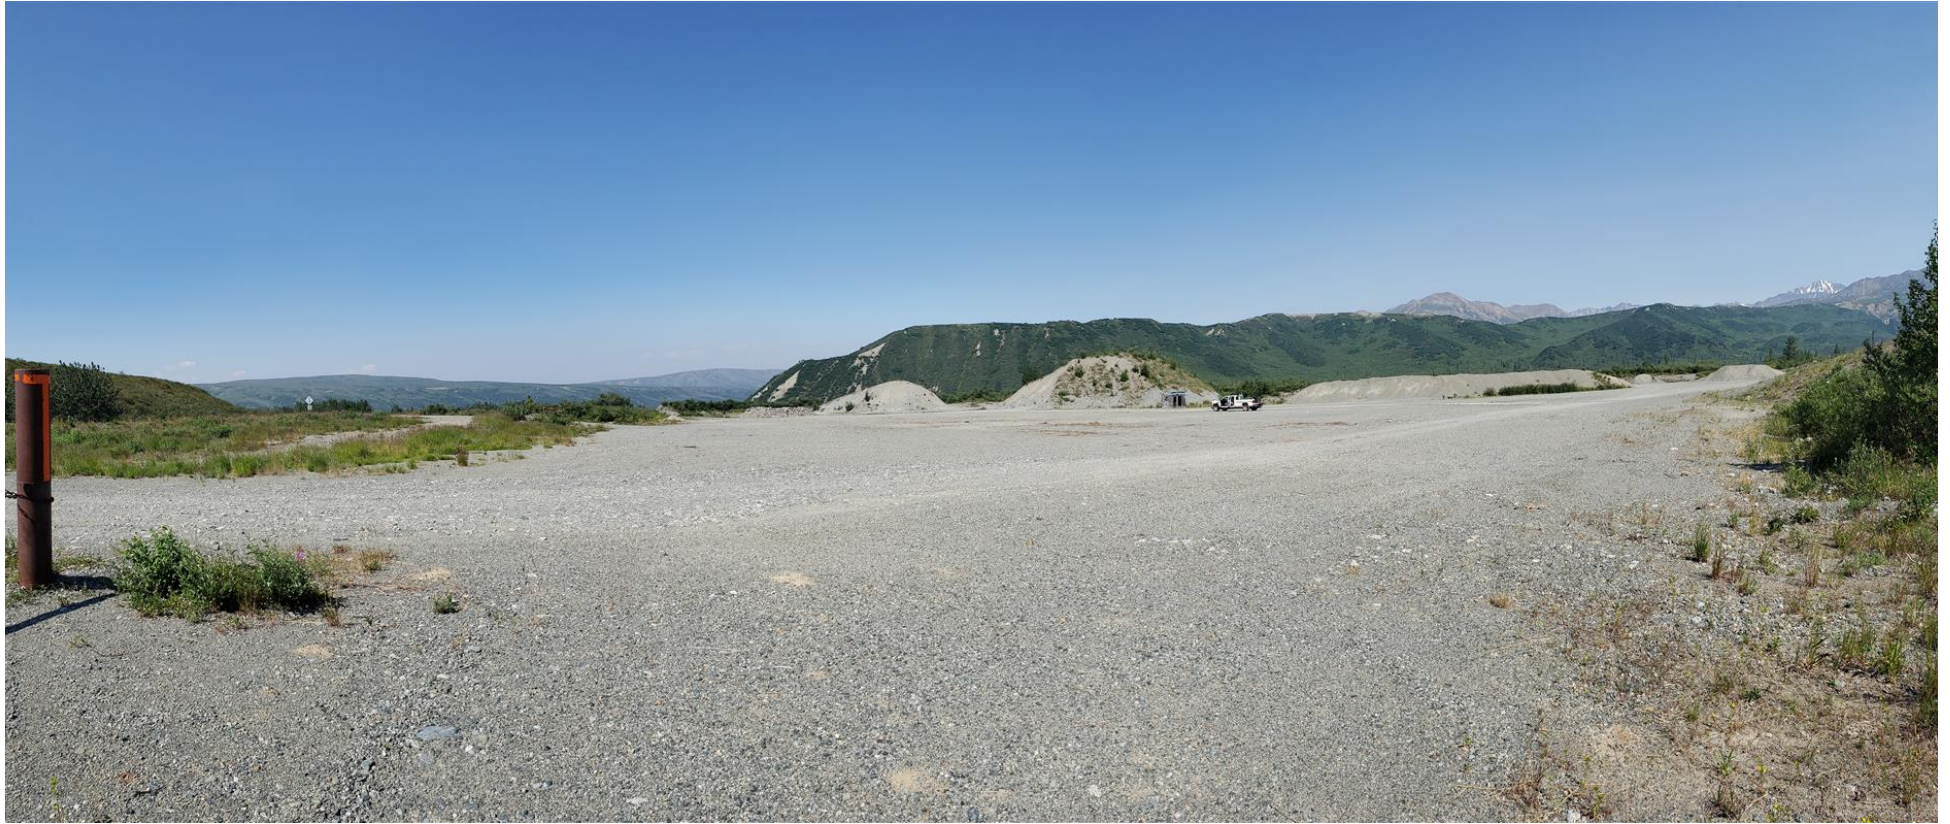
Photograph 1: View of the OMS 35-1.2 site from the southeast gate looking northwest.

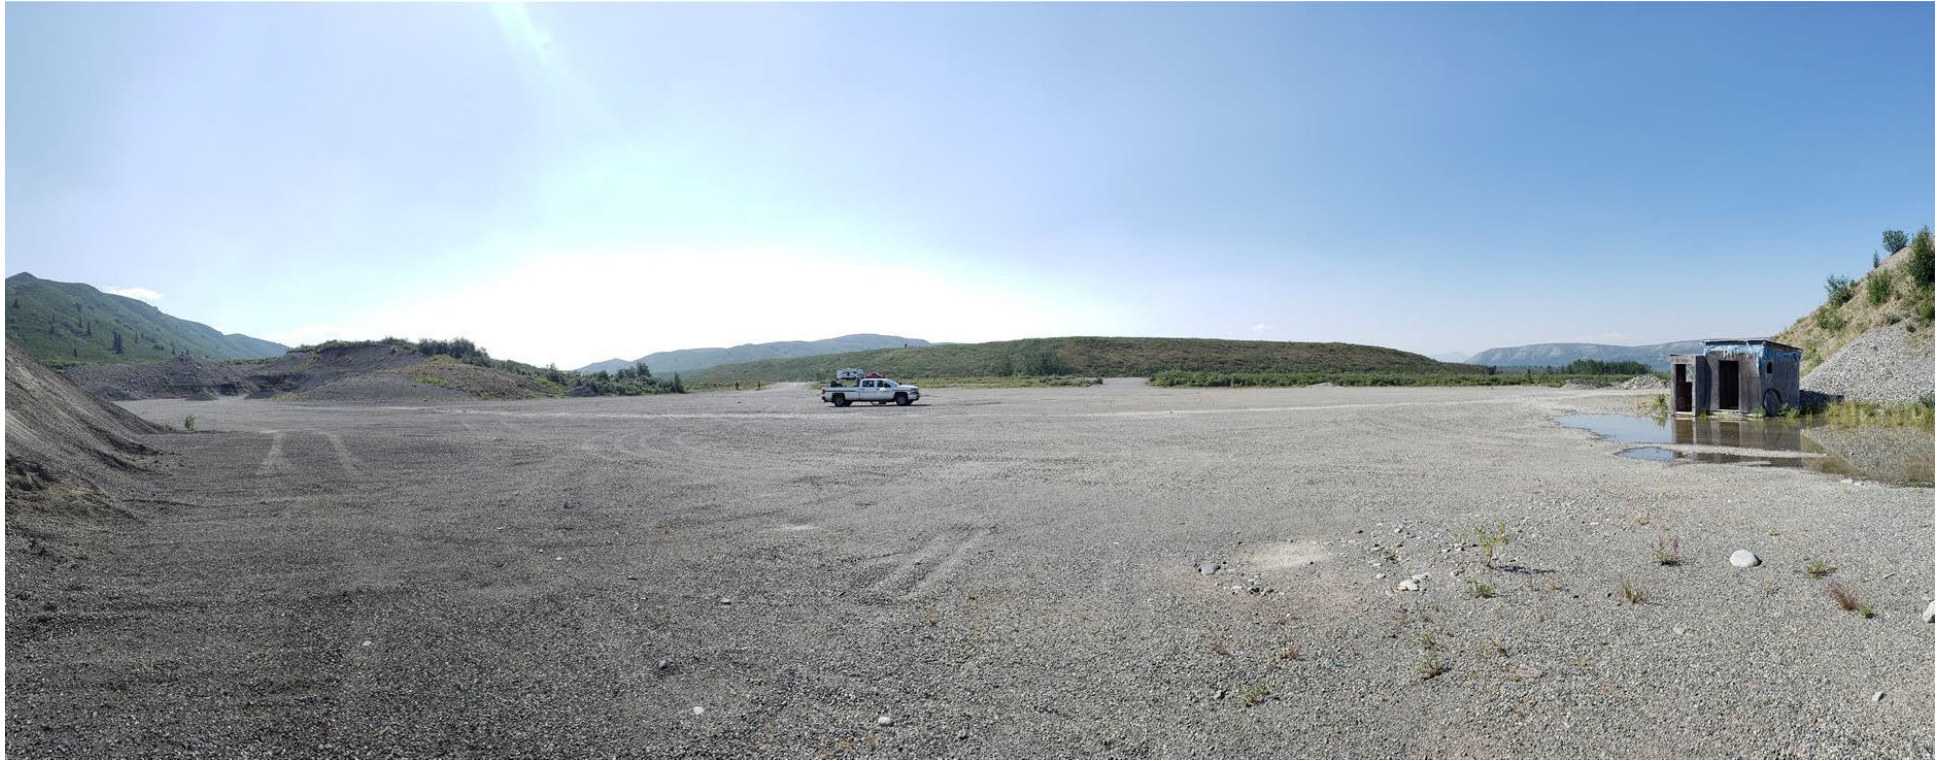
Photograph 2: View of OMS 35-1.2 site from gravel piles in northeast corner looking south.

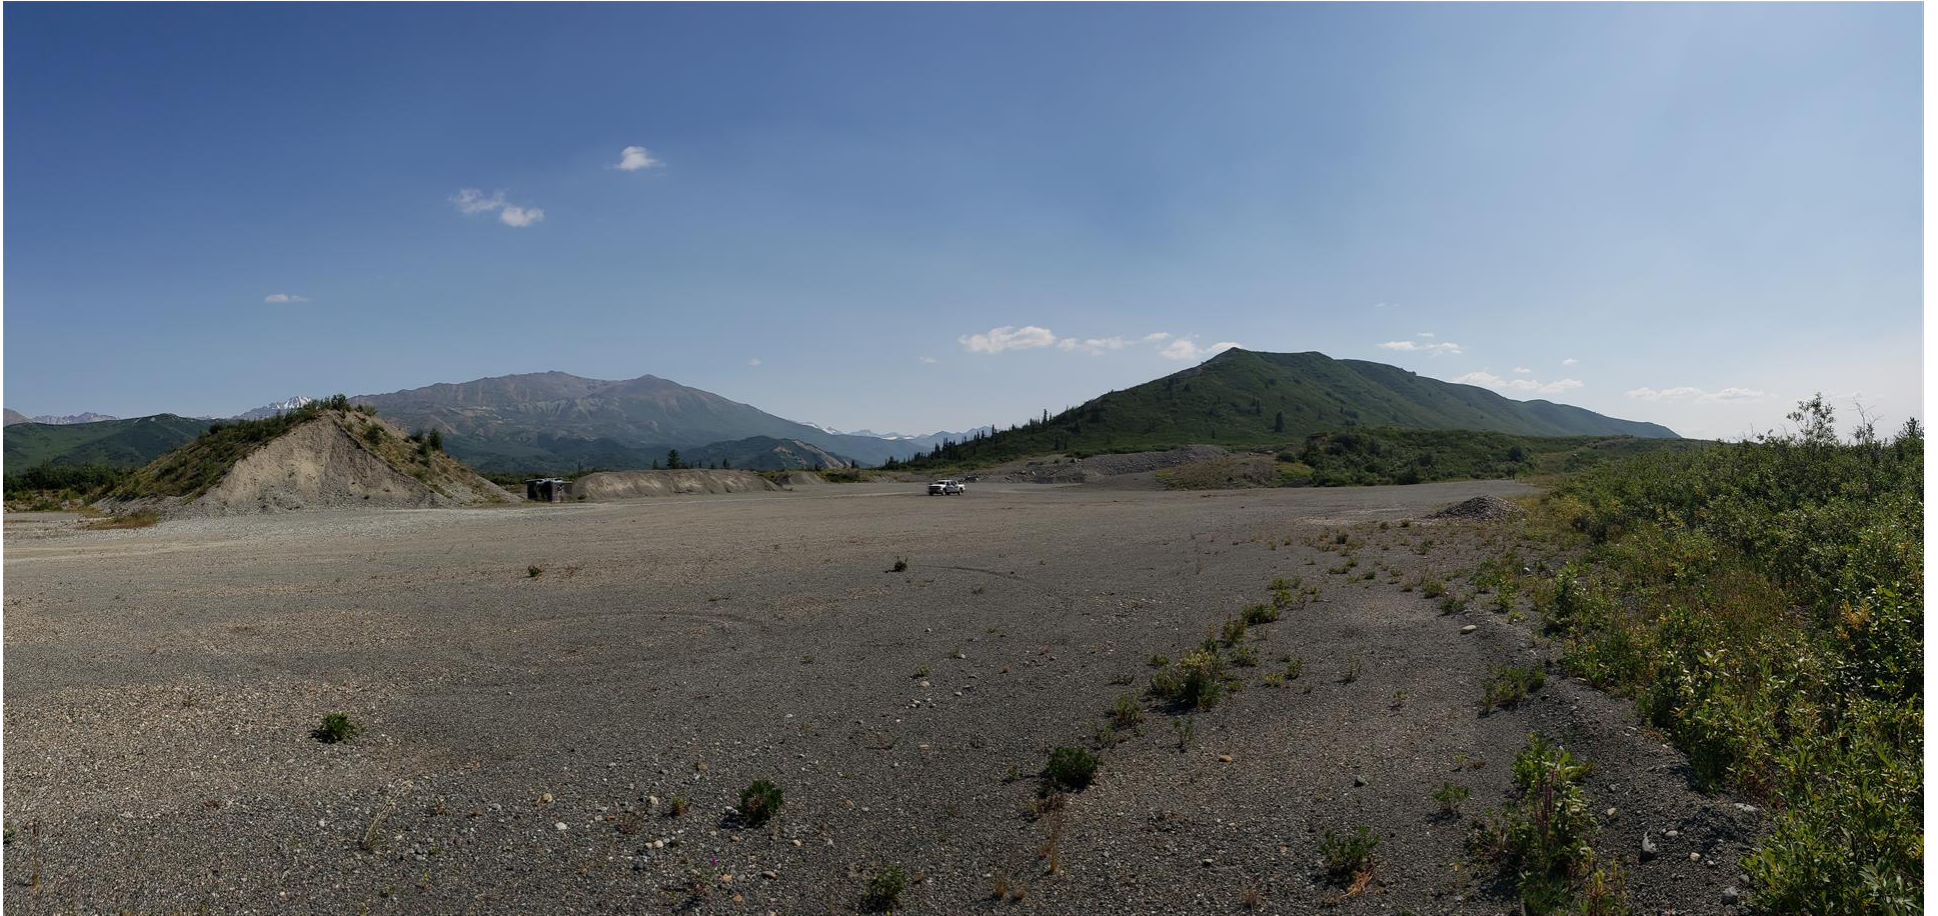
Photograph 3: View of OMS 35-1.2 site from the southwest corner looking to the east.

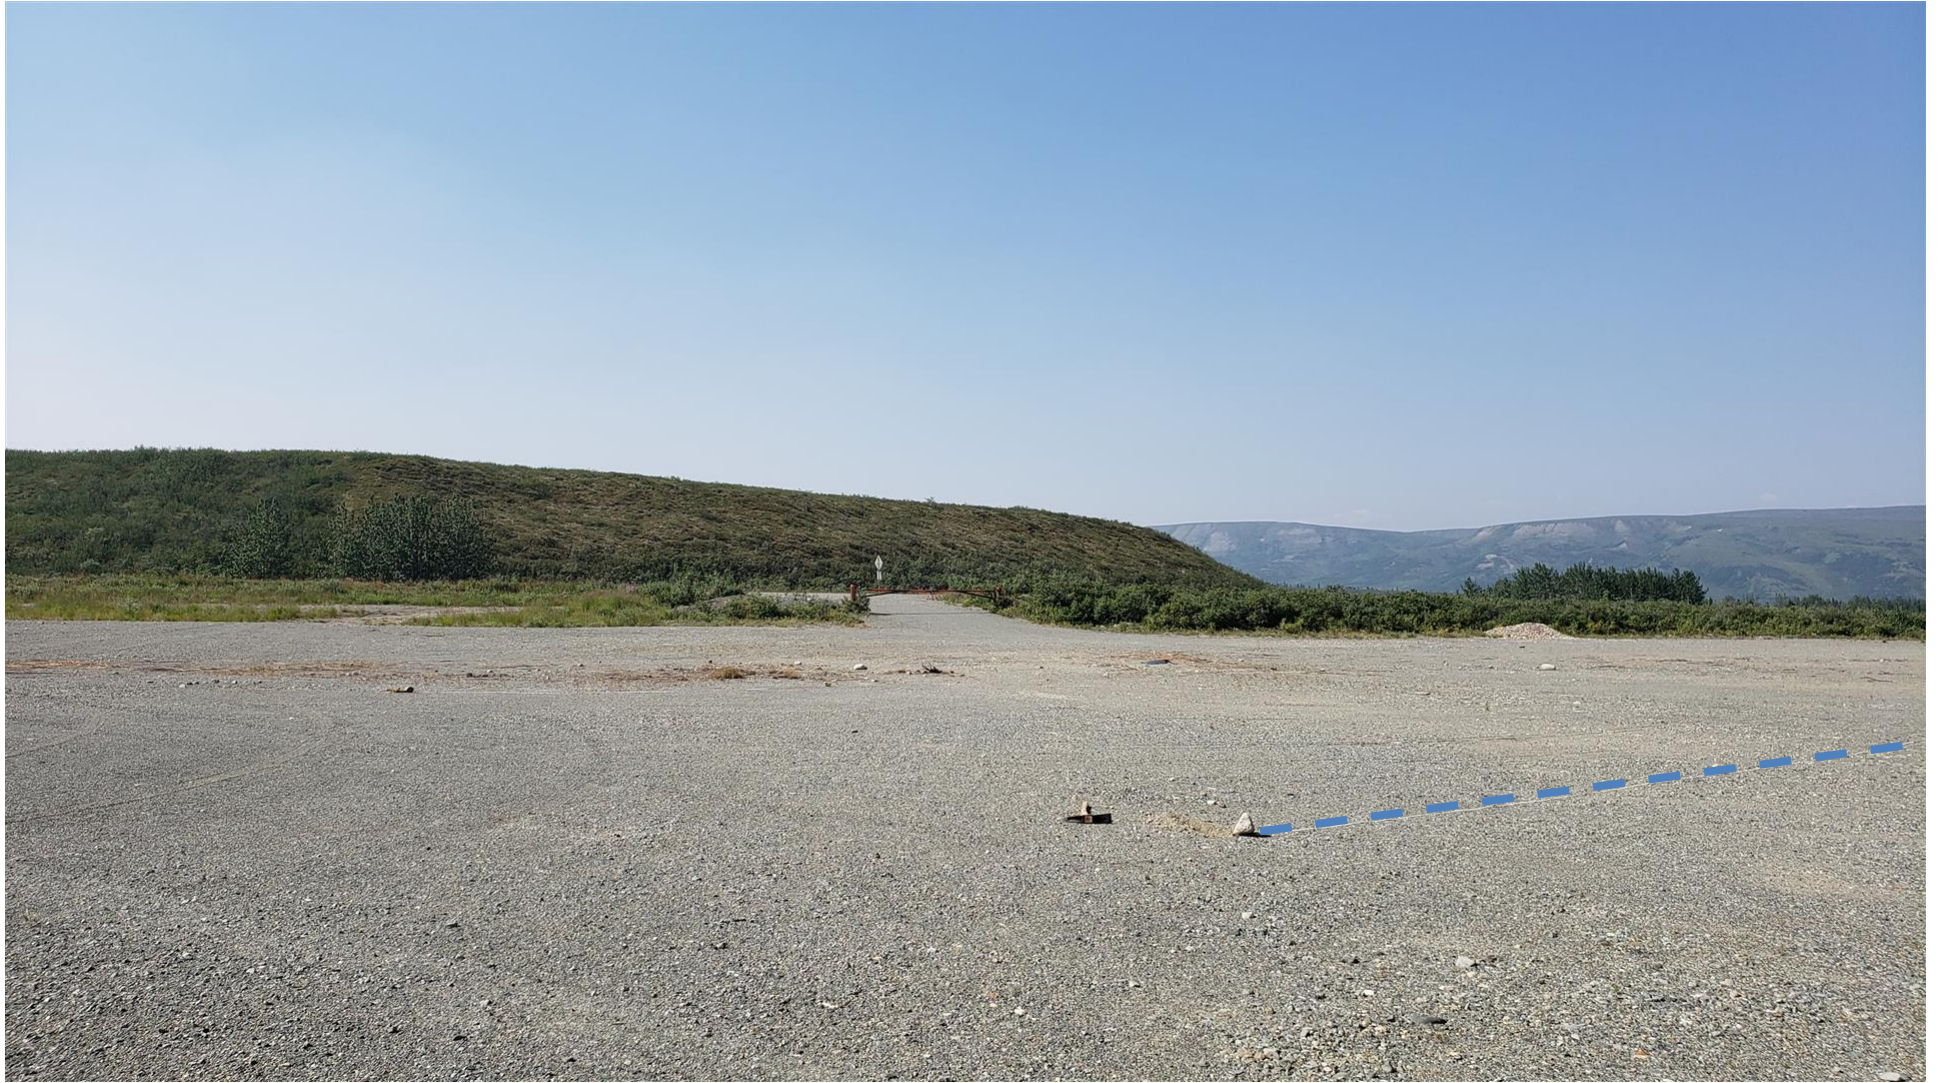
Photograph 4: View of OMS 35-1.2 site center gravel area looking southwest. The south screening transect is shown as a dashed blue line extending west.

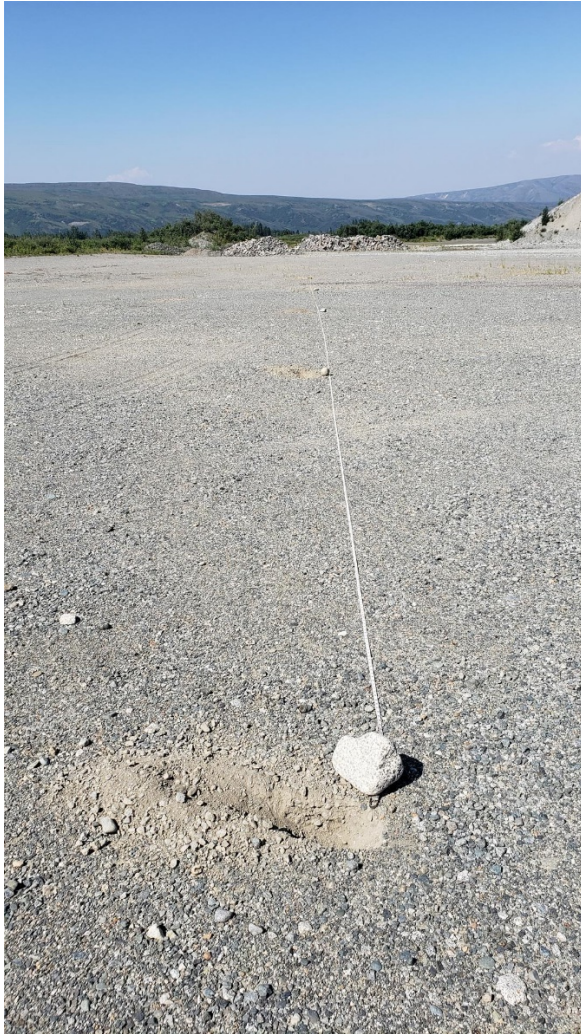
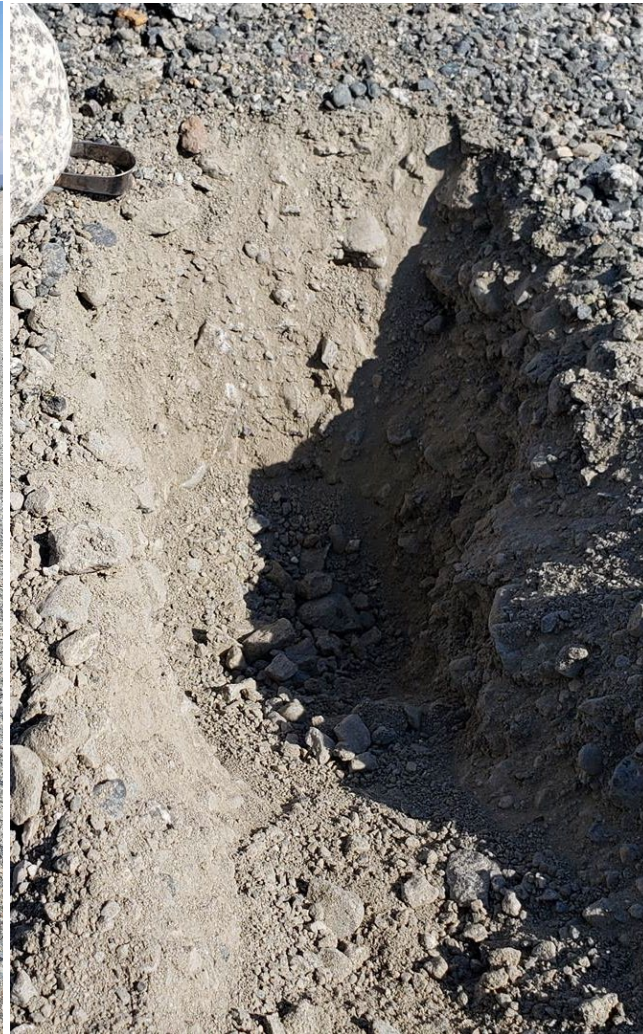
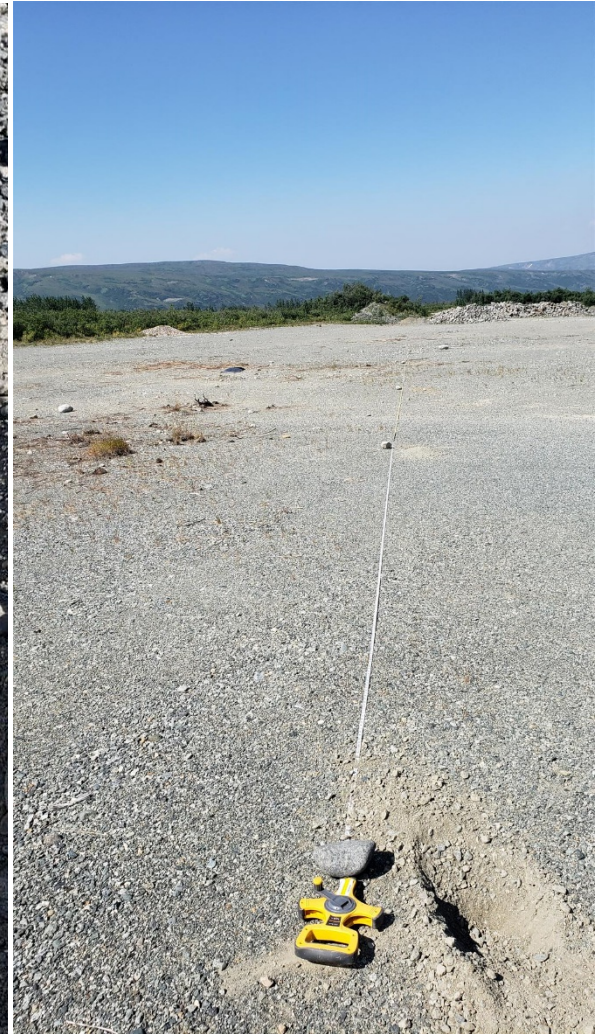
- No staining or substantial soil disturbances were identified during visual inspection of the main OMS site area (Photographs 1-7).
- No evidence of gravel mining activity in the last three years was observed, as evidenced by vegetation growing on gravel piles and the presence of observed gravel piles on historical aerial site photographs from 2016 (Figure 2).
- Site access gates do not prevent site access for vehicles as evidenced by fresh vehicle tracks on the gravel.

Photograph 5 (left): View to west along the north screening transect.
Photograph 6 (center): Typical screened pad gravel material.
Photograph 7 (right): View to west along the south screening transect.
