TRIP REPORT

FORT MORROW

Site Reconnaissance and Geospatial Data Acquisition Port Heiden, Alaska

**Alaska District
Pacific Ocean Division
U.S. Army Corps of Engineers**

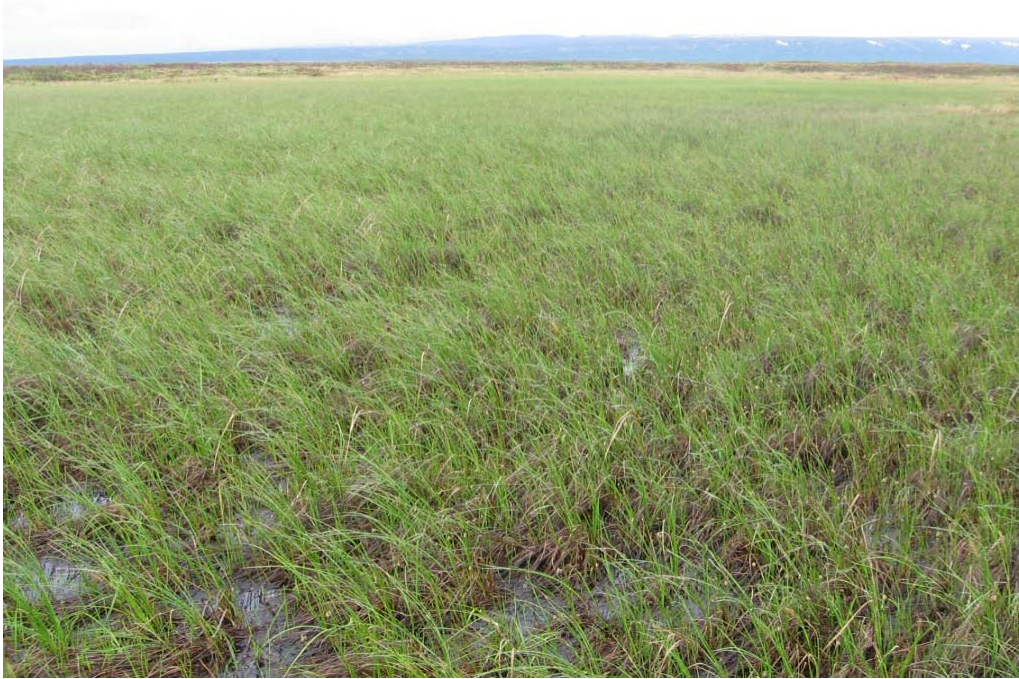
POA representatives walked this area and found it to be a swampy area typical of an old lake bed, and it was observed to lead into a watercourse toward the west that crosses under the road. POA found no indication of buried debris, and does not believe this is the location of concern. See the photograph below.

Looking northeast at swampy area east of road. (23 June 2010)

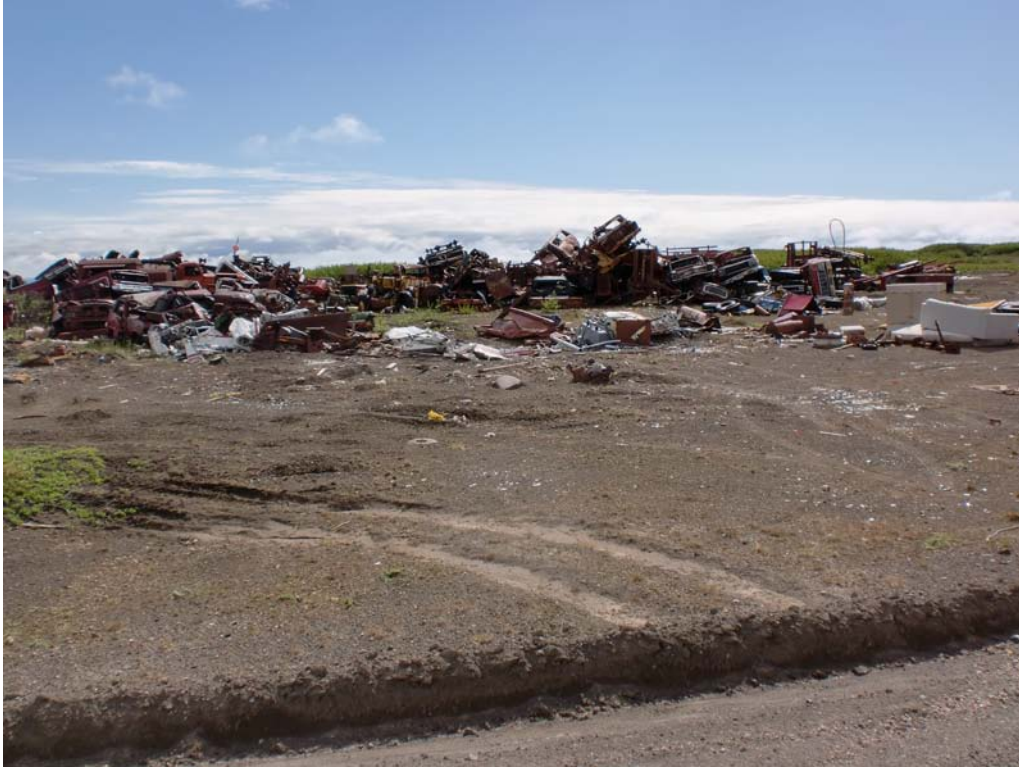
Looking west at debris pile near former garage building. Garage foundation is right of the photograph (23 June 2010)

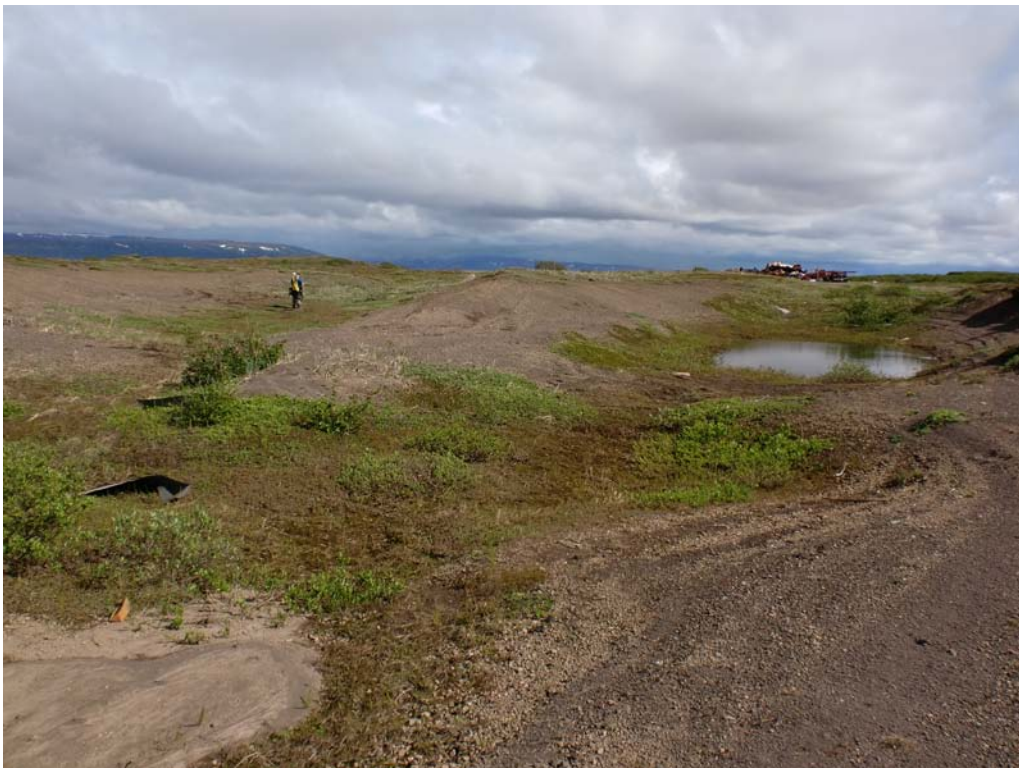
Maps from 1989 show drum storage in the area surrounding the garage. Spills were indicated on the 1989 maps at some of these drum areas, and some impacted soil was removed. An underground storage tank was removed from outside the west wall of the shop, and a spill was indicated near the southeast corner of the garage. Across the road to the north from the garage are several long trenches. Drums were reportedly stored in these trench areas. Spills were indicated on 1989 maps, and some soil was removed.

Looking south at depressions where drums were stored and spills occurred. (23 June 2010)

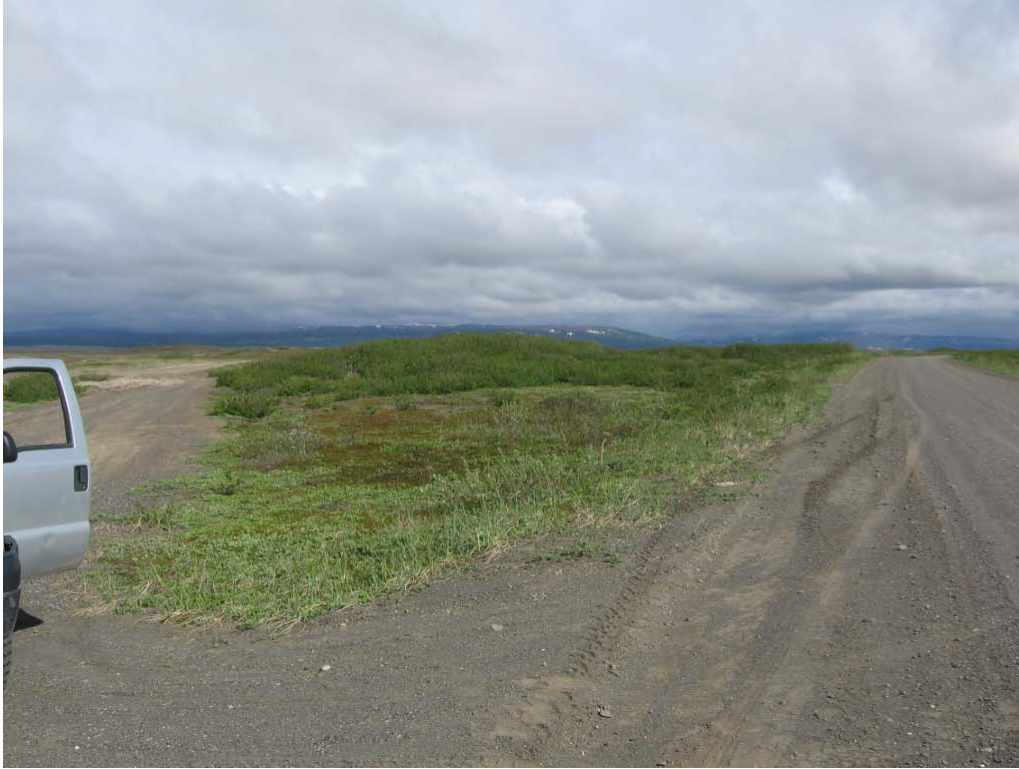
Looking southeast at area located northwest of garage, with prior drum storage. (23 June 2010)

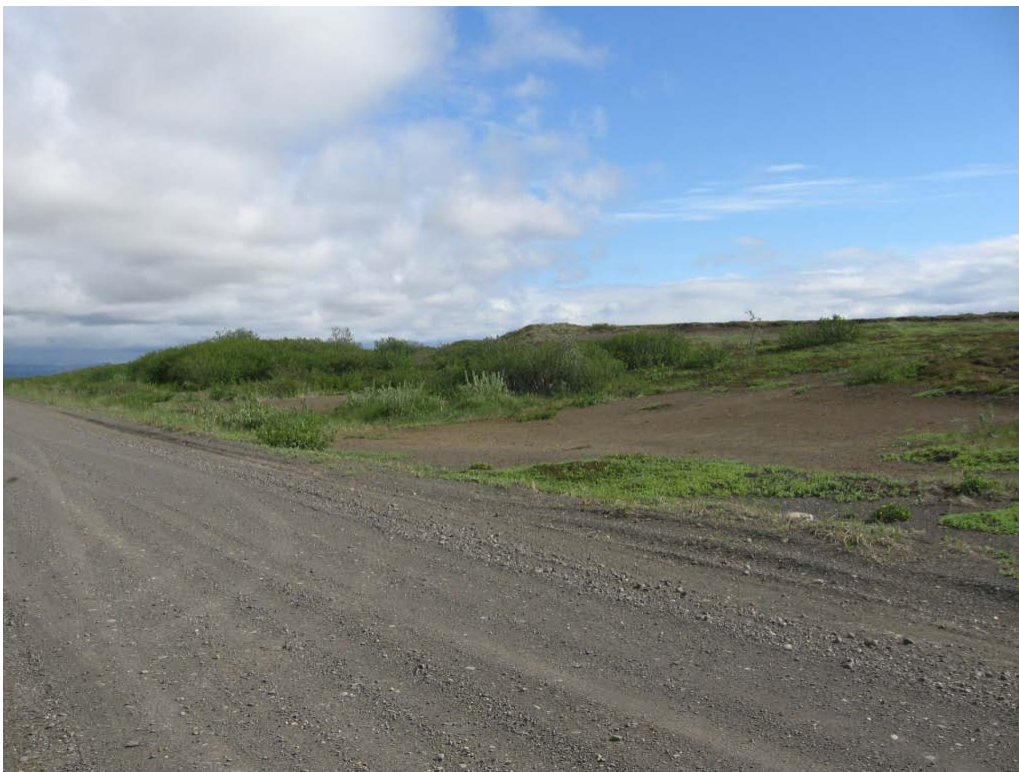
Looking south at area northwest of garage, with prior drum storage, spill, and prior soil removal. (23 June 2010)

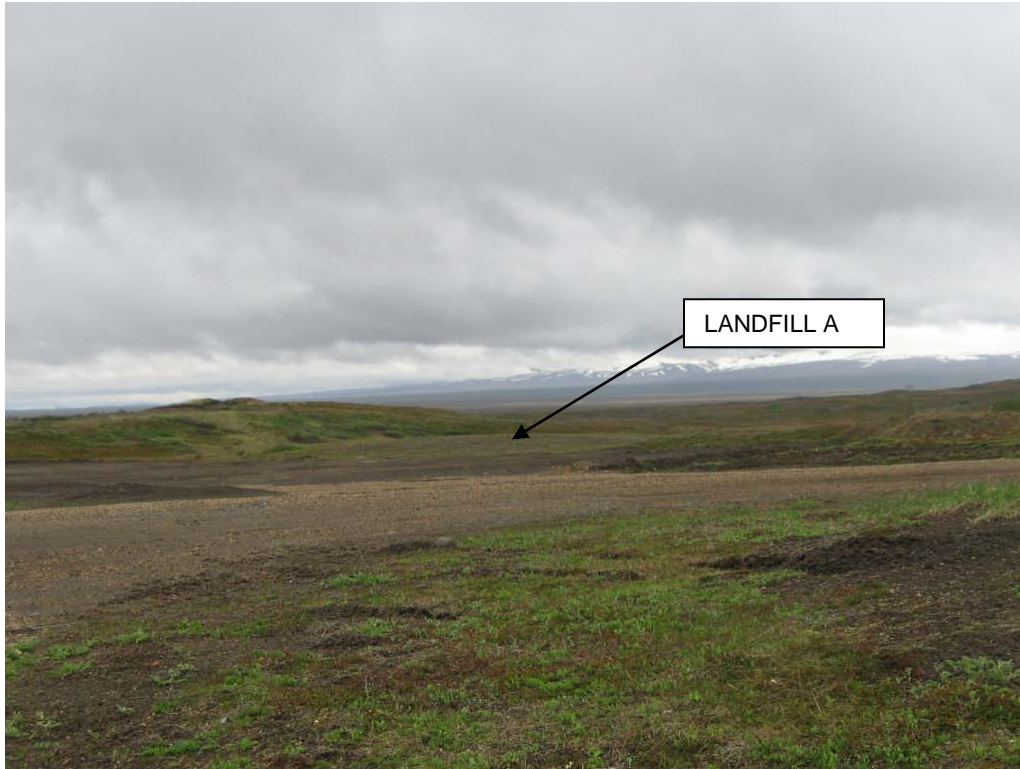
Looking east at Landfill A from eastern edge of former WAC site. (23 June 2010)

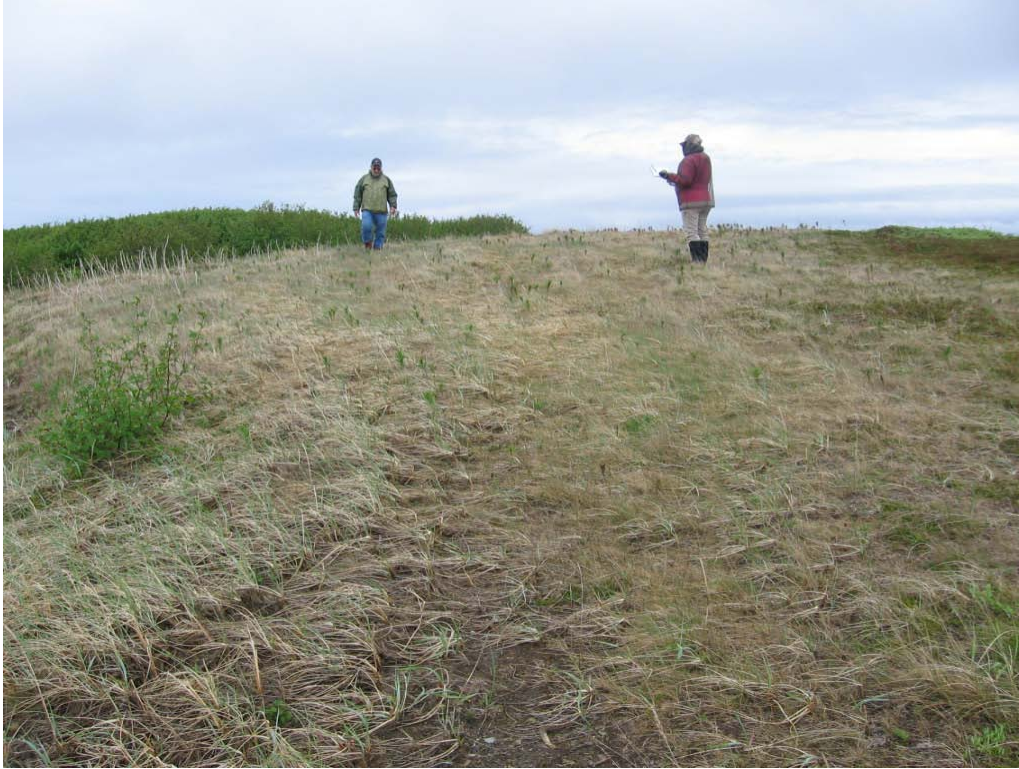
Looking northeast at Landfill B. (23 June 2010)

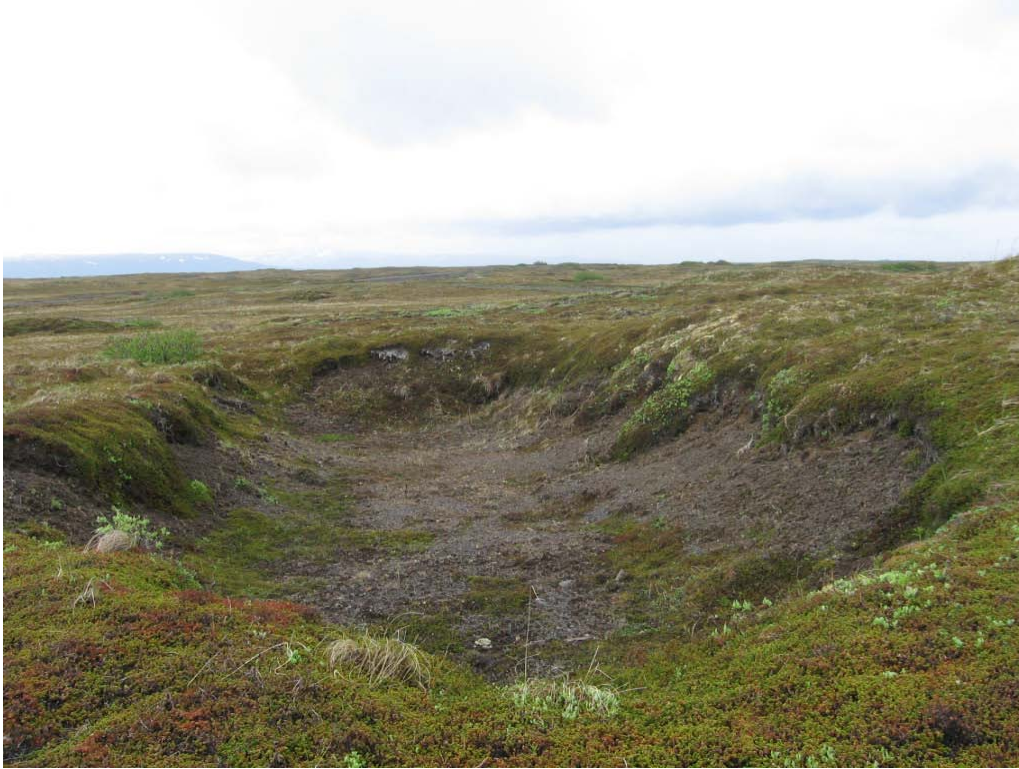
Typical building pit for a Quonset hut barracks structure. (23 June 2010)

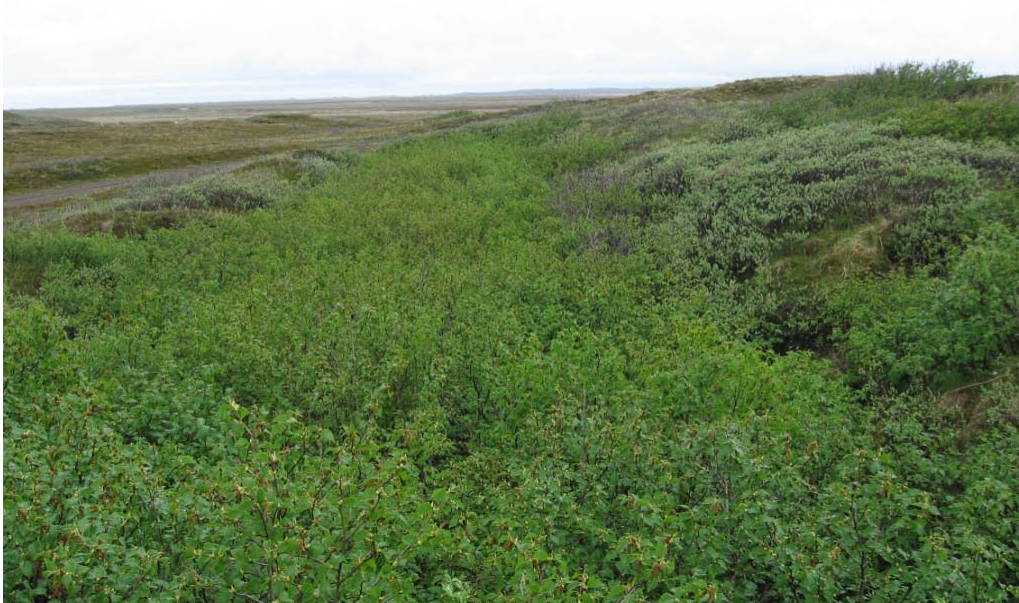
Typical building pit for a mess hall, this one overgrown with alder. (23 June 2010)

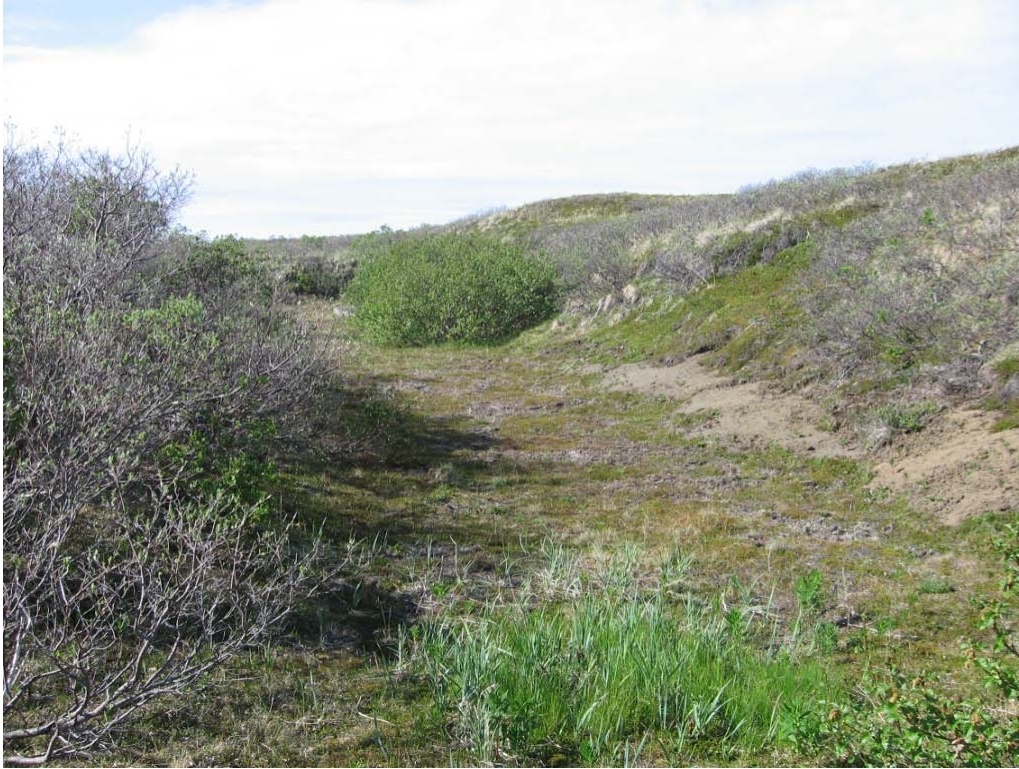
Looking north at building pit for reported ordnance storage building. (23 June 2010)

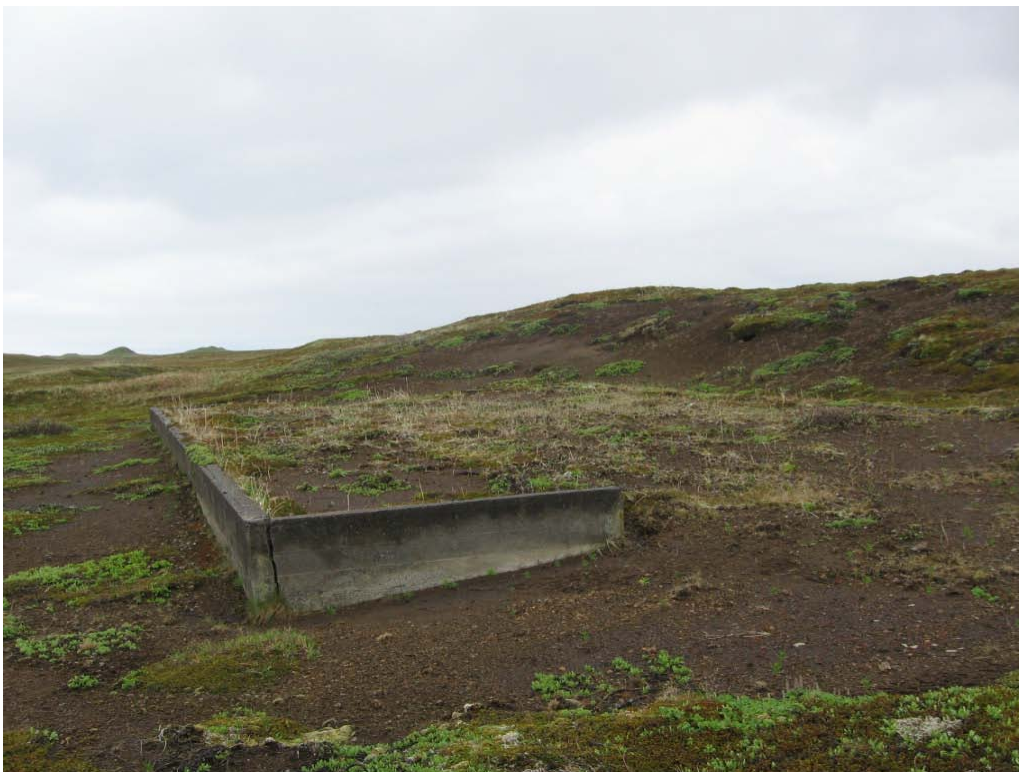
Looking north at warehouse foundation with concrete footings. (23 June 2010)

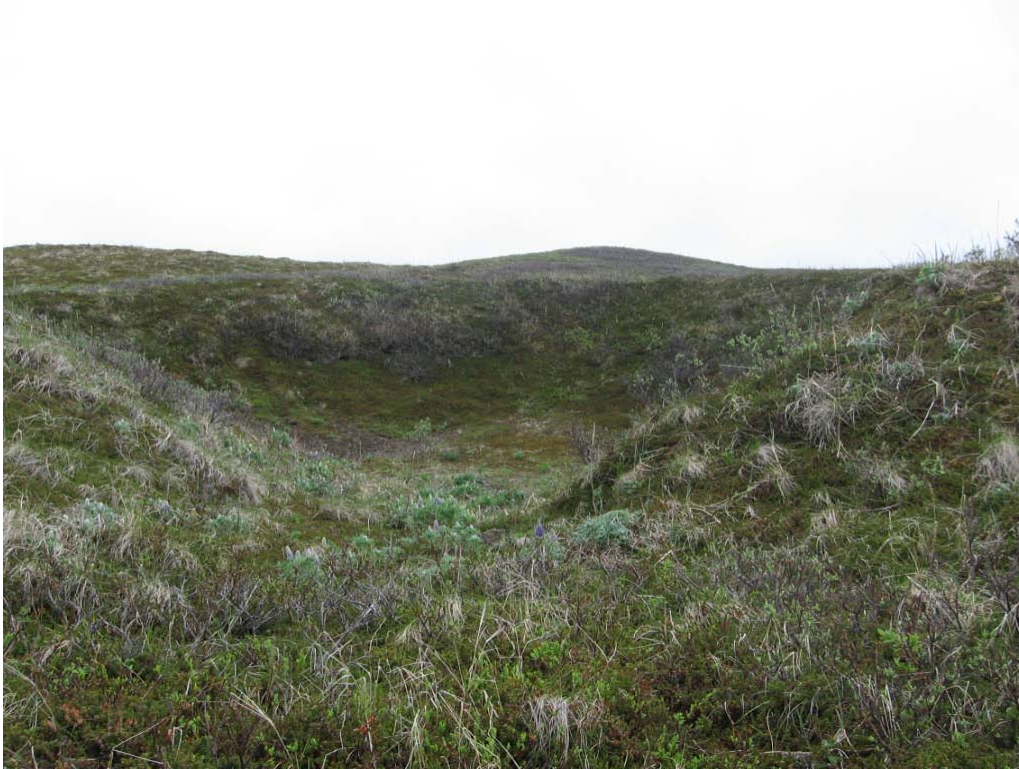
Looking south into a former fuel storage pit. (23 June 2010)

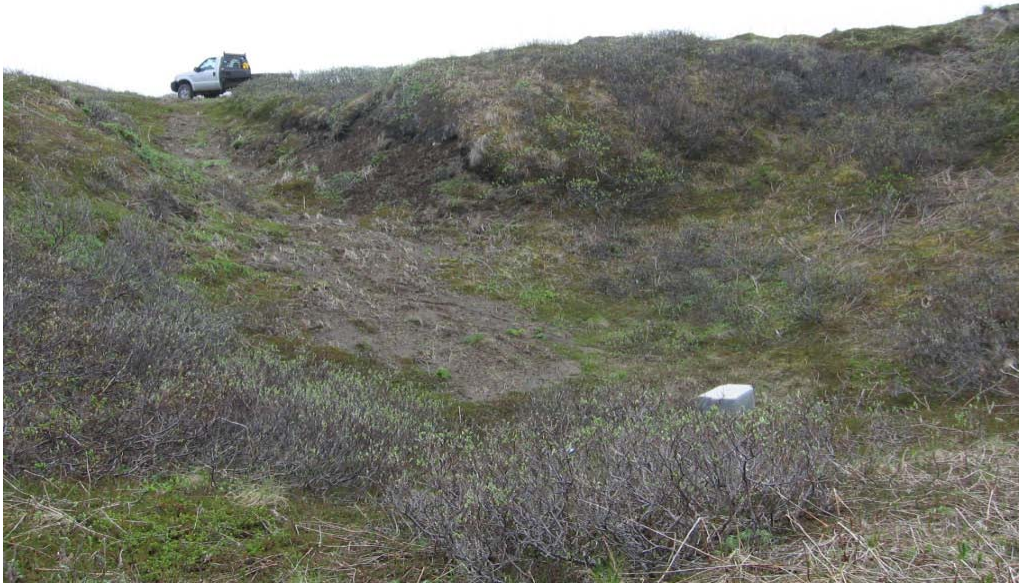
Looking southwest from inside a former fuel storage pit. (23 June 2010)

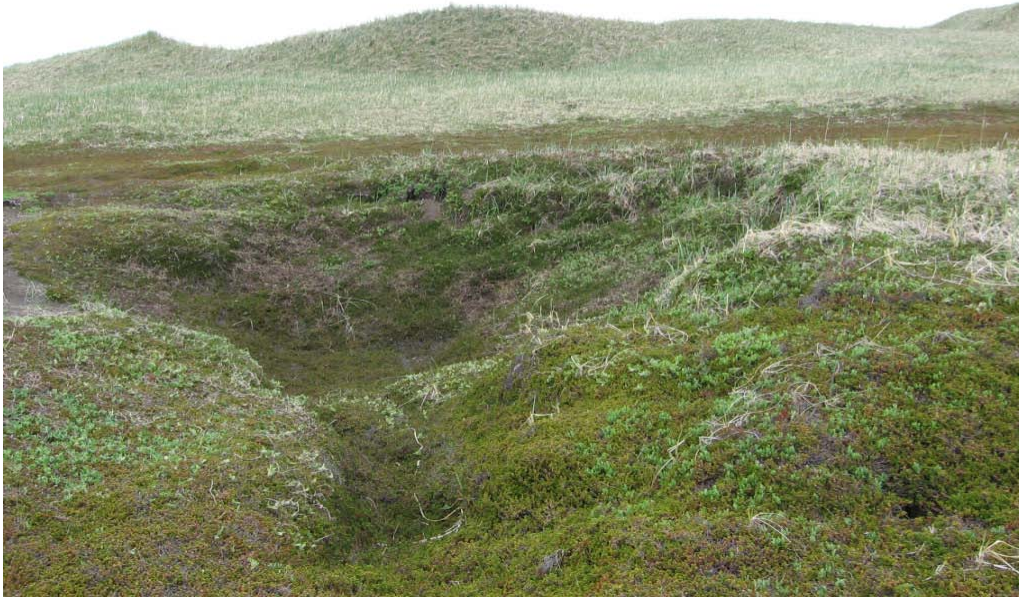
Numerous shallow pits and trenches were found along the western edge of the Fort Morrow area. These features are not shown on 1980s hardcopy maps, and are believed to be defensive defilade positions (“foxholes”).

Looking west at typical "foxhole" along western edge of Fort Morrow. (23 June 2010)

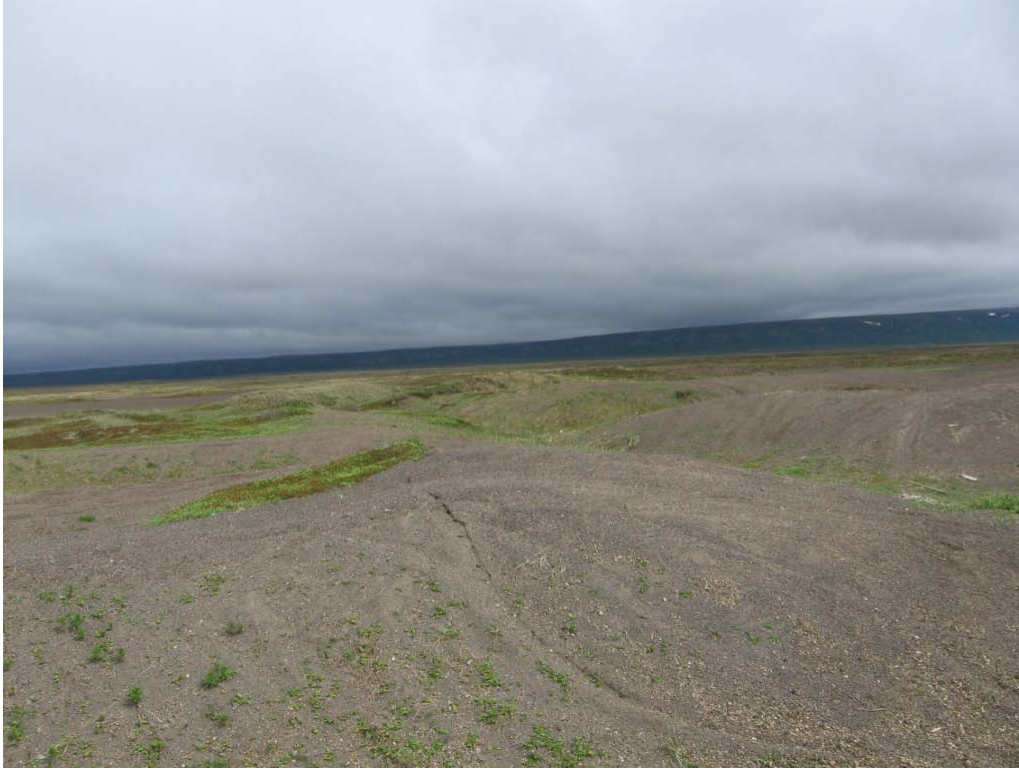
Looking northeast at bermed ground in infirmary compound area. Infirmary and wards were set in low areas between berms. (23 June 2010)

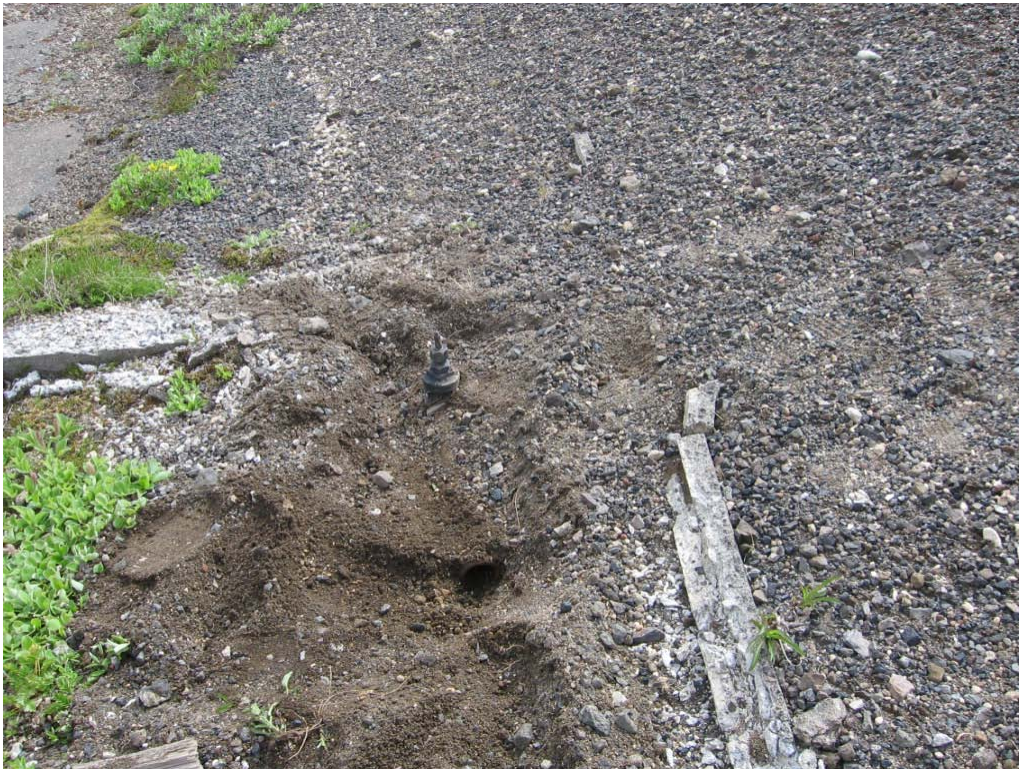
A concrete foundation was found in the southern part of the infirmary compound and buried piping was identified. One pipe smelled of petroleum.

Looking at concrete foundation at infirmary area. (23 June 2010)

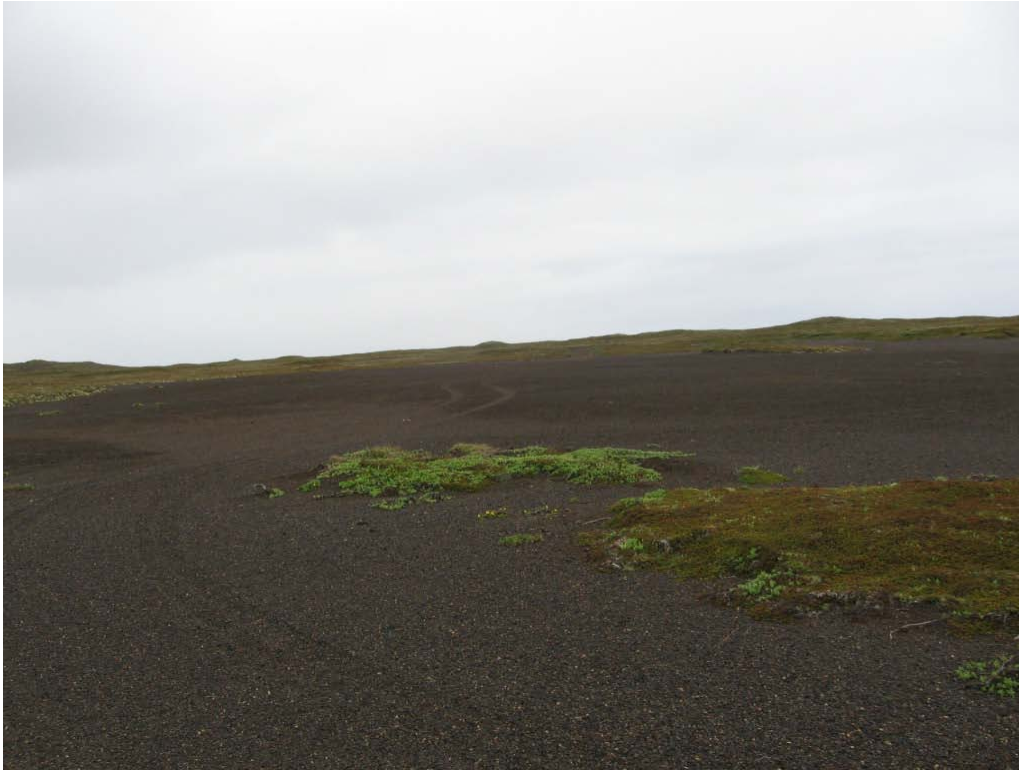
A location at the northwestern corner of the Fort Morrow area was shown in preliminary draft AGC information as a spill location, and was reported by the community as an ordnance location. The location was visited and found to be a large flat ground scar of sand and gravel surface soil. No debris was found. Hardened tar pieces were found at the surface.

Looking west at large ground scar along western road, reported as a spill area and an ordnance area. (23 June 2010)

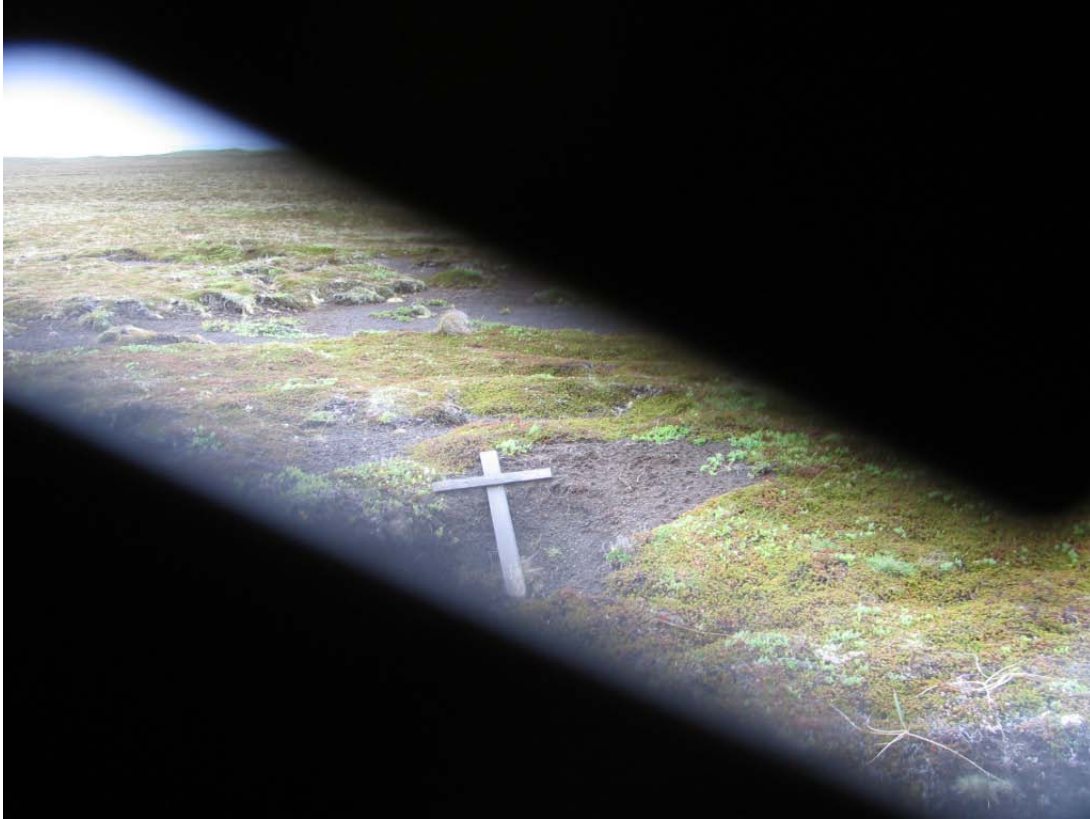
A wooden cross was found at this area. This location may be a gravesite. Coordinates of this feature are:

Looking southwest at wooden cross. Camera shutter partially closed. (23 June 2010)

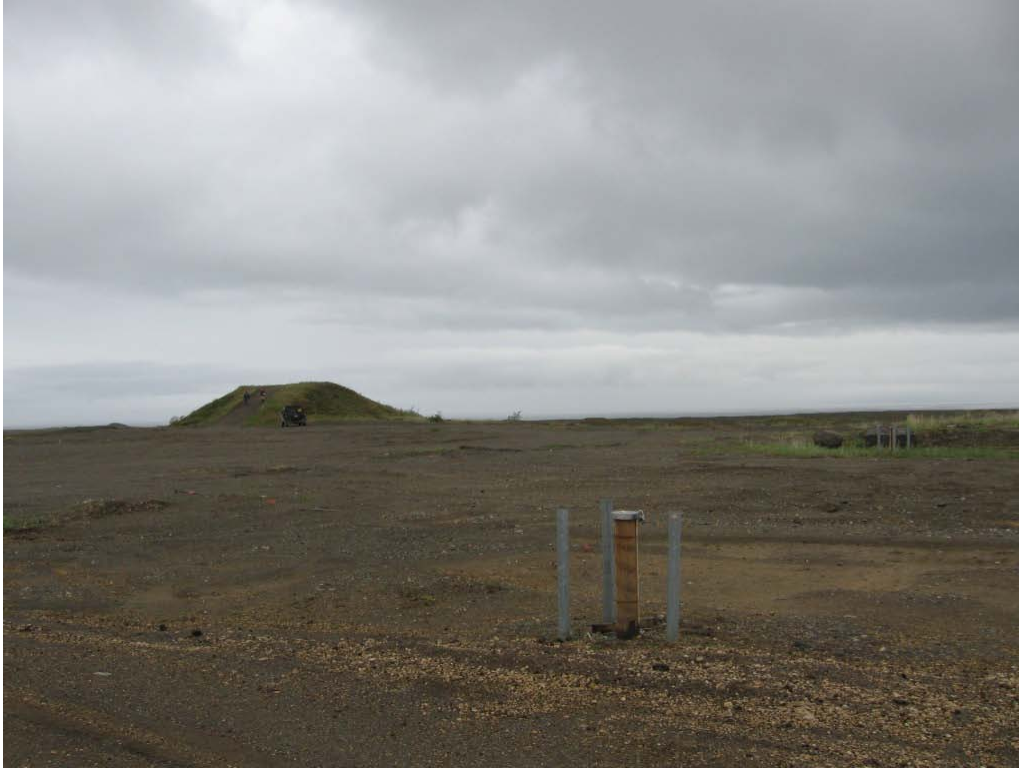
Looking west across the former WAC site area, with monitoring wells and concrete antennae foundation. (23 June 2010)

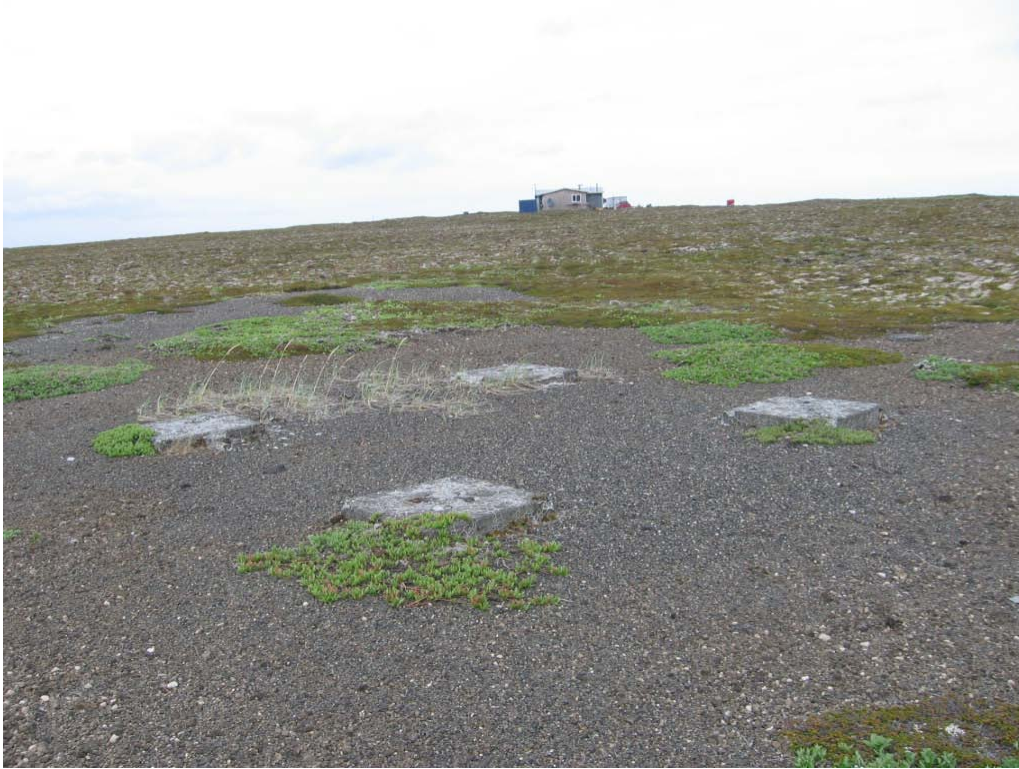
Looking northwest at C.A.A. Range Station antennae foundations. (24 June 2010)

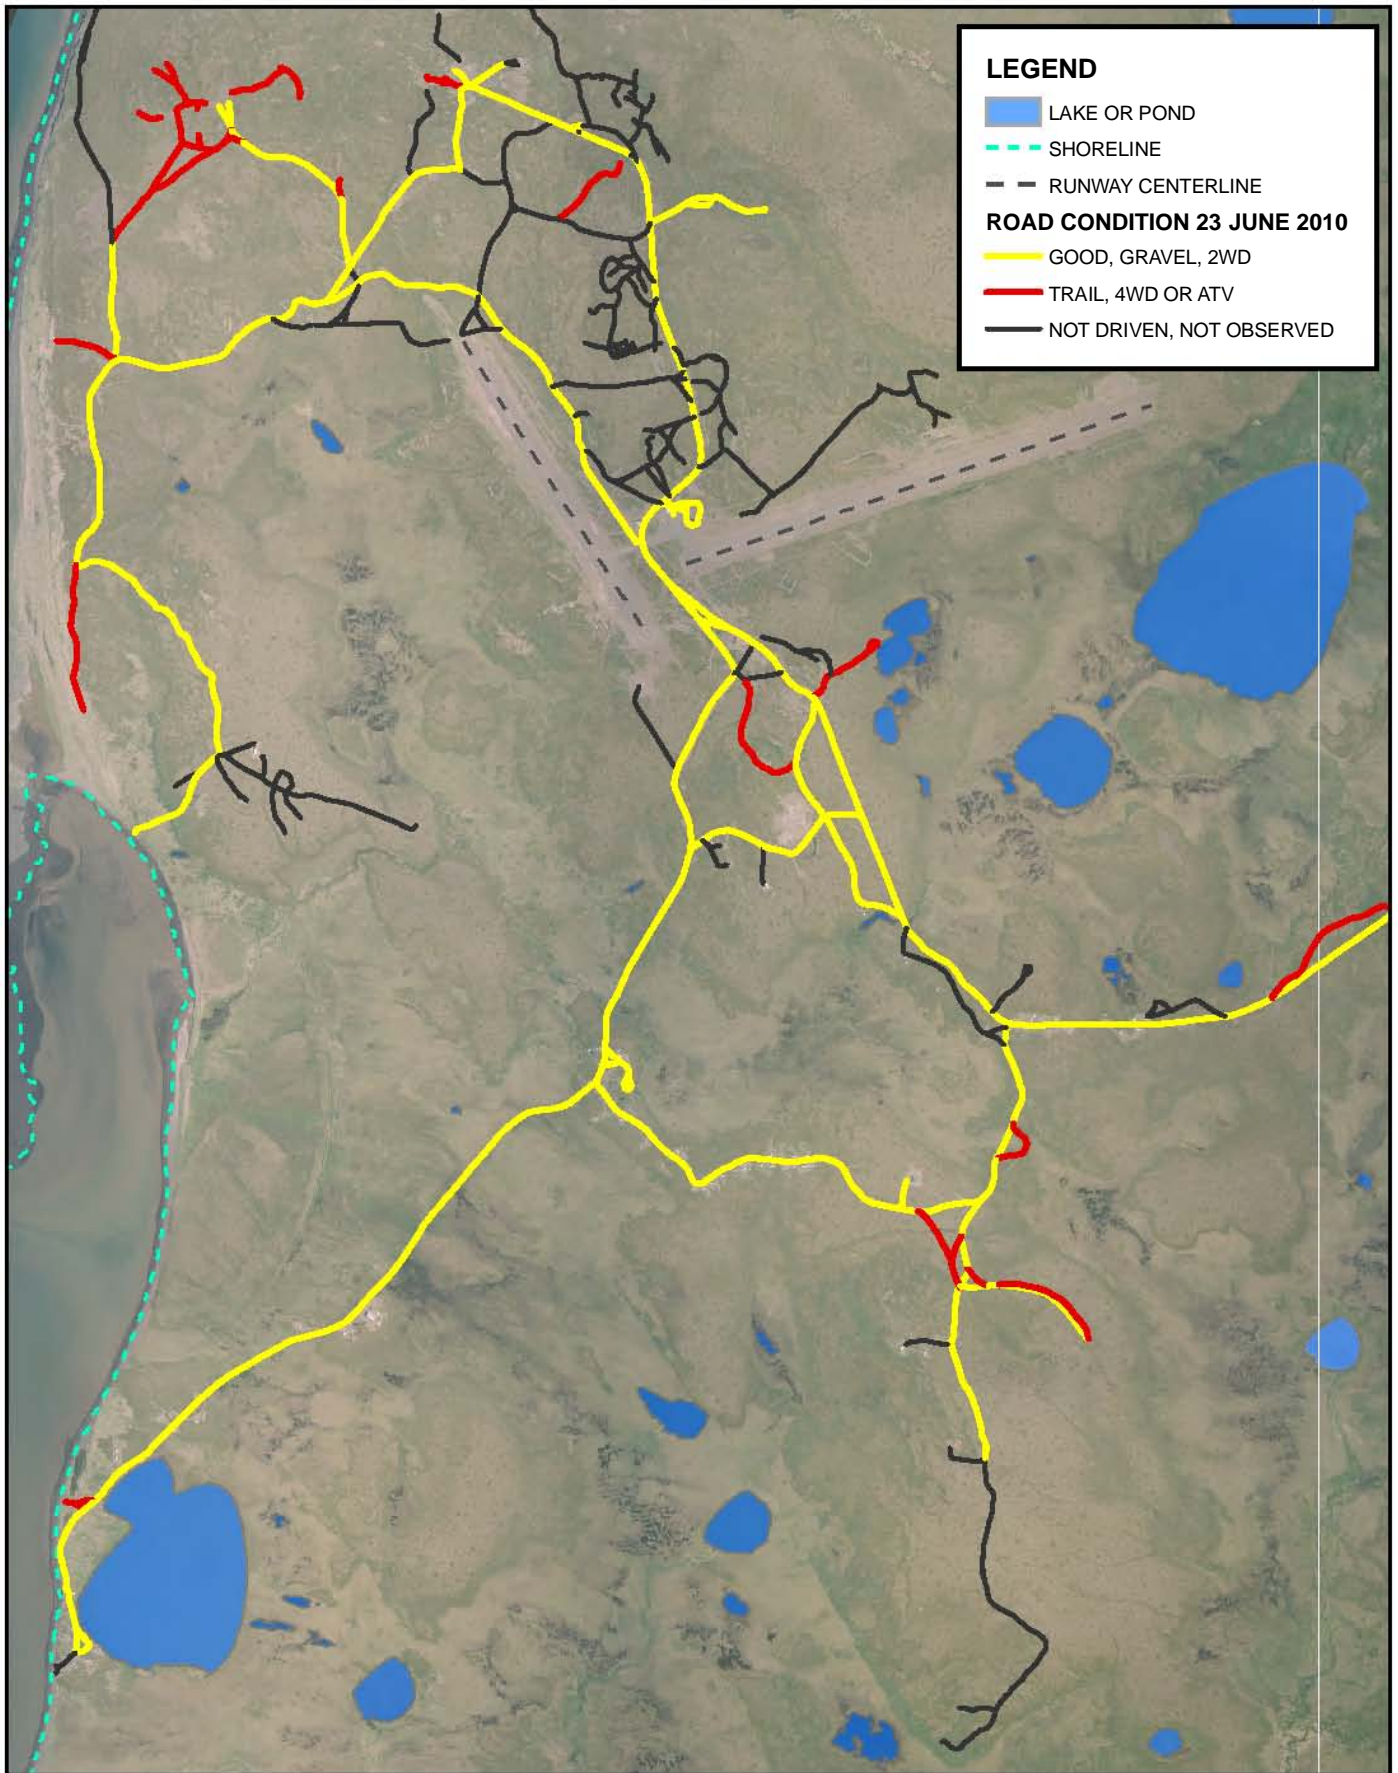
FIGURE 5

Many roads in the Fort Morrow area were driven to access sites. Road conditions are described in Figure 5. A 4WD pickup truck was used, however it remained in 2WD at all times during the site visit. During wet periods 4WD would be needed on some roads/trails.
