THIRD CERCLA FIVE-YEAR REVIEW AND THIRD NON-CERCLA PERIODIC REVIEW REPORT FOR SITES DP011, LF003, SS010, SS013, SS014, SS015, SS016, SS017, AND ST009 AT CAPE ROMANZOF LONG RANGE RADAR STATION, ALASKA

Final November 2018

United States Air Force Joint Base Elmendorf-Richardson, Alaska

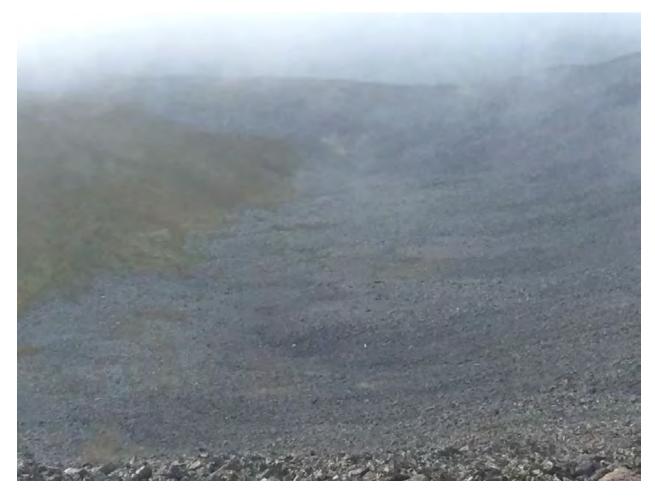
DP011 view east. Photograph shows base of the cirque with minimal debris scattered in colluvium boulders.

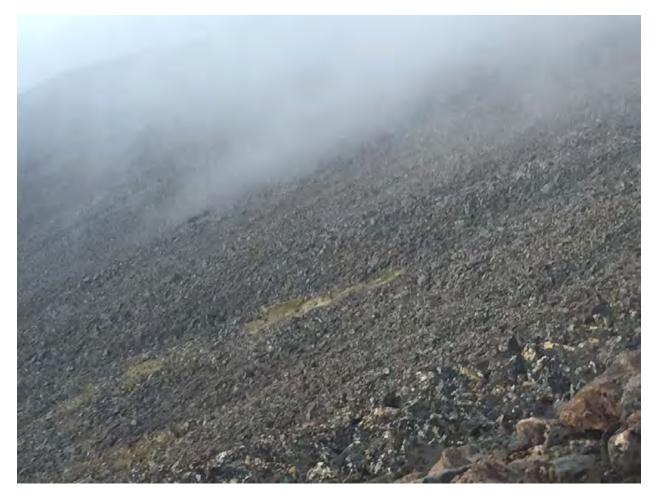
DP011 view south. Photograph shows cirque sloping with minimal debris scattered in colluvium boulders.

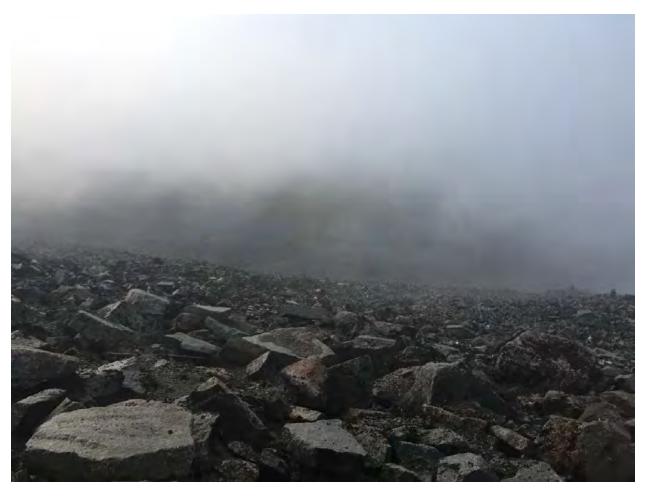
DP011 view east. Photograph shows cirque down slope from site access road with minimal debris scattered among boulders.

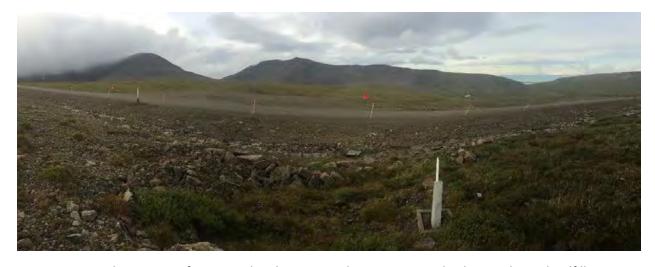
LF003 view south. CMW3 in foreground with MW-2 and LUC signage in background over landfill cap.

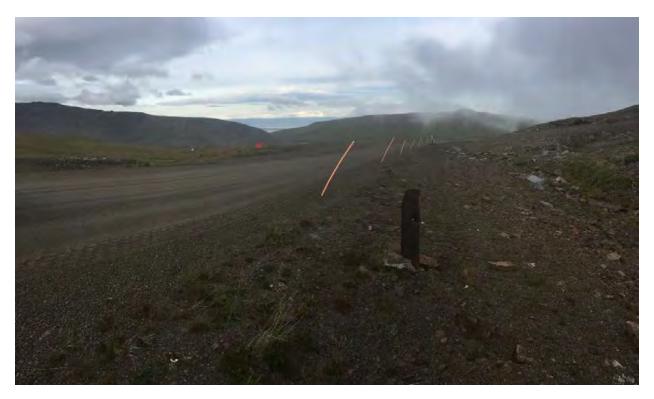
LF003 view west. MW1 shown in foreground along site access road.

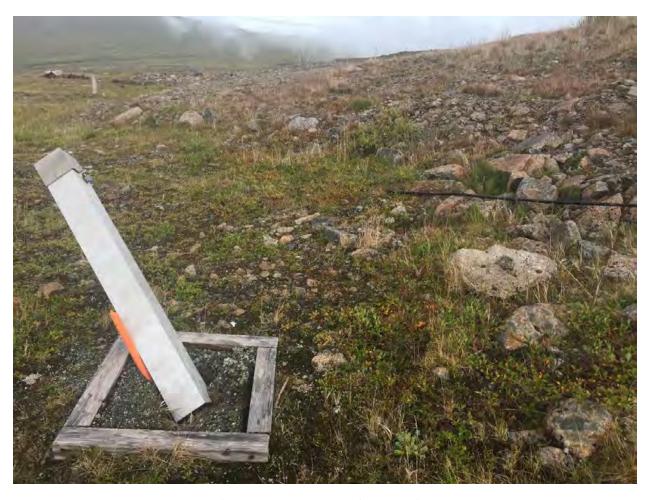
LF003 view west. CMW3 shown in foreground along toe of the landfill at photographs right.

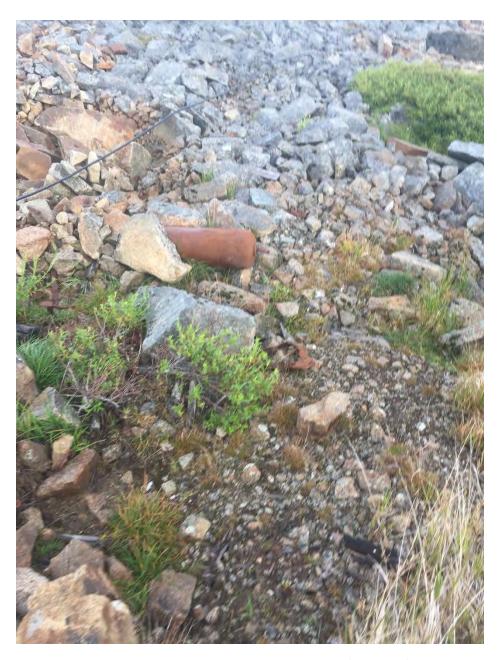
$\ \, \text{LF003 view east. Debris daylighting along western toe of the landfill.} \\$

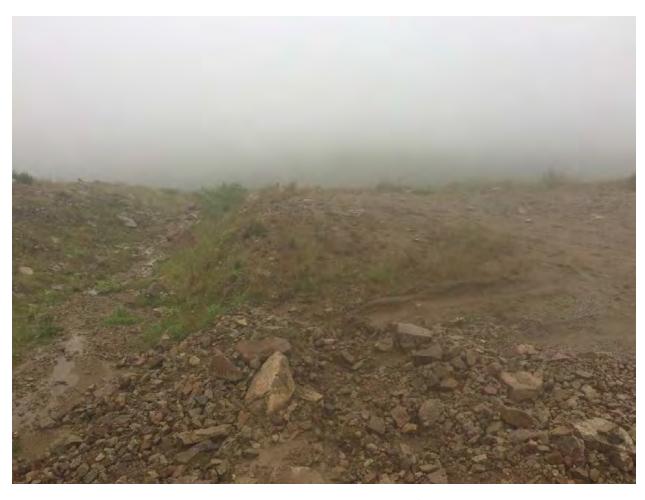
SS010 view south west. Drainage area bisecting monitoring wells in foreground.

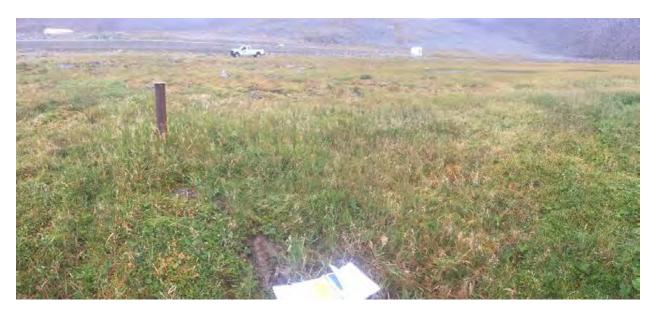
SS013 view north east shown well protective casing roughly located near former MW3 shown in foreground with water pump house and cold storage shown in background.

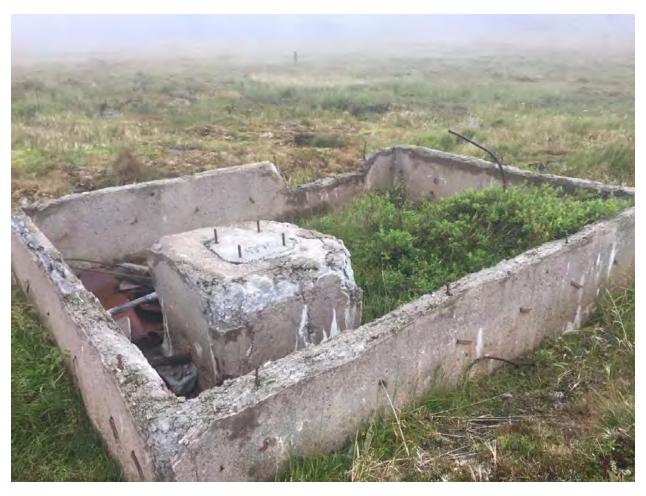
Site SS013 view south west. Concrete foundation in foreground and monitoring well protective casing in background.

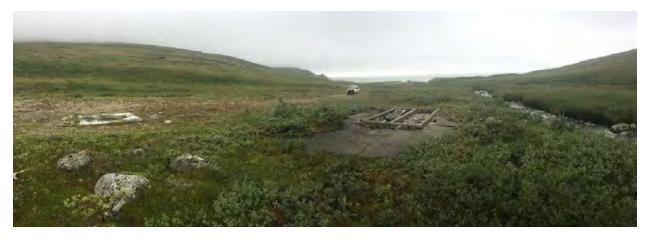
Site SS014 view south. Concrete and wood platform shown in foreground. MW3 shown in background along Fowler Creek.
