**DRIFTWOOD BAY RRS
ALASKA**

FINAL
PRELIMINARY ASSESSMENT/SITE INSPECTION
RADIO RELAY STATION
DRIFTWOOD BAY
UNALASKA ISLAND, ALASKA

JANUARY 1996

EMCON Alaska, Inc
4701 Business Park Boulevard, Suite 36
Anchorage, Alaska 99503-7166

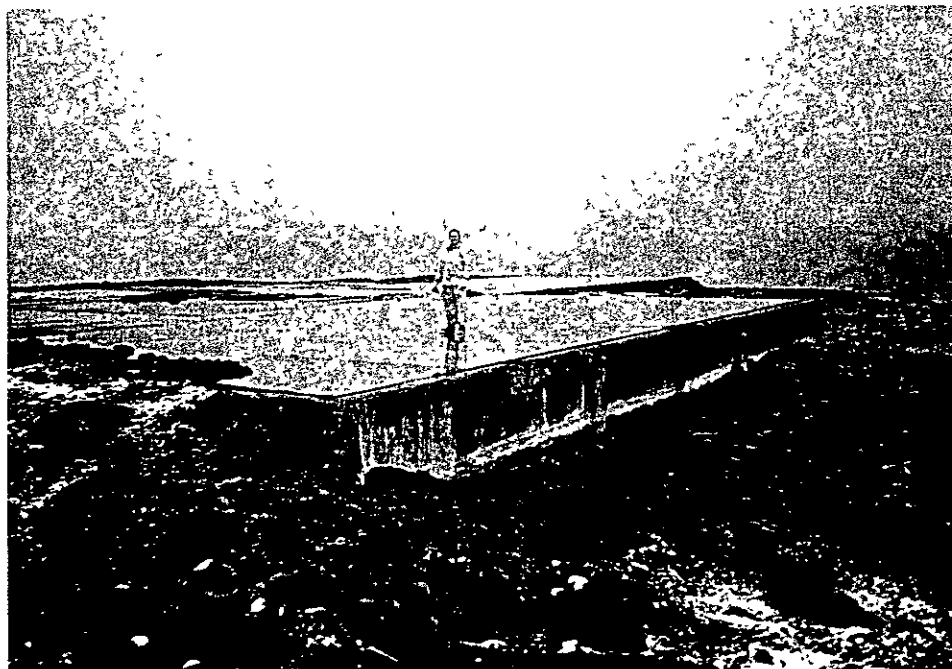
Photograph #1
East side of the former composite building foundation

The former composite building area is located approximately four miles west of Driftwood Bay at an approximate elevation of 1,275 feet above msl. Foundations of the composite building and the White Alice arrays are in place (Photograph 1, Appendix C)

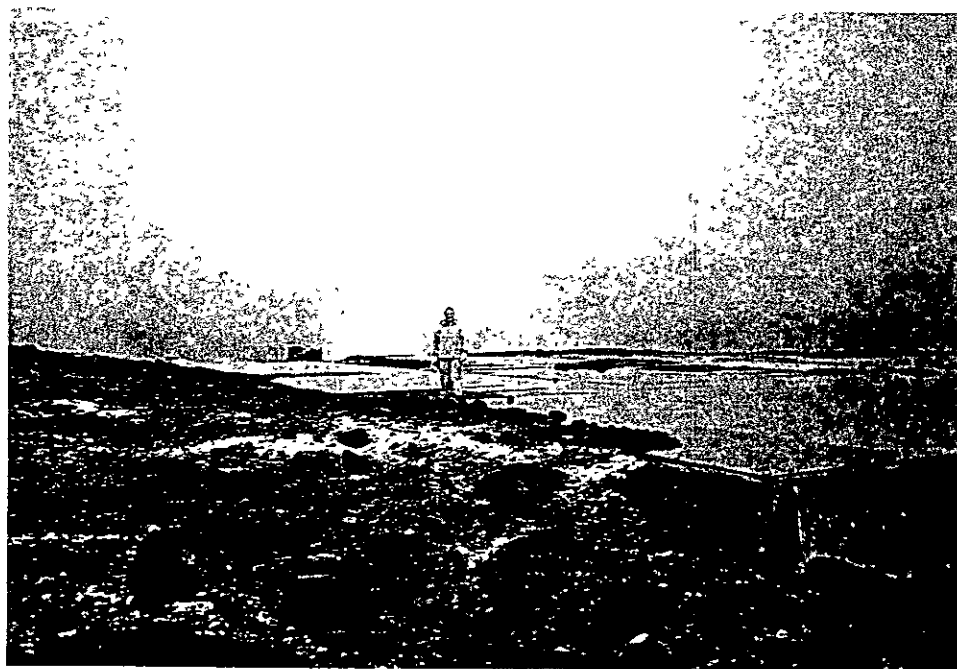
Photograph #2
The northern extent of the landfill ends at the south side of the composite building

foundation point. On the west side of the composite building, soil has covered the foundations of the White Alice antennas, but part of the feedhorn foundations were visible. The northern extent of the landfill was brought up against and level with the south side of the composite building foundation (Photograph 2, Appendix C). A culvert outfall is located approximately 250 feet northeast of the former composite building foundation. Two 20,000-gallon diesel USTs had been listed for removal during 1991 excavation activities but the contractor only found and removed one 20,000-gallon diesel UST.

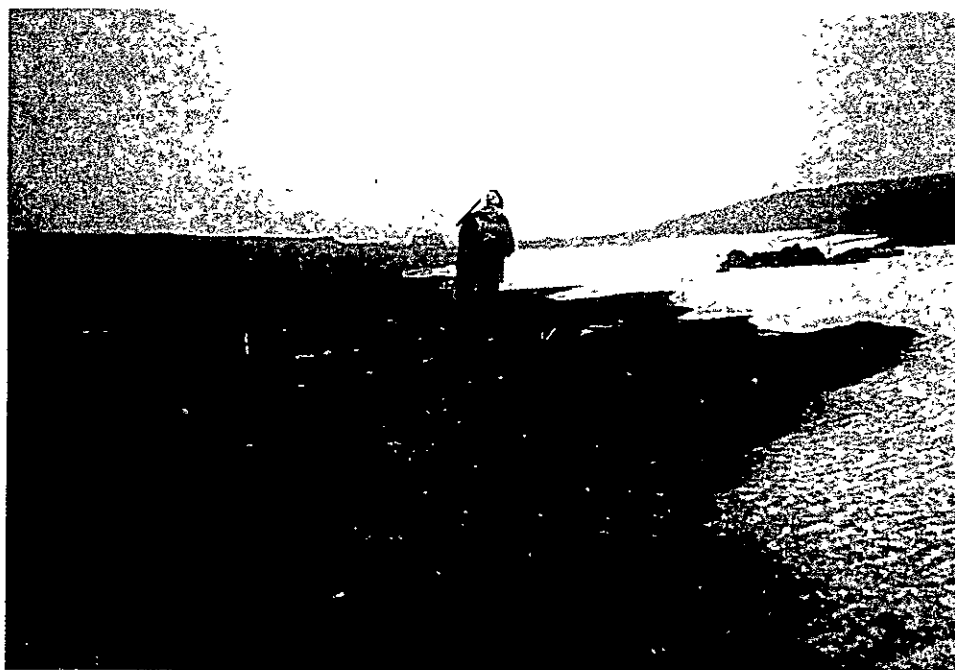
Photograph #3

Data for analyses conducted in 1995 and recommendations are included in Table 3. Soil samples 95DWD001SO and 95DWD005SO were collected near the foundation of the former south feedhorn location (Photograph 3, Appendix C). Sample 95DWD002SO was collected near the location of the former north feedhorn location (Photograph 4 in Appendix C). Figure 3 shows the locations of each sample.

Sample 95DWD002SO was collected approximately 3 inches bgs near the former north feedhorn location. PCB concentrations were not detected in the three samples. No apparent impact to soil was observed in the feedhorn areas.

Sample location of 95DWD001SO at the left stake Sample location of 95DWD005SO at the right stake The ATV in the background is at the foundation of the former composite building

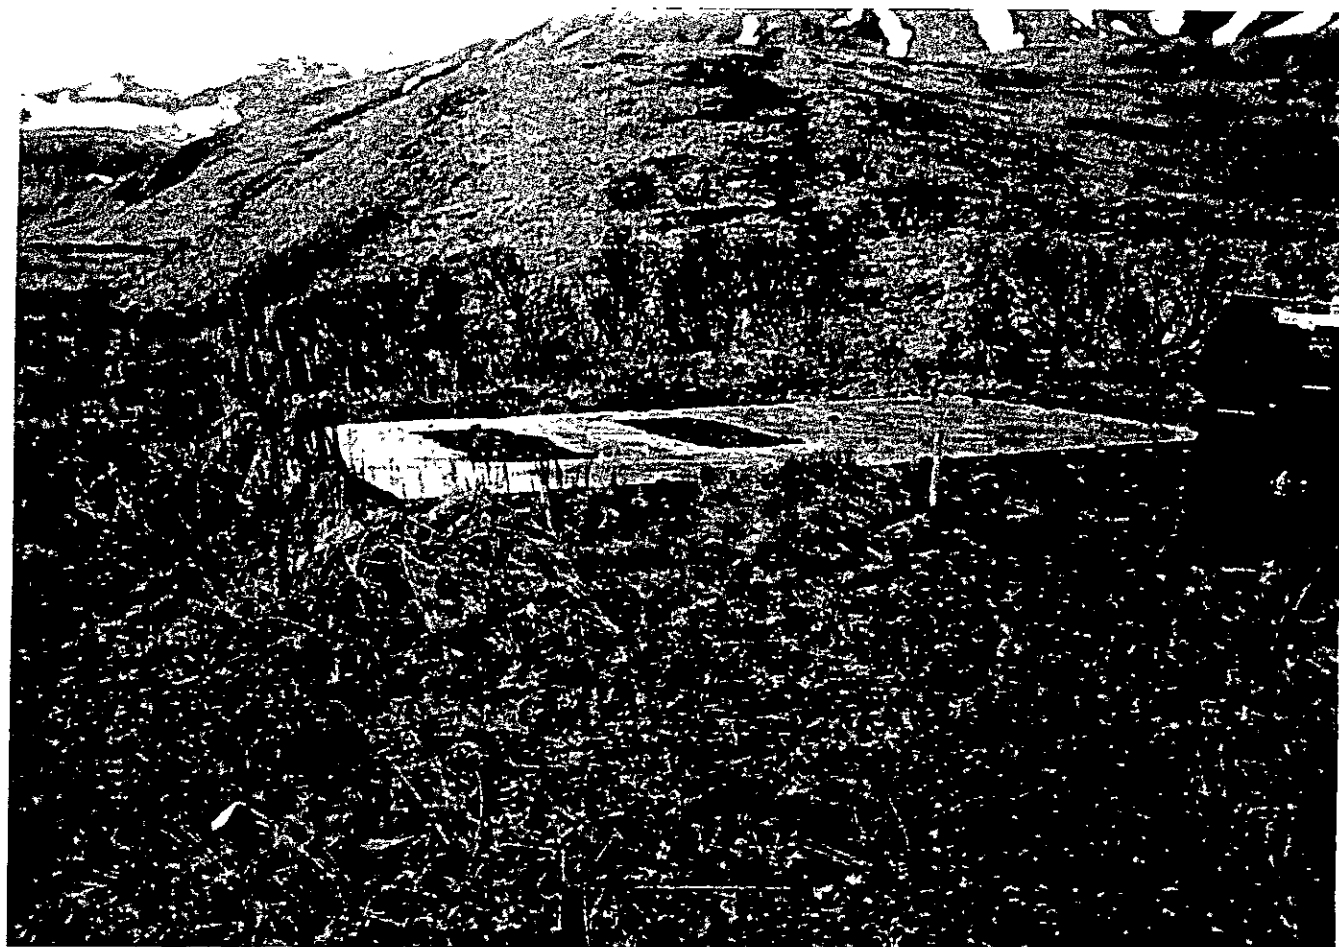
Photograph #8

Soil sample 95DWD015SO was collected approximately 4 feet from the center of the lighting vault on the north side of the foundation (Figure 4). The sample was analyzed for PCBs and pesticides, but none were detected (Table 8).

The foundation of the former lighting vault. The wooden stake marks the location of sample 95DWD015SO. The rectangular holes in the foundation appear where the former cement generator stands were located. The area on the left of the foundation is the former USTs location.

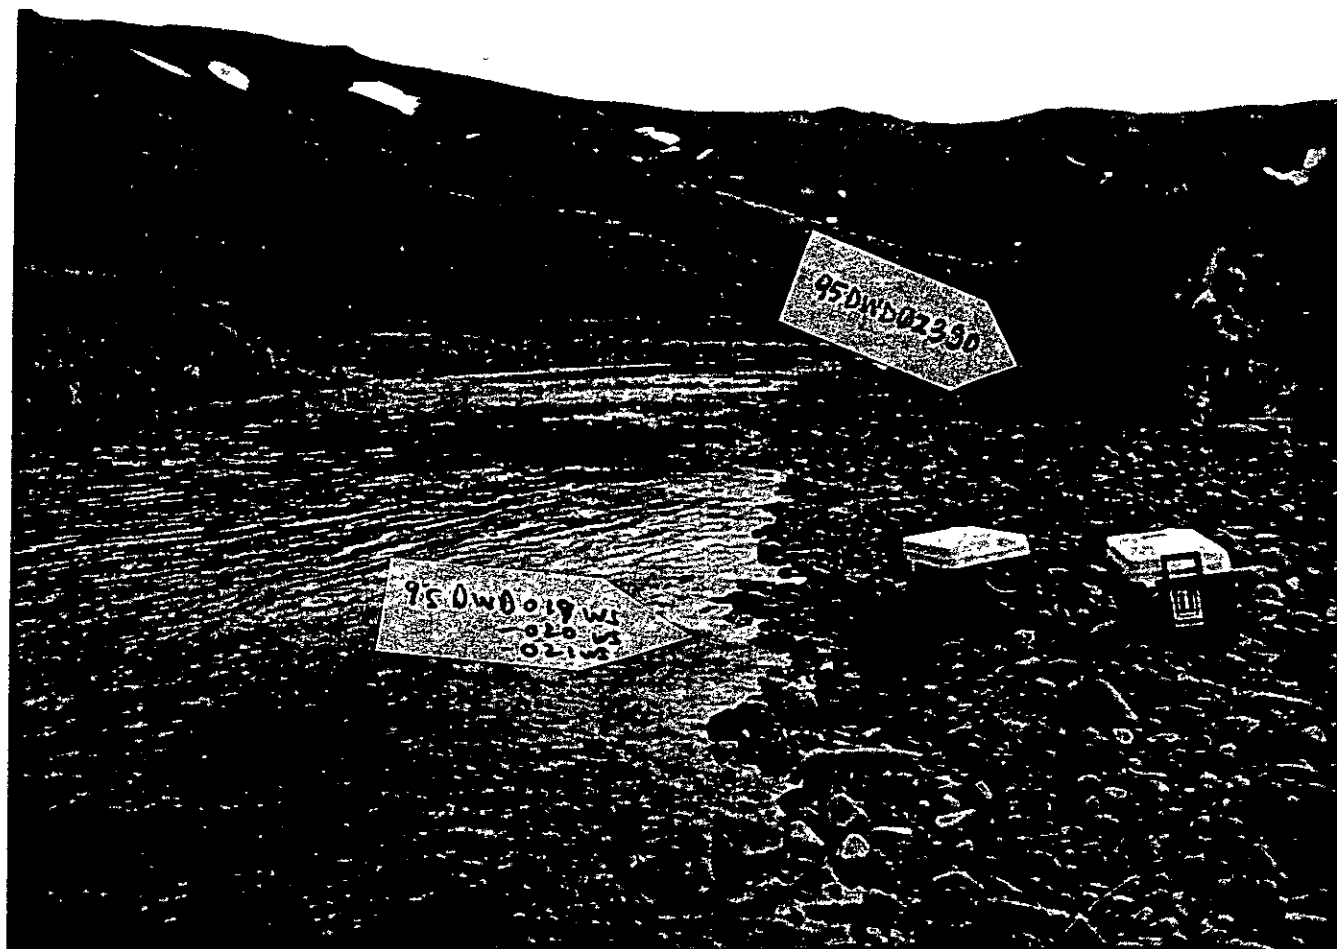
Photograph #12

Surface water samples 95DWD019WS (project sample), 95DWD020WS (QA/split sample), and 95DWD021WS (duplicate sample) were collected approximately 60 feet downstream of sample 95DWD023SO (Photograph 12, Appendix C). No impact was observed in the surface water.

Locations of sample 95DWD023SO (background) and water sample 95DWD019WS, 95DWD020WS, and 95DWD021WS

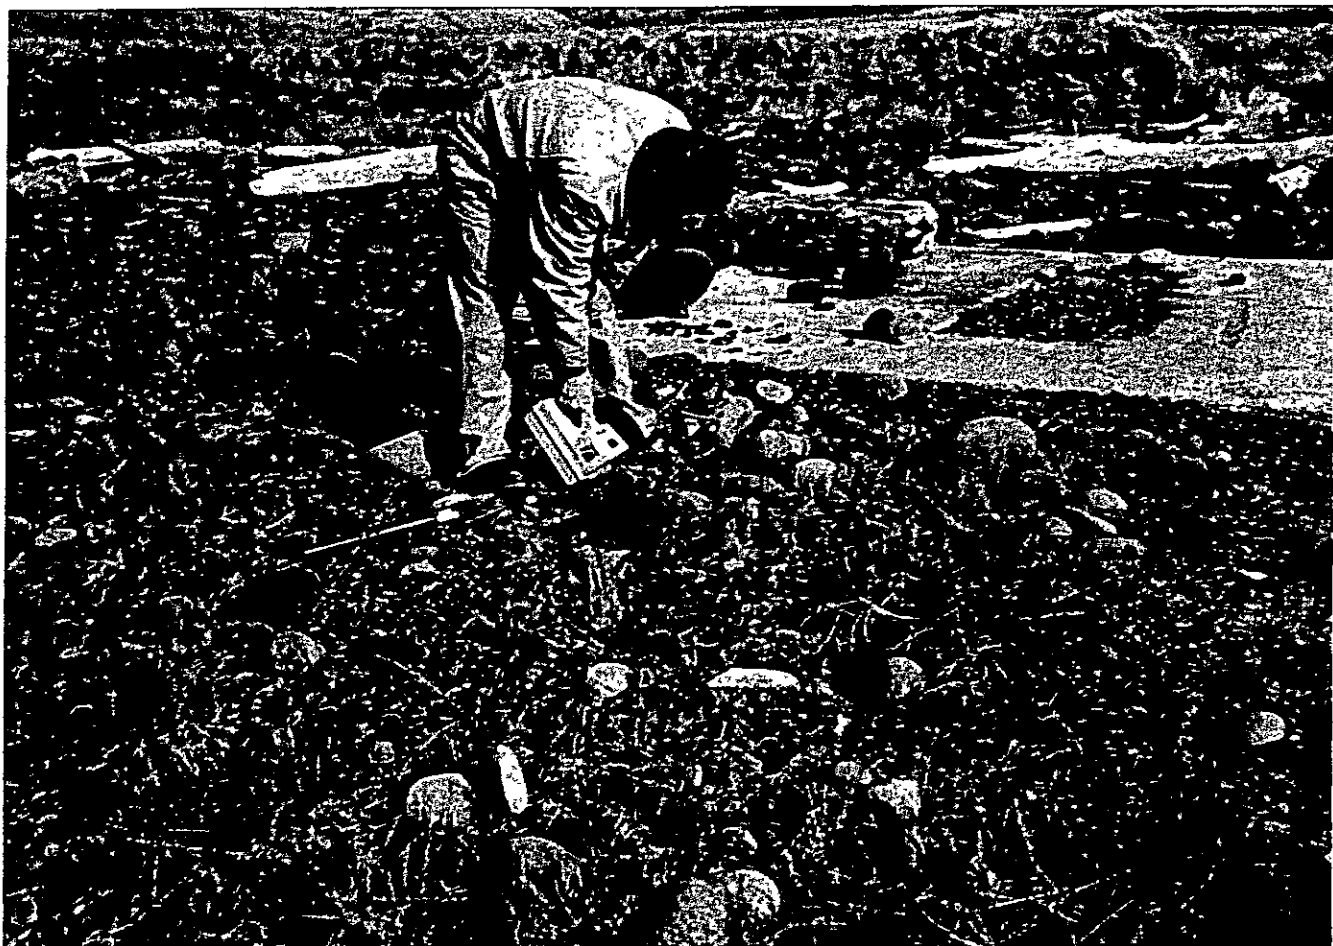
Photograph #14

Location of sample 95DWD027SO on the north side of the POL pumphouse.
