FINAL REPORT

PRELIMINARY ASSESSMENT/SITE INSPECTION

DRIFTWOOD BAY RRS, ALASKA

December 2005

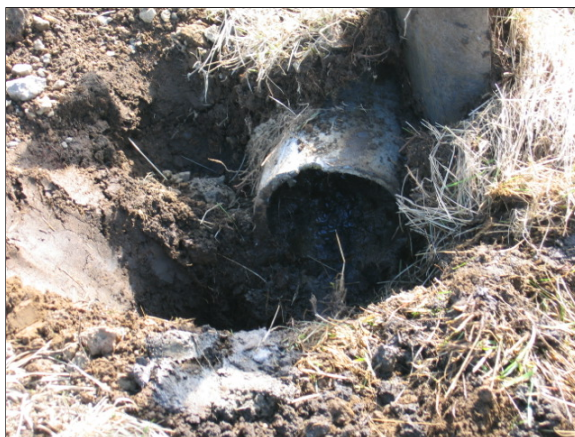
Photo 5-1. WP14 floor drain outfall.

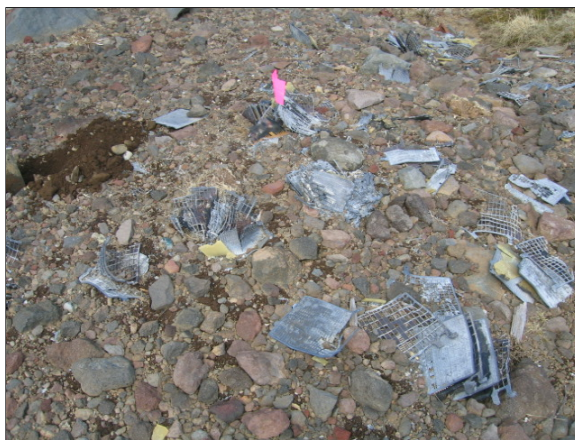
During reconnaissance of WP003, a small area of burned batteries was found 275 feet north of the northeast corner of the former composite building. The area was approximately 15 to 20 feet in diameter and contained over 12 burned batteries. Due to the burned condition of the batteries, their sizes could not accurately be determined. However, several of the batteries appeared to be at least 12-Volt in size. Soil within the area appeared stained. The batteries are shown in Photo 5-2.

Photo 5-2. WP14 burned batteries.

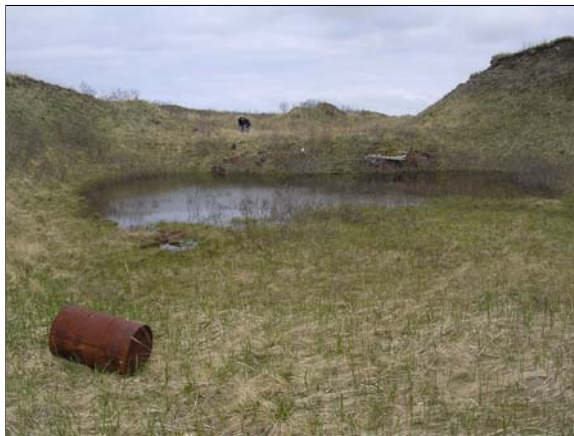
Ground reconnaissance was conducted within and around the open pit. The pit appeared to be a borrow pit that was then used as a disposal area. The pit was approximately 200 feet long by 75 feet wide and 20 feet deep. The north end of the pit appeared to contain an unknown quantity of buried debris that was exposed near the center of the pit. Several small test holes were hand dug to approximately three feet bgs within the apparent debris cover soil, but debris was not encountered at any location. South of the exposed debris was a small pond approximately 50 feet in diameter that contained several submerged 55-gallon drums. Several drums were also noted surrounding the pond. All drums were rusted and none contained legible markings. Dark green paint was noted on the end of one drum. Exposed debris included an engine, vehicle parts, batteries, and a small chrome cylinder that appeared to be a fire extinguisher. There was no evidence of stressed vegetation or stained soil and no sheen was noted at any location on the surface water. The disposal area is shown in Photo 5-3.

Photo 5-3. LF006 disposal area.

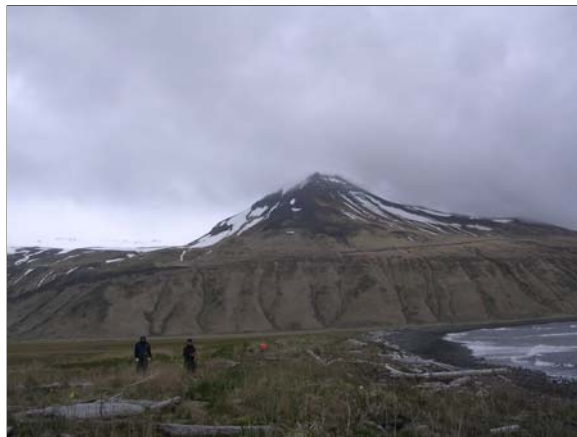
Photo 5-4. SS007 POL tank area.

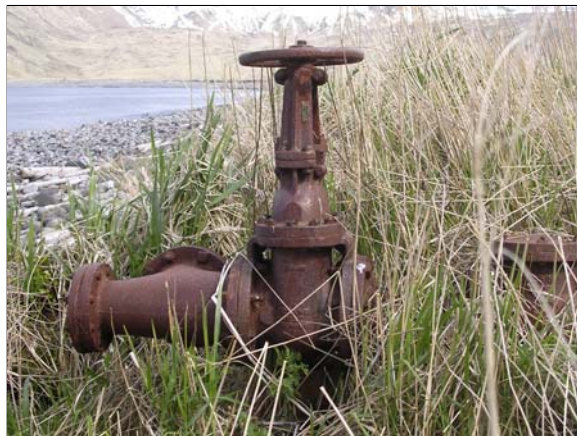
Photo 5-5. SS008 fill stand valve.

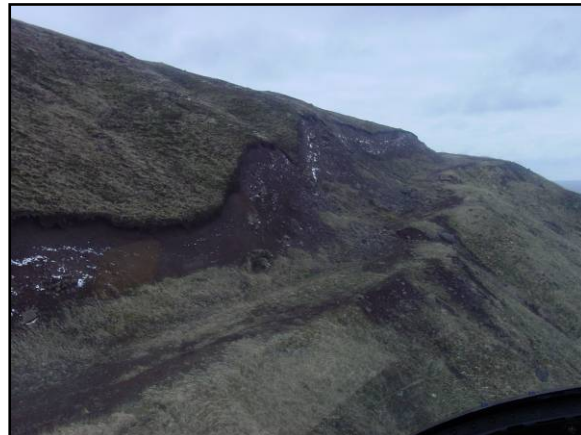
Photo 2. The road was found to be washed out in two main locations.

At the first washout, the road was covered with up to 15 feet of material ranging in size from large boulders to gravel. A culvert that formerly transported water from Snuffy Creek under the road had been blocked by the landslide and water was running down and across the road. However, the unburied portion of the culvert on the downhill side of the road appeared to be in good condition. Minor repairs would also be required at the location where Snuffy Creek was currently crossing the road. At the second washout, the road had been eroded several feet on the downhill side and would require excavation and a new culvert. From the second washout to the former composite building, the road was found to be in good condition and passable for four-wheel drive vehicles.

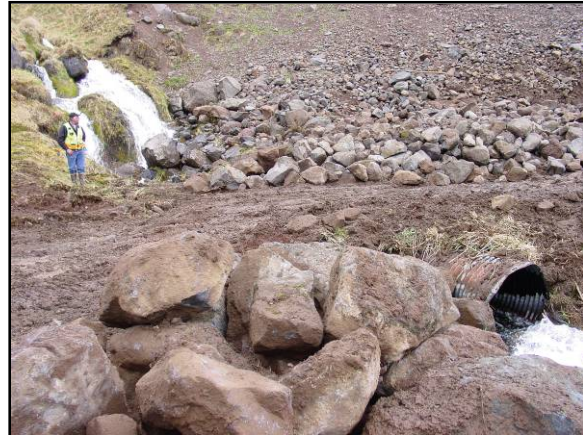
Photo 3. The culvert underlying the landslide was exposed on the uphill side.

Creek was again directed under the road (see Photo 3). Minor repairs were also made below the first washout at the location Snuffy Creek had been crossing the road. While the road was still wet following repairs at this area, it was immediately passable with a four-wheel drive pick-up truck.

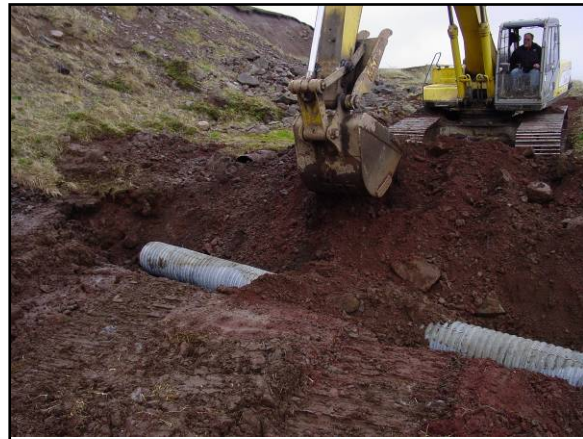
Photo 4. The second washout was widened and a culvert installed.

At the second washout, a small amount of material was removed from the uphill side of the road to make this area slightly wider and safe for vehicles. A culvert was then placed at the location of this washout to allow water to pass under the road and decrease the chance of a future washout (see Photo 4). This portion of the road was also immediately passable following repair. The excavator was driven to the top of the road to compact the surface and pick-up truck followed behind. The truck had no problems reaching the former composite building and the road was safe for vehicle traffic.
