PRELIMINARY ASSESSMENT REPORT
FOR
TRICON MINING
FAIRBANKS, ALASKA

December 1989

EPA PRELIMINARY ASSESSMENT FORM 2070-12
FOR
TRICON MINING
FAIRBANKS, ALASKA

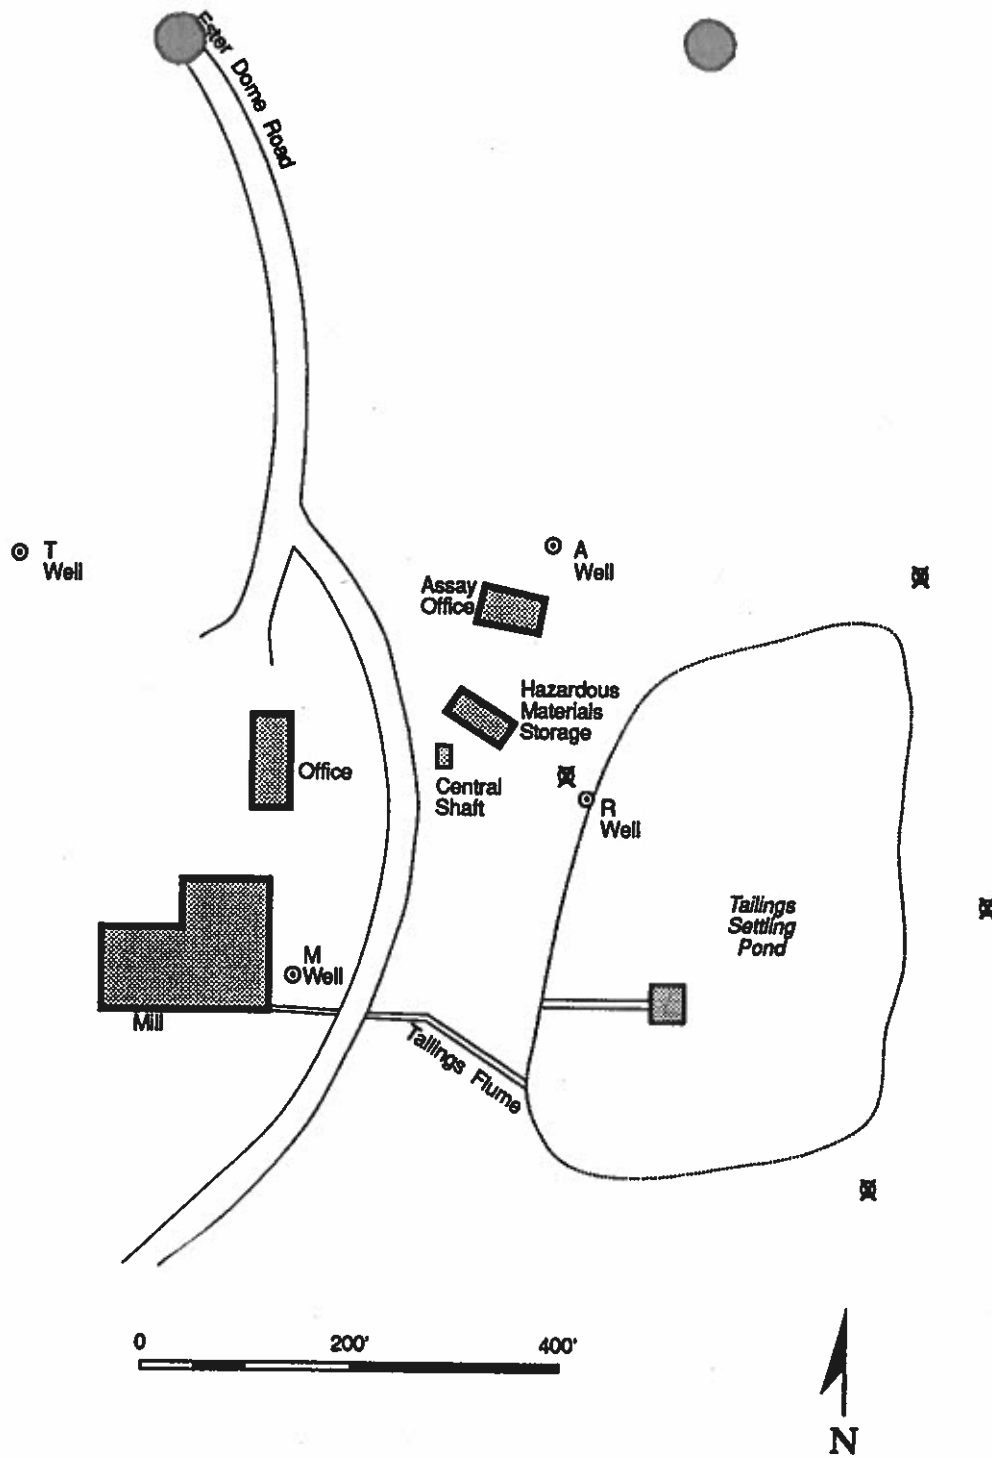
FIGURE 2
SITE MAP
 TRICON MINING SITE
 Fairbanks, AK

On April 28, 1989, Tricon collected a water sample from an on-site production well (Well A, Figure 2). The sample was analyzed by Tricon personnel using a colorimetric method for detection of total cyanide. Tricon's result was reportedly greater than 0.2 mg/L cyanide (Alaska MCL = 0.2 mg/L). The well was pumped for 4 hours at a rate of 5.7 gallons per minute and resampled. The colorimetric method detected 6.5 mg/L cyanide in the second sample. In addition, samples collected from several on-site wells in November, 1988 reportedly exceeded 0.2 mg/L cyanide (BLM 1989) (Armstrong 1989a).

Tricon personnel have indicated that an abandoned on-site well (Well R, Figure 2) may have acted as a conduit for cyanide to reach groundwater due to improper well construction. The R well is reportedly located on a fault line which trends toward and may be connected with Well A where cyanide contamination was detected in April 1989 (Armstrong 1989a).

The site inspection (SI) recommended for the Tricon Mining site should focus on the potential existence of continuing contaminant releases to groundwater from the on-site tailings pond, and the potential for or existence of off-site migration. New monitoring wells being installed by Tricon Mining will facilitate this data collection. In addition, follow-up sampling of nearby domestic wells should be conducted to verify that cyanide contamination is not affecting local drinking water supplies.
