Re: Decision Document: King Salmon AS GWZ 5 SA036

Cleanup Complete Determination

SA036 Groundwater Zone 5 King Salmon Divert King Salmon, AK 99613

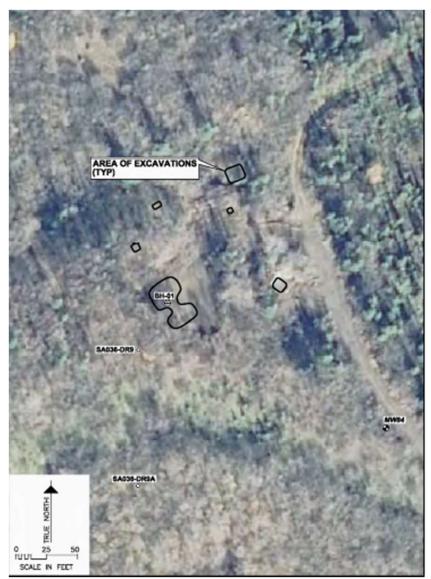
Figure 4: 2012 photograph detailing excavations at SA036-DR9.

Removal work at this site started in 2012. Thirteen drums were found scattered at seven separate locations; many of the drums had a solidified, tar-like substance that had partially seeped out. The drums were collected and removed from the site. Six drum areas were excavated to a depth of two feet and one

was excavated to a depth of three feet. Approximately 38 cubic yards of petroleum-contaminated soil were excavated and removed from the site. The chunks of solidified tar that were left behind from the drums were collected and removed. A total of 21 confirmation samples were taken from the walls and floors of the excavations and sampled for DRO, RRO, and PAHs. All samples were below cleanup levels; the maximum concentrations left onsite for DRO and RRO are 131 mg/kg and 487 mg/kg, respectively. The excavations were backfilled to their original grade with uncontaminated soil in October 2012.

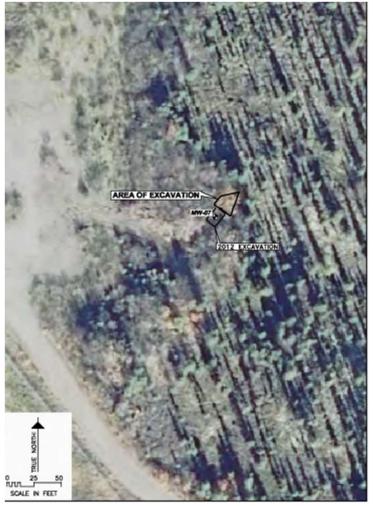
Figure 5: 2015 photograph detailing excavations at SA036-DR13.

In October 2015, approximately 24 cubic yards of POL-contaminated soil were excavated from the area where the oil switches were once located, and taken to the landfarm for treatment. Dispersed throughout the excavation were debris consisting of six empty, crushed drums, large tires, oil filters, lumber, empty buckets marked "adhesive", and large chunks of black, viscous material that had a creosote-like odor. The tarlike substance was containerized in two 55-gallon drums and removed from the site. While removing debris from the excavation, battery pieces fell out of the upper section of the southwest corner sidewall. All battery pieces and surrounding soil were shoveled into a 55-gallon drum, and lead was added to the analytical suite. Three confirmation samples were collected from the floor, and four samples were collected from the sidewalls. DRO, RRO, PAHs, and lead were detected in samples below cleanup levels; the highest remaining concentrations are 56 mg/kg DRO, 330 mg/kg RRO, and 14 mg/kg lead. All encountered debris was taken to the landfill, and the excavation was backfilled to the original grade with uncontaminated soil.
