SITE CHARACTERIZATION

AIR NORTH / BEN LOMOND METRO FIELD PROPERTY BLOCK 6, METRO INDUSTRIAL PARK FAIRBANKS, ALASKA

SEPTEMBER 12, 2007

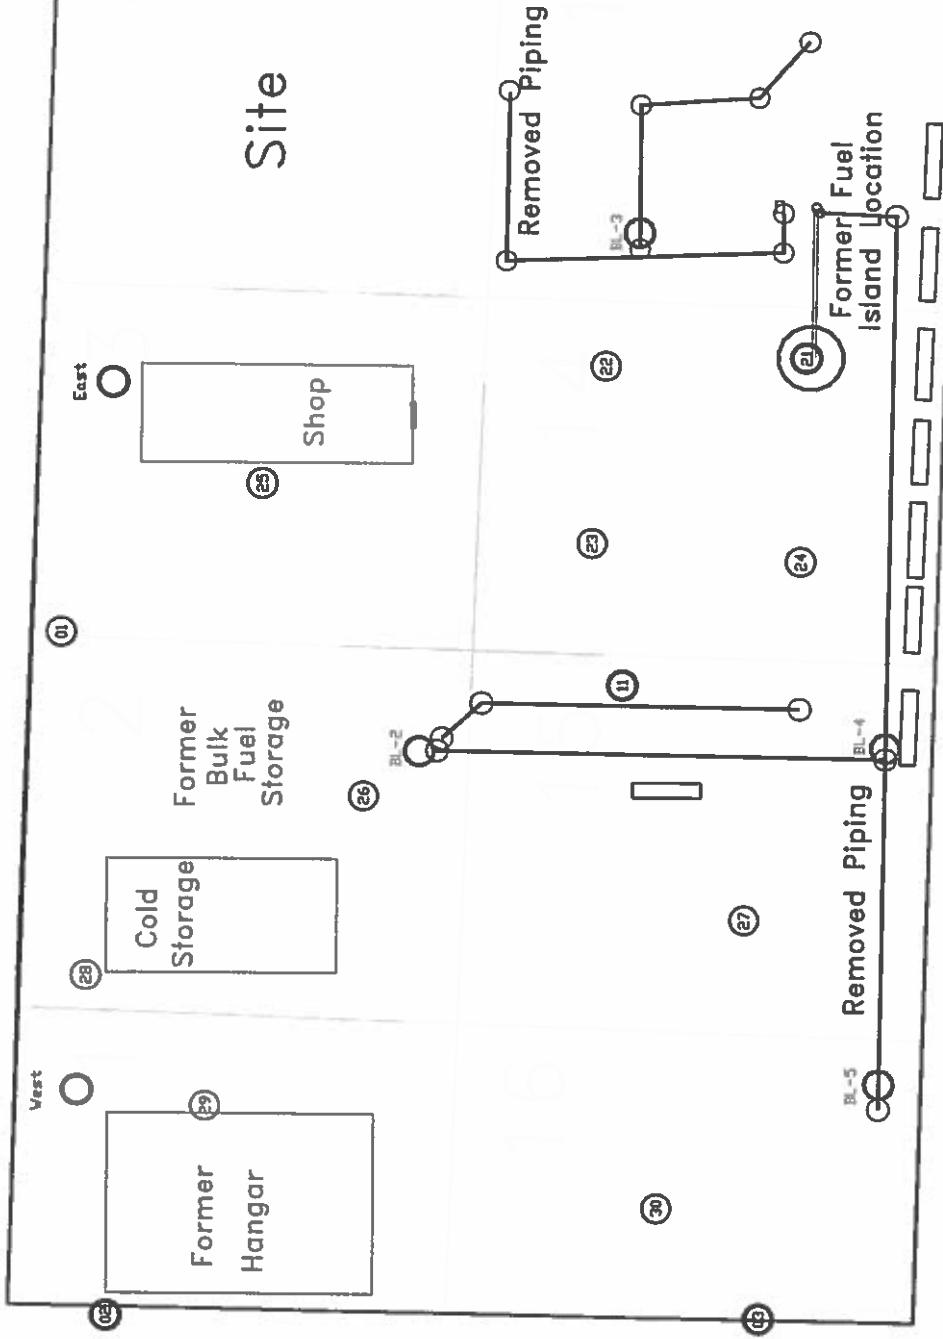
FIGURE
3

Excavation in the location of the former leak identified buried piping and soil contamination, consistent with the previous report. Based on the soil delineation completed to date, approximately 1,400 linear feet of piping has been removed and field screening indicated that approximately 75% of this was contaminated. All piping ended in buried elbows pointing to the surface. This generally confirms Ben Lomond's understanding that the former Air North fuel storage tanks were located above ground. Ben Lomond personnel reported that no aboveground tanks were present on the site when Ben Lomond occupied the property and the piping locations are the only evidence of the probable locations. At this time, no tanks are present and all known piping has been excavated and removed.

As indicated above, most buried elbow locations and many buried fitting locations appear to have leaked. Contaminated soil related to this distribution system had a foul odor and significantly elevated PID reading, often above the range of the instrument. Laboratory results from the most contaminated locations indicate that the soil contamination is primarily DRO and benzene, although GRO and other BTEX compounds are present in most samples. The highest concentrations of DRO and benzene are less than one order of magnitude above the respective cleanup levels, indicating that the highly volatile nature of the AVGAS contamination is resulting in field screening results that are well above normal. Overall, this suggests that the overall mass of contaminants in the soil is substantially lower than would be expected from the field screening results. Additionally, the more mobile contaminants may have already migrated to the groundwater.

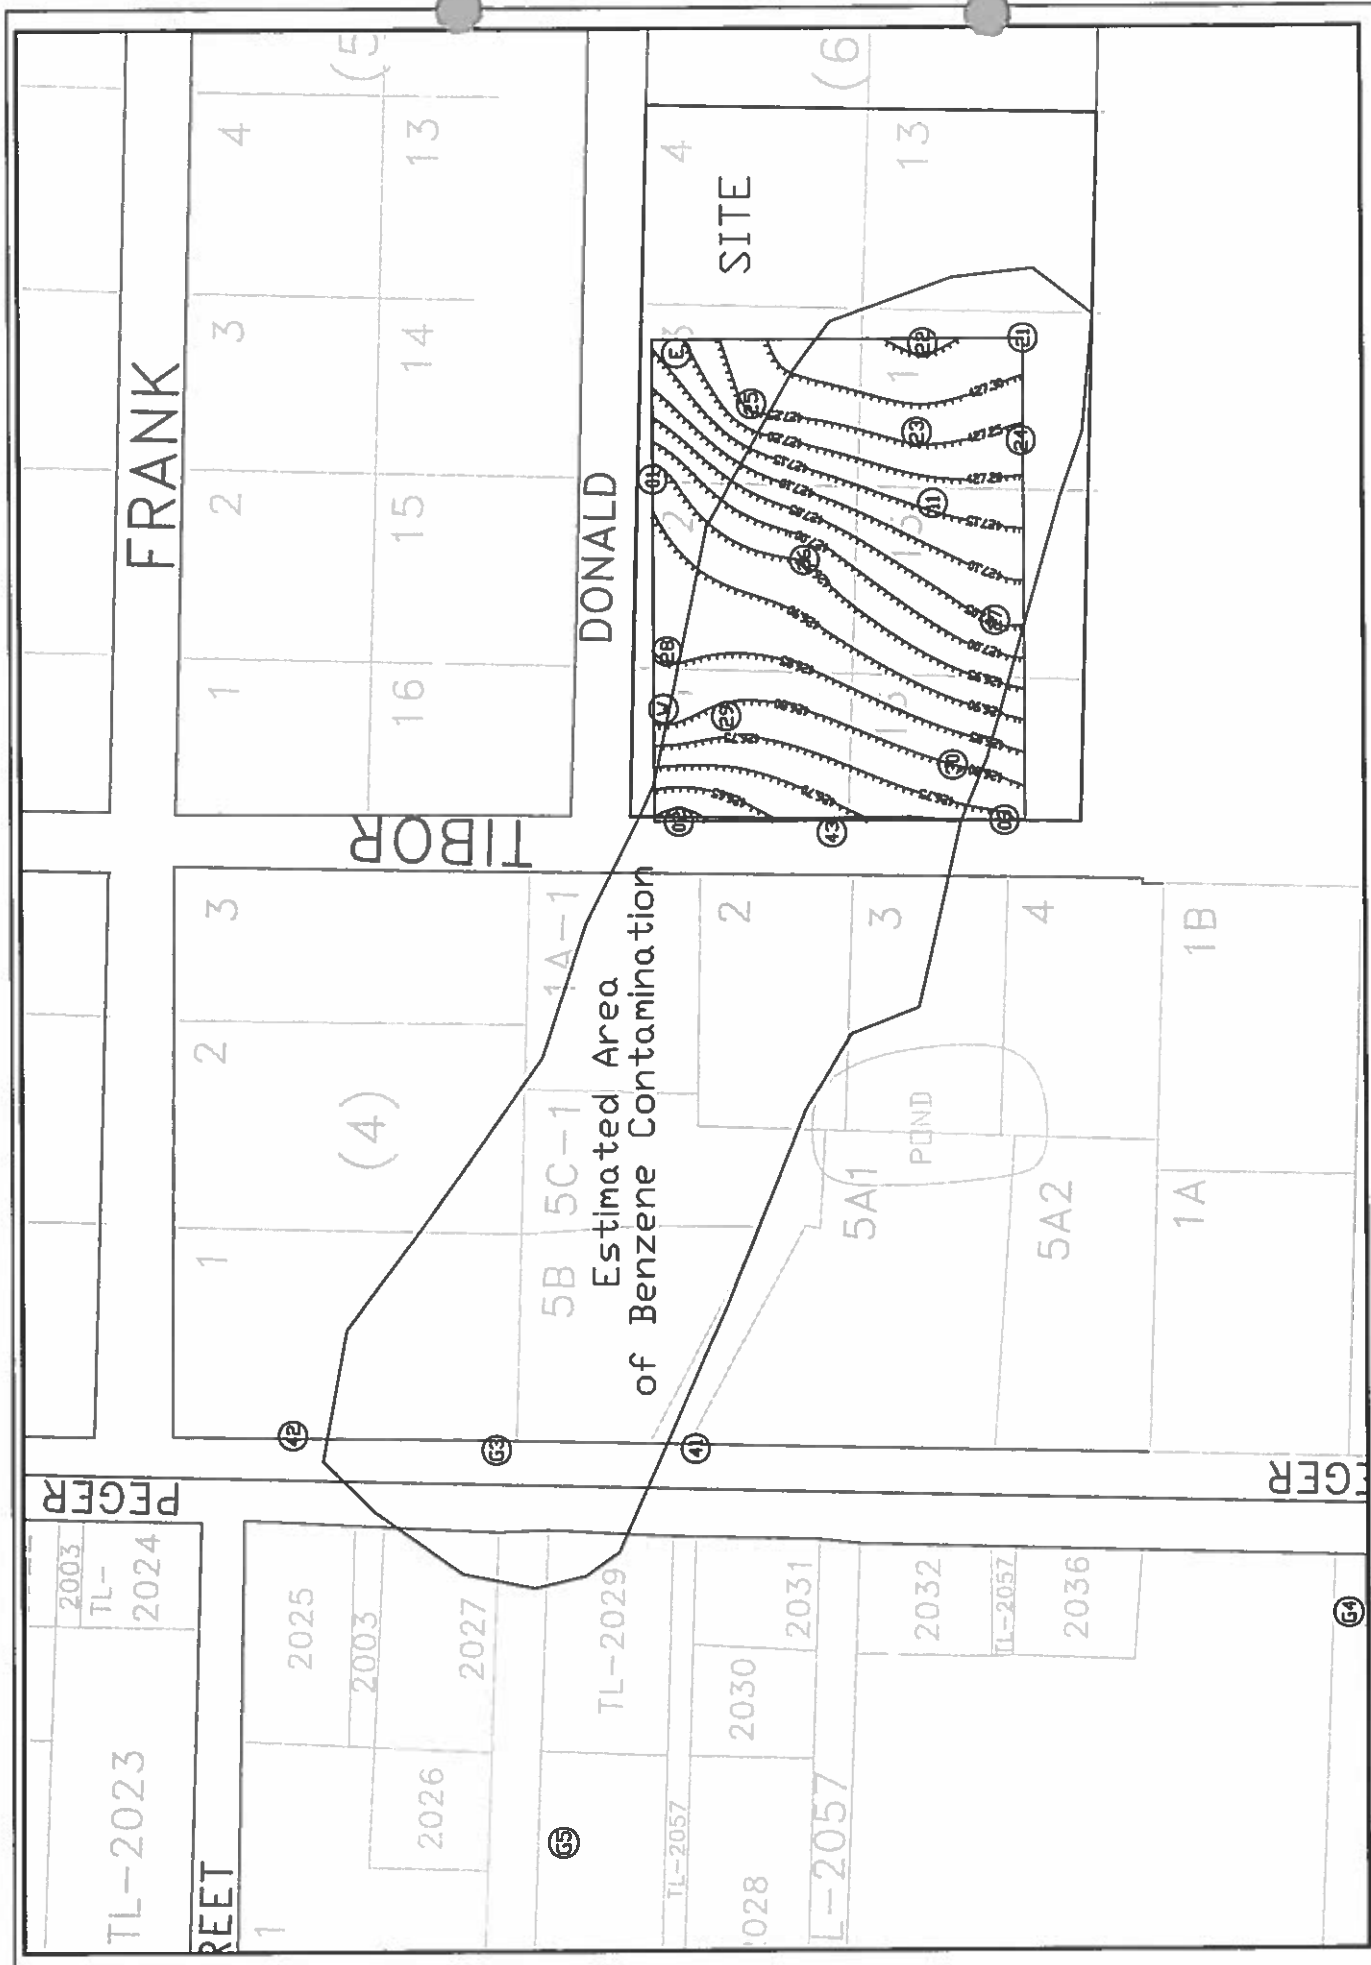
Hydraulic Gradient and Estimated GW Contamination
Ben Lomond Metro Field Property
Fairbanks, Alaska

Groundwater benzene concentrations exceeding the ADEC cleanup level have been identified beneath approximately 4.1 acres (50%) of the site (as shown in Figure 4). The age of this release (more than 20 years since termination of the leaks) and the groundwater monitoring in 2005 and 2006 indicate the contamination is relatively stable within the groundwater. The existing groundwater data indicate the former fuel dispensing island area and the near DP-26 are the most contaminated and active remediation in these two areas may expedite the cleanup of the whole site.

Due to the size of the on-site groundwater plume, natural attenuation is expected to be the primary mechanism of remediation across the site. Focused active remediation may be appropriate at the most contaminated source areas to facilitate the eventual natural biodegradation. Both of these types of remediation can be evaluated on a pilot basis. Sampling and analysis of geochemical parameters to evaluate natural attenuation in up to five wells is recommended. The goal would be to evaluate both the center and the edges of the plume, as well as a background location. Specific locations and parameters would be specified in a brief work plan. In addition to the geochemical parameters, pilot testing of a pumping system and air stripping in the Ben Lomond equipment is recommended for up to 30 days. This could be undertaken at the same time and location as the pilot landfarming project to take advantage of the excavation to install remediation system hardware as well as equipment and personnel availability. However, the air stripper is at a fixed location and a pilot study near the air stripper would significantly reduce the need for transfer of contaminated water across the surface of the site. Reinjection of treated water on site may be acceptable on a pilot study basis with minimal or no engineering plan reviews by ADEC and/or inventory of injection wells with EPA.
