Subject: Interim Characterization Report
Doyle's Fuel Storage Facility
SE 1/4 B.L.M. Lot 51, S34, T6S, R11W, City of Kenai, Alaska
Reckey # 98-23-01-289-01

This report outlines the groundwater investigation at the subject property conducted on October 25, 26, and 27, 1999. The investigation followed the outline set out in the Interim Site Characterization Plan dated 10-7-99.

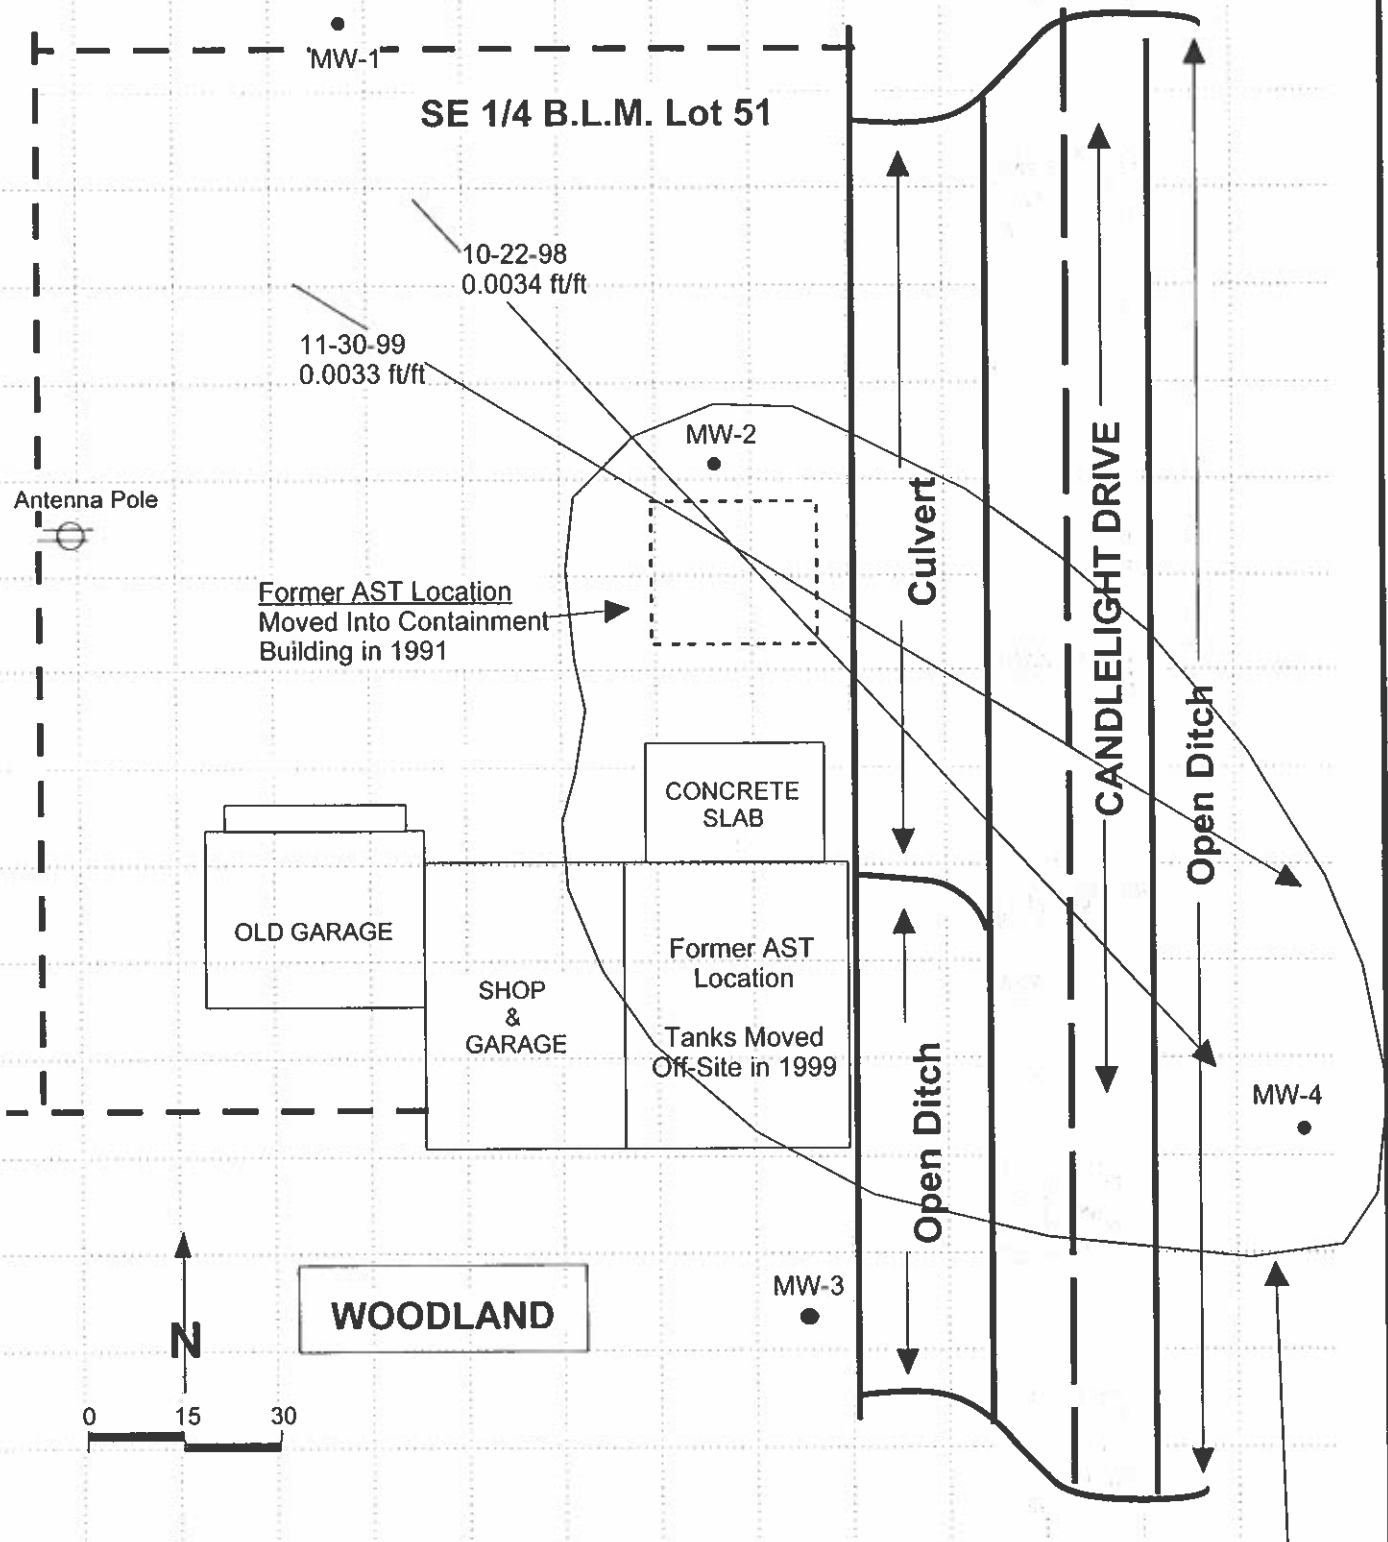
Figure 1. Groundwater
Contamination Map
Doyles Fuel Service
12-7-99

Comparison of the current groundwater direction and gradient with the direction and gradient determined from the 1998 investigation, shows that the flow direction has changed substantially. The current flow direction is not directly towards MW-4 as was previously thought. If additional monitoring indicates that the flow direction is the same as present, an additional well will probably need to be installed to the north of MW-4. An additional up-gradient well may be installed at that time as well.

Estimated plume boundary based on overall well data and contaminants that exceed cleanup levels.

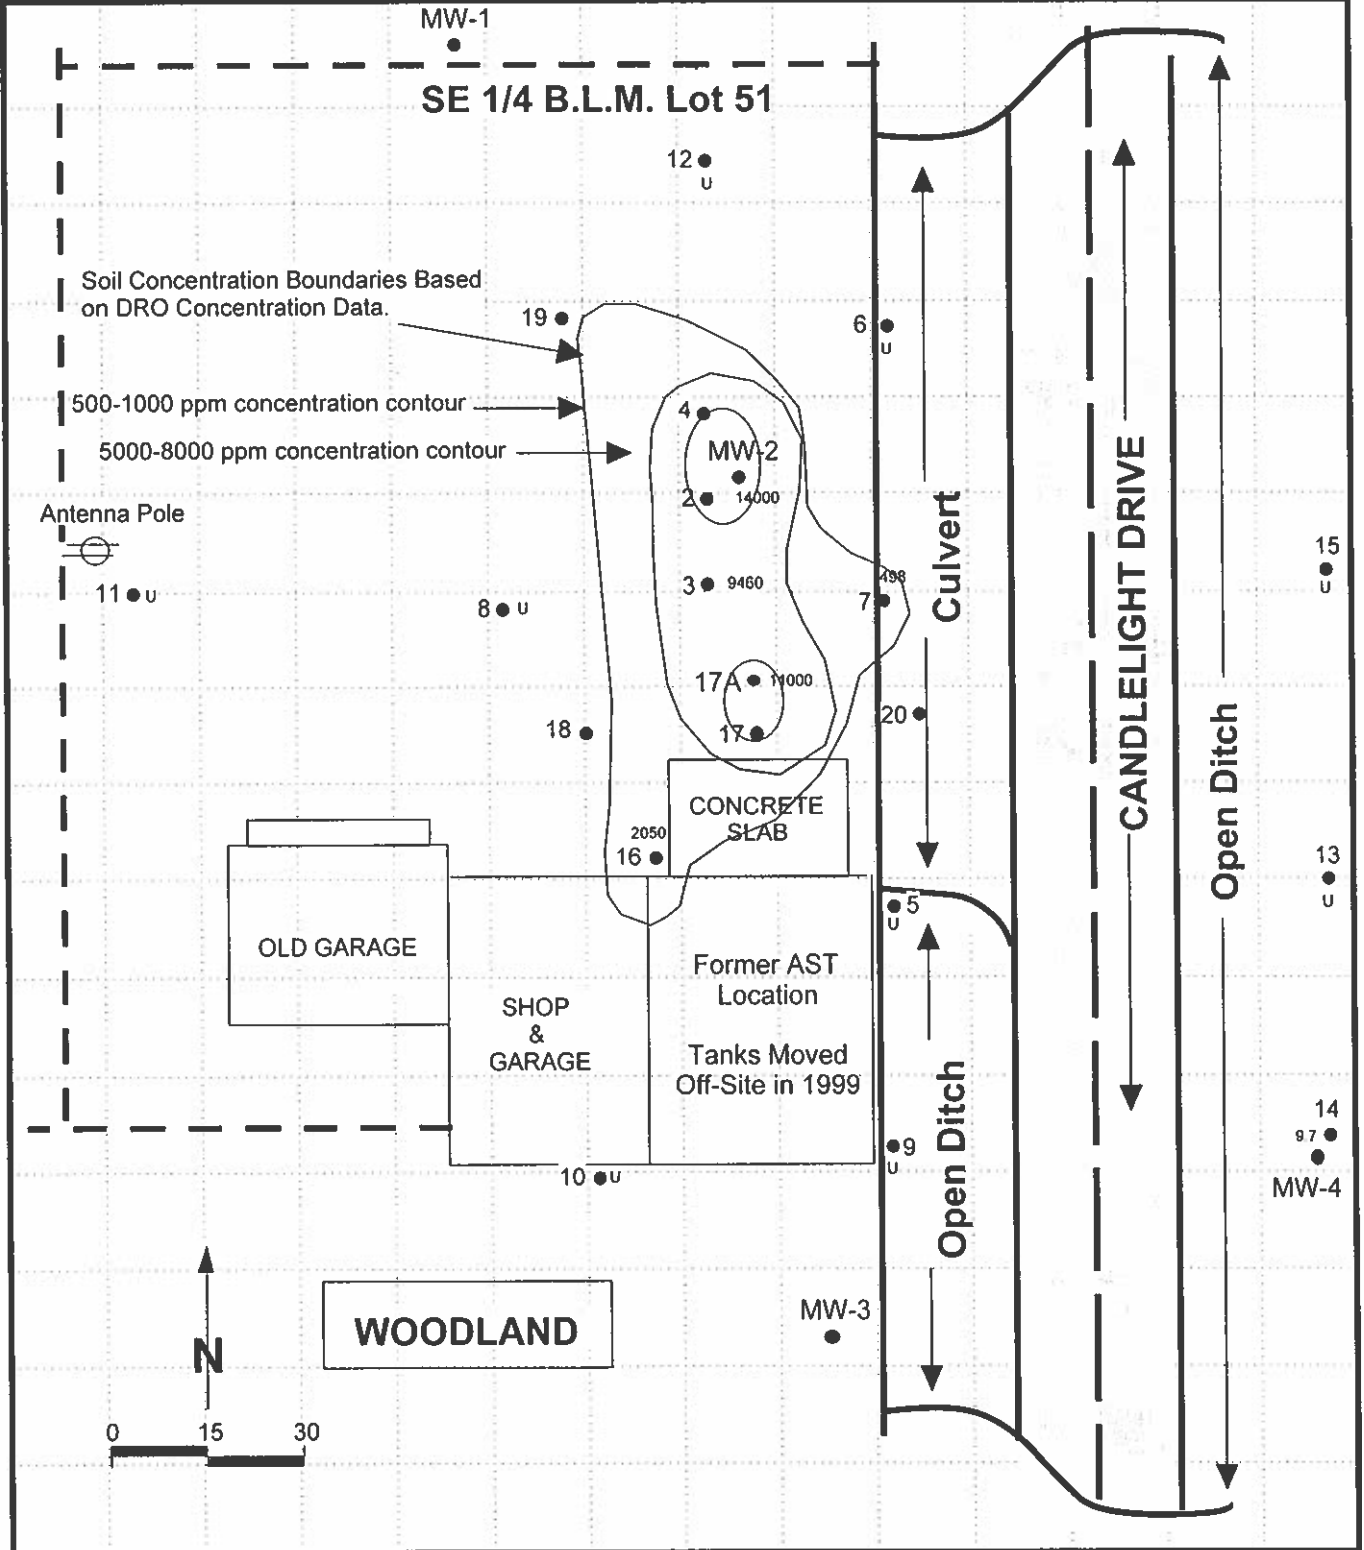
Figure 2. Soil Contamination Map
 Doyle's Fuel Service
 12-2-99

soil contamination detected at locations 16, 17, and 17A (Figure 2). This spill is also probably responsible for groundwater contamination detected at MW-3, and partially responsible for contamination found at MW-4. If the groundwater direction changes seasonally, then contamination at MW-4 may have resulted from fuel releases near MW-2 and soil borings 16 and 17.
