Re: Report of Groundwater Sampling Rounds 2, 3 and 4
Doyle's Fuel Storage Facility, Spill 98-23-01-289-01
SE ¼ B.L.M. Lot 51, S34, T6S, R11W, City of Kenai

Fig. 1. Groundwater Contamination Map
Formerly Doyle's Fuel Service
Mile 8.5 Kenai Spur Highway

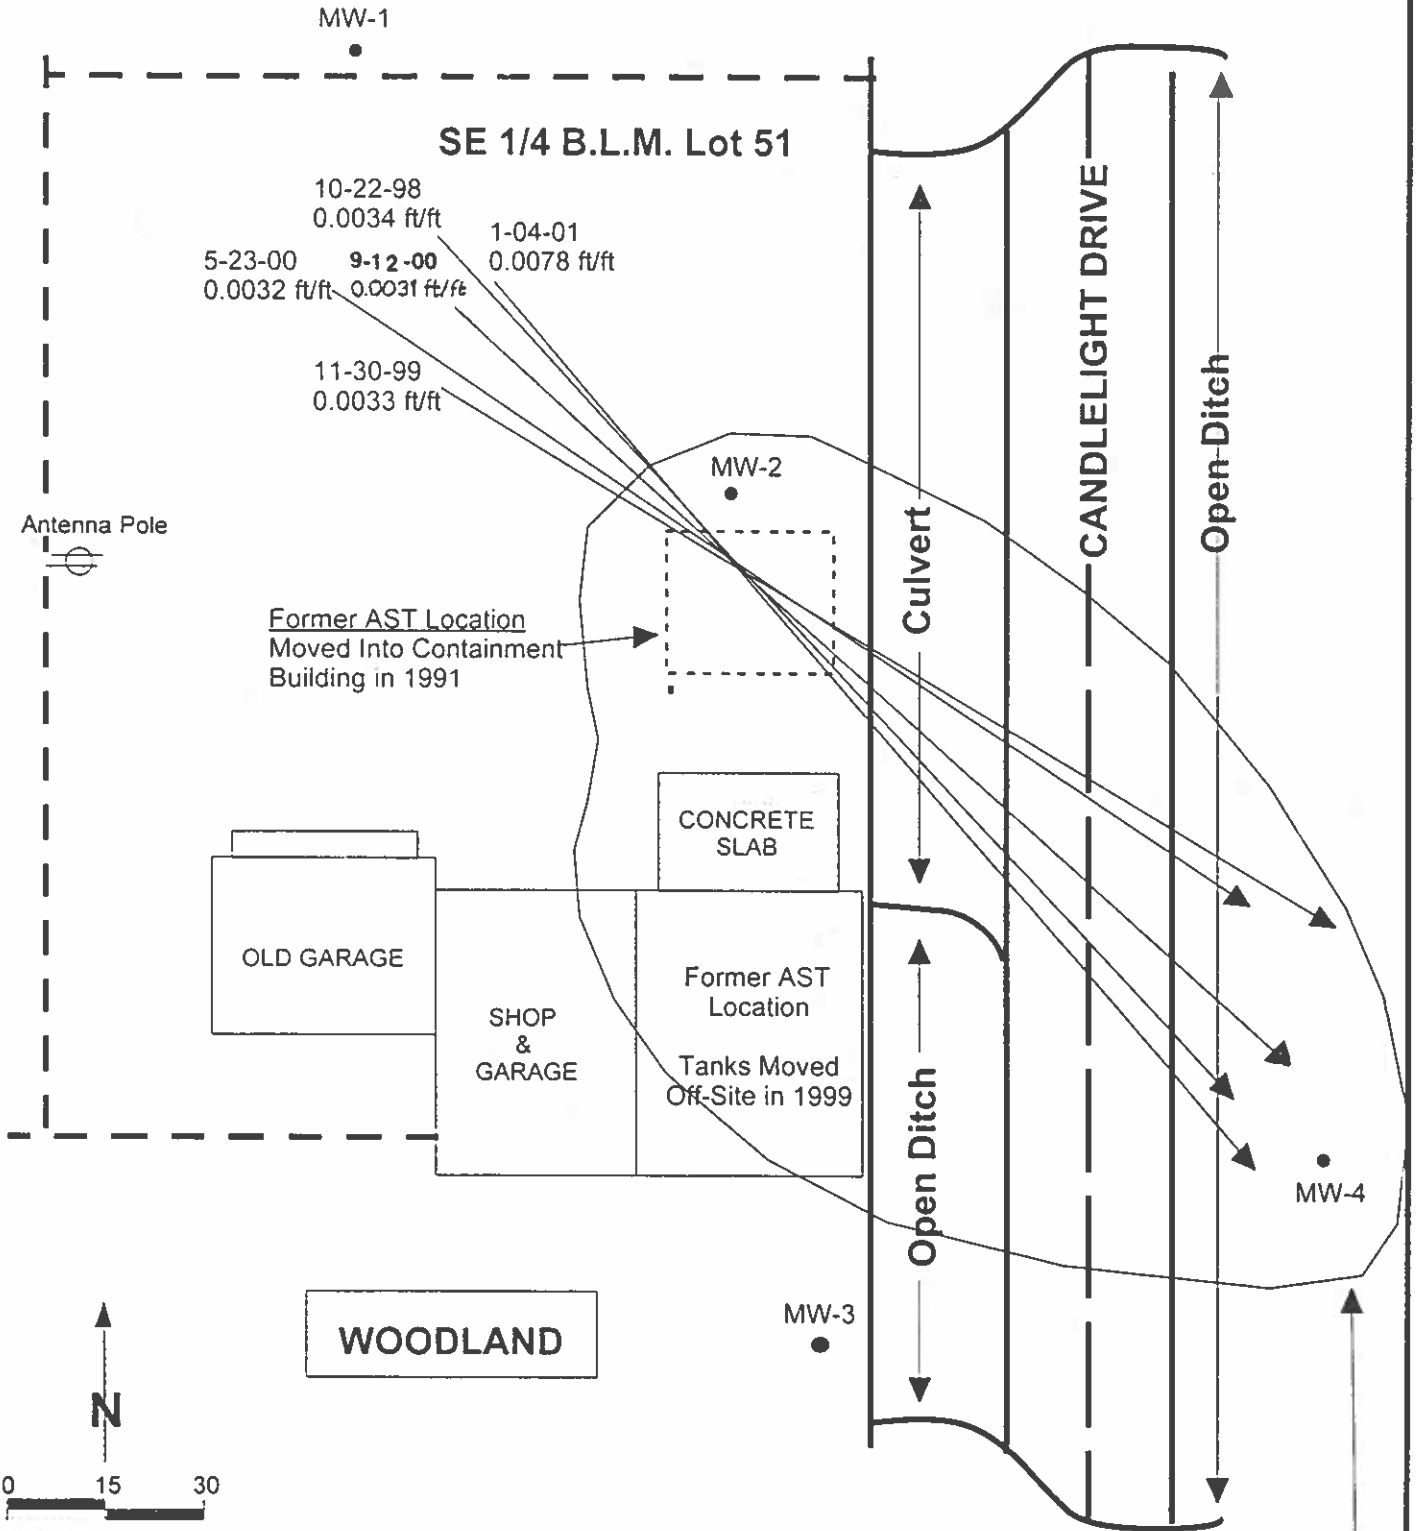
Inspection of the site-specific data shows that contamination is present at the site and that contamination levels exceed the current regulatory standards. Besides the two major diesel fuel releases described in the 12-20-99 report, analytical results from the last three sample rounds indicate at least part of the subject site has been impacted by a gasoline release. The highest GRO/BTEX levels were detected at MW-4. The source of the gasoline contamination has not been determined. There is no record of gasoline being stored at the subject site, drums of fuel products used to be stored on property [no longer occupied] north of the subject property. Aerial photographs reviewed during the initial site assessment indicated there had been drums, fuel tanks, and trucks parked around the site. Groundwater flow at the site has varied slightly but in general has been to the southeast, from the former aboveground diesel storage tank location toward MW-4. The GRO/BTEX levels were less at MW-2 than at MW-4, which indicates the source of gasoline contamination was not directly up gradient of well MW-2.

Estimated plume boundary based on overall well data and contaminants that exceed cleanup levels.

Additional groundwater sampling points are needed to determine the status of the contamination plume and whether the gasoline contamination is from an on-site or off-site source. To help define the extent of the plume at least one sample point should be placed along the Candlelight Drive right-of-way, 30 to 40 feet north of MW-4. Further research of historical uses of the subject property and nearby up-gradient properties may help identify the source of the gasoline contamination. If historical information is not helpful, an additional sample point along the north property line may be needed, probably one point between MW-1 and Candlelight Drive, and maybe another to the west of MW-1. Another round of water samples should be collected this spring during the high water table, from the existing wells and any additional sample points.
