ROZAK ENGINEERING

Re: Report of Groundwater Sampling Events 5, 6, 7 & 8
Former Doyle's Fuel Storage Facility, Spill #1998230128901
SE ¼ B.L.M. Lot 51, S34, T6S, R11W, City of Kenai

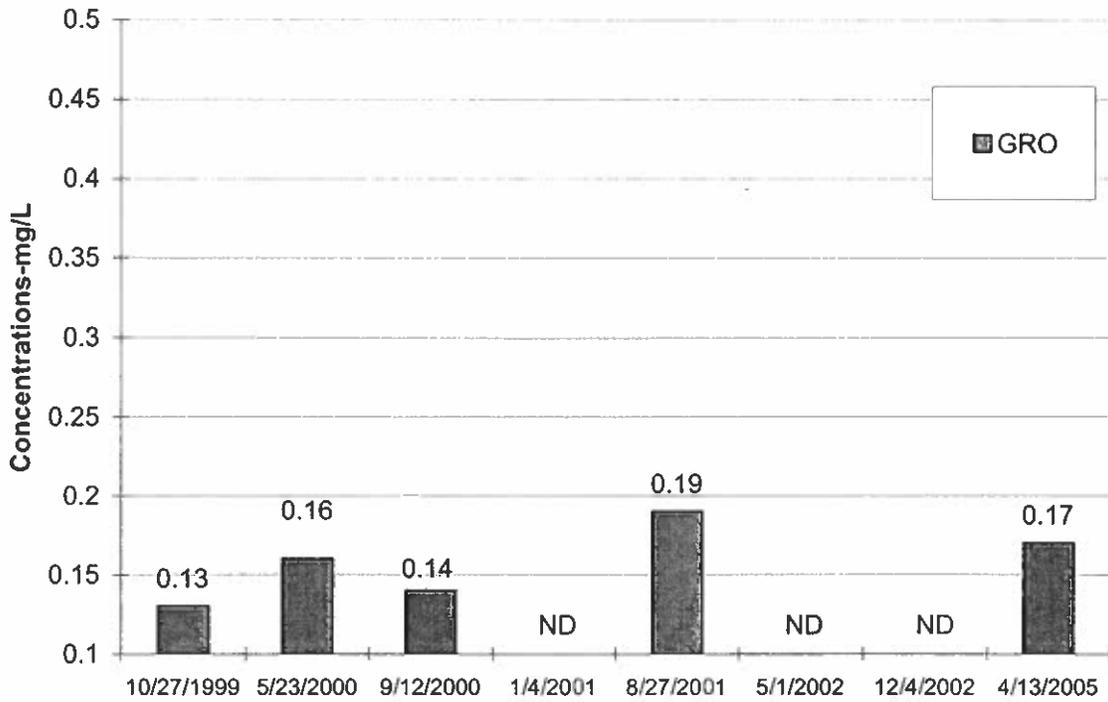
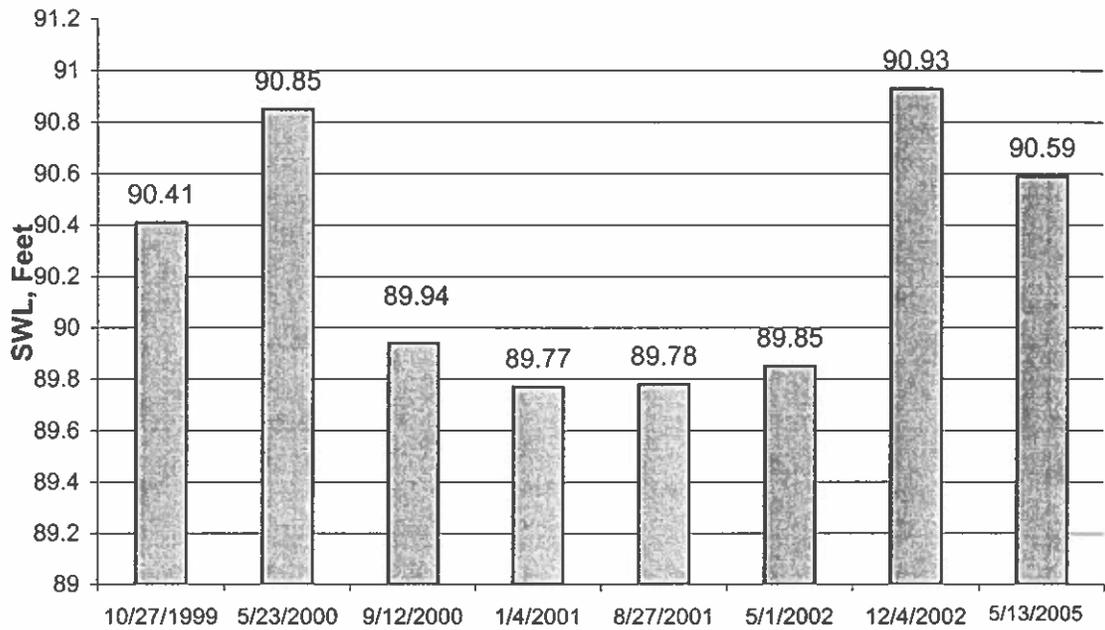
MW-1 This well is approximately 110 feet upgradient from the site of the two 15,000-gallon tank aboveground tanks suspected to be the primary source of the contamination. Petroleum hydrocarbons (PHC) contamination was not expected at this location, however, PHC were detected during six of the eight sample events. The concentrations have been relatively stable and less than the cleanup levels.

- GRO concentrations of 0.13 to 0.19 mg/L were detected in 5 of 8 groundwater sample events. GRO in the last groundwater sample was 0.17 mg/L, which is 0.04 mg/L less than the first groundwater sample collected 5 ½ years earlier.
- DRO was detected three times: 0.32 mg/L in the first sampling event, 0.68 mg/L in the second sampling event, and 0.50 mg/L in the seventh event.
- Benzene was detected twice: 0.0006 mg/L (0.0001 mg/L above the detection level) in the second and the fifth sampling events.
- The difference from lowest to highest measured groundwater level is 1.15 feet.
- There is no apparent correlation between the PHC concentrations and the groundwater level.

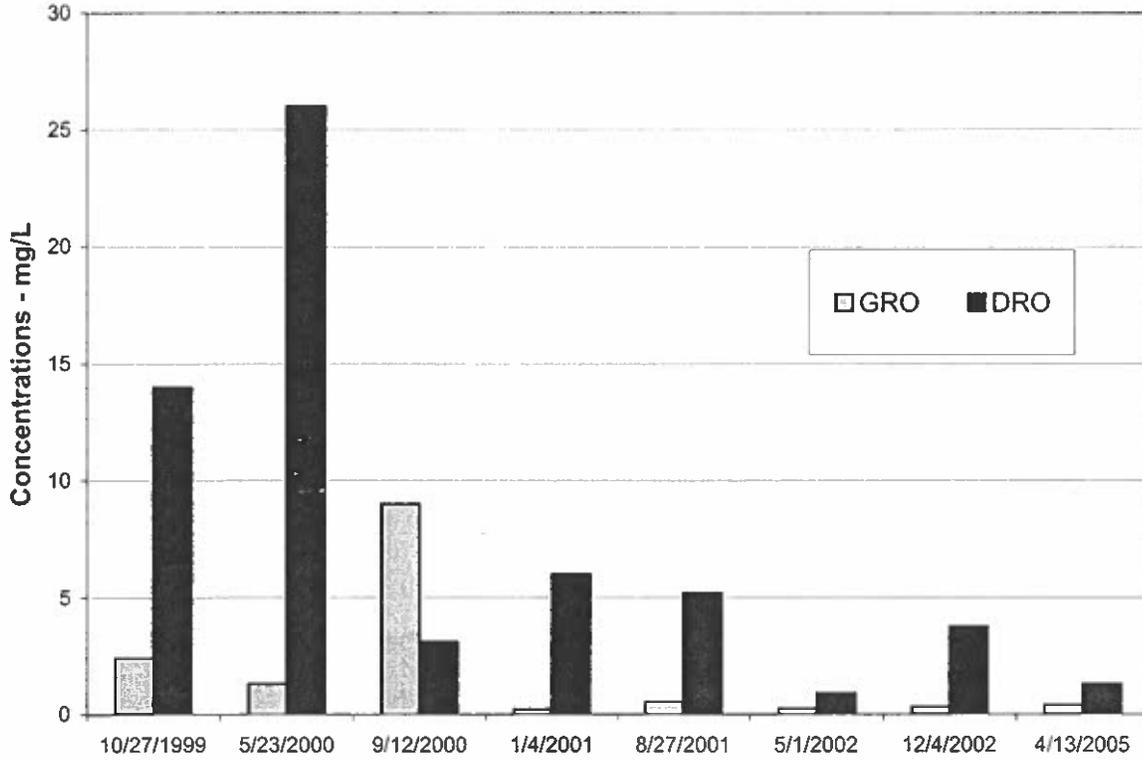
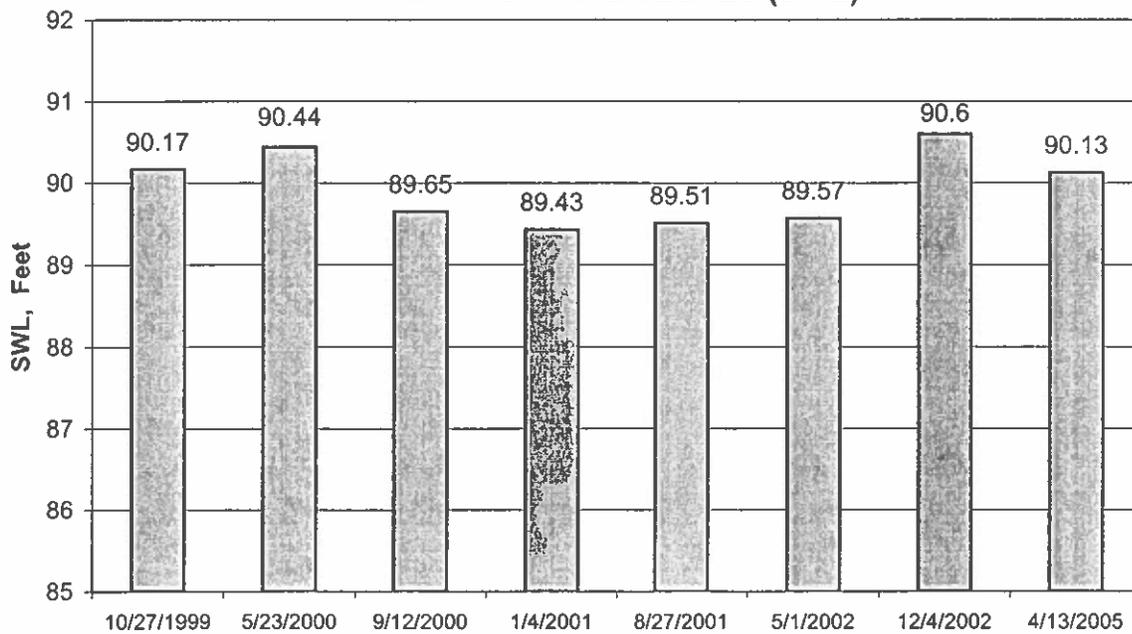
MW-2 This monitoring well is located 20 feet north of the former above ground tank site. Elevated PHC concentrations in groundwater were expected because the soil samples collected during the soil boring for this monitor well exhibited PHC odor from 3 feet to 11 feet bgs. PHC concentrations in groundwater have shown a stable or declining trend since the unexplained spike in GRO and BTEX detected in the third sample event (May 2000).

- GRO concentrations during the first three sample events exceeded the cleanup level. GRO for the last five events has been less than the cleanup level.
- DRO concentrations during sample events 1 through 5 and 7 exceeded the cleanup level. Since May 2000, the levels have shown a declining trend.
- Benzene concentrations exceeded the cleanup level four times. Except for the spike in September 2000, the levels have fluctuated from below the cleanup level to three times the cleanup level.
- The difference from lowest to highest measured groundwater level is 1.17 feet.
- Except for the spike on September 2000, higher DRO concentrations generally occur with higher groundwater levels.

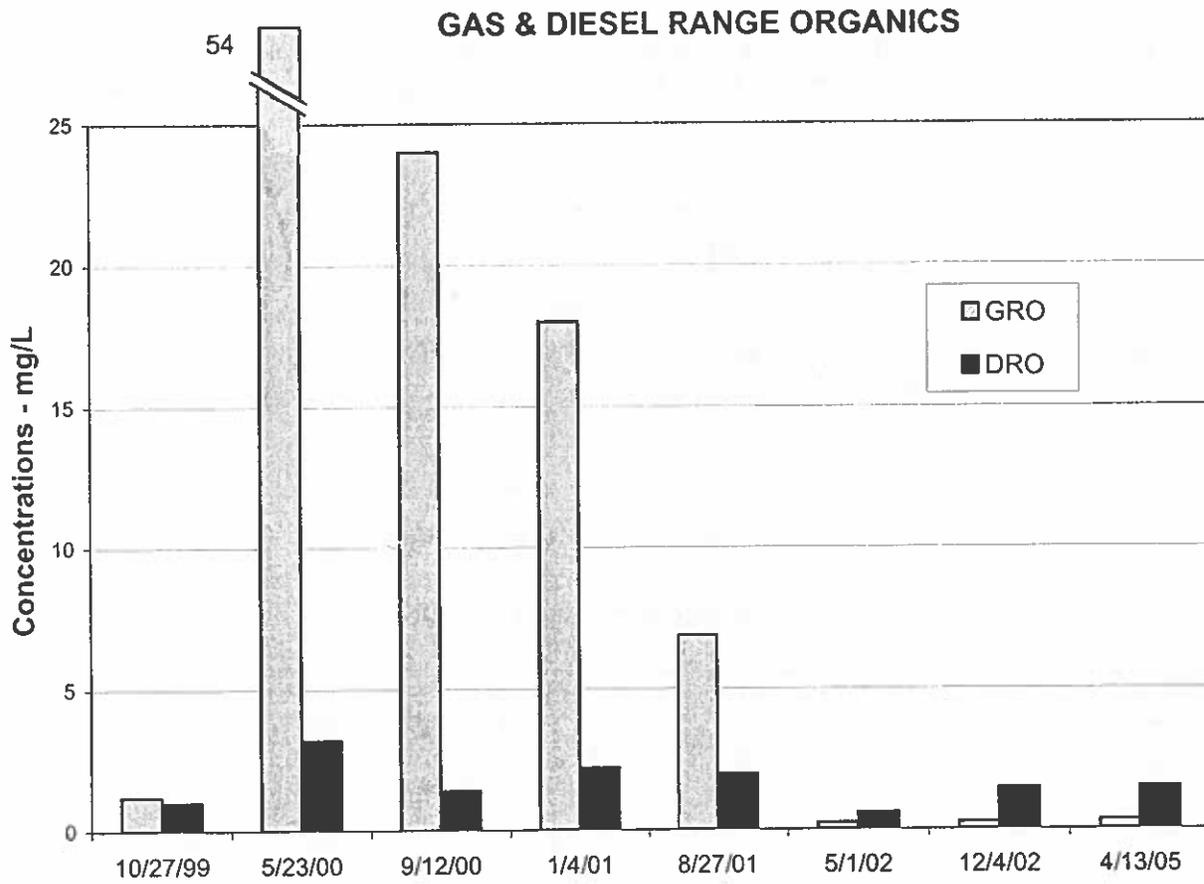
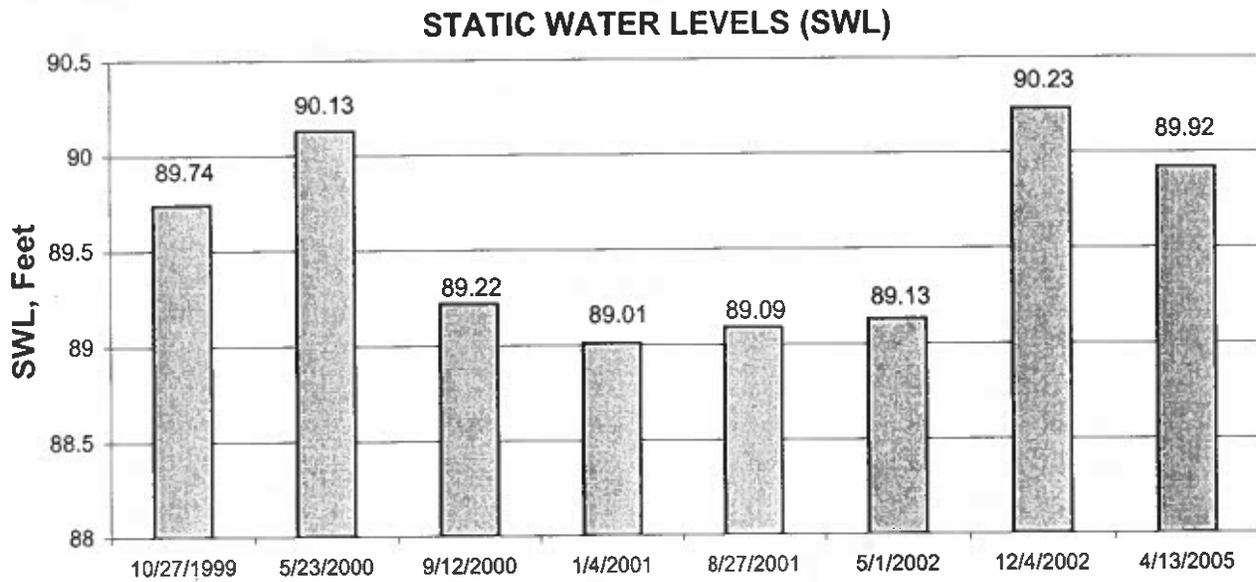
MW-4 This well is on the east side of Candlelight Drive ROW, 73 feet east of MW-3 and approximately 120 feet down gradient from the 15,000-gallon tank site. Low levels of PHCs—less than cleanup levels—were expected at this location.

- Analysis results for the first sample event were a little higher than expected but were not inconsistent with other site data.
- The second groundwater sample event (5/23/00) produced much higher concentrations than were expected and the contamination was not consistent with other site data or analysis results of the first groundwater sample event. The laboratory checked the chain of custody and quality control for the second sample round, reexamined the analysis results to verify the GRO and BTEX were from a gasoline or diesel fuel source, and reported, “The sample in question does not appear to be significantly contaminated with a middle distillate fuel [diesel]. The DRO pattern indicates a significantly, 50-80%, weathered gasoline.”

- For the next three sample events the laboratory continued to report “DRO pattern consistent with weathered gasoline.” This was different than the laboratory reports for samples from the other wells, which stated, “DRO pattern consistent with weathered middle distillate.”

- GRO was detected every sample event and exceeded the cleanup level at events 2 thru 5. Concentrations declined since event two and were relatively stable the last three events.

- Benzene was detected and exceeded the cleanup level during every sample event.
- DRO was detected during each sample event and exceeded the cleanup level three times.

- The difference from lowest to highest measured groundwater level is 1.22 feet.
- There is no apparent correlation between PHC concentrations and the groundwater level.

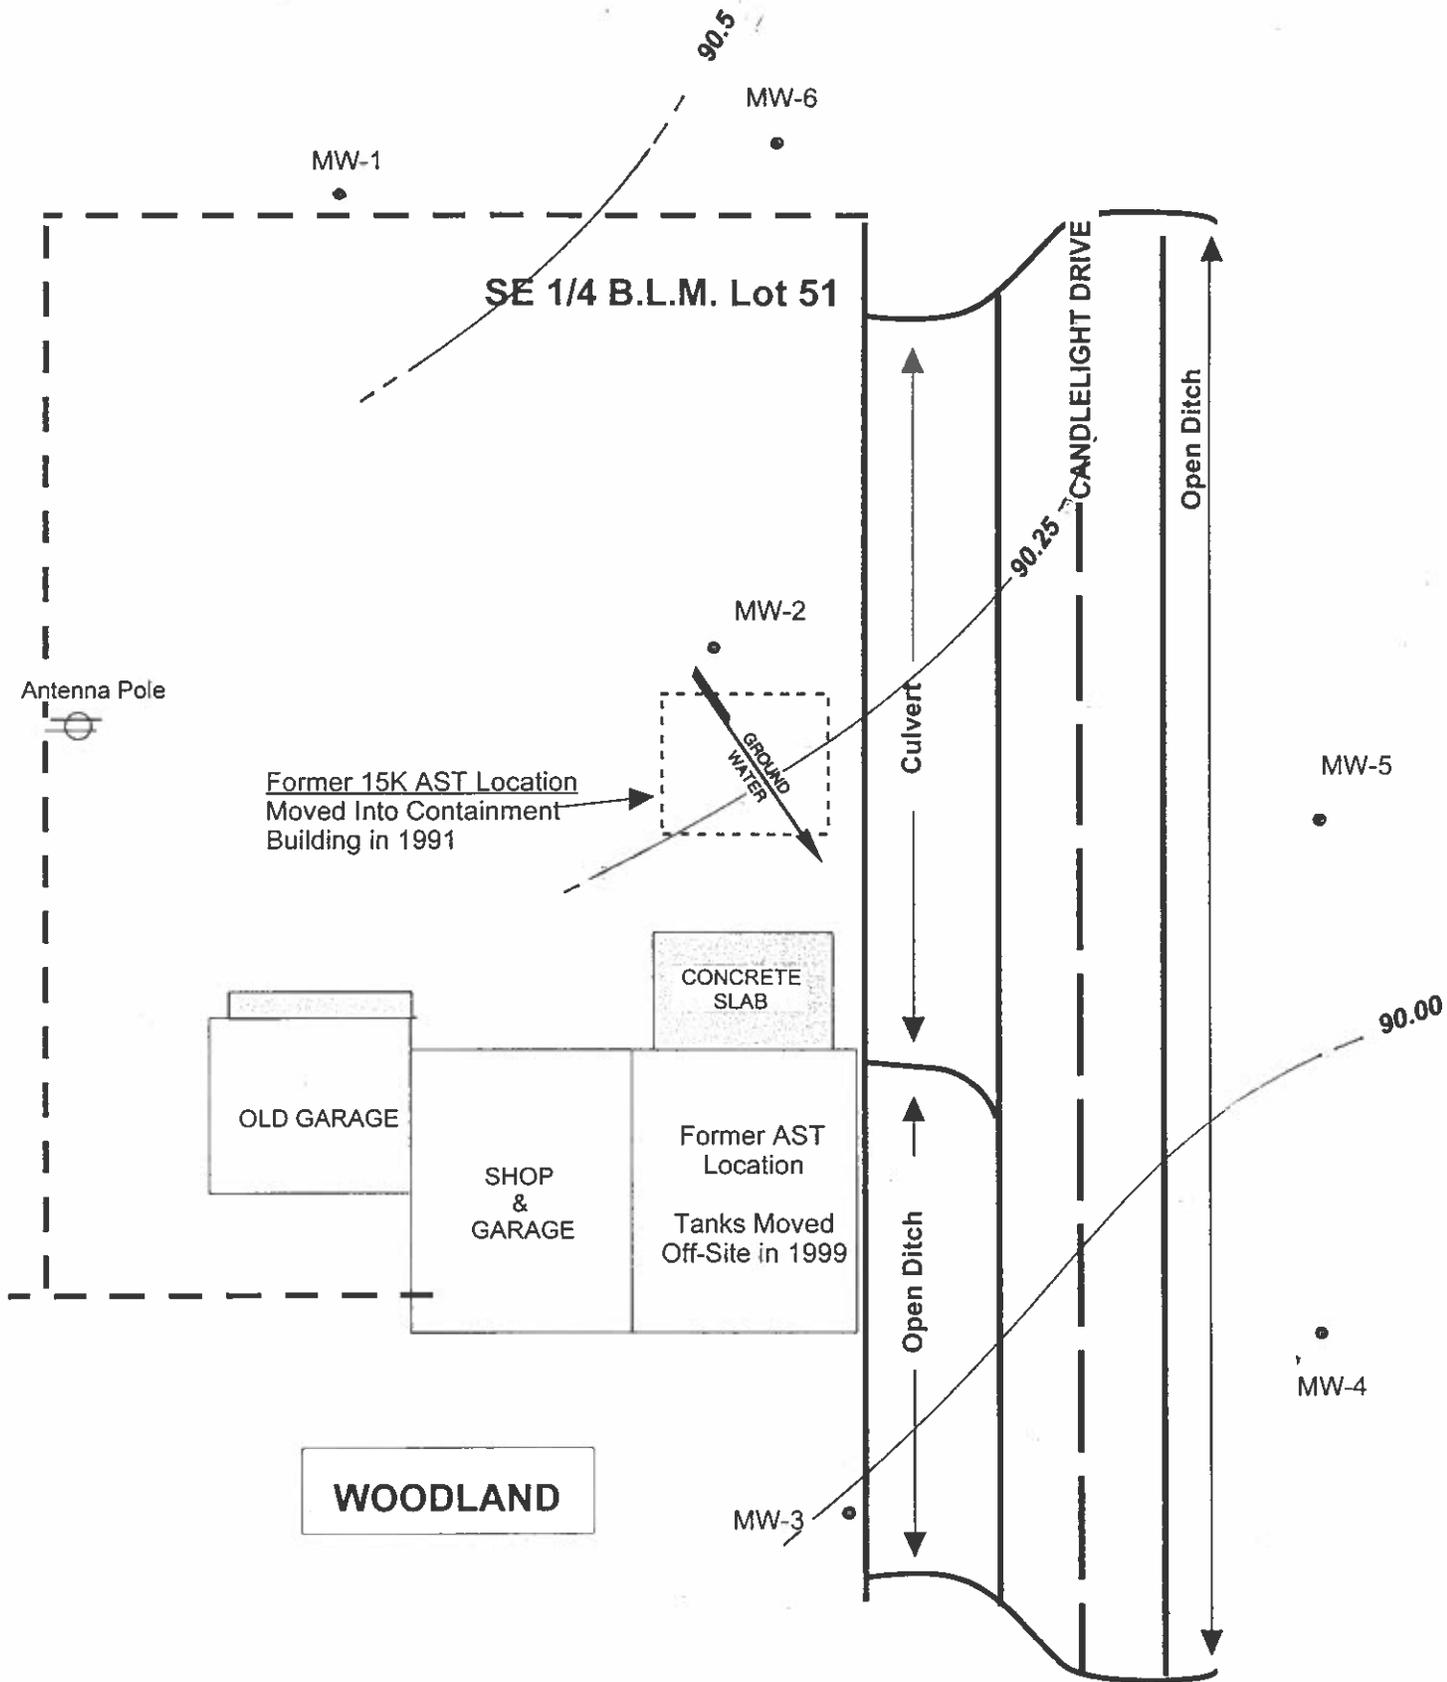
GROUNDWATER MONITORING MAP
FORMER DOYLE'S FUEL SERVICE SITE
 Groundwater contours derived from survey on April 13, 2005
 "•" at MW-1 indicates location of monitoring well #1

Once during each year of groundwater sampling, the top of PVC riser for each monitoring well was surveyed. The elevation survey was conducted to an accuracy of 0.01 foot. Elevations were referenced to an assumed elevation of 100.00 feet at the top of the PVC casing at MW-1. Before the monitoring wells were bailed, the depth to groundwater in wells was measured to the nearest 0.01 foot. Groundwater elevations were determined by subtracting the measured depth to water from the elevation surveyed to the top of PVC casing. The groundwater flow direction was then determined graphically. Elevation contours and arrow depicting direction of flow derived from the April 13, 2005 survey are shown on the Groundwater Monitoring Map. We evaluated the groundwater surveys for the eight sampling events and found the groundwater:

- Flow direction was more uniform than reported March 2001. Flow is southeast across the site, varying less than 10 degrees from a line between the former ASTs and MW-4.
- Gradient averaged 0.0033 ft/ft, calculated from the average difference of 0.71 feet between the highest (at MW-1) and the lowest (at MW-4) measured groundwater level.
- Levels at the six wells fluctuated 1.15 to 1.22 feet between highest and lowest measurements.
