CORRECTIVE ACTION REPORT
TRAILSIDE GENERAL STORE
HOMER, ALASKA

PROJECT NO. 002-10
DECEMBER, 2002

Subject: Trailside General Store Corrective Action Report

ADEC Spill # 99-23-00-119-01

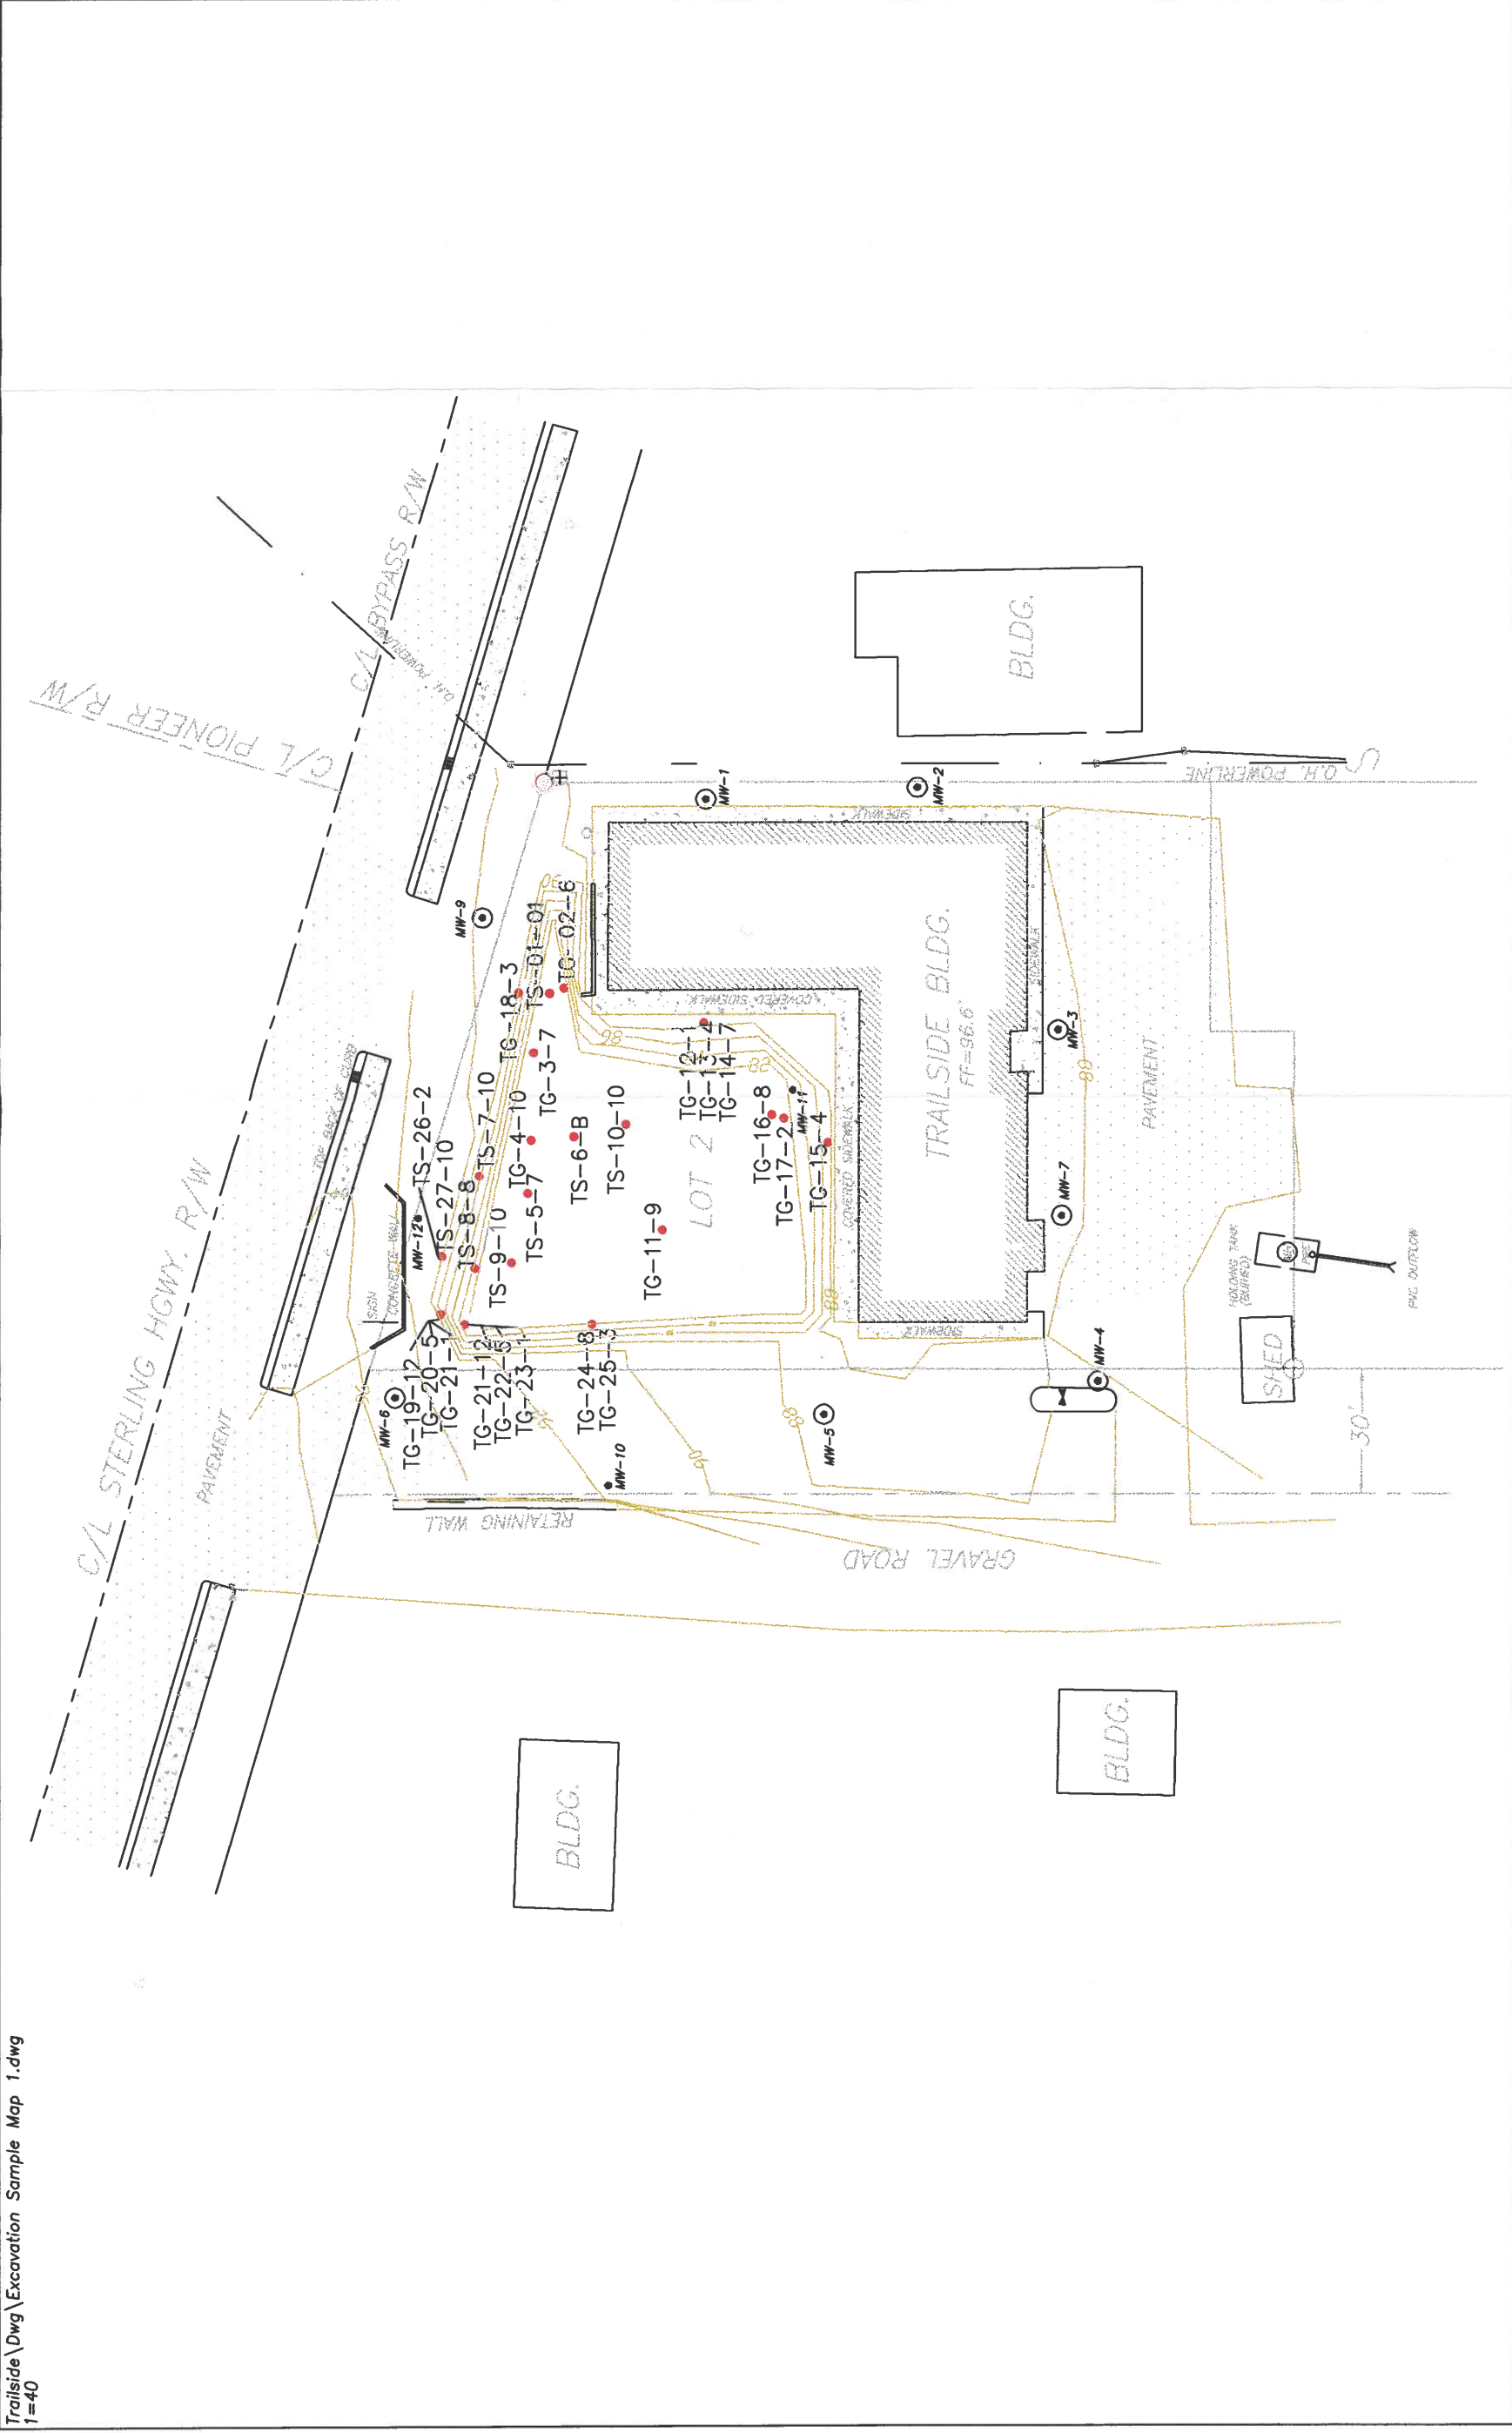
FIGURE
2

At approximately 15:00 hours site excavation work was initiated off the north end of the building in the general area of MW-8 (Figure 2). Frozen soil was encountered to a depth of three feet below ground level, underlain by approximately two feet of peat with coal, which was underlain by dense gray silt to nine feet. The excavation remained dry at the time of sampling. A representative soil sample, TS-01-01, was collected from the silt at approximately six feet below ground level (bgl). Tabulated sample results are presented in Table 1; the laboratory analytical reports are presented in Appendix A.

The excavation had extended to 55 feet west of the west wall of the north leg of the building. The excavation was approximately 10 feet deep in this area. See Figure 2. A characterization sample was collected from the tenth truck out of the site this day. Sample TS-06-B was collected from the base of the excavation at approximately 10 feet deep in moist silt

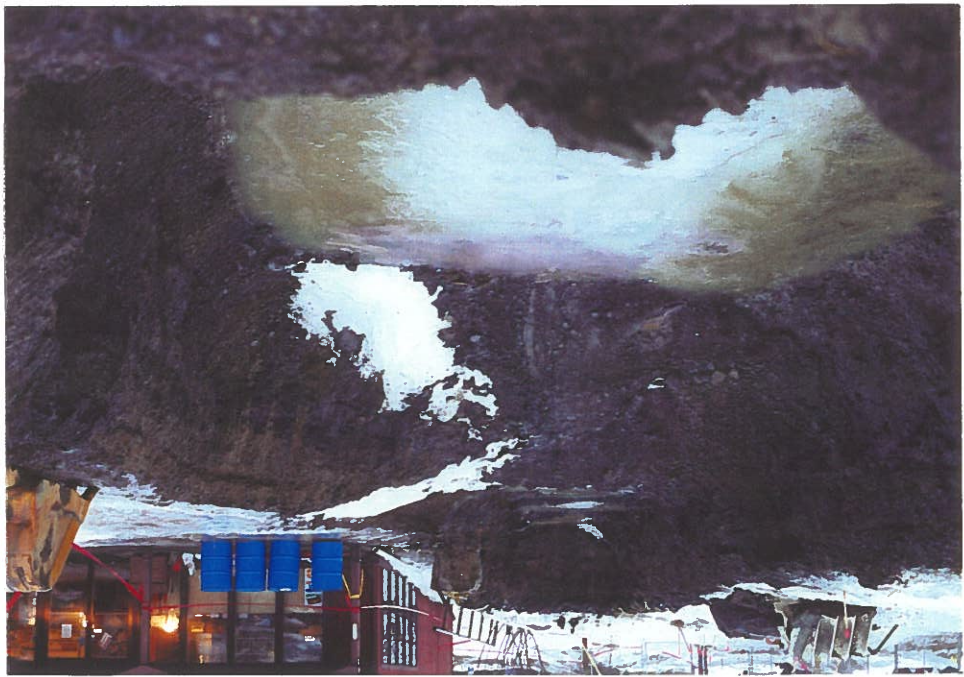
The excavation that was opened on January 26th now had approximately one foot of water in the base. Photo 2, Appendix F. It appeared that the water was moving thru the sandy silt layer on top of the lower silt approximately six feet bgl. The highest PID reading in this area was found in the lower peat layer. The surficial soils had a PID reading from 15 to 26 ppm. These soils were frozen and were stockpiled separately at the Arndt gravel pit. As the excavation progressed it became evident that the quantity of low impact soils was minimal; and the frozen soils exhibiting low PID readings were incorporated into the contaminated soil stockpile.

<p>PHOTOGRAPHER: Peter Campbell</p>	<p>DATE: 1/27/00</p>	<p>DIRECTION: Looking east</p>	<p>COMMENTS: End of day excavation</p>	
	<p>PHOTOGRAPHER: Peter Campbell</p>	<p>DATE: 1/28/02</p>	<p>DIRECTION: Looking east</p>	<p>COMMENTS: Note product on water surface</p>	
	<p>PHOTOGRAPHER: Peter Campbell</p>				
	<p>DATE: 1/28/02</p>

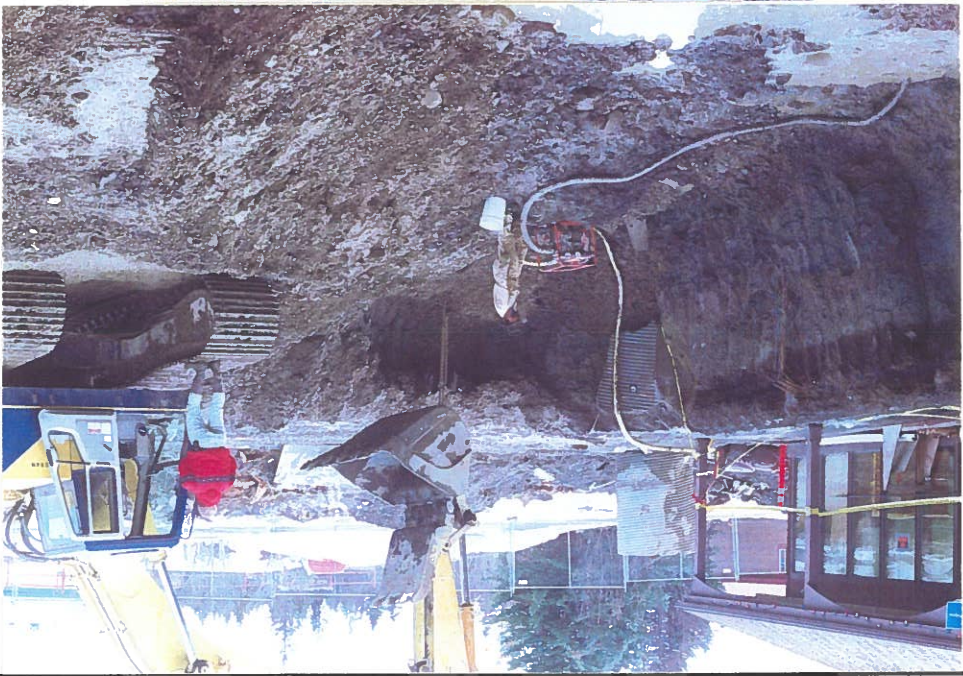
COMMENTS: Excavation dewatering in front of Trailside General Store, sample locations TS30 & TS-31.
