CONTAMINATED
SITES
FAIRBANKS

**RE: INTERIM REPORT OF 1998/1999 SITE INVESTIGATION FINDINGS,
HOLDER PROPERTY AND DAVISON STREET RIGHT OF WAY,
FAIRBANKS, ALASKA, NTP 1820121001A**

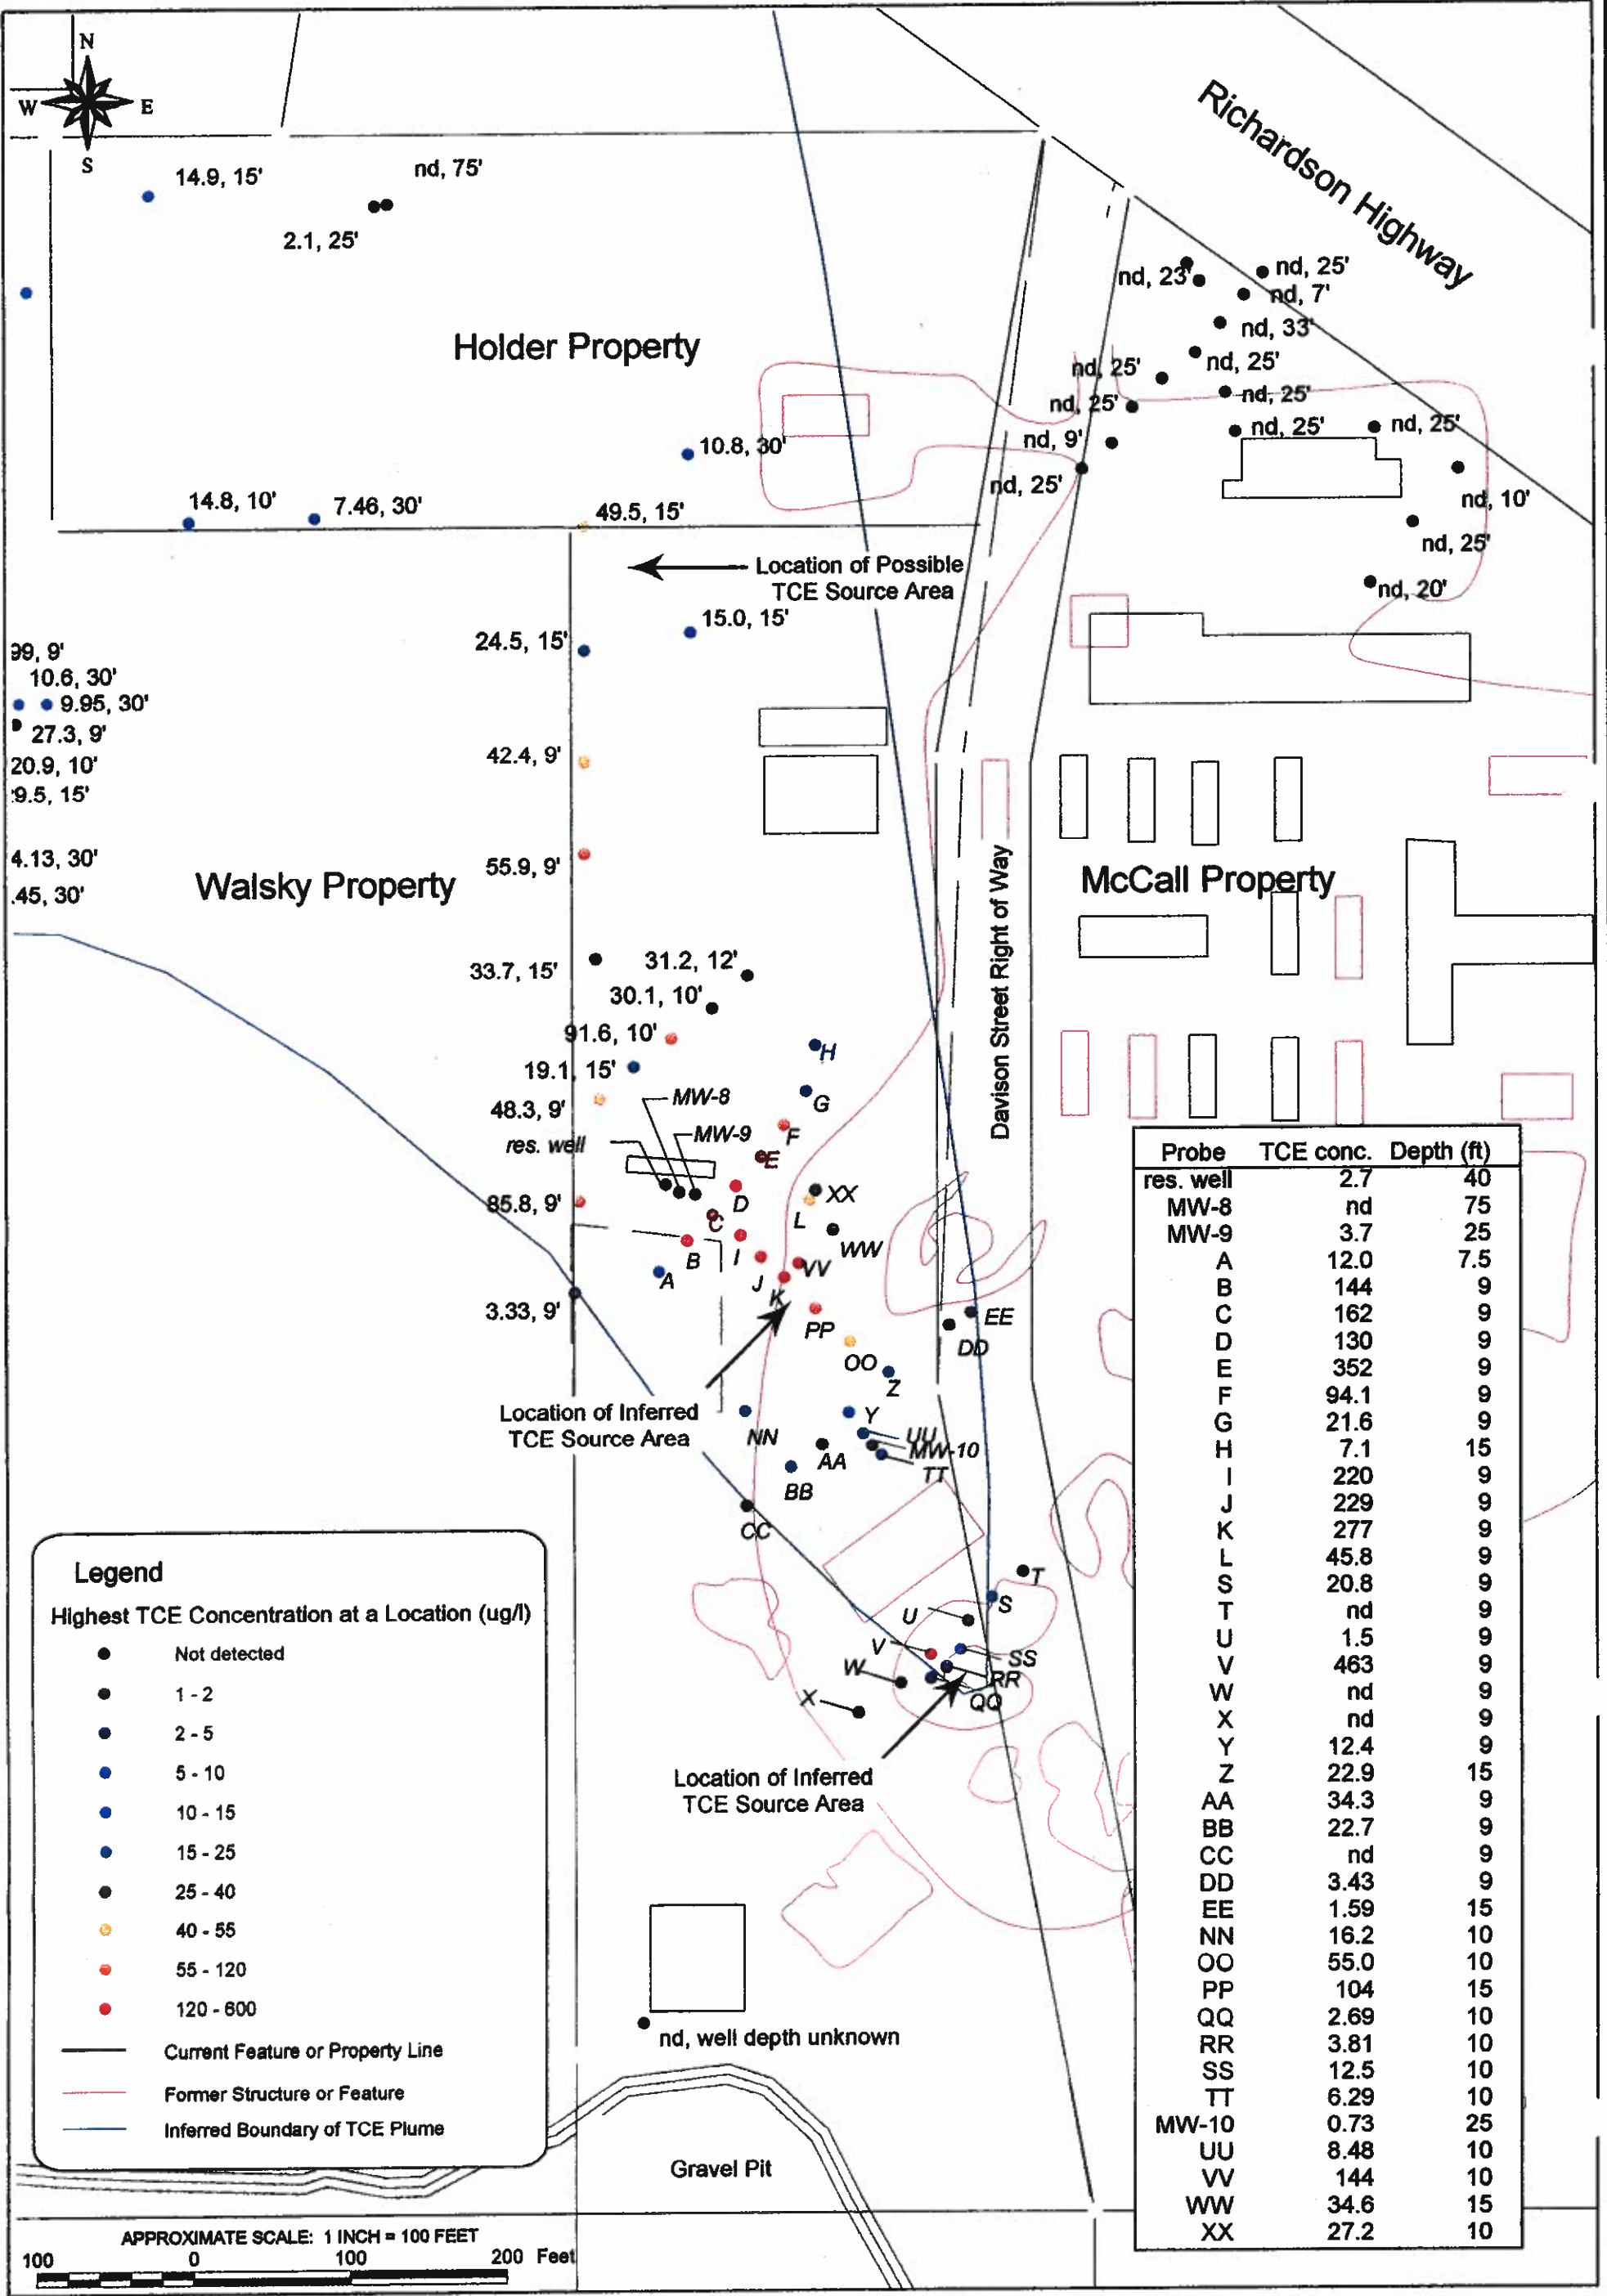
The maximum concentration of TCE at each Geoprobe® location (regardless of sample depth) is shown in Figure 2. The estimated extent of the groundwater plume is drawn in this figure, as well as the inferred locations of the TCE source areas. TCE concentrations at selected depth intervals are shown in Figure 3 through 5.

The extent of the TCE groundwater contamination on the Holder property is depicted in Figure 2. The plume is about 300 feet wide at its widest point on this site. In general, TCE groundwater concentrations at 9 or 10 feet below ground surface were greater than those at 30 feet, suggesting that the sources are shallow and that the released TCE did not penetrate deep into the aquifer. The limited data suggest that groundwater as deep as 50 feet below ground surface is also contaminated with TCE. The TCE plume extends downgradient onto the Walsky property. One or more sources of TCE, as well as TCA, on the Walsky property also contribute to the plume of groundwater contamination. Since the Walsky TCE source or sources are approximately downgradient of the Holder TCE source, the two plumes commingle. No TCA was detected on the Holder property, implying that the TCA source is entirely on the Walsky property.

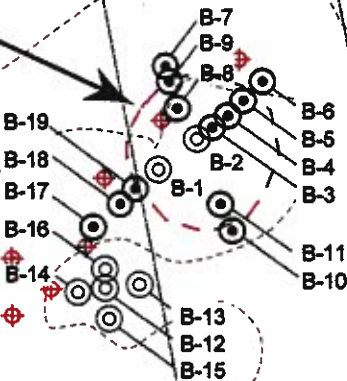
6

In the Davison Street right of way, DRO was reported in the soil samples at up to 20,200 mg/kg. The highest level was found in the sample from a depth of 5 feet in boring B-2. Ten feet away, the DRO concentration was 4,710 mg/kg in boring B-1. GRO was measured at 21.3 mg/kg in the one sample analyzed, and likely represents the lighter portion of the diesel contamination. Residual range organics were not reported in the samples. The following petroleum hydrocarbon constituents were reported in a number of samples in the right of way at less than the ADEC soil cleanup levels: 1,3,5-trimethylbenzene, 4-isopropyltoluene, naphthalene, toluene, and *o*-xylene. Only DRO and TCE levels exceeded the soil cleanup levels. No TCE source was inferred to have been detected with soil sampling in the right of way.

A slight petroleum hydrocarbon odor was noted on some of the samples from borings B-12 and B-13 on the Holder property, but PID field screening readings were not significantly elevated. A petroleum hydrocarbon odor was also noted on some of the samples from both borings B-1 and B-2 in the right of way, and a sheen was observed on the water in boring B-2. Samples collected at the water table from borings B-1 and B-2 exhibited elevated PID readings. The inferred extent of petroleum hydrocarbon soil contamination, based on the PID readings, is shown in Figure 6. TCE and DRO analytical results, as well as PID field screening results, are tabulated in Figure 6.

The soil gas survey identified a petroleum hydrocarbon source area in the Davison Street right of way. Contaminated soil is as shallow as 2 feet below ground surface. The area of contaminated soil was delineated by field screening soils with a PID. Soil sampling confirmed the presence of diesel-range fuel above the ADEC soil cleanup level. VOC groundwater contamination above MCLs does not appear to be associated with this source area. TCE is not associated with this hydrocarbon source, although it and the TCE source described below overlap somewhat. Cleanup of the contaminated soils is required under 18 AAC 75.340.
