PHASE I ENVIRONMENTAL SITE ASSESSMENT
SEEKINS FORD-LINCOLN-MERCURY
FAIRBANKS, ALASKA

Seekins Ford-Lincoln-Mercury, Inc.
1625 Old Steese Highway
Fairbanks, Alaska 99701

April 1996

6-024-01173-1

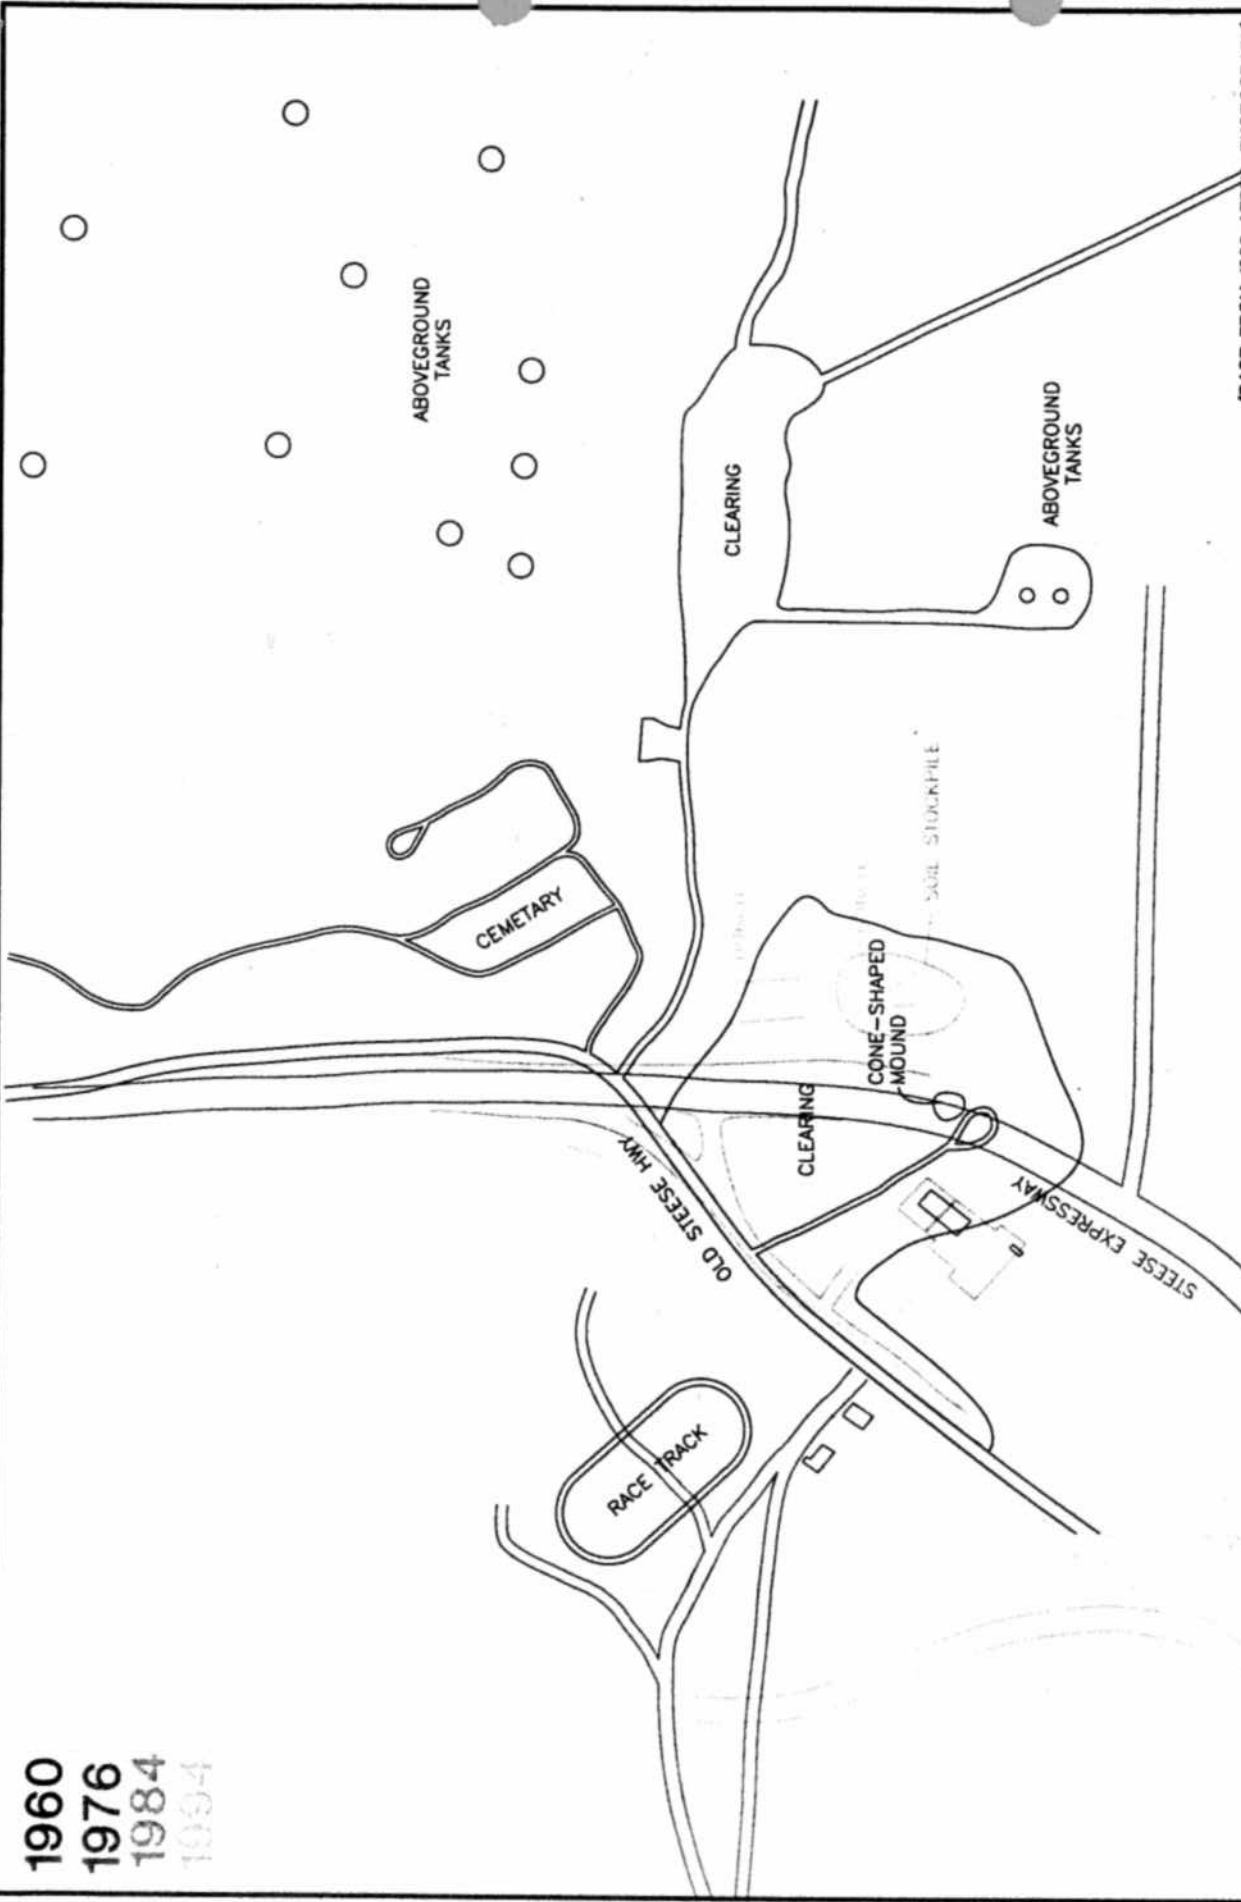
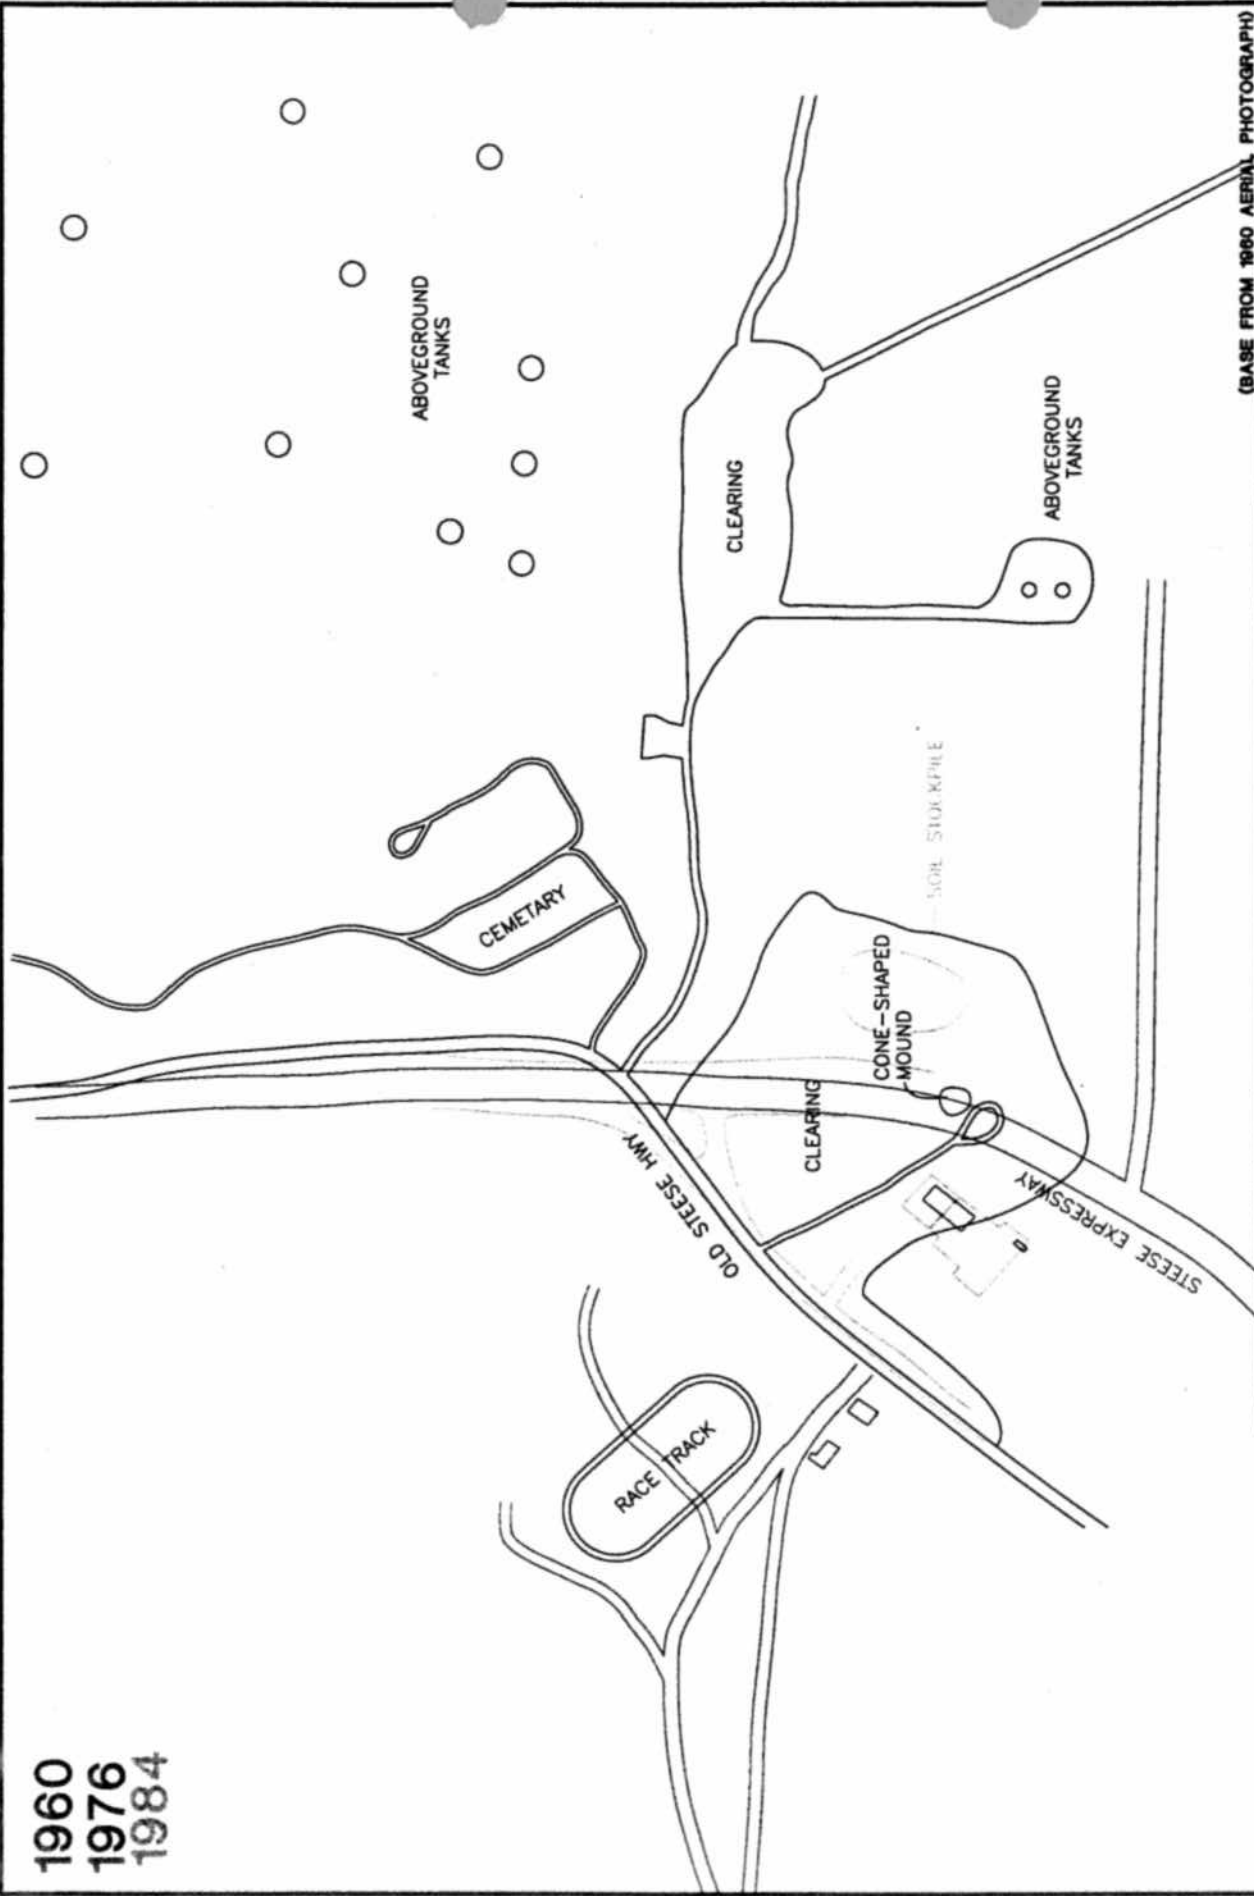
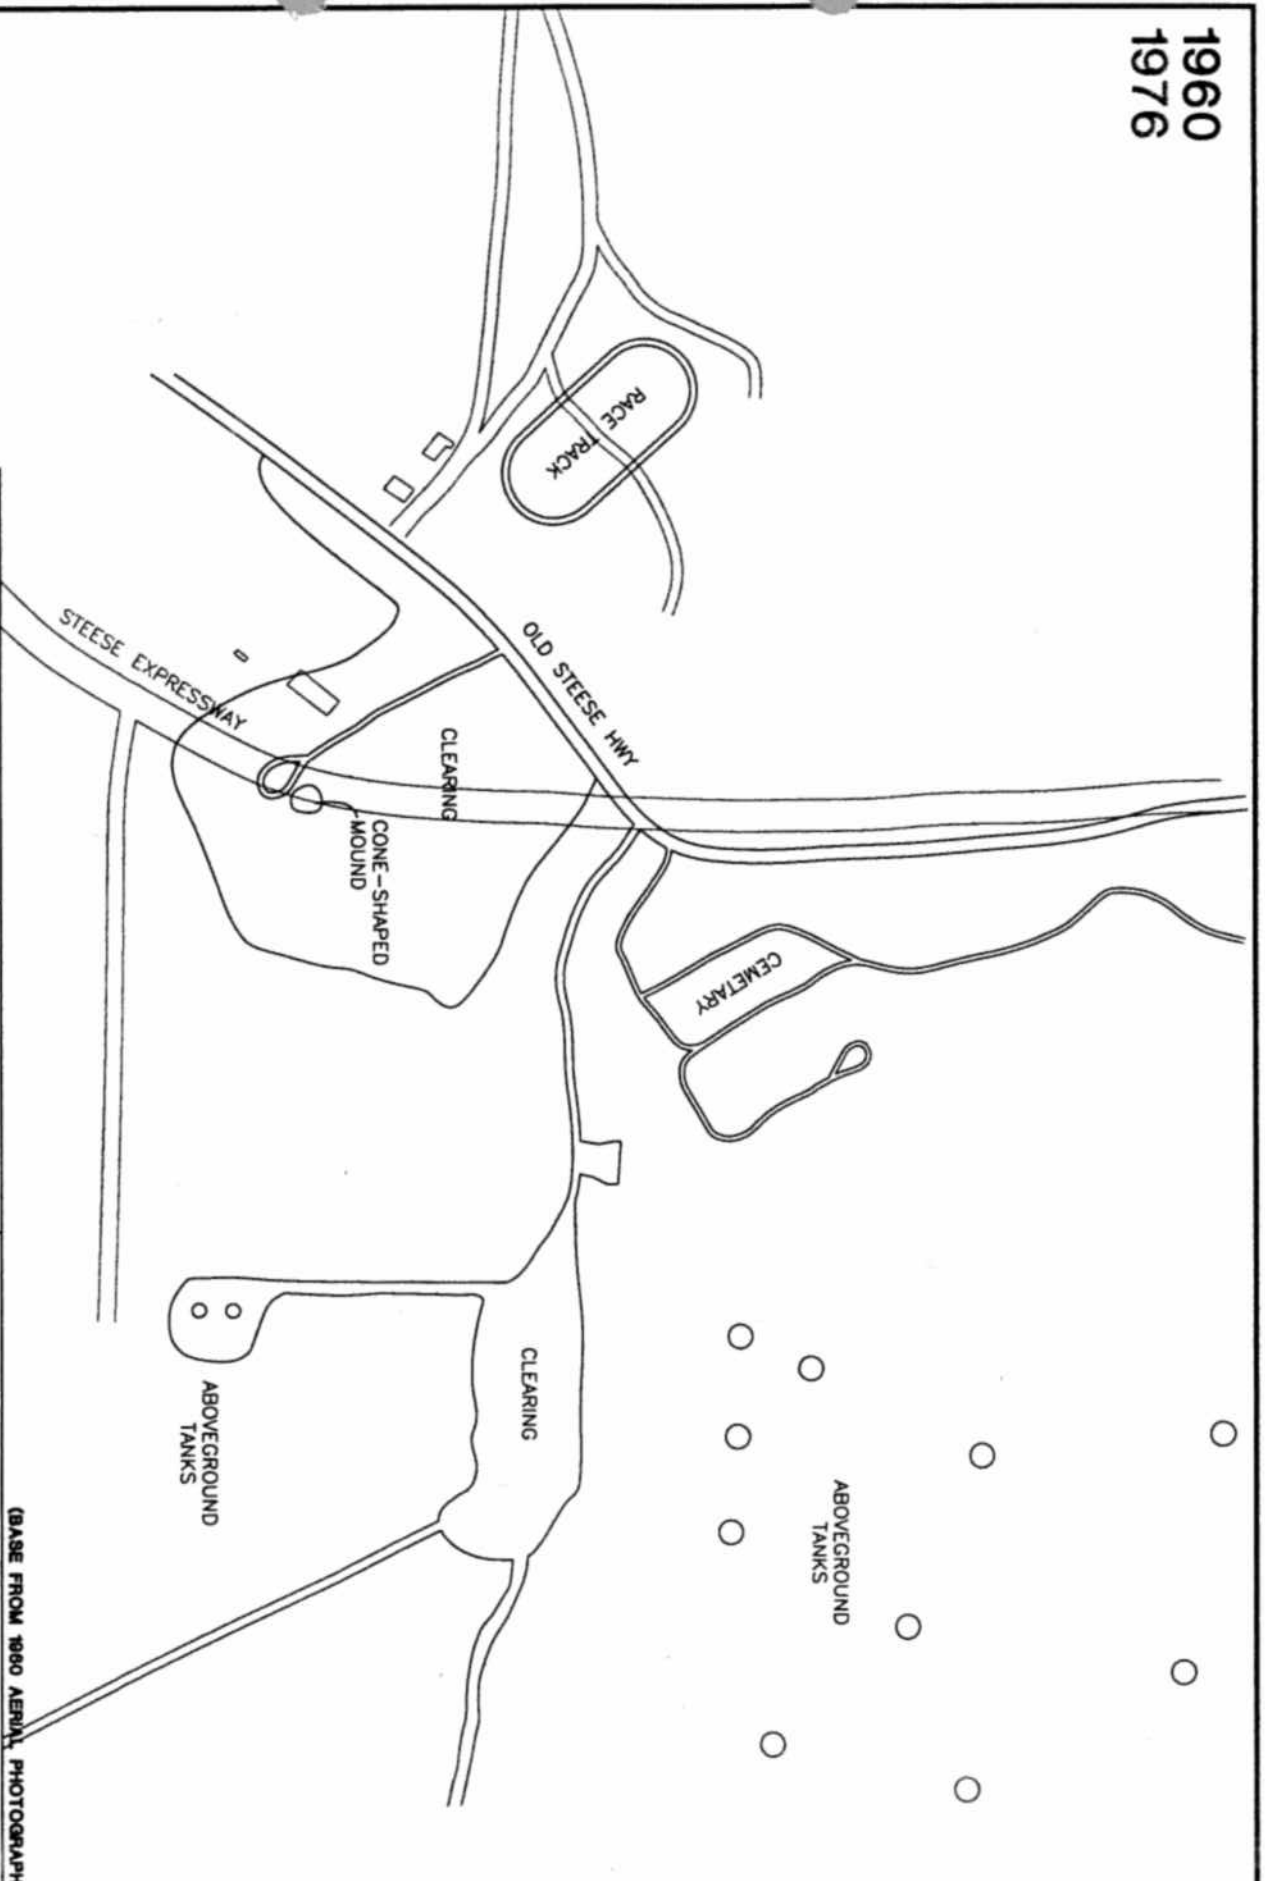
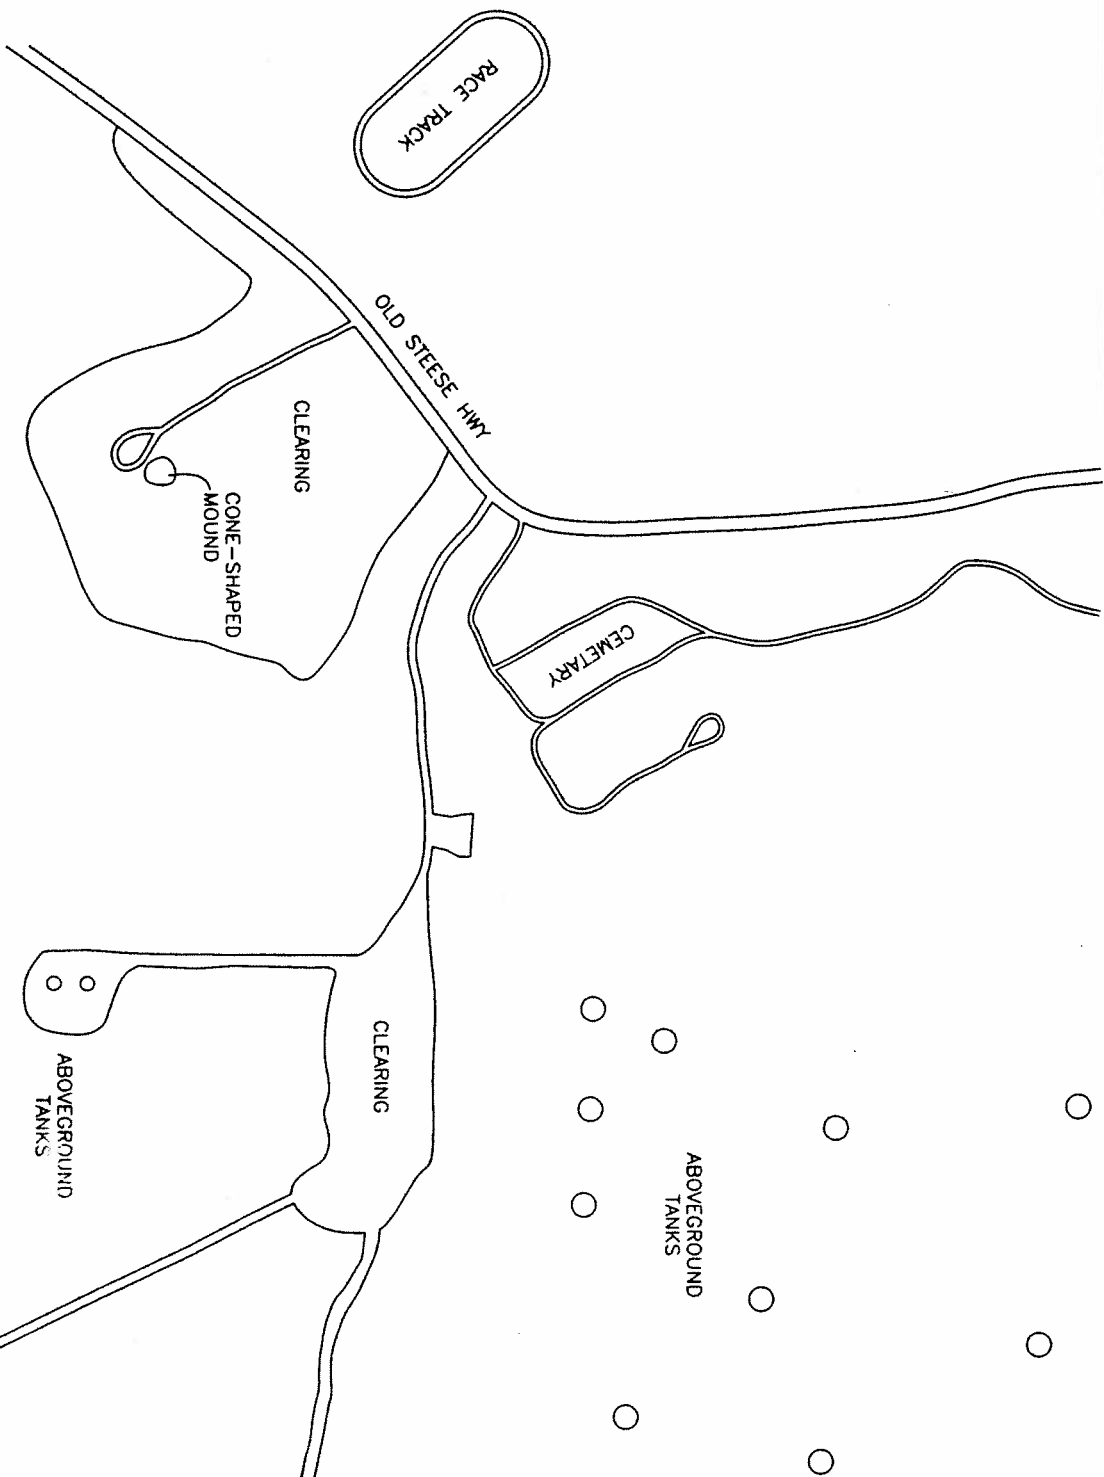
SITE HISTORY (WITH OVERLAYS)
FIGURE 4

The aerial photographs provide a record of development on the subject site and in the site vicinity. When the nature and/or use of a property could not be clearly identified from the photograph alone, reference was made to the Fairbanks city directories and/or FNSB assessment records. In addition to the photographs in Appendix B, a series of overlays showing the progression of development in the site vicinity since 1960 is provided as Figure 4. The following paragraphs summarize the observations noted for each photograph, including the items shown on the overlays.

1976 Aerial Photograph: The 1976 photograph records many significant changes to the site vicinity. As recorded on the photograph, construction of the Steese Expressway had begun and the right-of-way for the highway cut the former 20-acre clearing approximately in half. In reference to earlier photographs, the northbound lanes of the new highway appear to pass over the location of the conical hill once located in the clearing. The presence of the new road also serves to define the location and current extent of the Seekins property. Development on the property is seen to consist of a warehouse-type building and a large aboveground storage tank in a containment cell to the southwest of the building. Both structures are located near the eastern property line. Several small buildings and/or trailers can be seen in the southwest corner and along the western edge of the property. The property is unpaved and numerous patches of dark, apparently stained soil are

visible. The largest and most obvious patches of darkened soil are located in the area between and west of the warehouse and storage tank. FNSB assessment records indicate that the property was owned by the Bentley Trust but that six trailers, two sheds, and one office were owned by Northwest Construction, Inc. One additional building is noted to have been leased by Northwest Construction from Mukluk Freight Company. The same records indicate that the warehouse was built in 1975 and used as a repair shop. A notation in the assessment records states that all buildings had been "removed or buried" by November 1978.

It is also notable that both the former repair shop and the aboveground storage tank were located on the site directly above the existing plume of impacted groundwater. Although other possible sources for the contamination did exist on the site, the possibility that the former shop and tank may have contributed to the impacted groundwater should not be ignored.

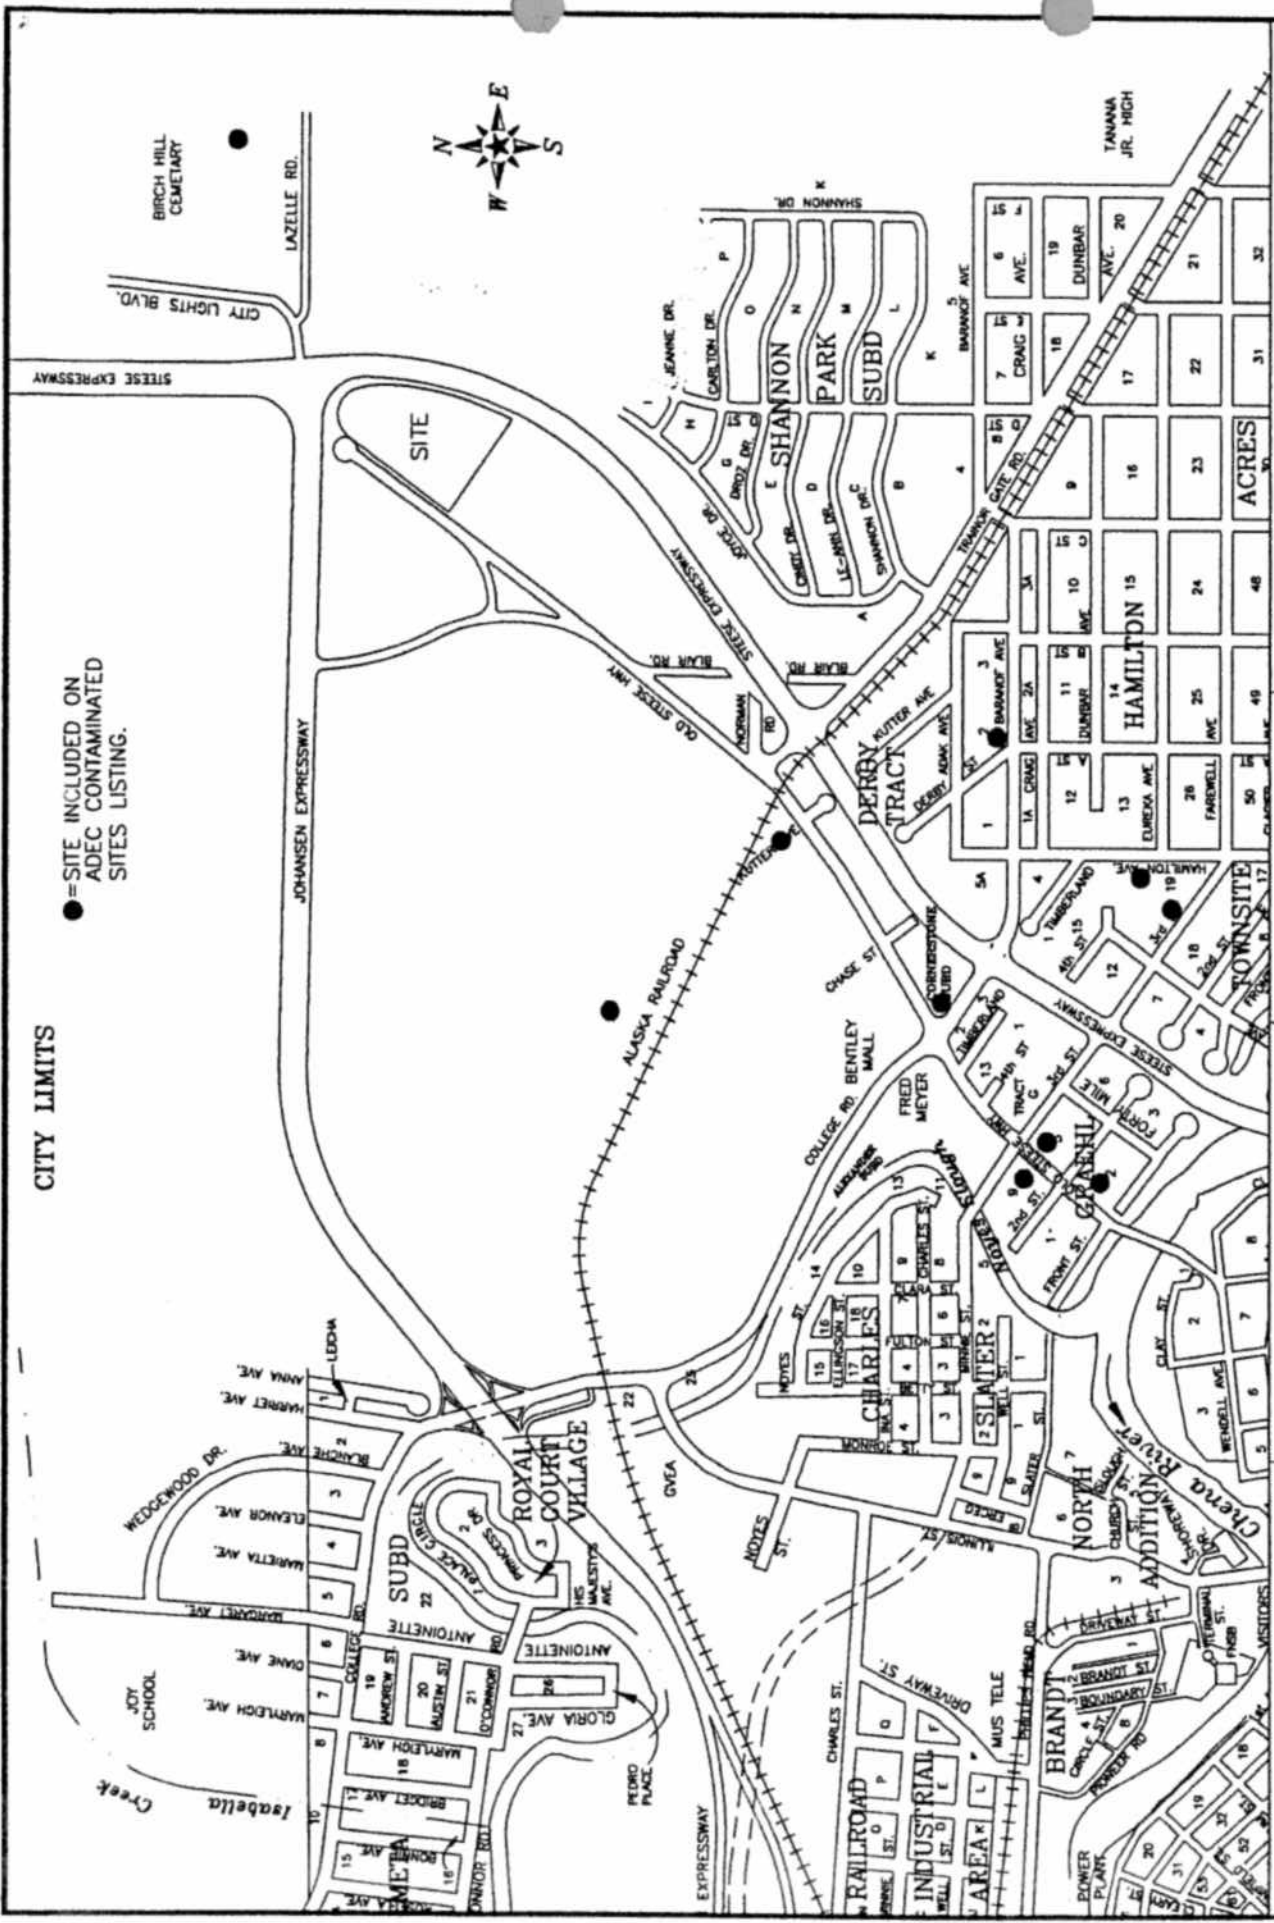
ADEC CONTAMINATED SITES
FIGURE 3

AEE personnel reviewed the ADEC files for the ten listed sites to verify the location and current status of each site. As shown on Figure 3, nine of the above-listed sites were found to be located both hydrologically down gradient and more than one-half mile from the subject site. The Fort Wainwright Fairbanks fuel terminal is the exception. This site is located less than one-half mile from the subject site and is situated both hydrologically upgradient and topographically uphill of the site. On this basis, the Fairbanks fuel terminal is the only site in the above list that is considered to have the potential to adversely impact the subject site.
