**FOCUSED SITE INVESTIGATION  
MAIL TRAIL ROAD SITE  
FAIRBANKS, ALASKA**

*Prepared for:*  
Crowley Maritime Corporation  
2401 4th Avenue  
Seattle, Washington 98121

*Prepared by:*  
America North Inc.  
201 E. 56th Avenue, Suite 200  
Anchorage, Alaska 99518

October 25, 1991

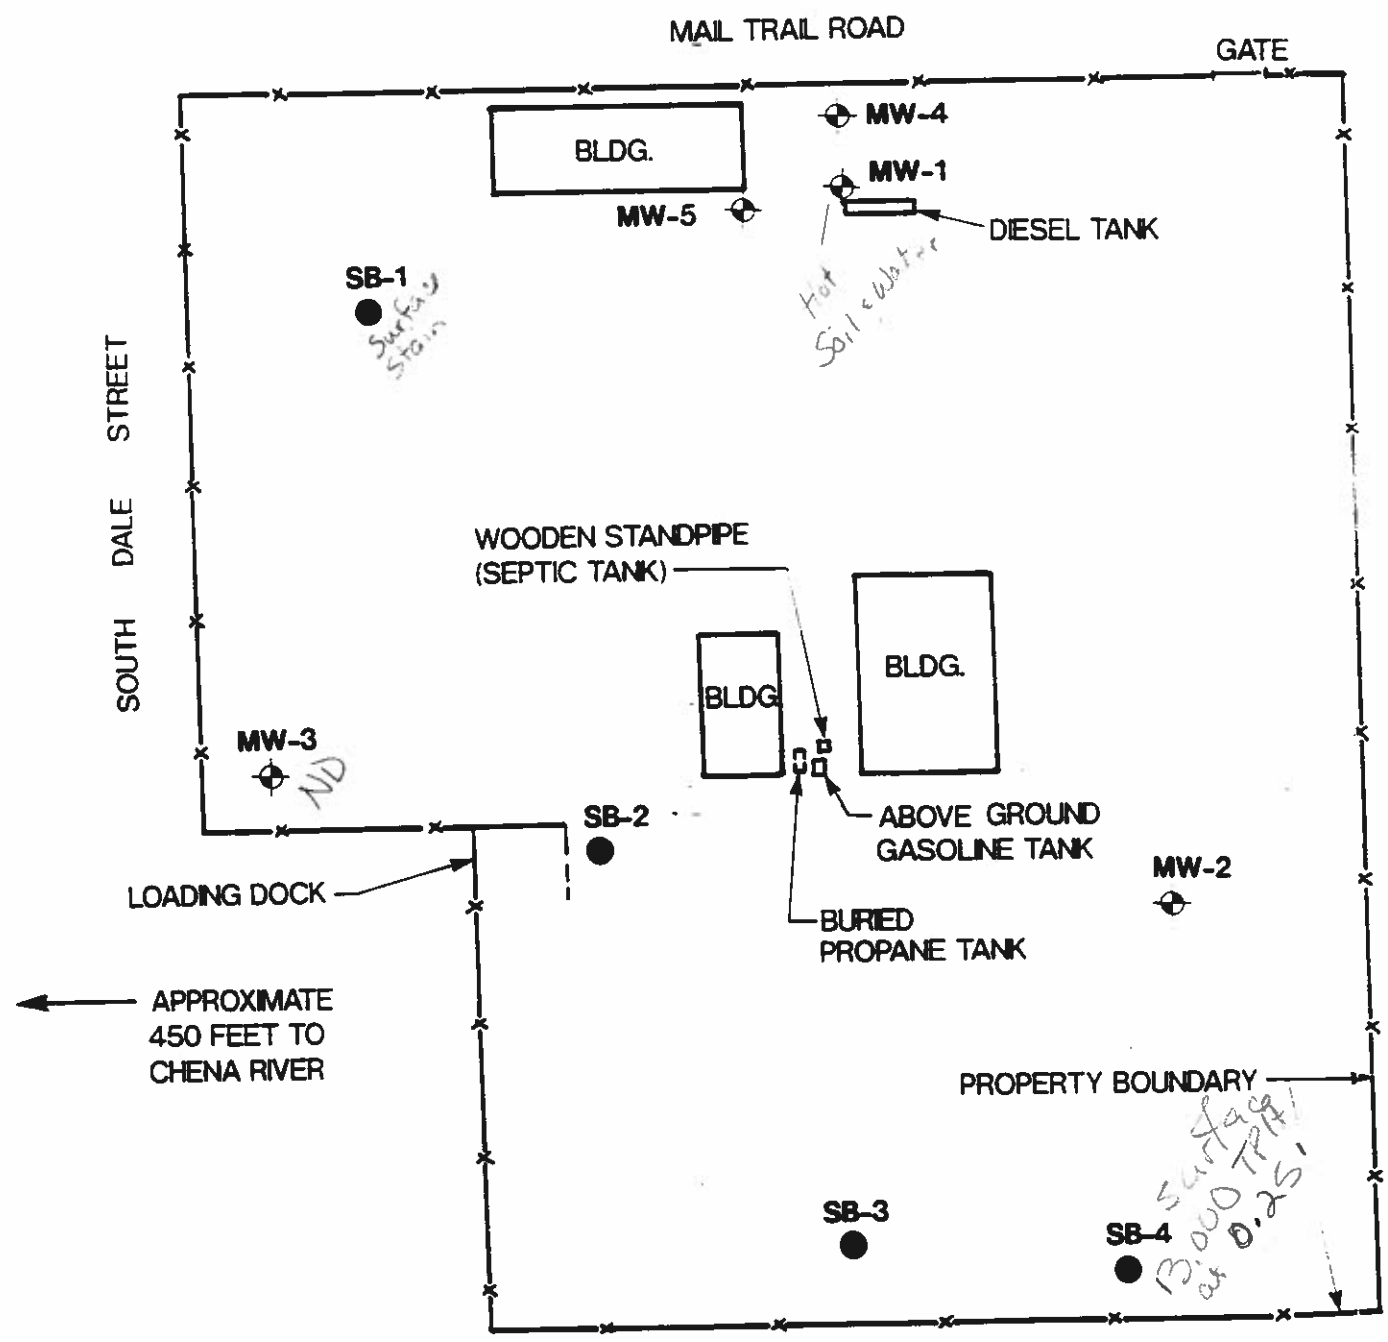
**Underground Storage Tank.** One underground storage tank exists at the site. Based on results of chemical analysis of selected soil and ground water samples from a soil boring/monitoring well located near the tank, diesel-range petroleum hydrocarbons are present in the vicinity of the tank. The contamination is likely due primarily to spillage during refueling operations over the years. It was not determined in this investigation whether the tank had leaked. As the area adjacent to the tank is not paved, any spills which may have occurred could potentially have seeped into the ground near the tank. Additional soil and ground water sampling would be needed to determine the level and extent of diesel-range petroleum hydrocarbons in this area of the site.

**Drums and Surface Staining.** The drums observed on site likely contain varying amounts of petroleum-based compounds (e.g., oil, grease, lube oil). Drum contents have not been tested. Many of the drums are in poor condition (dented or rusted) and do not contain lids. Areas of visibly stained soil are often associated with the drum storage areas.

Crowley is coordinating with a contractor to stabilize, test, and remove the drums and visibly stained surface soil.

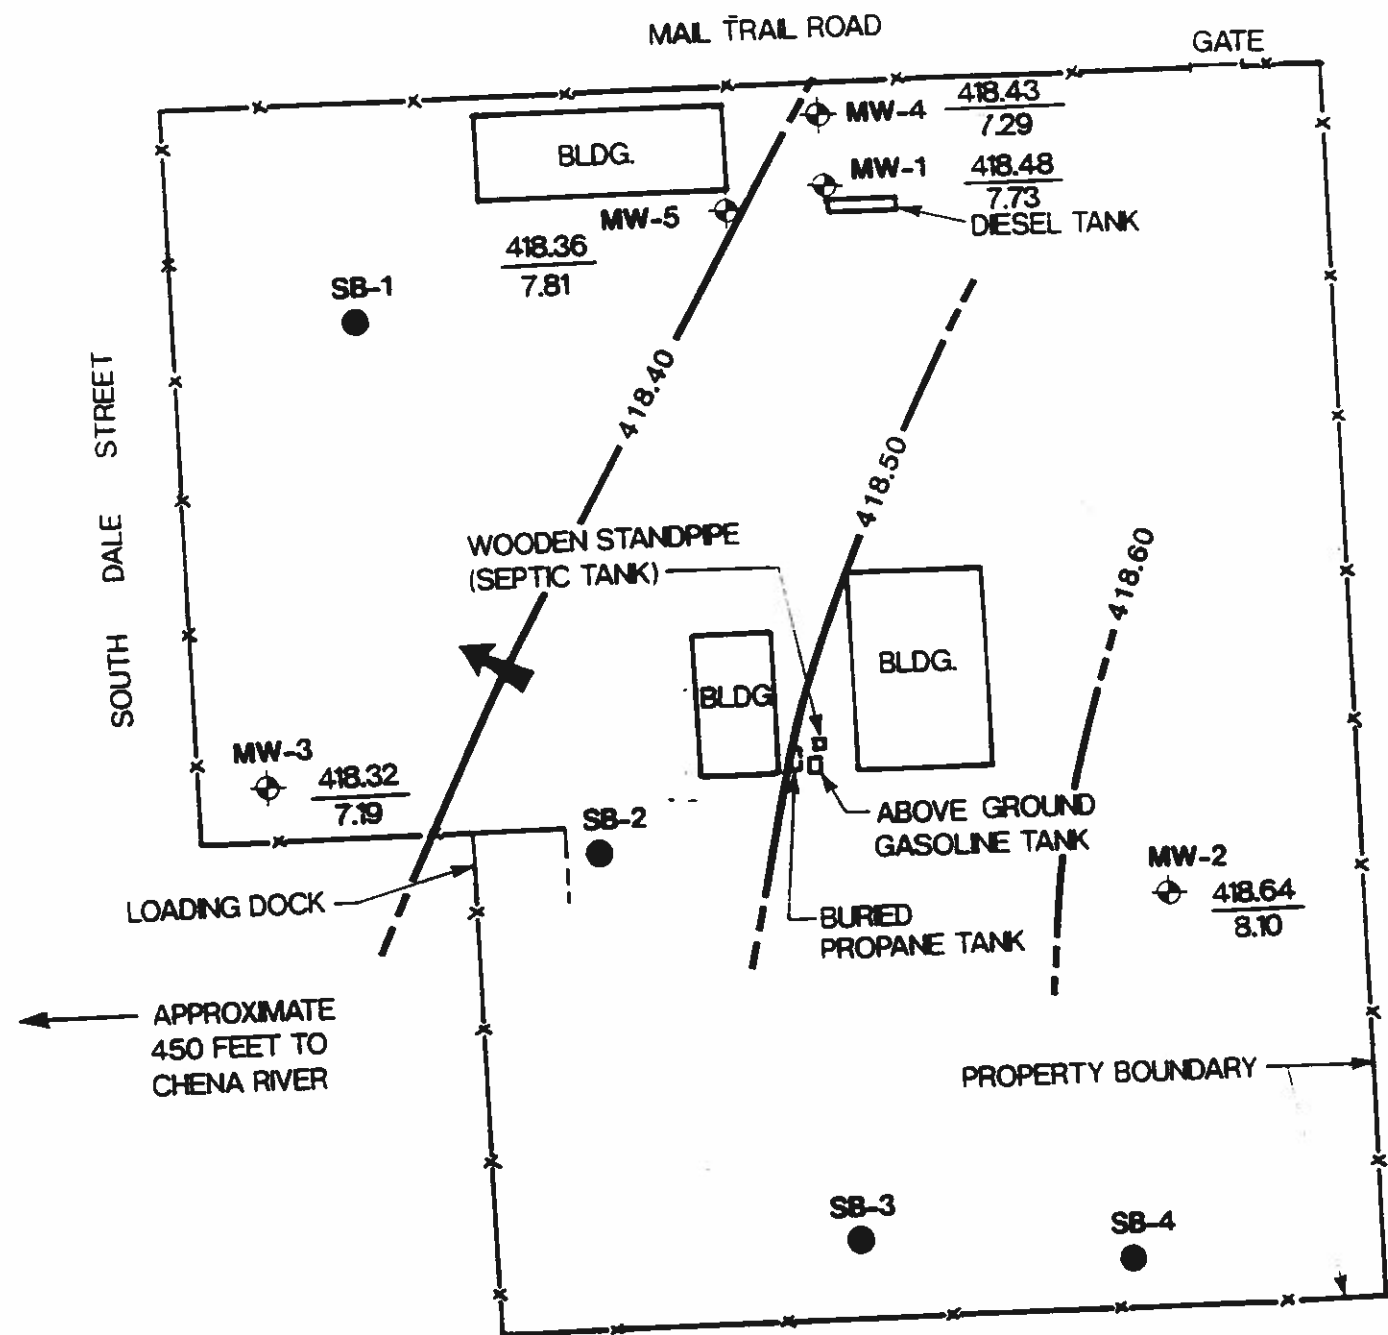
- The general direction of ground water flow beneath the site was west-northwest on September 4, 1991, and depth-to-water measurements ranged from approximately 8 to 9 feet below ground surface on this date.

Water level measurements were converted into ground water elevations using the results of a monitoring well casing elevation survey performed by RCH Surveys of Fairbanks, Alaska. The survey was completed to an accuracy of 0.01 foot relative to Airport Survey Monument Number 263. A maximum ground water elevation difference of 0.32 feet was calculated between wells MW-2 and MW-3 on September 1991, which are approximately 470 feet apart. A hydraulic gradient of 0.0006 foot/foot was calculated using these data. The direction of ground water flow was generally to the west northwest in September 1991. Figure 4 presents a ground water elevation contour map of the water table surface using the September 4, 1991 data. Table 1 presents depth to water and ground elevation data for each monitoring well. Ground water sampling measurements are presented on ANI Water Sample Field Data Sheets in Appendix D.
