Final
2021 Monitoring Well Decommissioning Report
National Guard Federal Scout Readiness Center

Gambell, Alaska

February 2022

Prepared by:
Brice Engineering, LLC
3700 Centerpoint Drive, Suite 8223
Anchorage, Alaska 99503
www.BriceEng.com

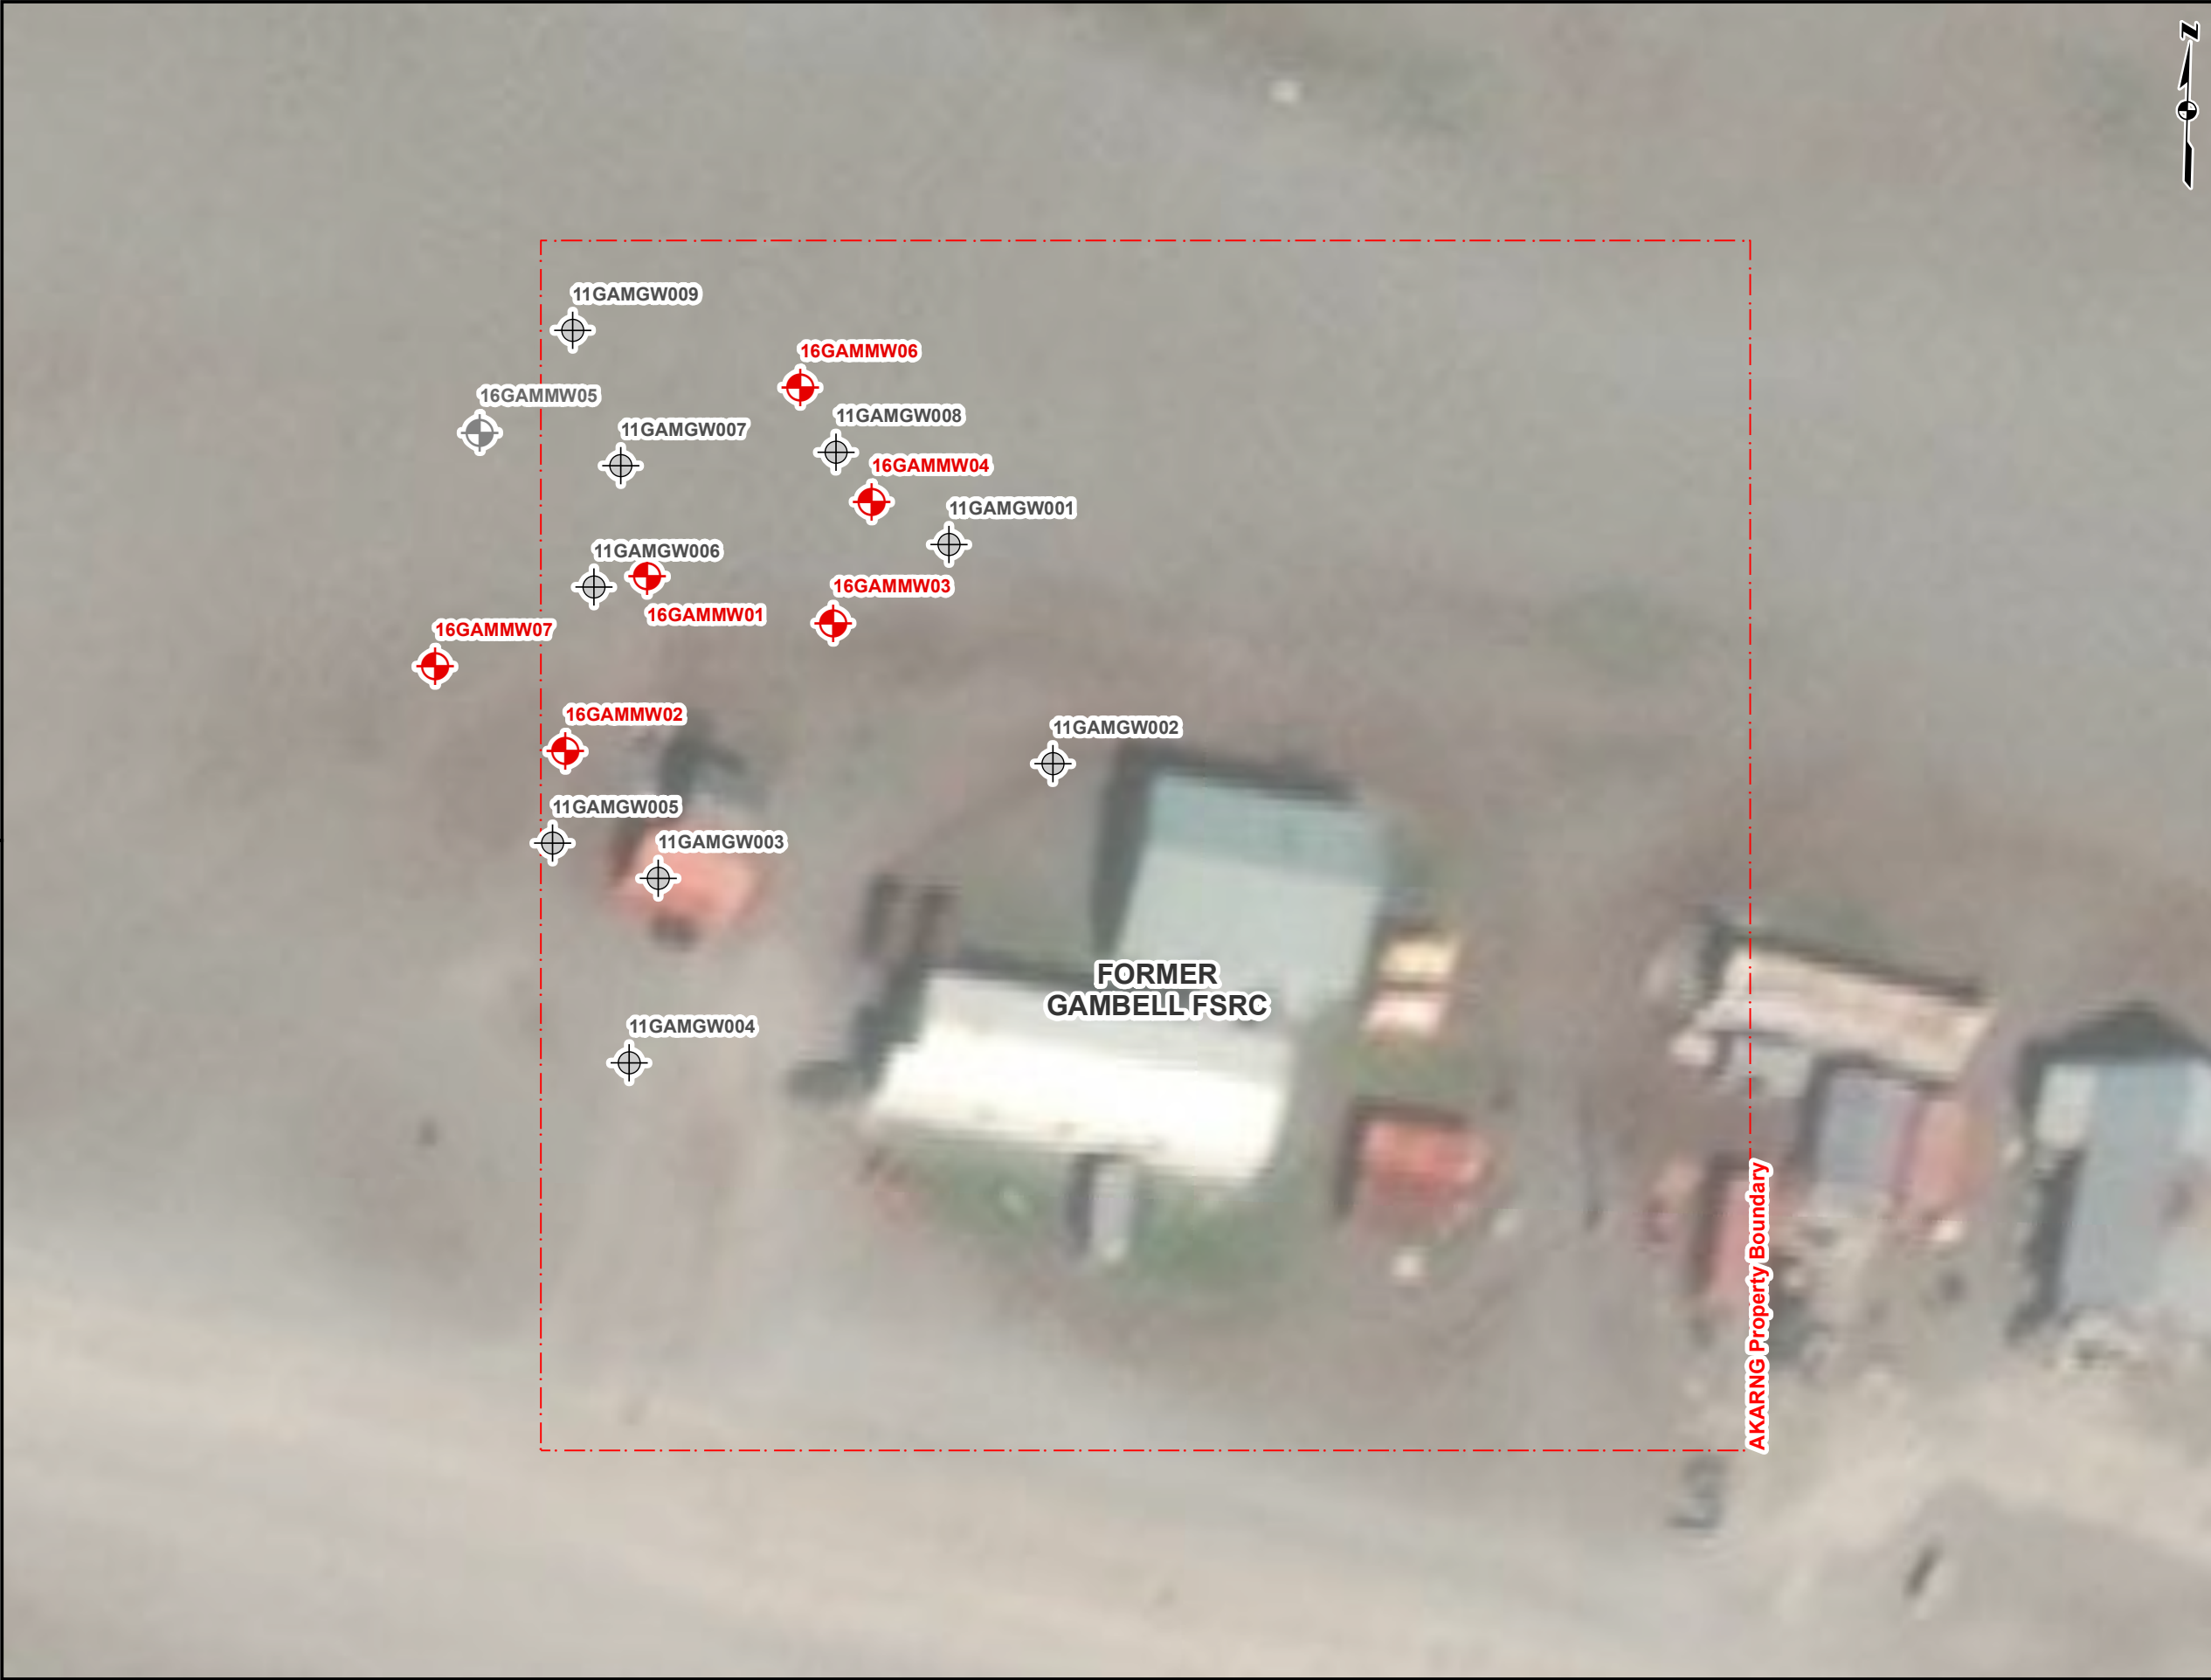
FORMER GAMBELL AKARNG FSRC AND GROUNDWATER MONITORING WELL LOCATIONS

1. Wells not decommissioned in 2021 are presumed to have been removed or damaged to the extent that location would be impractical.

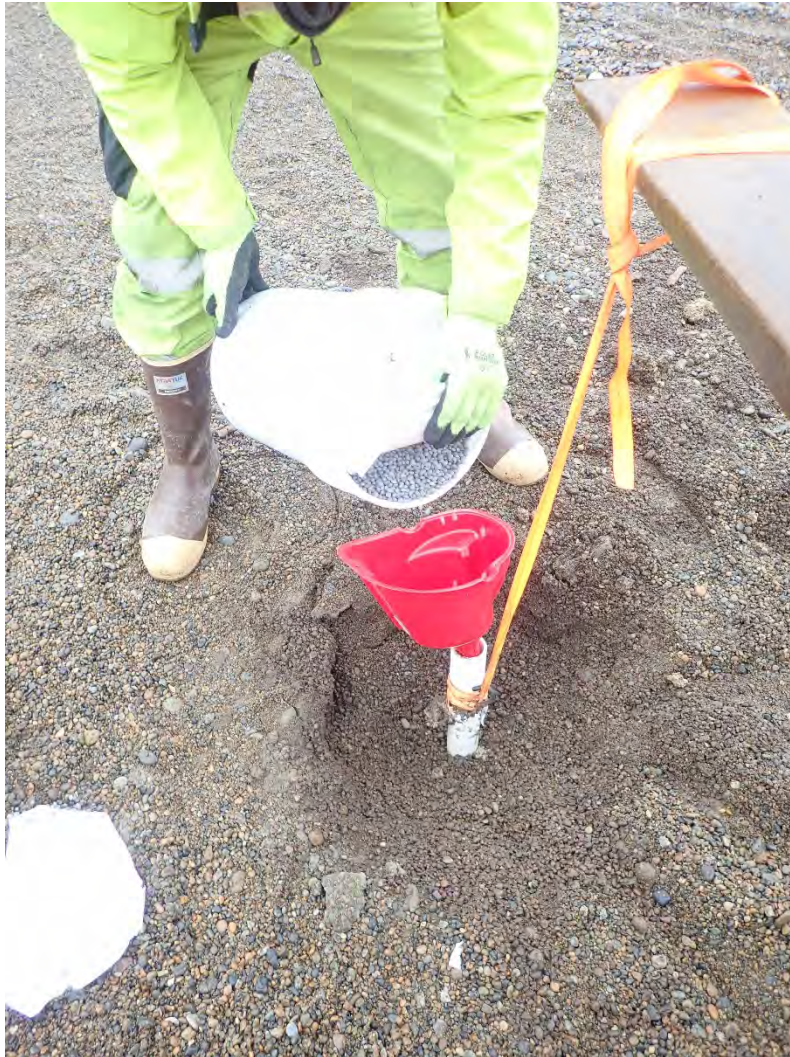
Photograph 1: Well 16GAMMW02 with concrete casing and lid removed. Well PVC strapped to loaded fork blade. JP pouring bentonite pellets into well before removal.

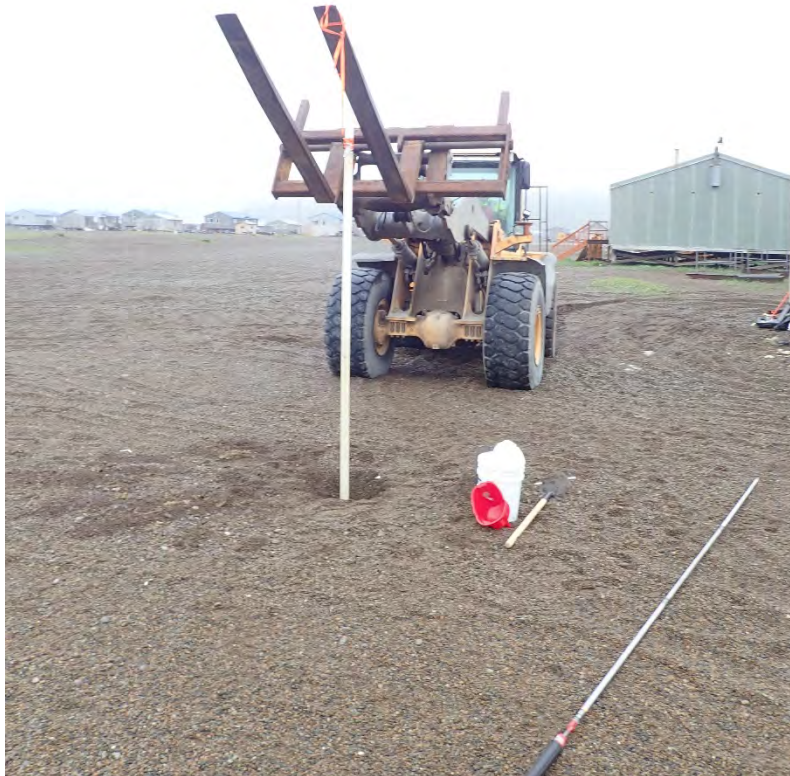
Photograph 2: Well 16GAMMW02 being removed by SM using loader. Well screen has been knocked from bottom of well using slide hammer attachment in bottom right of photo. Well PVC has been filled with bentonite pellets before removing to act as a tremie pipe.

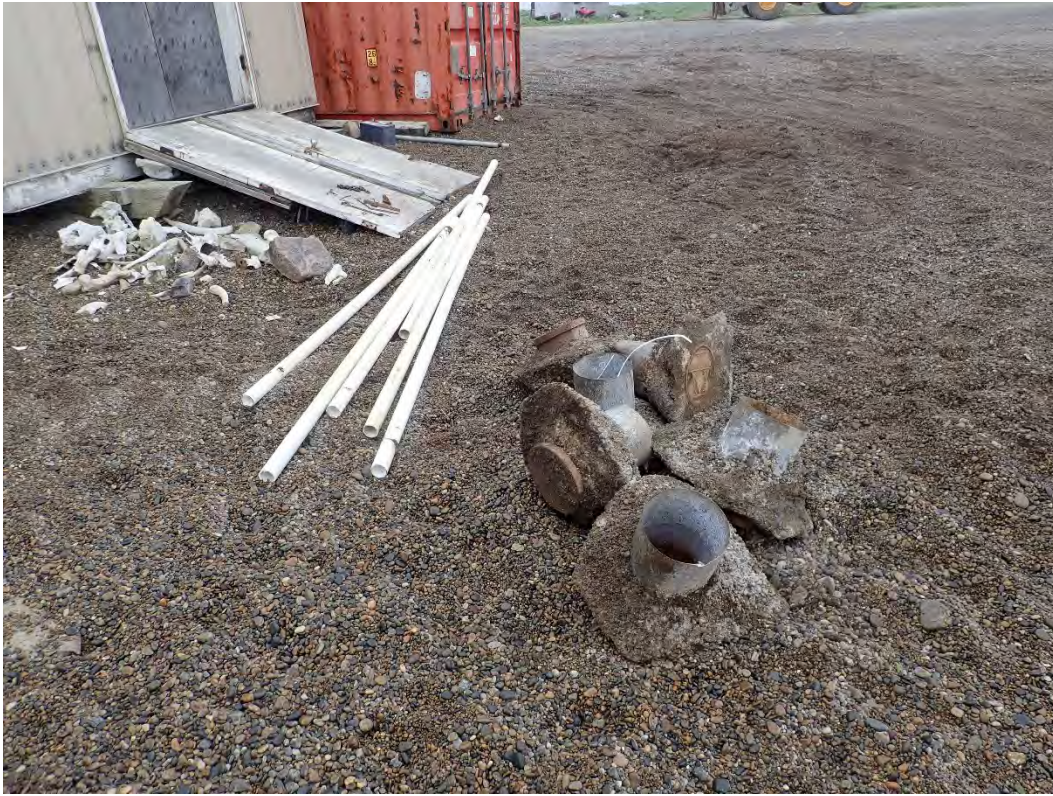
Photograph 3: Six flush mount wells, casings, and lids removed and ready for disposal.

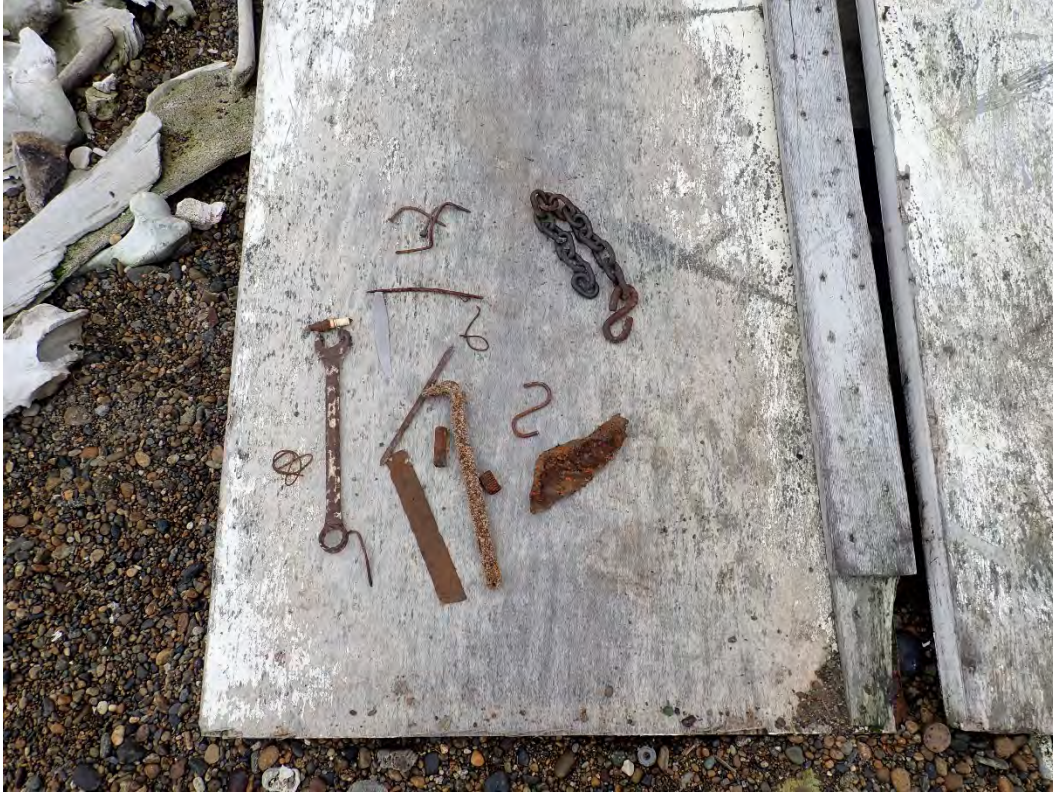
Photograph 4: Miscellaneous metal debris found in the vicinity of the gravel pile while attempting to locate well 16GAMMW05.

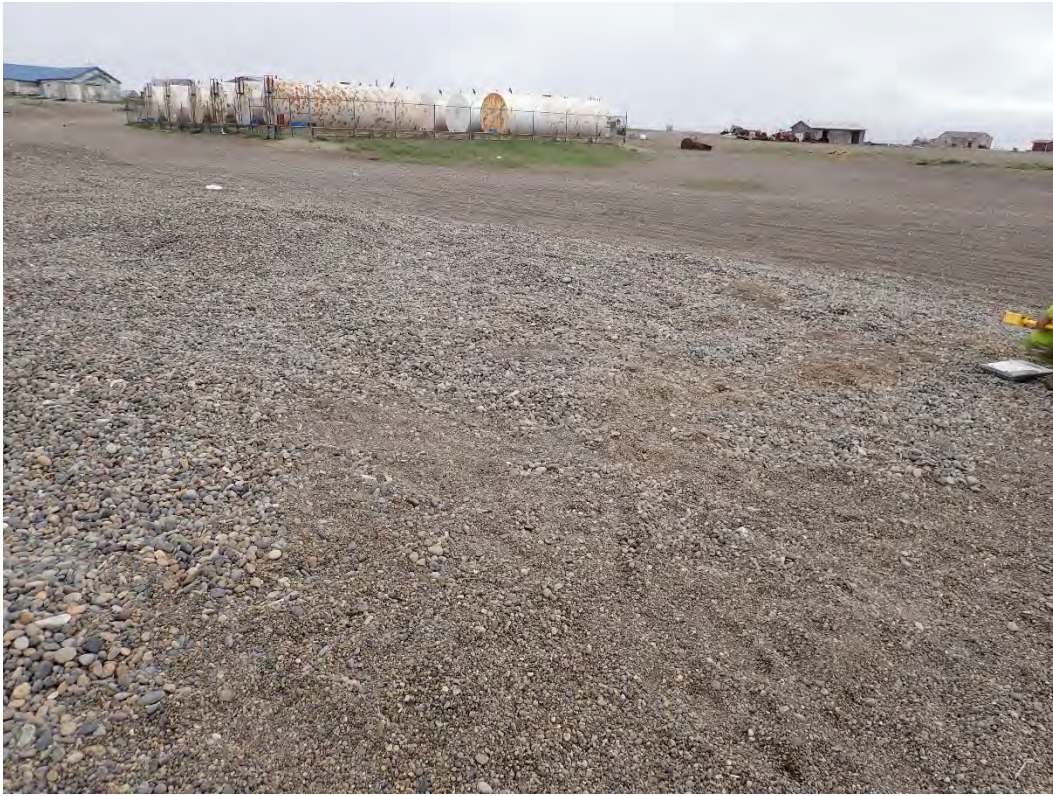
Photograph 5: GPS location of well 16GAMMW05 is within this area of gravel that differs from surrounding gravels. It is evident that there was once a larger gravel pile in this area. Heavy equipment used to move this gravel may have damaged or removed the well.

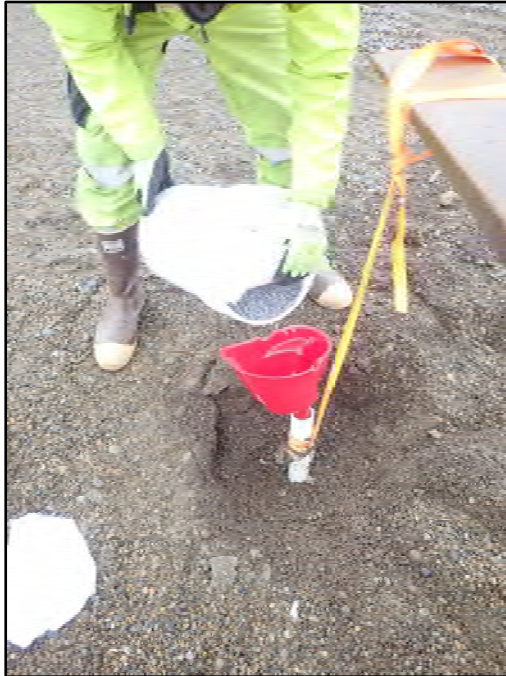
Photograph 1: Well 16GAMMW02 with concrete casing and lid removed. Well PVC strapped to loaded fork blade. JP pouring bentonite pellets into well before removal.

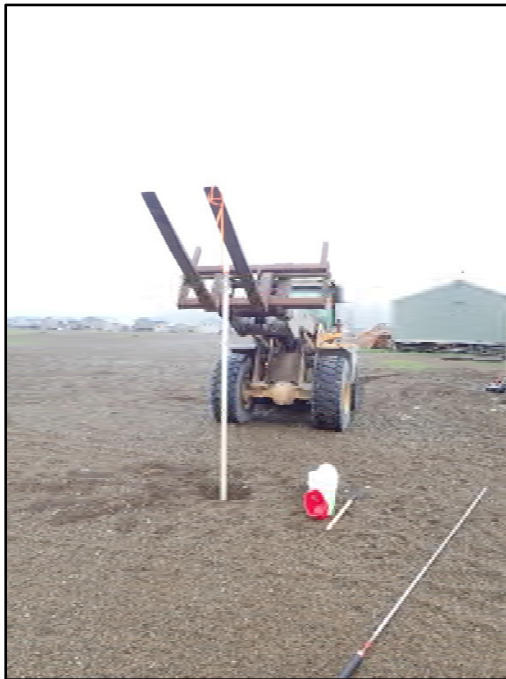
Photograph 2: Well 16GAMMW02 being removed by SM using loader. Well screen has been knocked from bottom of well using slide hammer attachment in bottom right of photo. Well PVC has been filled with bentonite pellets before removing to act as a tremie pipe.

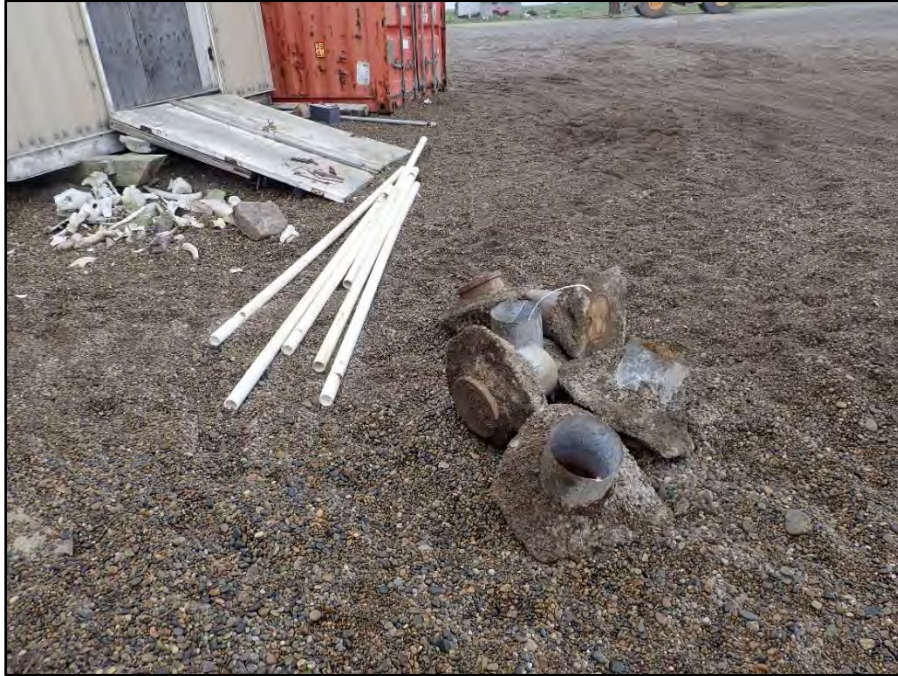
Photograph 3: Six flush mount wells (16GAMMW01, -02, 1-03, -04, -06, -07), casings, and lids removed and ready for disposal.

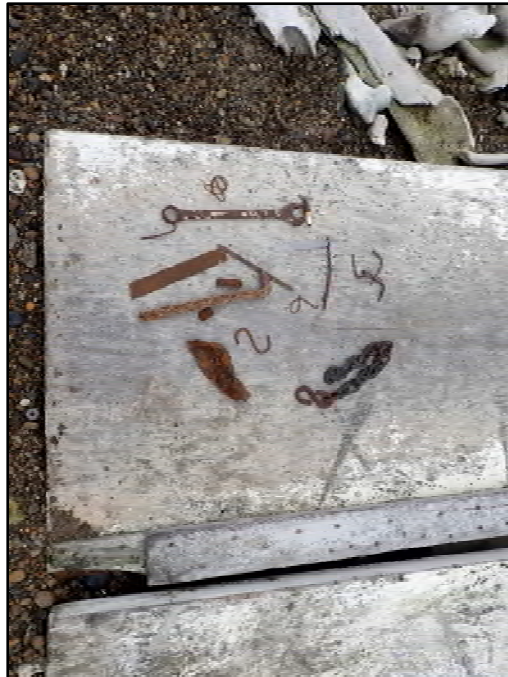
Photograph 4: Miscellaneous metal debris found with the metal detector in the vicinity of the gravel pile while attempting to locate well 16GAMMW05.

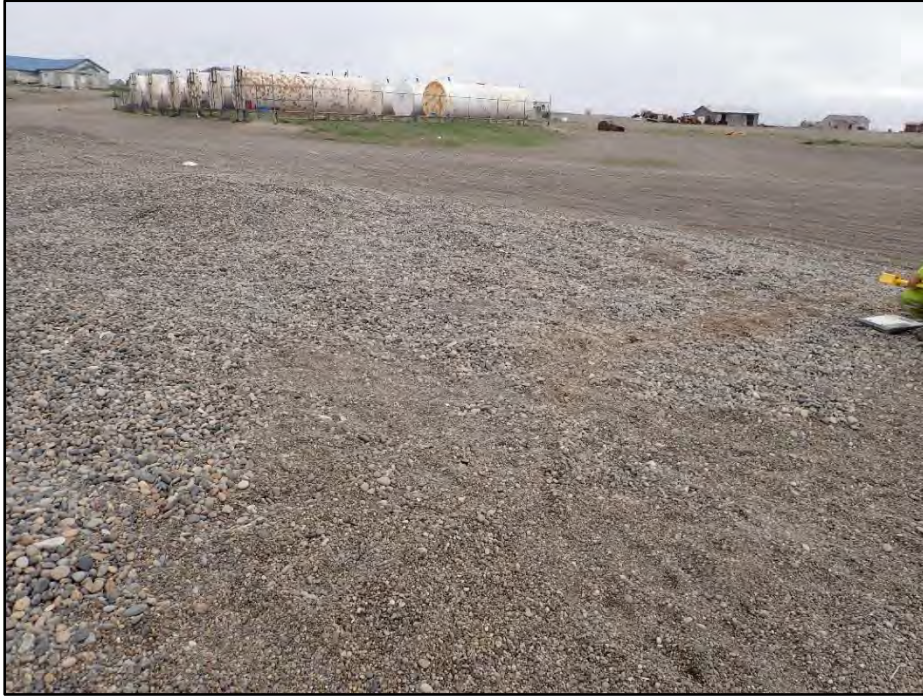
One permanent groundwater monitoring well installed in 2016 (16GAMMW05) could not be located. GPS showed the well location in an area of piled gravel that differed in size from the gravel of the surrounding site. An approximately 80-foot by 80-foot grid was established around the GPS location of the well. Multiple attempts were made to search for the well using a metal detector in east to west and north to south passes. Anomalies indicated by the metal detector were investigated with hand tools and resulted in a collection of small, miscellaneous metal debris unrelated to the monitoring wells. The field crew on site presumed that heavy equipment was used to move gravel in and out of this area and could have damaged the steel overcasing of the well, which may have then been removed. Heavy equipment was not used to further investigate the subsurface in this area, and no evidence of well 16GAMMW05 was found.

Photograph 5: GPS location of well 16GAMMW05 is within this area of gravel that differs from surrounding gravels. It is evident that there was once a larger gravel pile in this area. Heavy equipment used to move this gravel may have damaged or removed the well.
