RESTORATION
SCIENCE & ENGINEERING, LLC

Subject: Bethel Youth Facility UST #1 Monitoring Well Decommissioning Report
ADEC File No. 2407.26.016

Restoration Science & Engineering, LLC (RSE) is providing this letter report documenting monitoring well decommissioning via removal of four (4) groundwater monitoring wells located at the Bethel Youth Facility (BYF) in Bethel, Alaska at 950 State Highway. This site is listed under file 2407.26.016 in the Alaska Department of Environmental Conservation (ADEC) contaminated sites database.

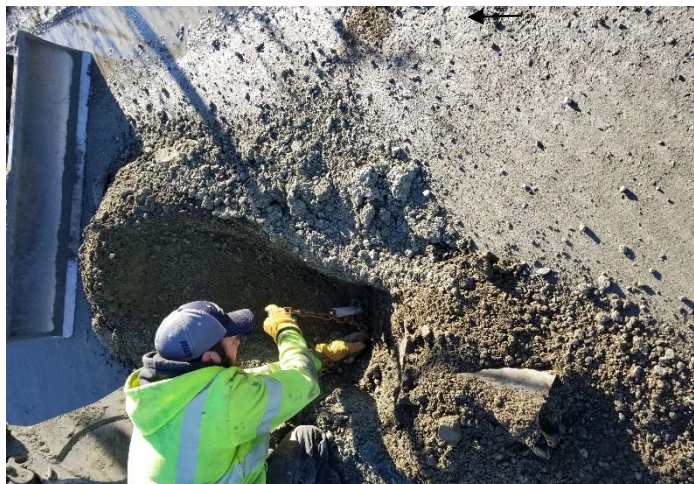
Connecting Bolt to MW-1 Well Casing for Removal

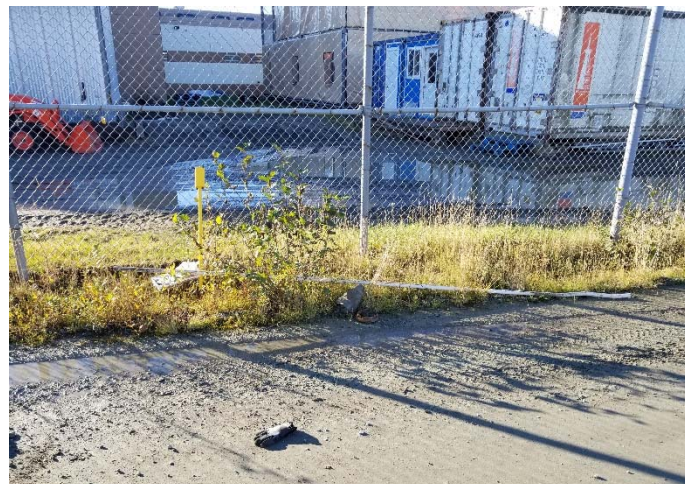
Removed MW-1 Casing

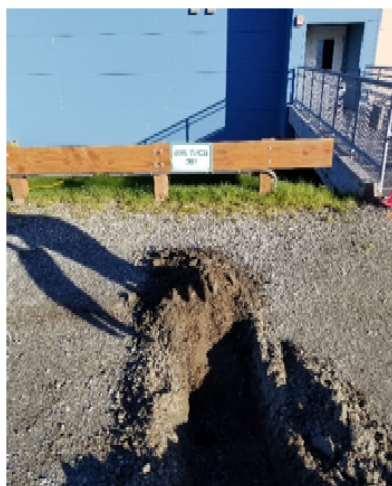
Excavation at MW-3 to Expose Top of Casing

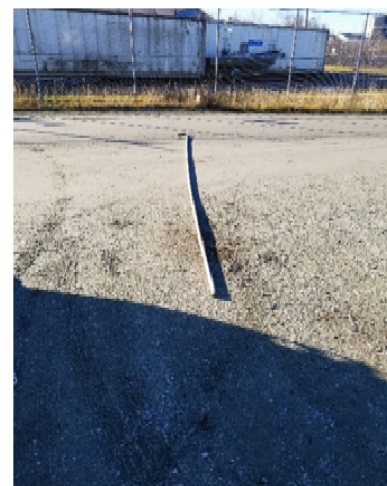
Removed MW-3 Casing

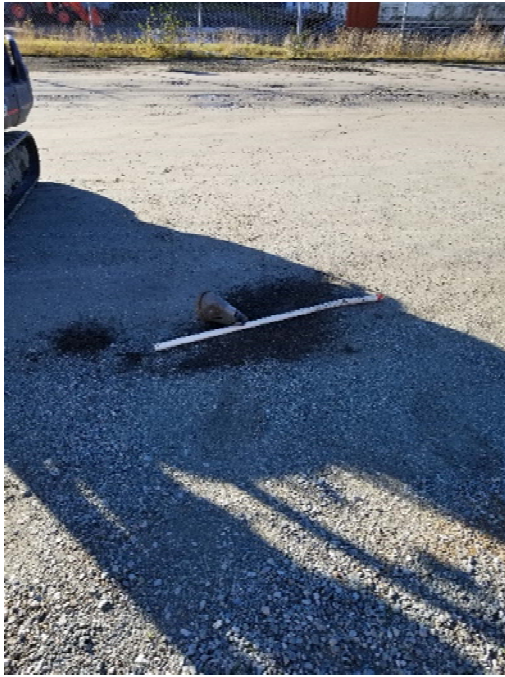
Wells MW-1 and MW-3 were removed intact with the well borehole filled to approximately two feet bgs with bentonite, and sandy gravel from two feet bgs to the ground surface. The PVC well casing from well MW-4 was unable to be removed and broke off approximately 5.5 feet bgs, and the well borehole filled to approximately three feet bgs with bentonite, and sandy gravel from three feet bgs to the ground surface. Well MW-8 was pulled by hand until the bottom of the well casing was approximately four and a half feet below ground surface (bgs) before becoming stuck, at which point, the casing was cut off at grade. The MW-8 well borehole was filled with bentonite grout to approximately three feet bgs, and sandy gravel was used to fill the excavation to just below ground surface at which point the soil and grass plug that had been removed was replaced on top of the hole.

Broken MW-4 Casing

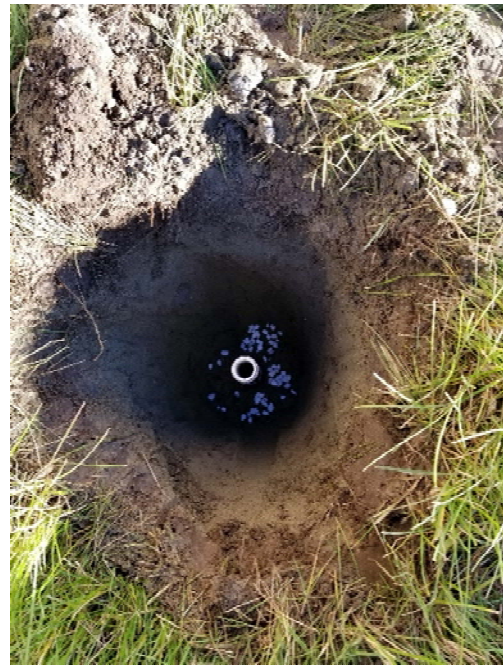
MW-8 Casing

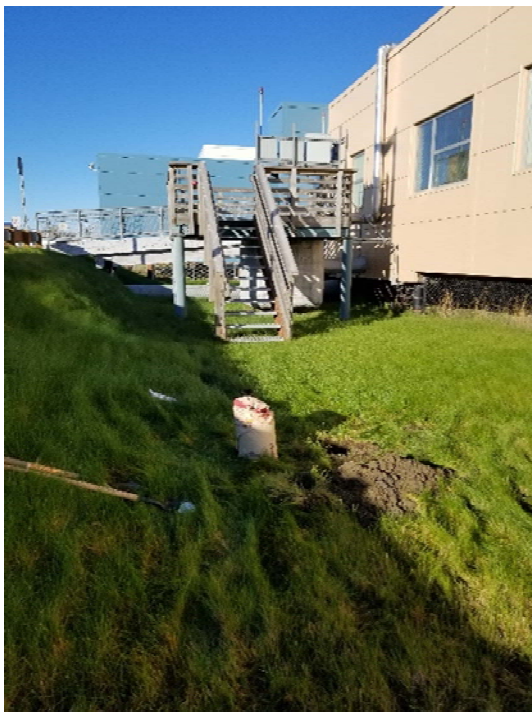
MW-8 Location and Bentonite
