2016 Five-Year Review Report for Sites OT001 and LF002 at Kalakaket Creek Radio Relay Station, Alaska

**United States Air Force
Joint Base Elmendorf-Richardson, Alaska**

April 2016

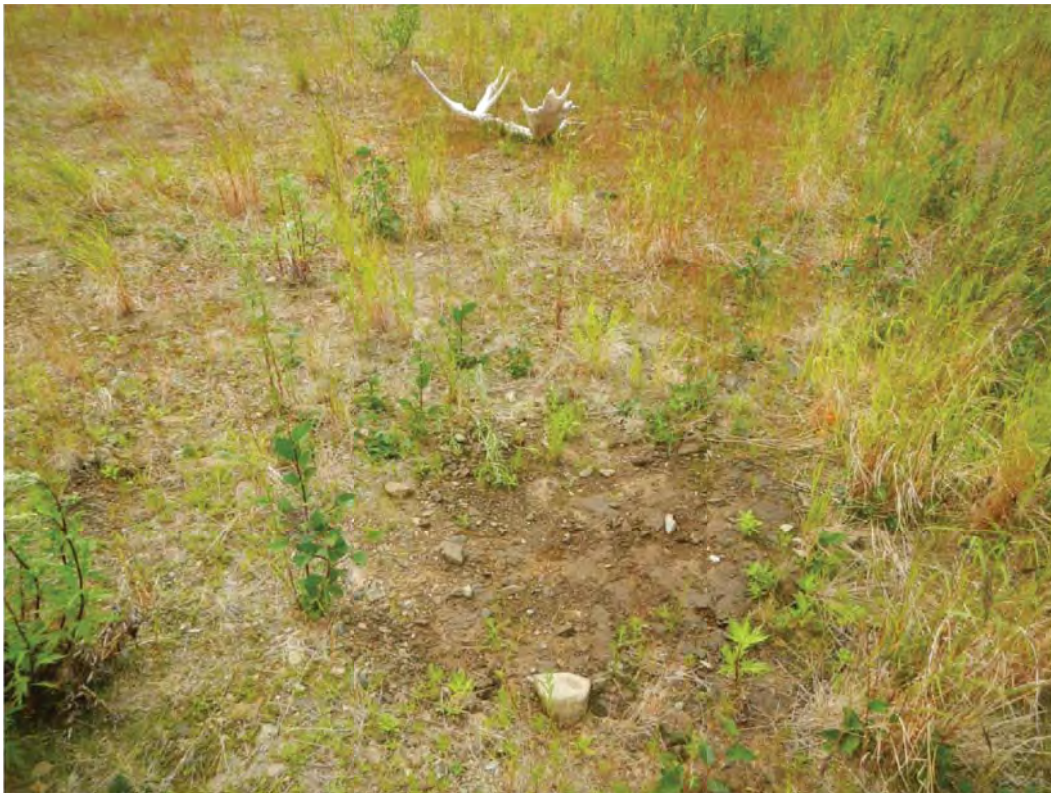
Photo 2: Oil-stained soil at western end of airstrip; view south.

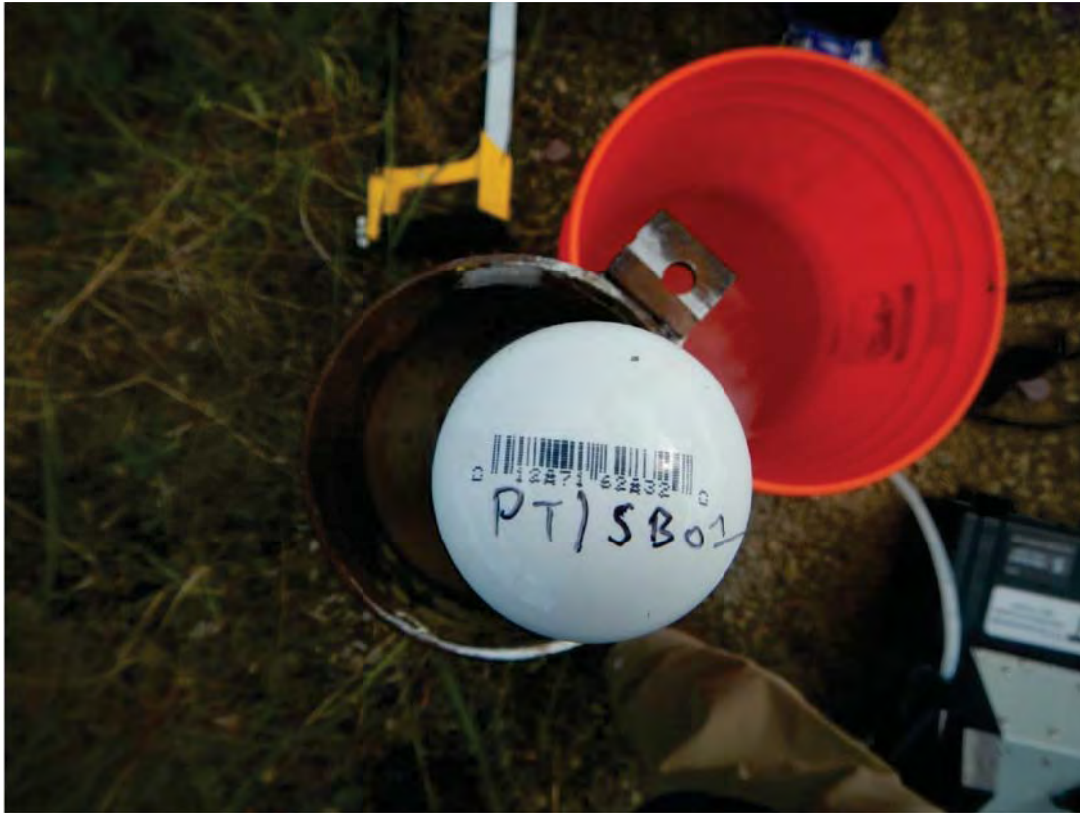
Photo 5: Site OT001, Subarea PT1, well PT1SB01; view of replaced well cap.

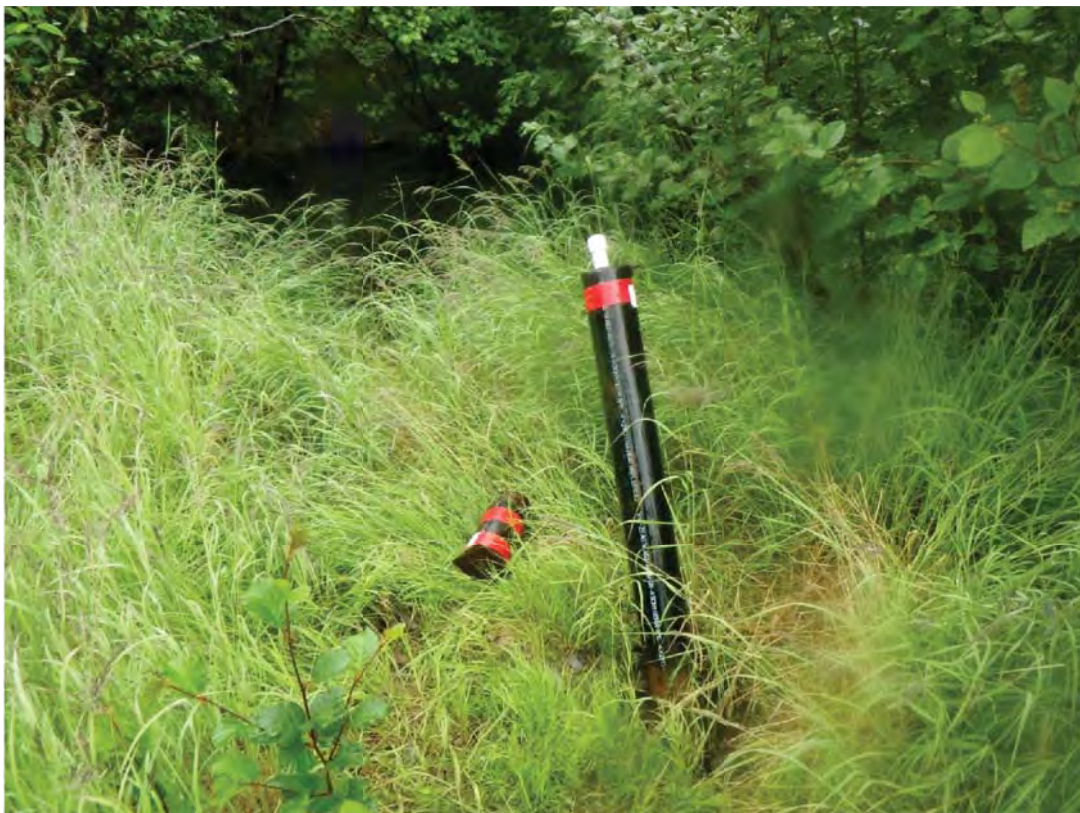
The 2012 and 2013 field inspections noted damage to two Site OT001 monitoring wells: PT1SB04 and PT1SB15 (USAF, 2013; 2014). The wells were reportedly leaning at approximately 45 degree angles from the ground surface due to frost jacking. In July 2014, the protective polyvinyl chloride (PVC) well casings at Wells PT1SB04 and PT1SB15 were removed just below the ground surface and replaced with new, 4-inch inner diameter section A53 American Society for Testing and Materials (ASTM)-rated steel, which is structurally stronger and conditioned for applications under pressure to better withstand frost jacking during winter months (USAF, 2015). Missing well caps from Wells PT1SB01 and PT1SB09 were also replaced to properly secure the wells (USAF, 2015).

Photo 6: Site OT001, Subarea PT1, well PT1SB04; view of pre-repair condition.

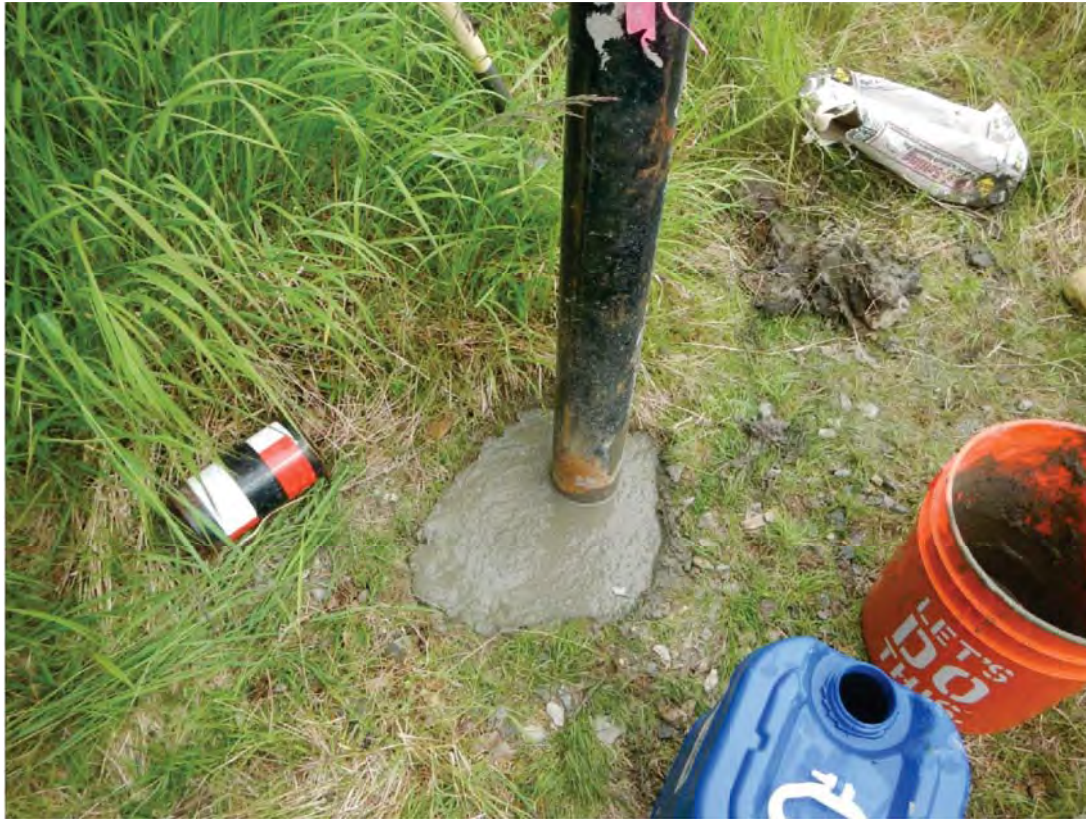
Photo 7: Site OT001, Subarea PT1, well PT1SB04; view of 2014 repaired condition.

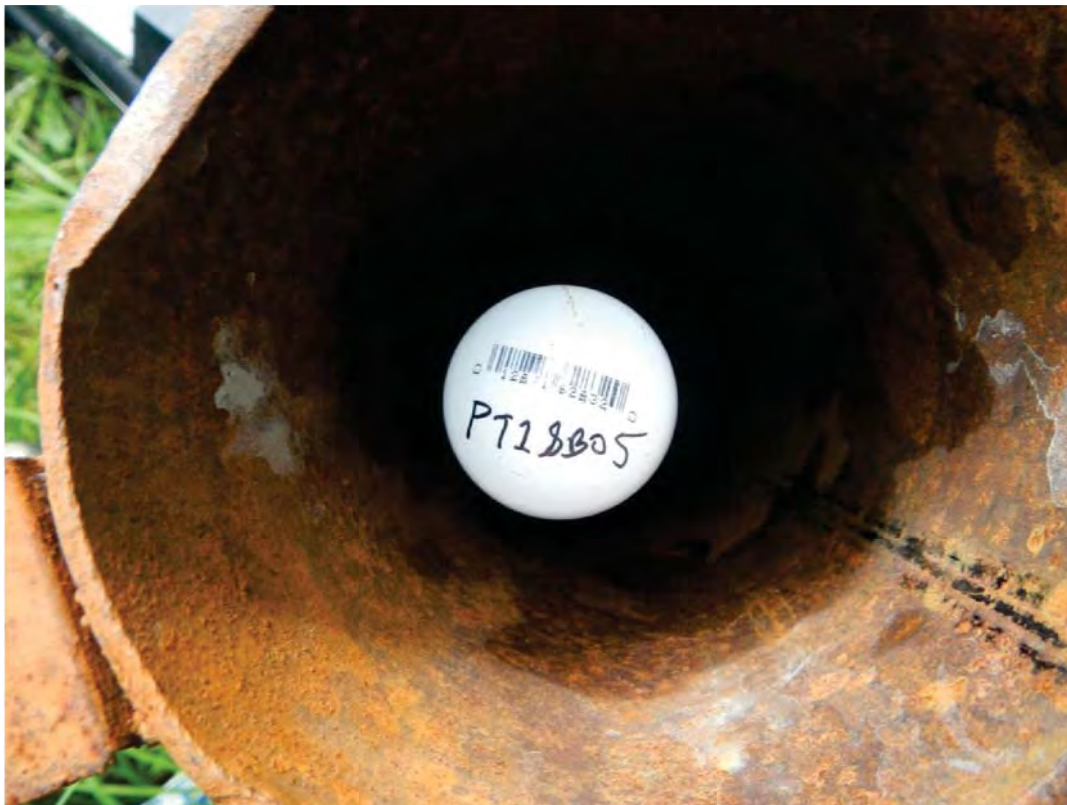
Photo 8: Site OT001, Subarea PT1, well PT1SB05; view of replaced well cap.

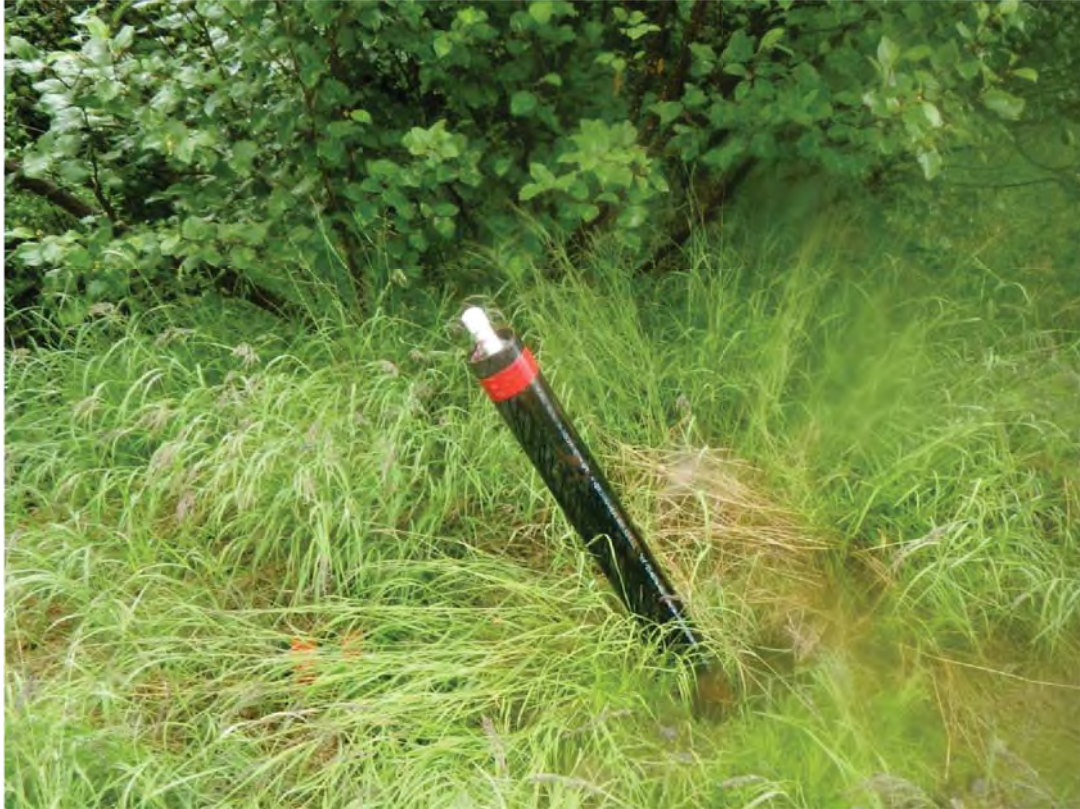
Photo 9: Site OT001, Subarea PT1, well PT1SB15; view of pre-repair condition.

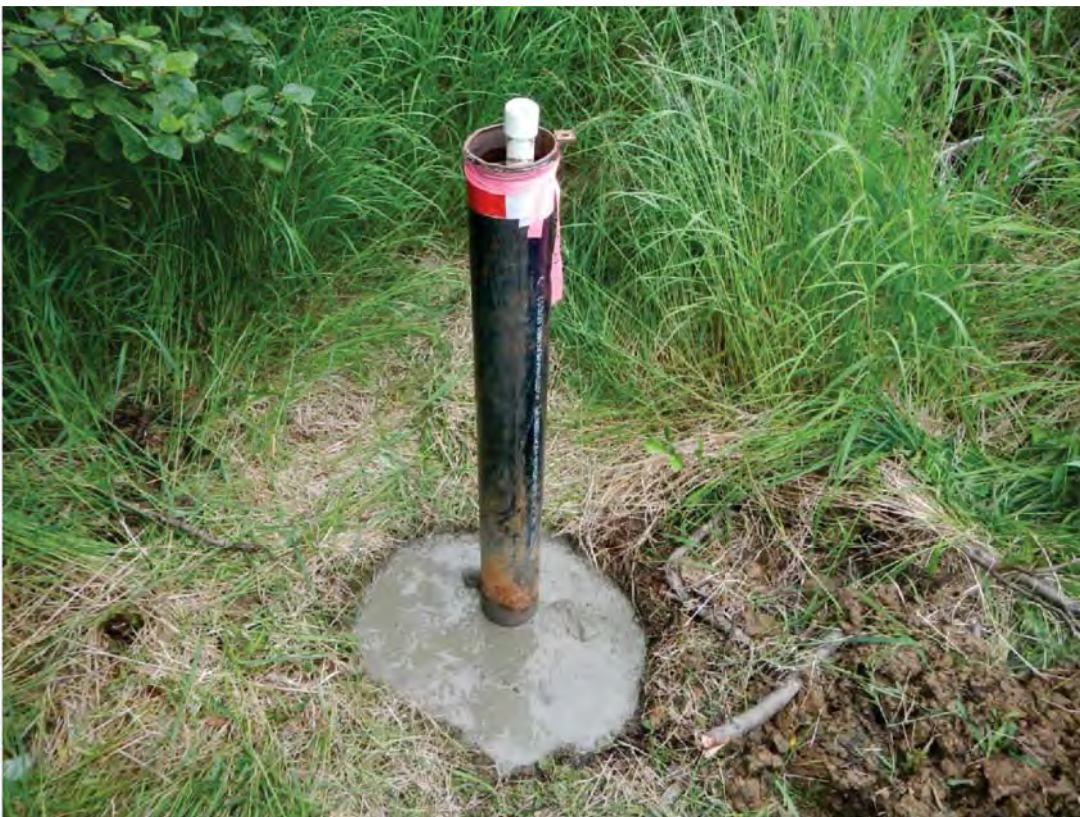
Photo 10: Site OT001, Subarea PT1, well PT1SB15; view of 2014 repaired condition.
