Subject: House of Harley Monitoring Well Decommissioning Report, 4334 Spenard Road, Anchorage, AK 99517 - ADEC File # 2100.38.425.  
RSE Project Number: 21-2339

Restoration Science & Engineering, LLC (RSE), on behalf of Ourtrust LLC, is providing this Monitoring well decommissioning report, detailing removal of six groundwater monitoring wells MW-1, MW-2, MW-3, MW-4, MW-5 and MW-6 on April 28, 2022.

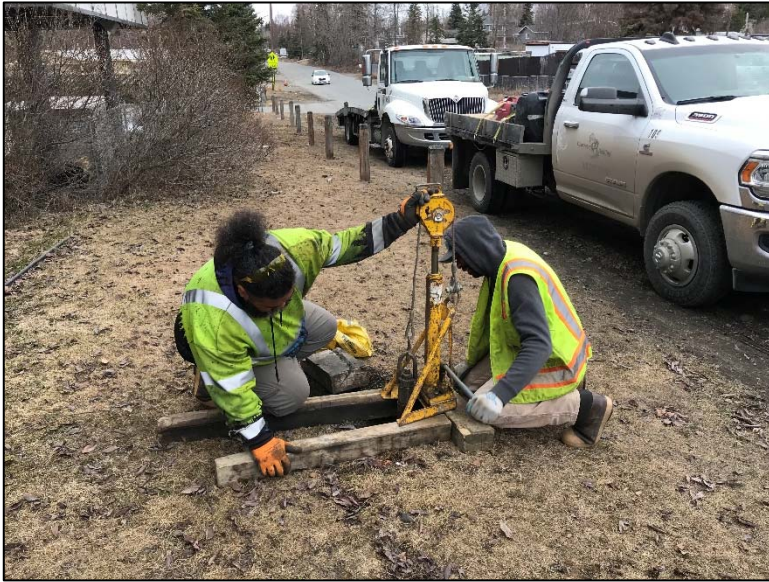
MW-6, view is north

On April 28, 2022, RSE Qualified Environmental Professional (QEP) Kyle Wiseman mobilized to the site with Discovery Drilling, Inc. (Discovery) personnel and successfully decommissioned six groundwater monitoring wells. Both MW-5 and MW-6 were fully removed including the screened sections. The PVC casing of MW-1 broke approximately eight feet below grade during removal and was successfully decommissioned. MW-2, a metal micro well, could not be removed and was successfully decommissioned in place with bentonite and capped with cold patch asphalt. The top of the PVC casing on MW-4 was cracked and broken which prevented Discovery from

0928 - WELL MW-6 REMOVED

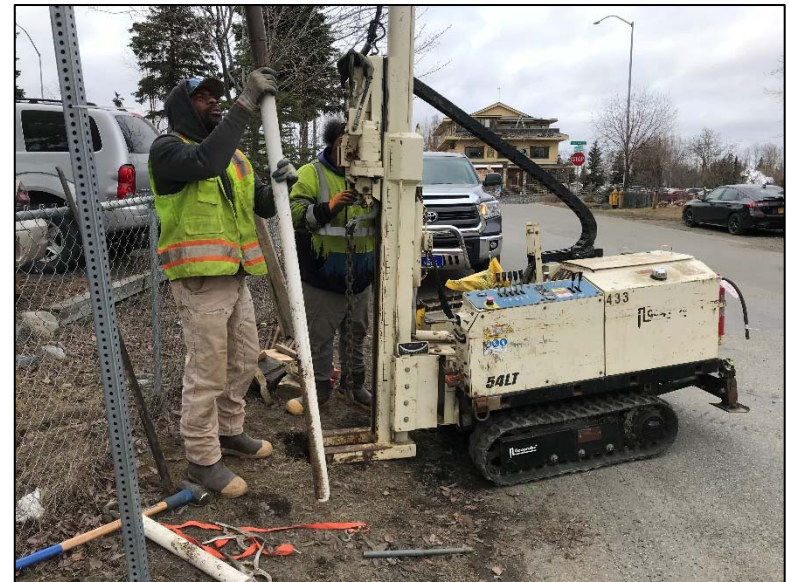
MW-1, view is south

Pole ON PVC PVC BROKEN, RECOVER 8' FILL WITH BENTONITE.

1005 - MW-1 REMOVED.

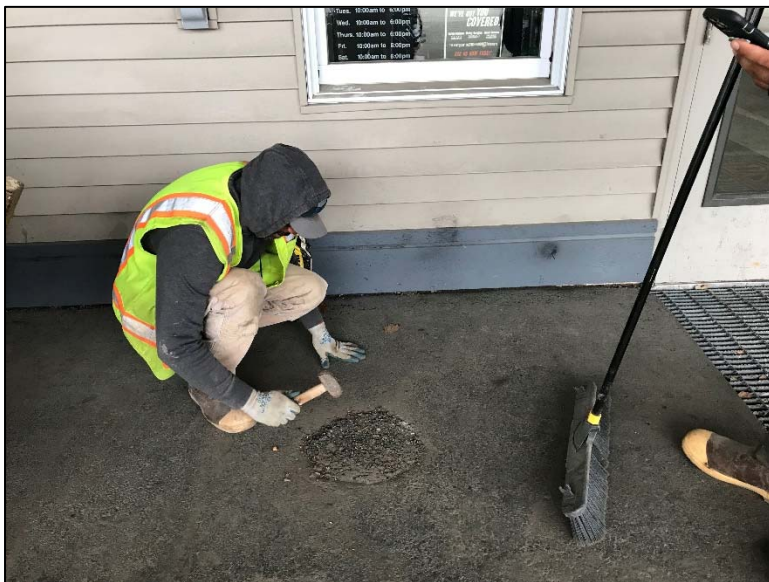
MW-2, view is south

1015 - BEGIN REMOVING MW-2, TOP OF WELL METAL TACKED ON

BLOCK DURING ATTEMPTED REMOVAL, UNABLE TO GRAB PIPE, INSTEAD

OF BUSTING UP ASPHALT TO REMOVE FLUSH MOUNT CASING

AND DIGGING BY DOOR TO ATTEMPT TO PULL, ~~ET~~ FILL

WITH BENTONITE ~~AND~~ AND COLD PATCH, P+A IN PLACE.

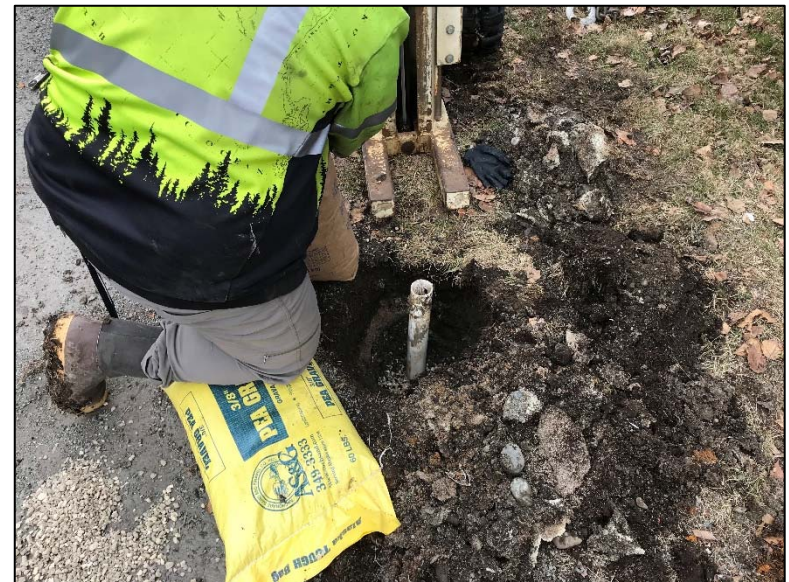
MW-4, view is close up

PVC removal by standard means. RSE and Discovery hand dug down around the well to improve PVC retention, nevertheless RSE recovered three feet PVC before the well was decommissioned in place. MW-3 was observed to have frost-jacked down approximately 18 inches below the access point. Ice and frozen soil observed around the outside of the PVC prevented Discovery from removing the PVC. MW-3 was closed in place with bentonite.

1046 - AT MW-4, PVC CRAWLED AT TOP, DIG OUT SOME, ONE

FOOT RECOVERED, NEED TOOLS TO REMOVE FURTHER, PACE +

1225 - RETURN TO MW-4, DIG OUT MORE, CUT PVC, UNABLE TO PULL,

DIG OUT DRILL THROUGH SIDE AND FROM WITH BELT

PULL w/ RIG, HEAR LOUD POP, TREMI BENTONITE, PULL UP 2'

(3' TOTAL) FILL WITH BENTONITE, REPLACE DIRT, CAP WITH
