EXPLOSION AND FIRE - PLANT 10
SWANSON RIVER FIELD - ALASKA

EXPLOSION AND FIRE -- PLANT 10
SWANSON RIVER, ALASKA

ABSTRACT

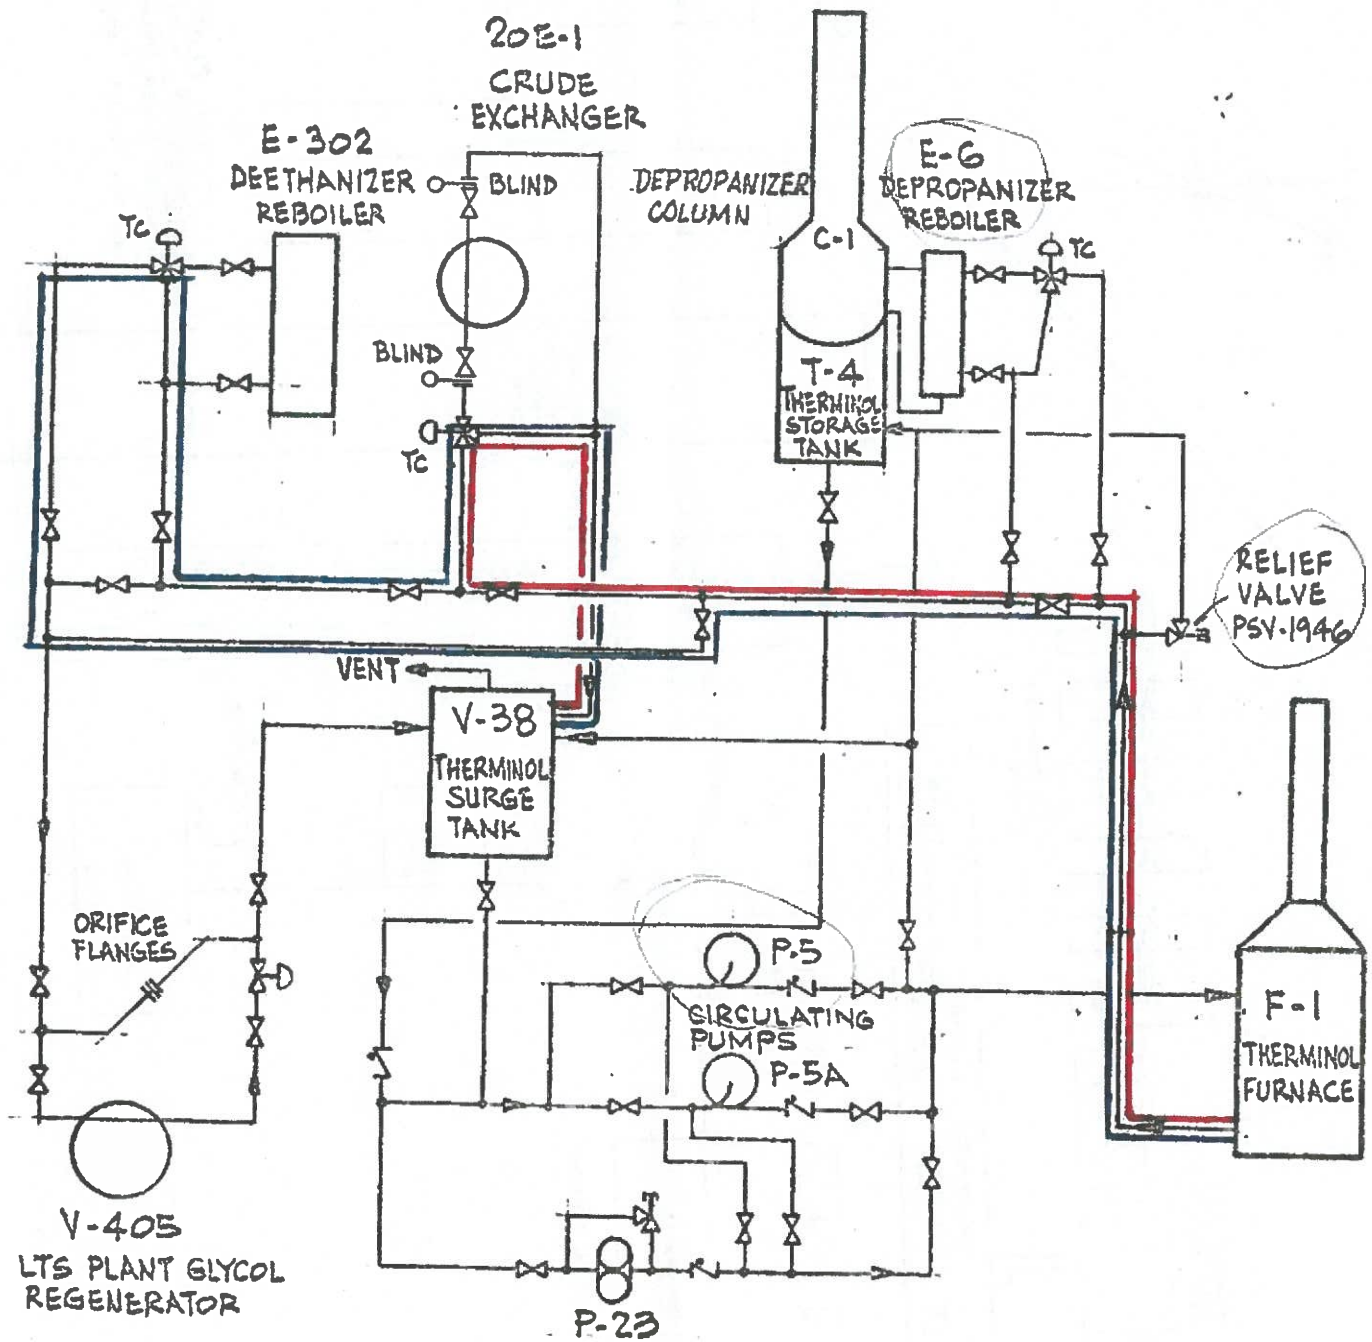
FLOW DIAGRAM OF THERMINOL (AROCOR) SYSTEM
 SKETCH #1
 SWANSON RIVER FIELD ALASKA

- a. The Therminol header was open for circulating through part of the header system and was being pressured by a centrifugal Therminol pump, P-5, (red line on Sketch 1).
- b. E-6 depropanizer reboiler was closed to circulation, but open to pressure - only the inlet valve was closed.
- c. E-302 deethanizer reboiler was also blocked off.
- d. 20.E-1 crude oil heater was isolated from the heating fluid system by blinds.
- e. V-405 Glycol Regenerator at the LTS skid was closed.

Even though both gaskets may have been "weakened," the fact remains that they were holding prior to the failure in the economizer section of the Therminol furnace. Thus it is concluded that the spiral wound gasket was subjected to abnormal pressure just before it was blown from its seat. A review of Sketch 1 (blue line) shows that under normal circulating conditions any pressure build-up in E-6 should be dissipated into the surge tank unless there was a plug in this line near the deethanizer skid. If such a plug existed, relief valve PSV-1946 (set for 130 psig) should have relieved high pressure back to the Therminol storage tank. However, after the fire PSV-1946 was plugged - It would not open when tested at 300 psig.

From the above facts, it is concluded that liquid hydrocarbon, probably propane and butanes+, leaked into the shell side of E-6 reboiler from C-1 depropanizing column while the Therminol system was down for furnace tube repairs. After the furnace repairs were complete, sections of the Therminol system were pressured to establish flow. At approximately 11:00 PM, January 25, 1972, the system was closed up and efforts were being made to return it to service. Circulation had been established in a section of the line from Building A to the furnace. At approximately 11:15 PM, January 25, 1972, circulation was set for the Therminol main header from the furnace to the deethanizer column and return. The Therminol in the lines between the Furnace and Building A was about 400°F. When the valves were set to circulate past the deethanizer column, a plug occurred in the Therminol line somewhere near the deethanizer, thus effectively "closing in" the Therminol system between P-5 pump (check valve), the plugged line and the plugged PSV-1946 (see Sketch 1).

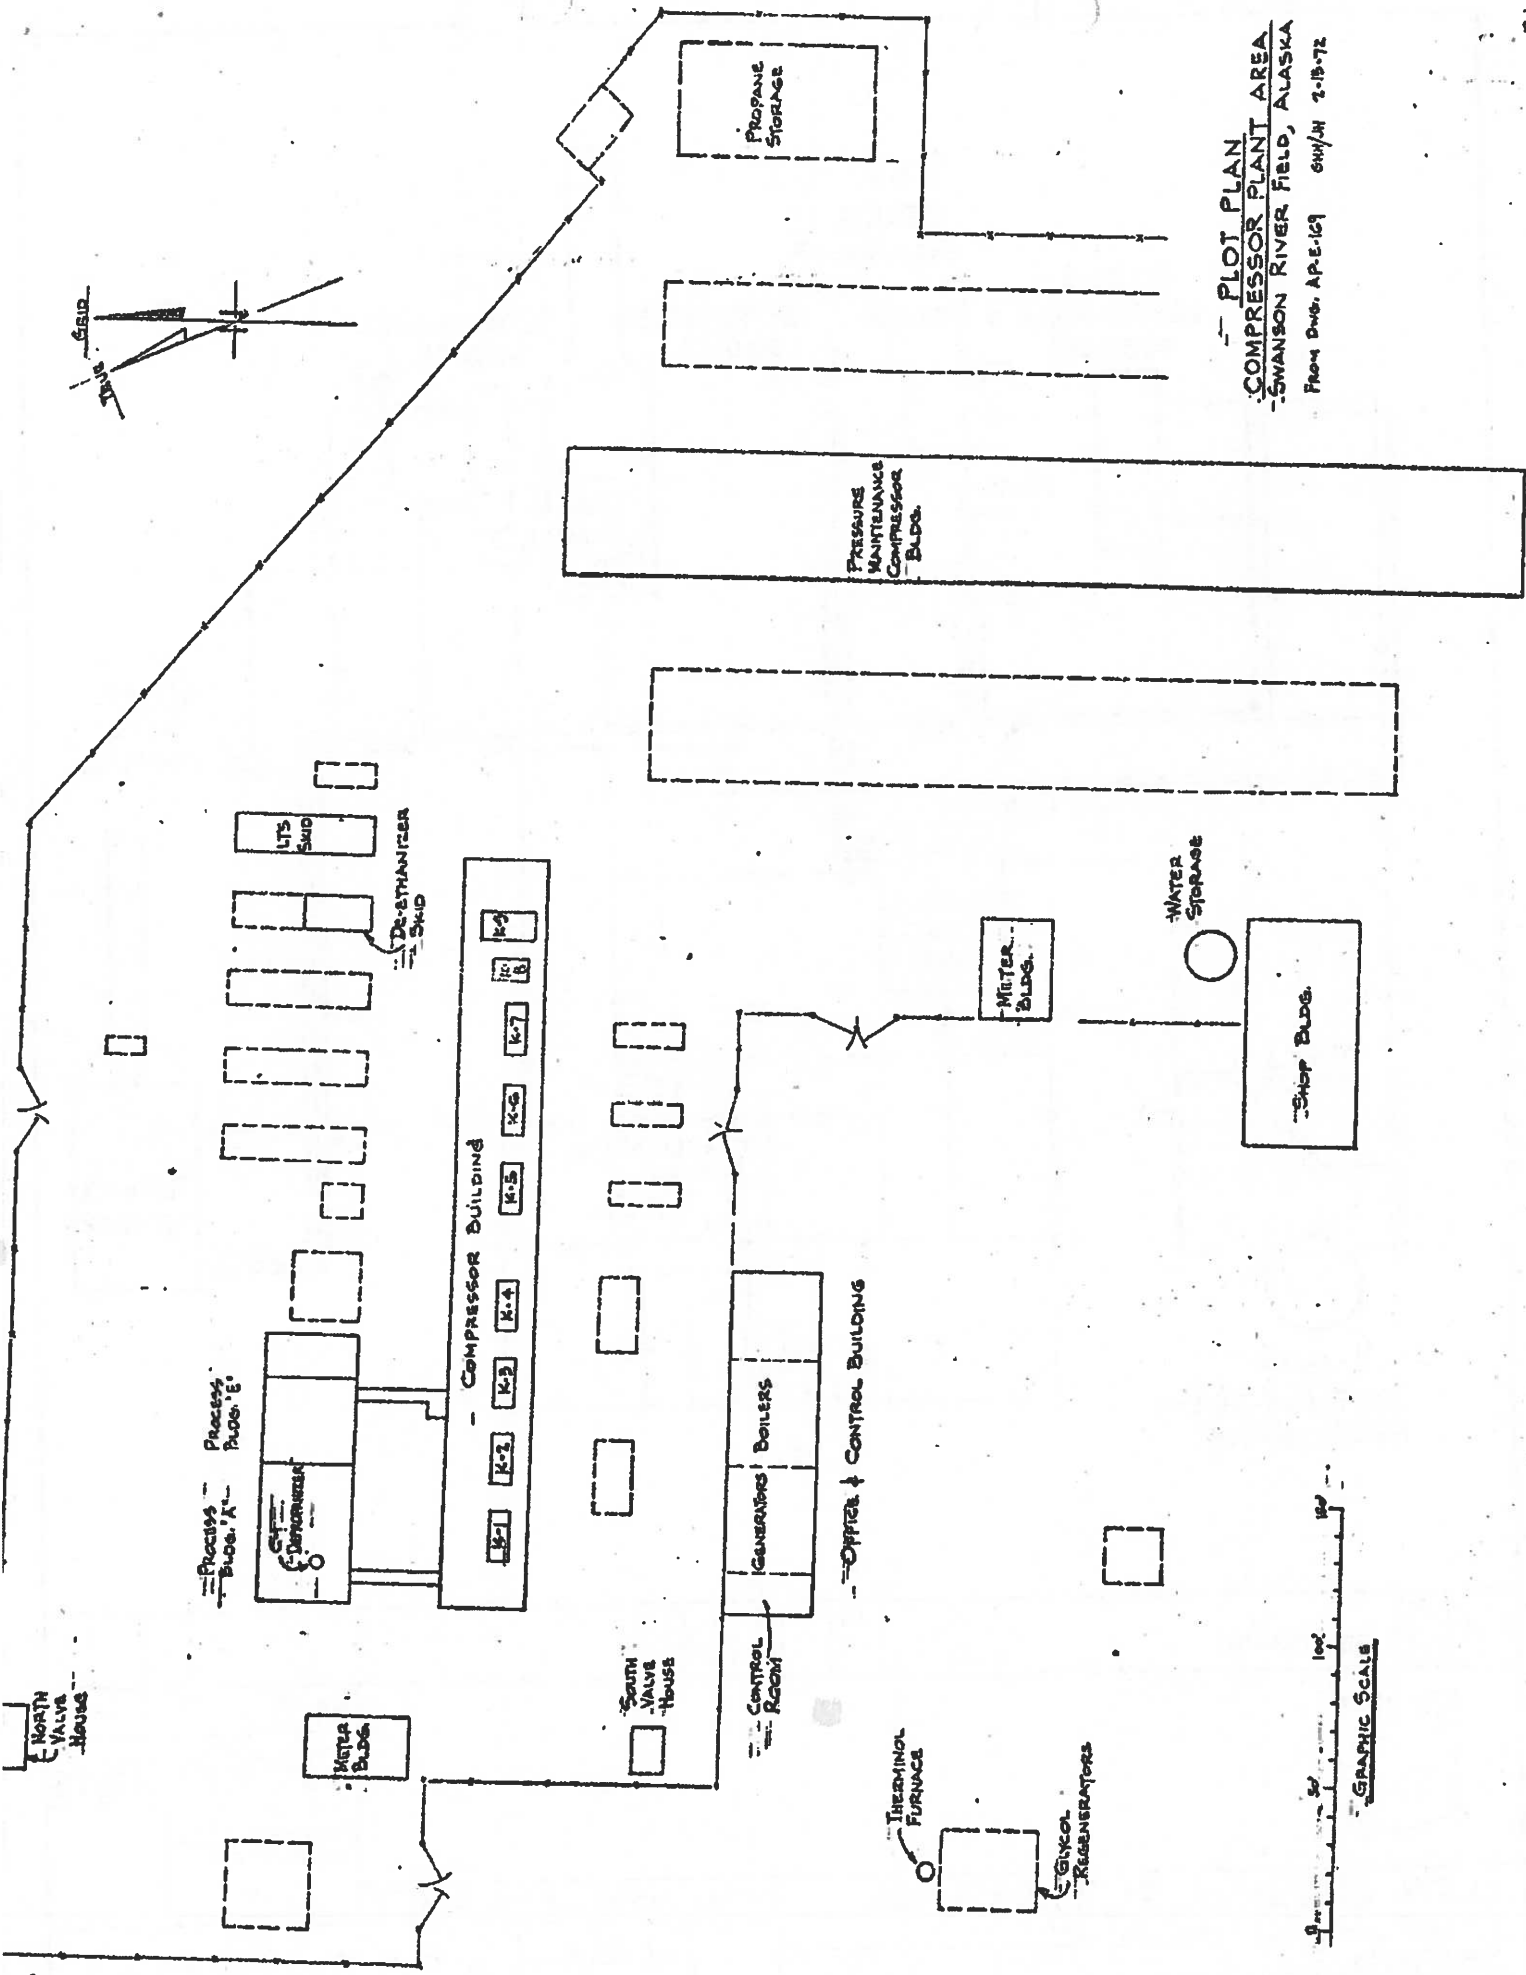
-- PLOT PLAN
 -- COMPRESSOR PLANT AREA
 -- SWANSON RIVER FIELD, ALASKA
 FROM DWG. A.P.E.109 6/11/72

On January 26, 1972 at 1:30 AM, there was an explosion in Swanson River Plant 10 Compressor Building, followed by fire in the Process Building. The explosion resulted in major damage in the Compressor, Process, Office and Control, and Meter Buildings. (See the attached Plot Plan.) Moderate to minor damage occurred at the LTS and deethanizer skids. Damage to the Pressure Maintenance Building, Shop Building, and other outlying buildings was confined to broken windows, doors, light fixtures, and distortion of exterior metal sheeting. The only significant fire in the Process area caused no major structural damage to major pieces of equipment or pipelines. Fortunately, the two operators on duty received only minor scratches and bruises.

The Therminol furnace is located approximately 300 feet from the circulation pump and about 540 feet of circulation line is required to reach the deethanizer reboiler at the end of the main circulation header -- making a total line length of approximately 1100 feet. (See Plot Plan.) Two centrifugal pumps (supplemented by a small positive displacement gear pump) are normally used for circulation. The Therminol system is protected against over pressuring by a surge tank vented to the atmosphere, a pressure relief valve, and a relief valve bypass around the positive displacement pump.
