## Phase I Environmental Site Assessment

Matanuska Townsite, Lot 15, Block 4, East Matanuska Spur Road,  
Matanuska-Susitna Borough, Alaska.

**March 2009**

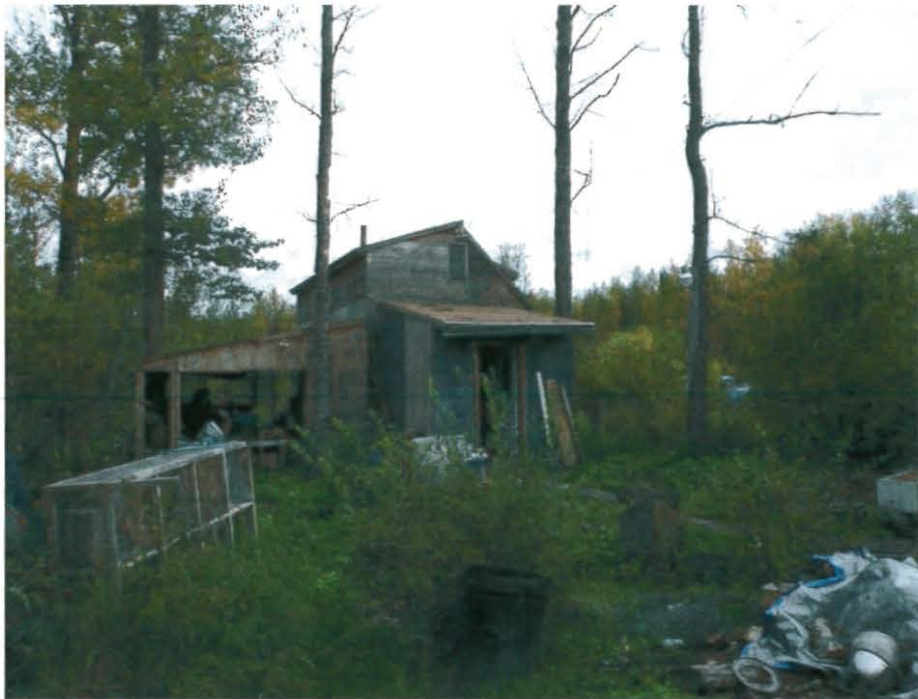
The subject property features a small plywood bungalow with a shed containing possessions of Ms. Poirier. (Photos 1-4) The remainder of the property includes scattered debris. (Photos 5-12) No hazardous substances or poorly contained fluids were encountered on the subject property. Material on the subject property is considered solid waste and could be disposed of at an approved landfill facility.

Photo 1: Subject property owned by Eklutna Inc. with bungalow residence of Ms. Poirier

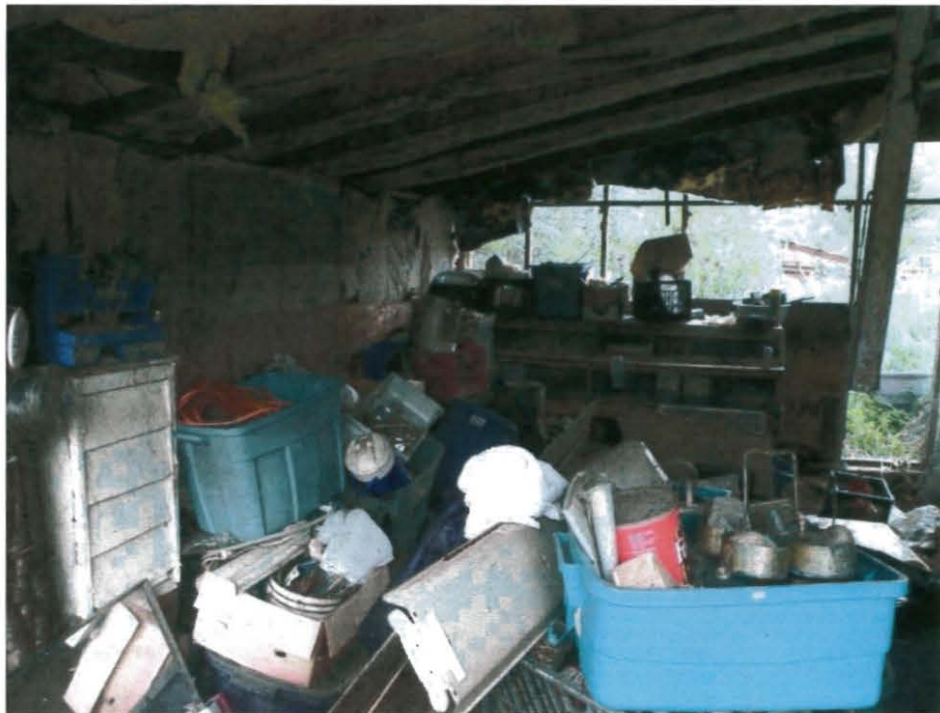
Photo 2: Subject property. Contents of shed attached to Poirier residence.

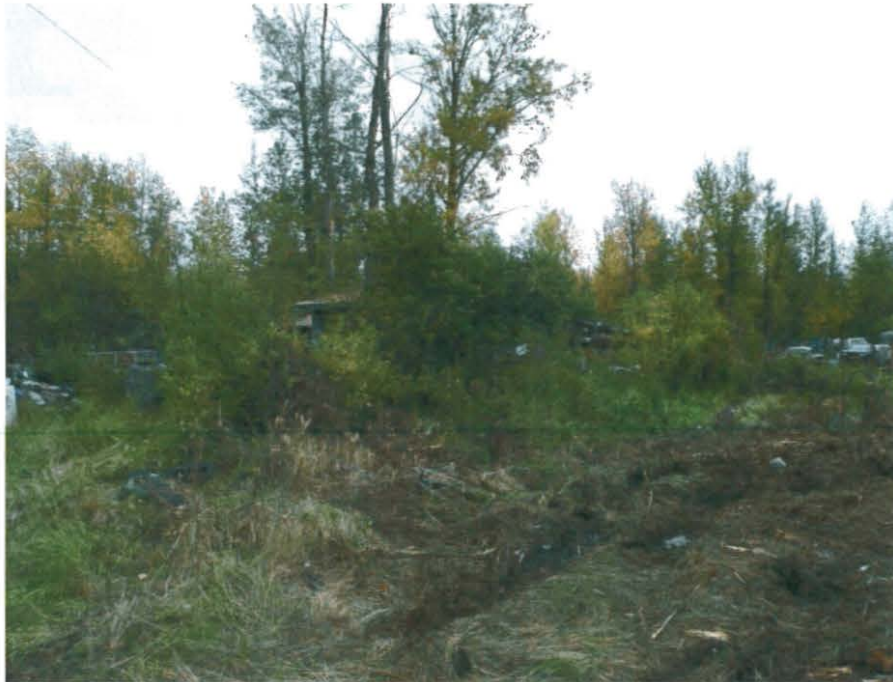
Photo 3: Subject property with D Street ROW recently cleared photo right

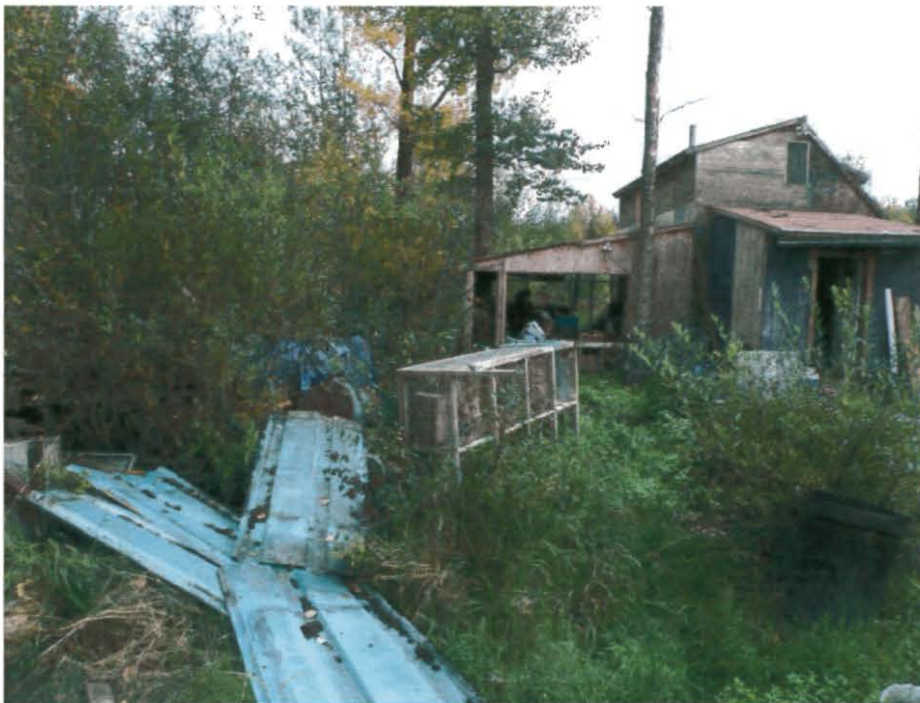
Photo 4: Subject property demonstrating debris

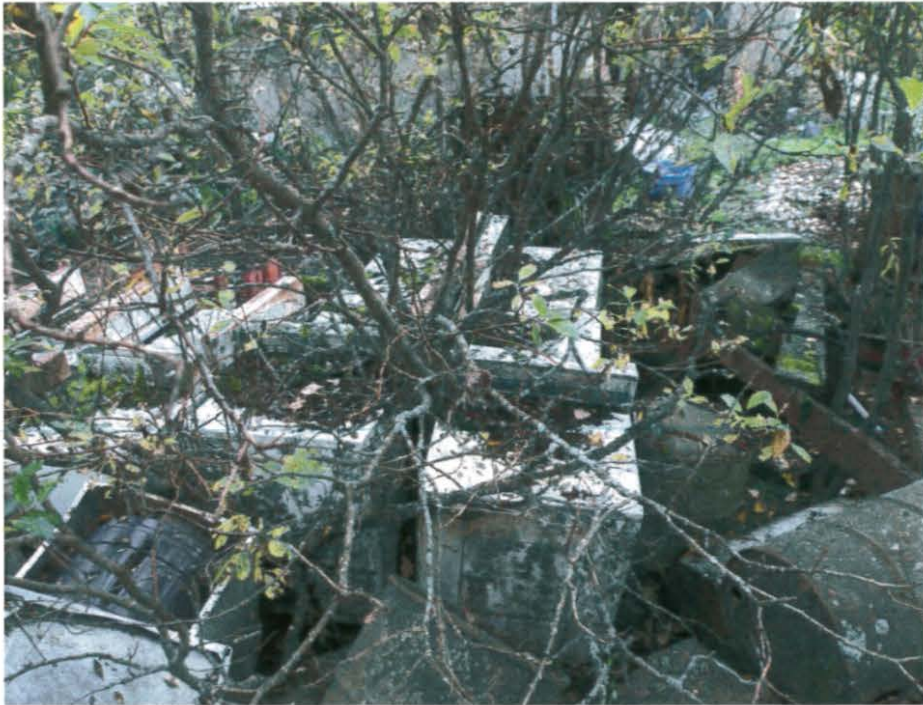
Photo 5: Debris on subject property adjacent to ROW between Eklutna Inc Lot 15 and Poirier Lot 1 featuring empty drum storage and washing machines

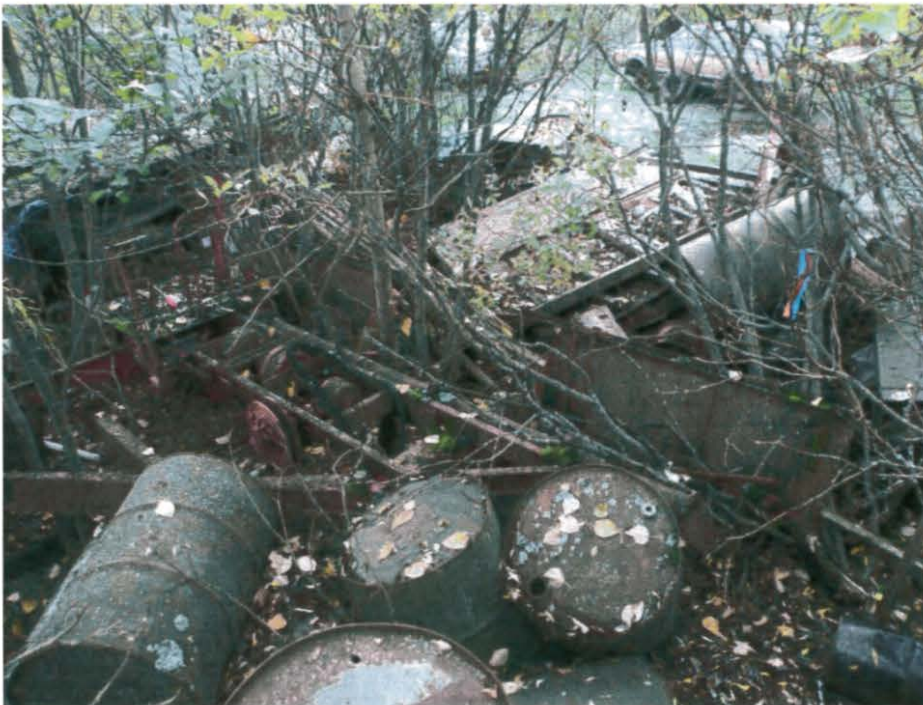
Photo 6: Subject property corner adjacent to Poirier Lot 1 featuring scrap metal.

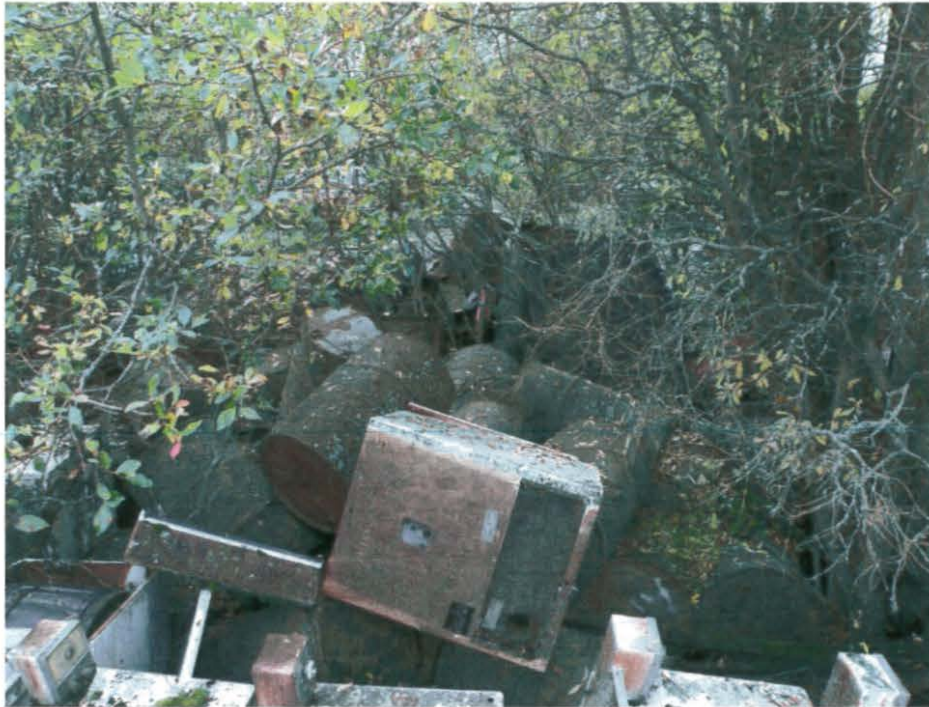
Photo 7: Empty drums on subject property along ROW adjacent Poirier Lot 1

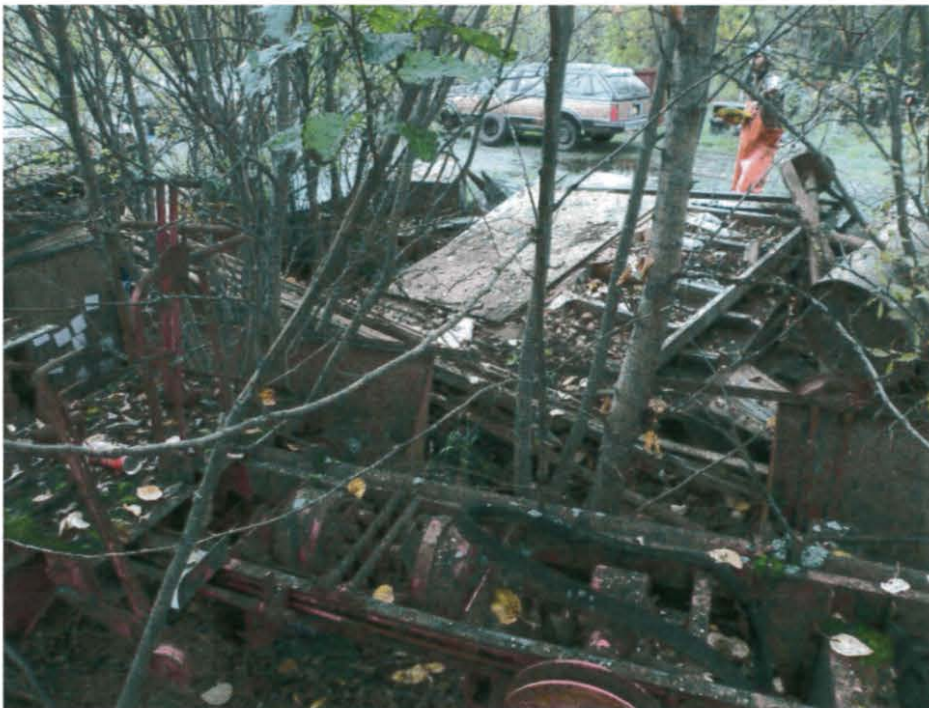
Photo 8: Subject property along ROW adjacent Poirier Lot 1 featuring empty drum storage and debris

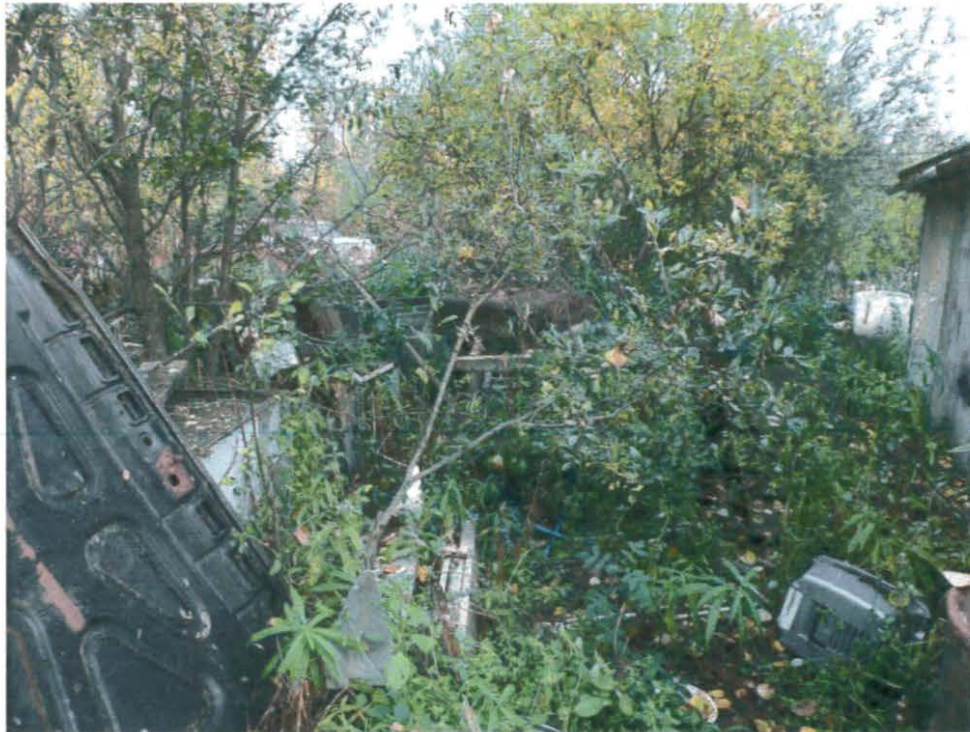
Photo 9: Subject property featuring debris

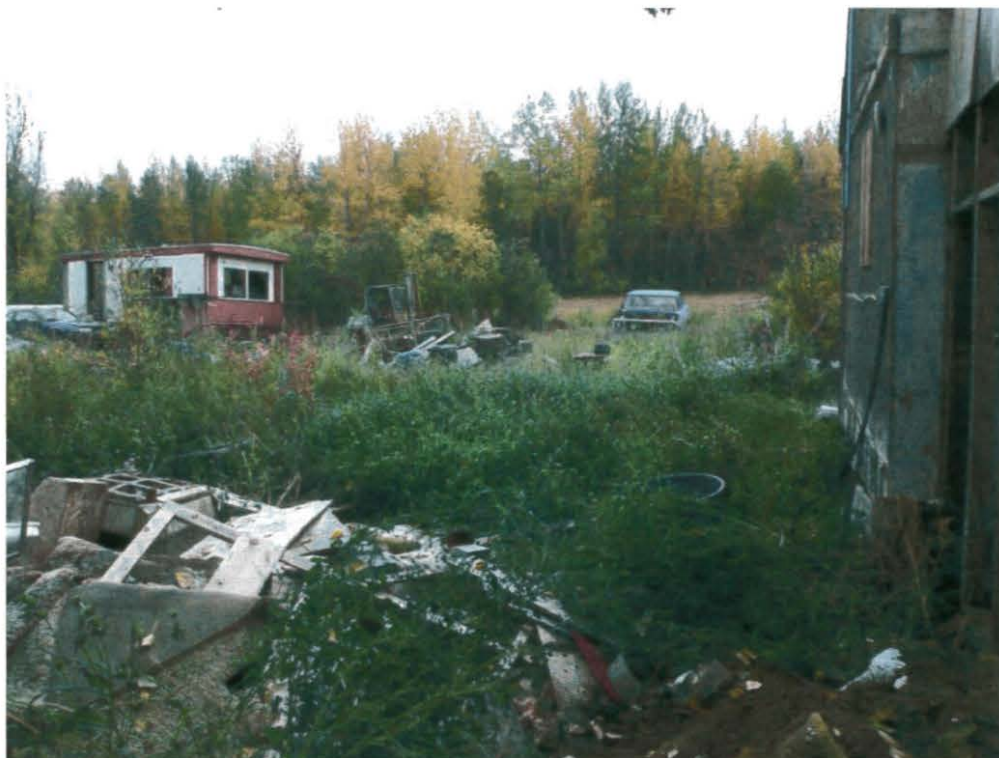
Photo 10: Subject property featuring Poirier residence at photo right. Eklutna Inc property extends to front of red and white trailer photo left

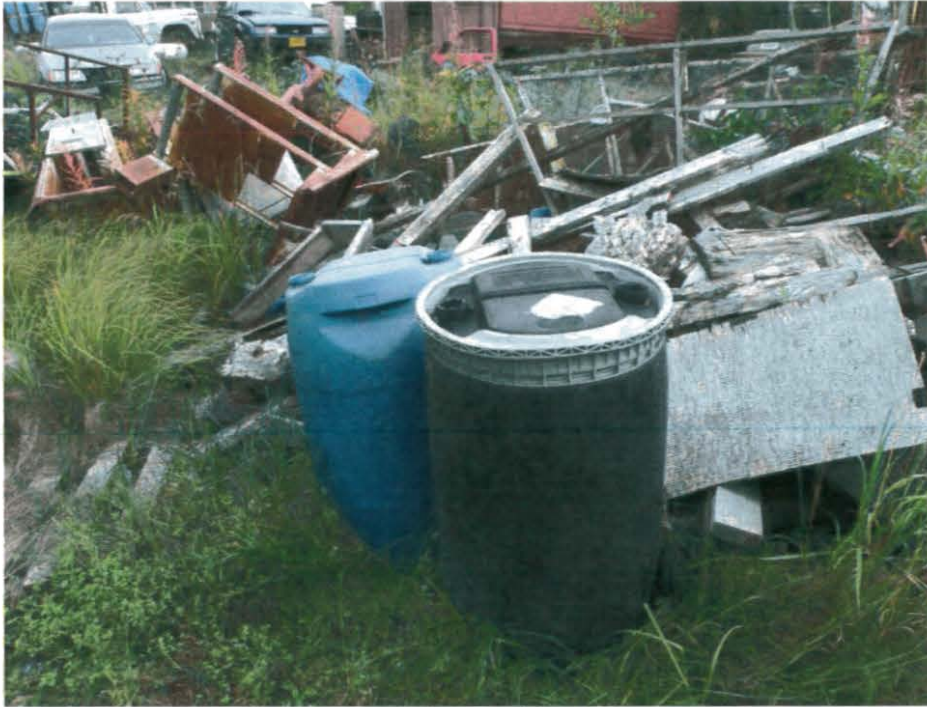
Photo 11: Debris on subject property.

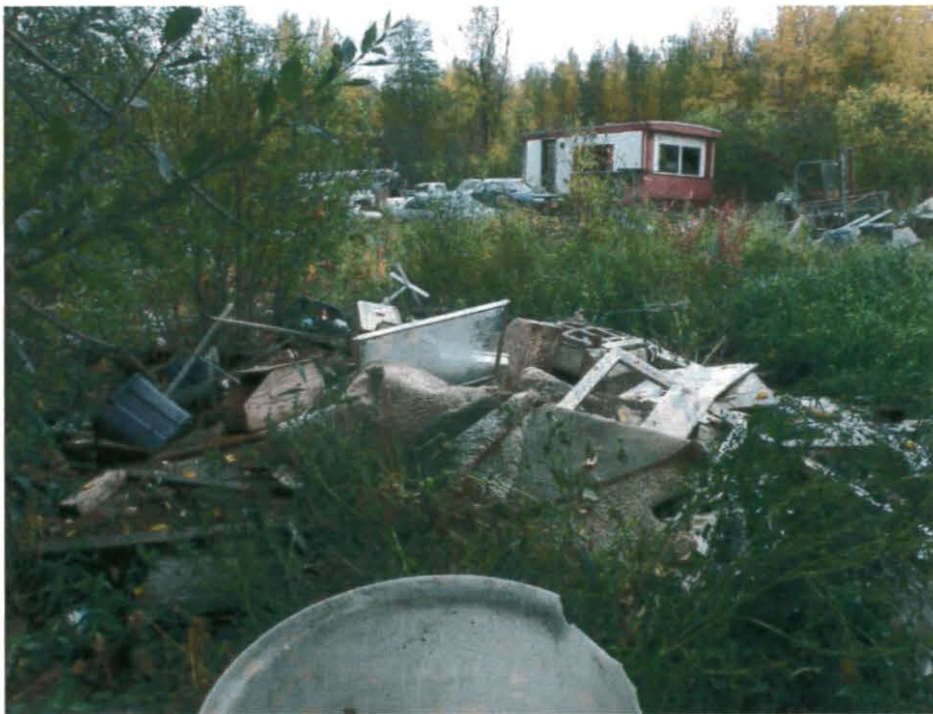
Photo 12: Debris on subject property.

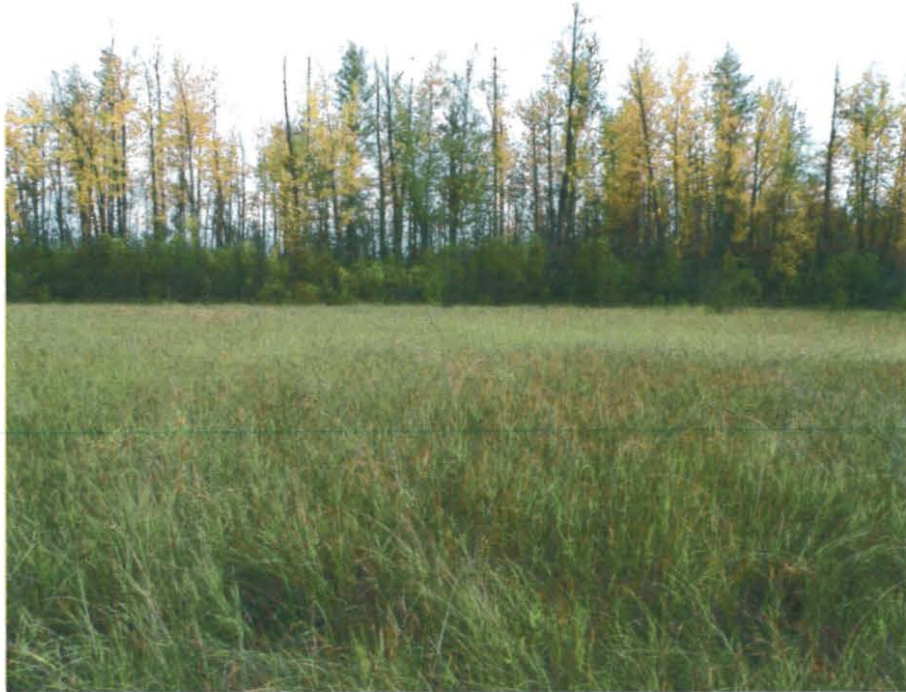
Other EI owned property adjacent to the site was investigated including; Lots 10-13 of Block 1, Lots 11-13, 15-16, 18-19, and 21 of Block 2, Lots 1-14 of Block 3, Lots 6-8 of Block 4 and Lots 1-5 of Block 5. No debris was located on any of these lots. (Photo 13)

Photo 13: General setting of Eklutna Inc.'s Lots 10-13 of Block 1, Lots 11-13, 15-16, 18-19, and 21 of Block 2, Lots 1-14 of Block 3, Lots 6-8 of Block 4 and Lots 1-5 of Block 5.  
No debris was located on any of these lots.

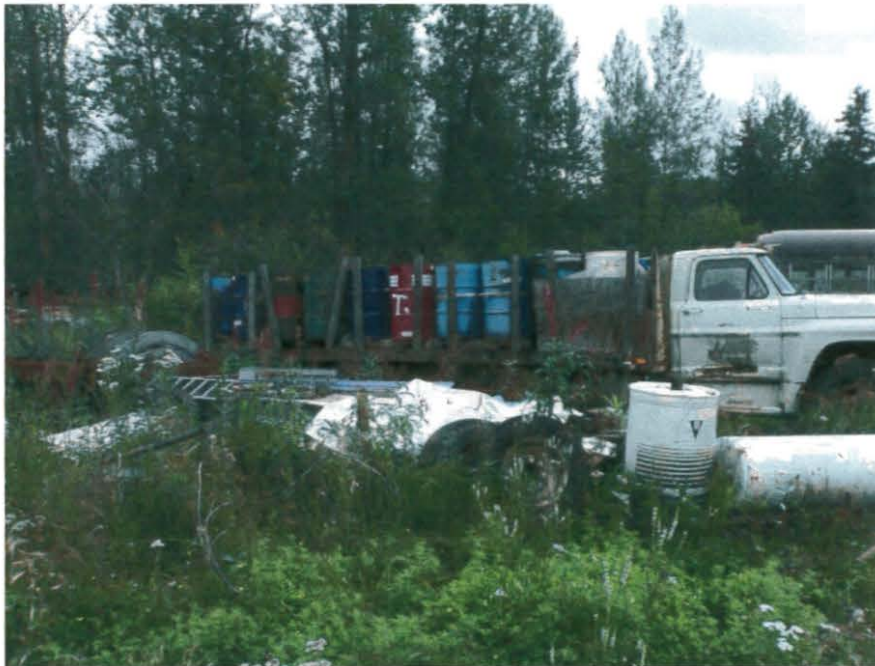
Adjacent properties owned by Poirier include Lots 1, 2, 13 and 14 of Block 4. Lots 13 and 14 feature significant concerns such as an estimated 52 drums and numerous buckets stored on a flat bed and on the ground, many of which are actively leaking. (Photo 14) Soil contamination is evident on the Poirier property though it appears limited. (Photo 15) The landscape between the Poirier property and the subject property is level and contamination from the Poirier property could reasonably impact the subject and other adjacent properties. Non-hazardous debris includes a burned trailer, vehicles and general debris. (Photo 16) One transformer shell is also present but has been drained.

Photo 14: Poirier property Lot 13 and 14 of Block 4. Full Drum storage area featuring an estimated 52 drums stored on flatbed trailer and pallets behind truck. Many of the drums are actively leaking.

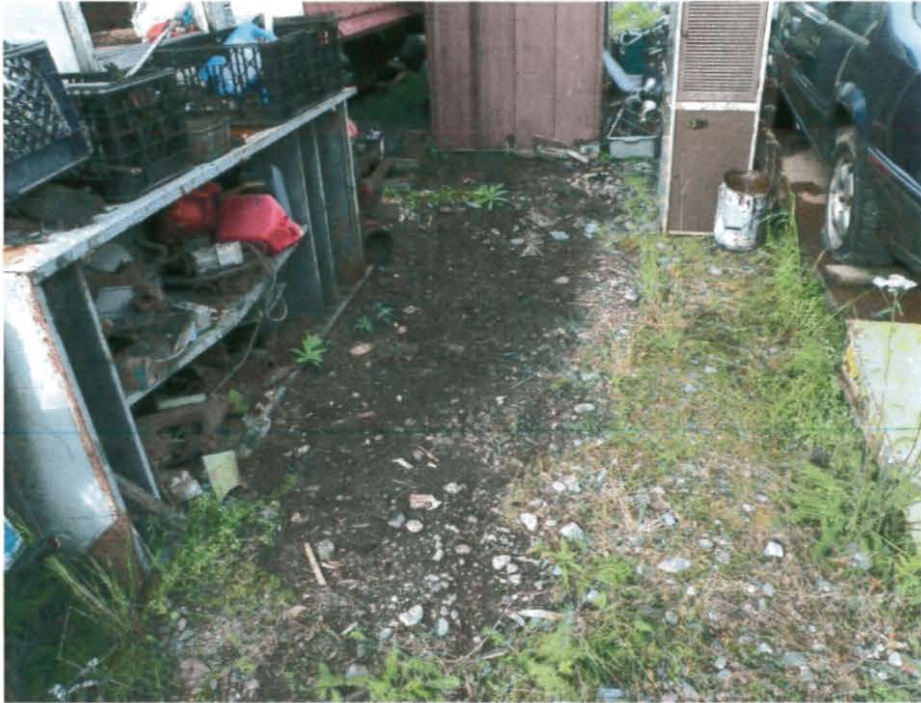
Photo 15: Surface soil staining on Poirier Property Lot 13 of Block 4

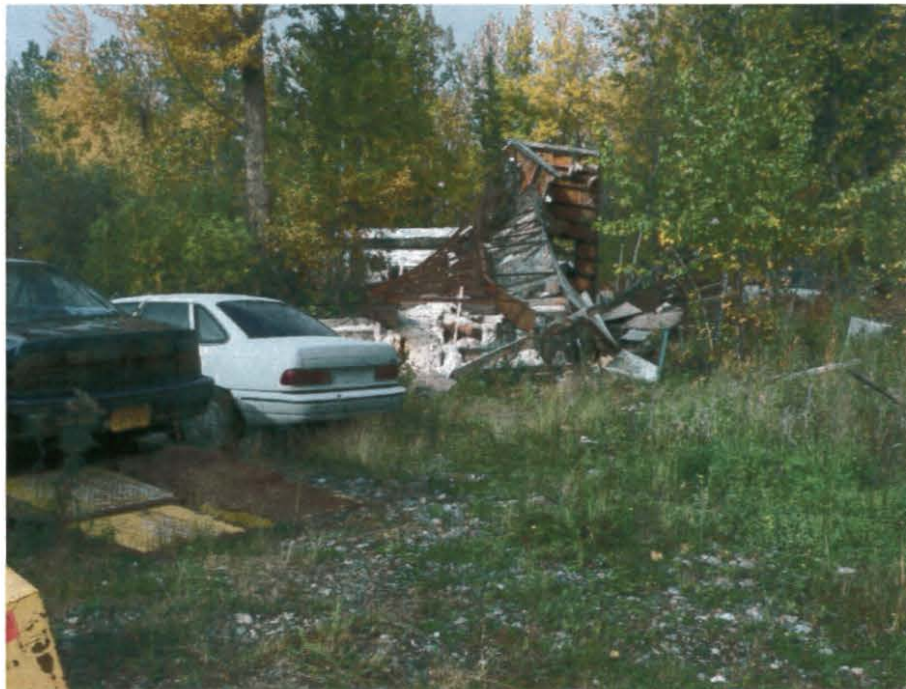
Photo 16: General debris and cars located on Poirier Lots 13 and 14 of Block 4

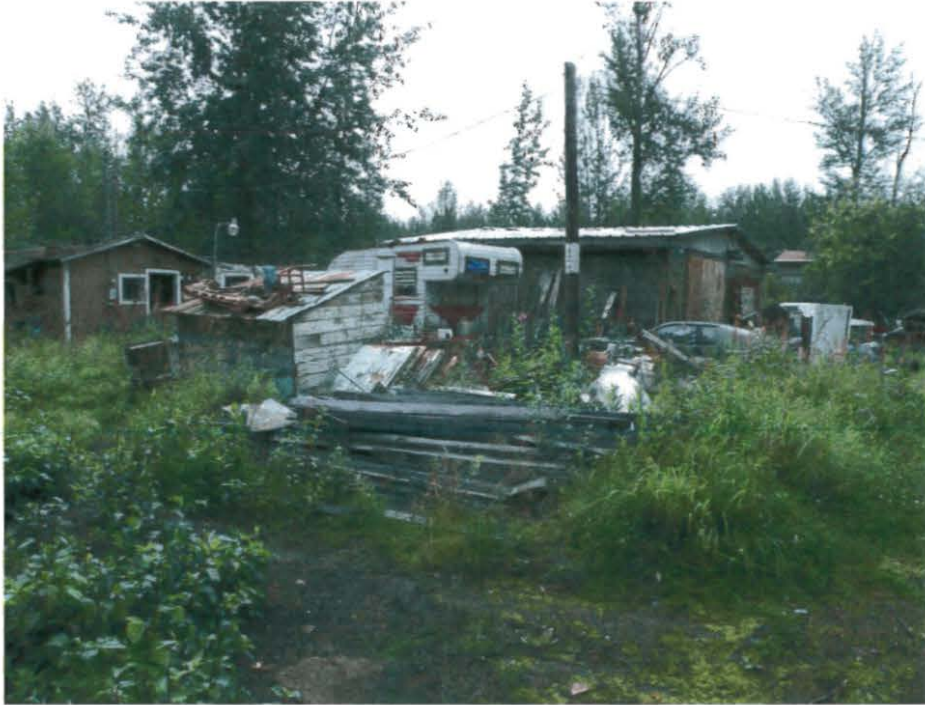
Photo 17: Poirier Lots 1 and 2 of Block 4

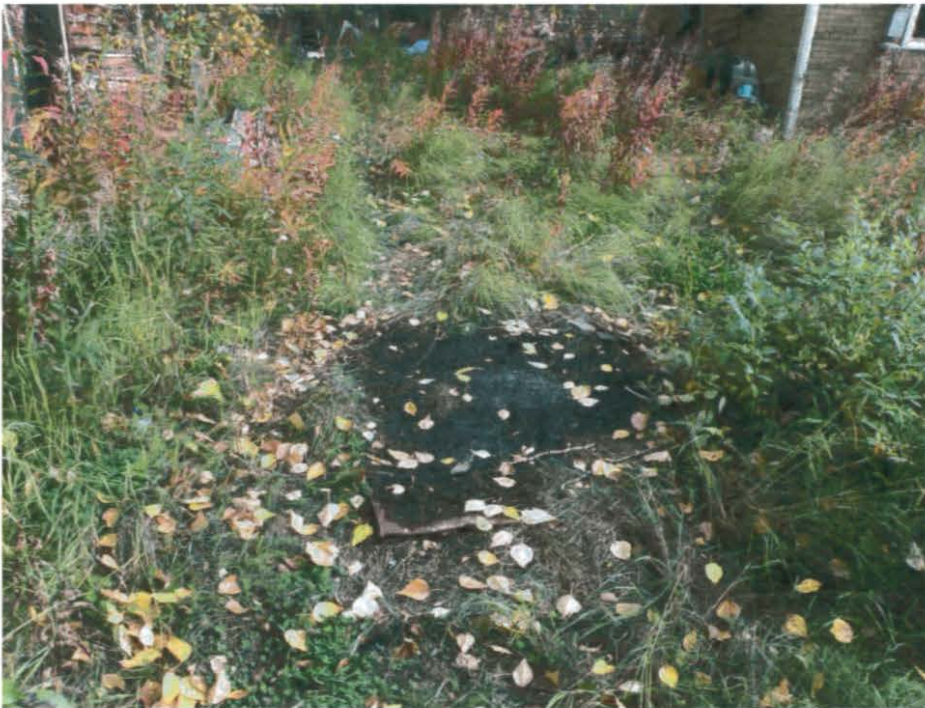
Photo 18: One of 3 areas of soil staining from wire and/or battery burning located on Poirier Lots 1 and 2 of Block 4.

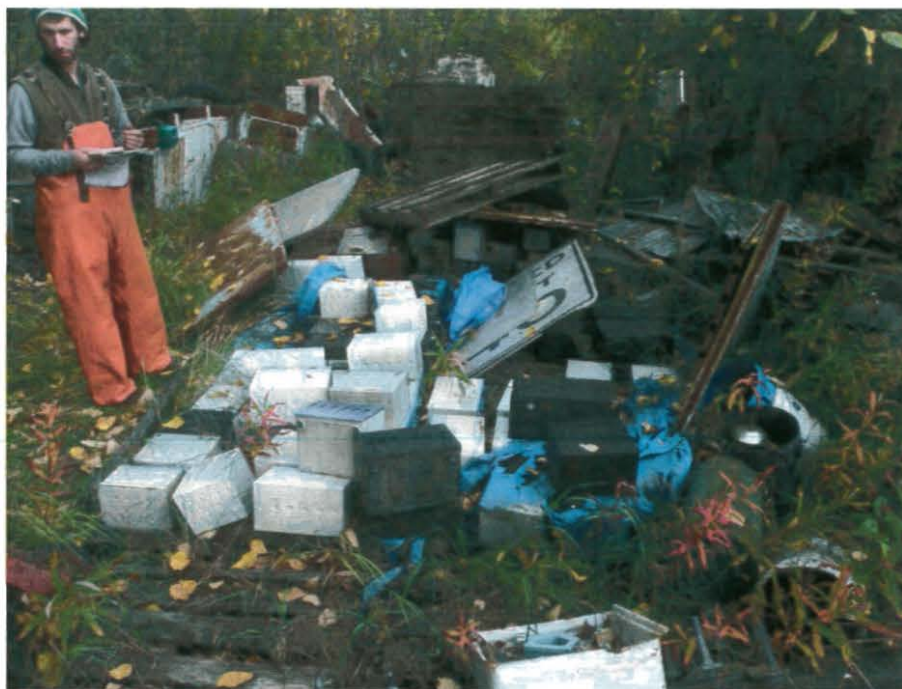
Lots 1 and 2 of Block 4 feature one small shop, two sheds and a small camp trailer. (Photo 17) Three areas of the property evidence wire and/or battery burning with stained soils and blackened debris. (Photo 18) At least 100 batteries (Photo 19), 120 paint cans (some with free product) and one transformer shell were identified

Photo 19: Estimated 100 batteries located on Poirier Lot 2 of Block 4

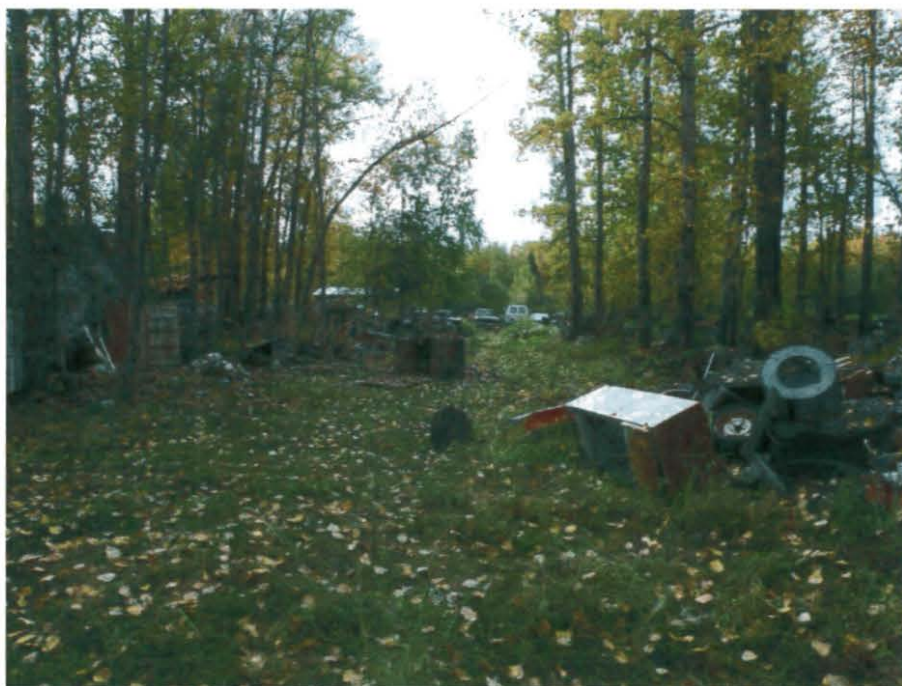
Photo 20: 2<sup>nd</sup> Street ROW facing toward D Street

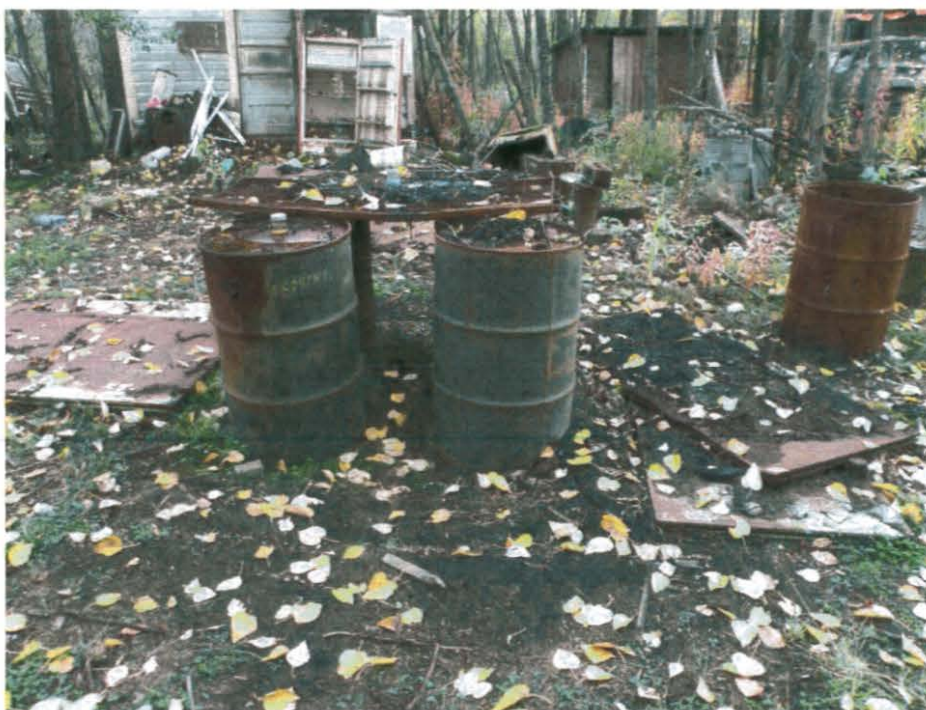
Photo 21: Wire burning area located in 2<sup>nd</sup> Street ROW. Visible soil staining was observed around the empty barrels.

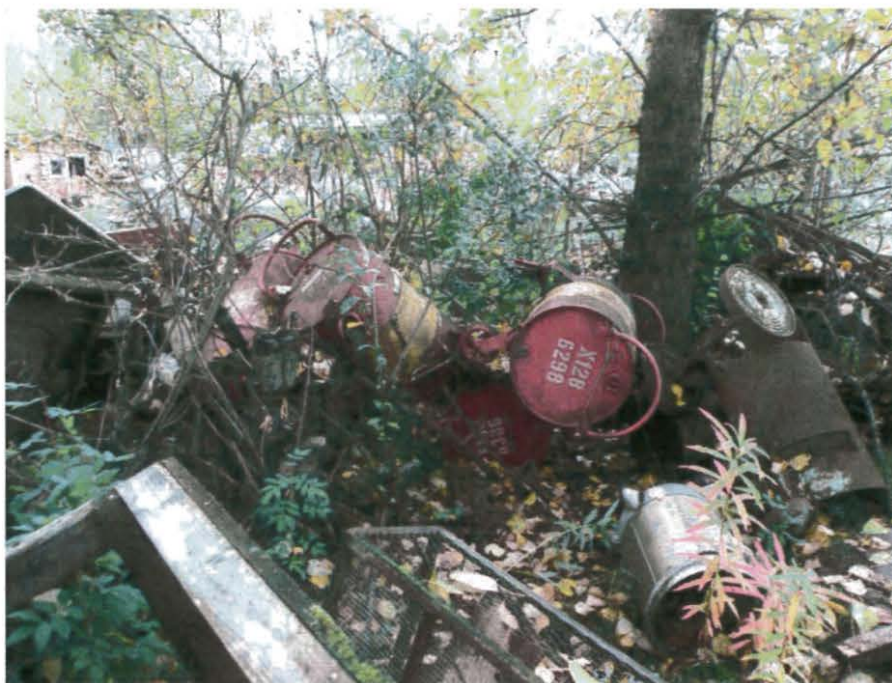
Photo 22: General Debris located on 2<sup>nd</sup> Street ROW.

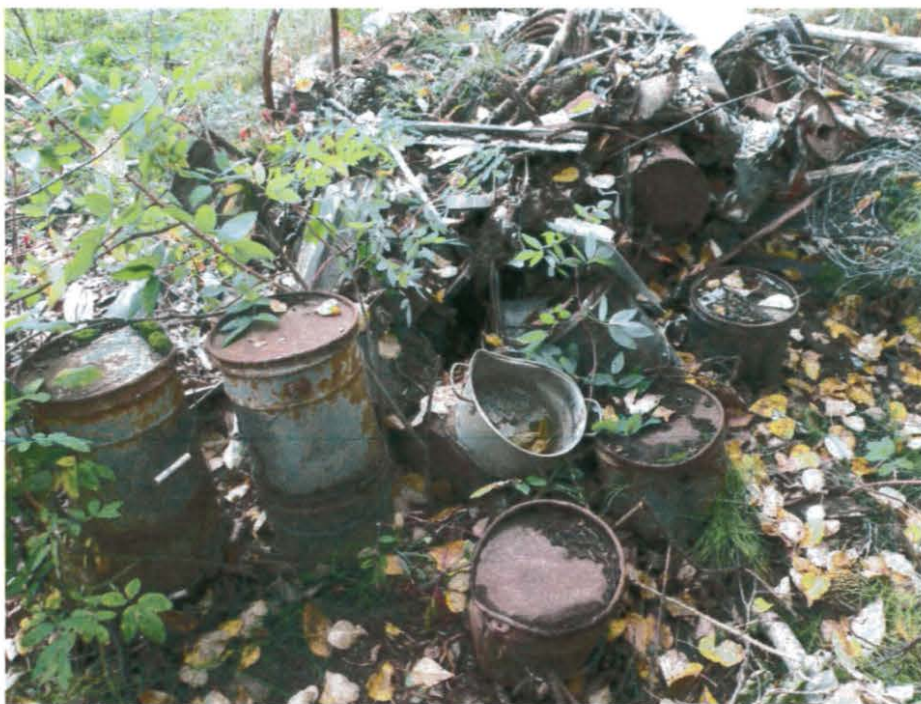
Photo 23: Estimated 12 full 5 gallon buckets of paint in 2<sup>nd</sup> Street ROW

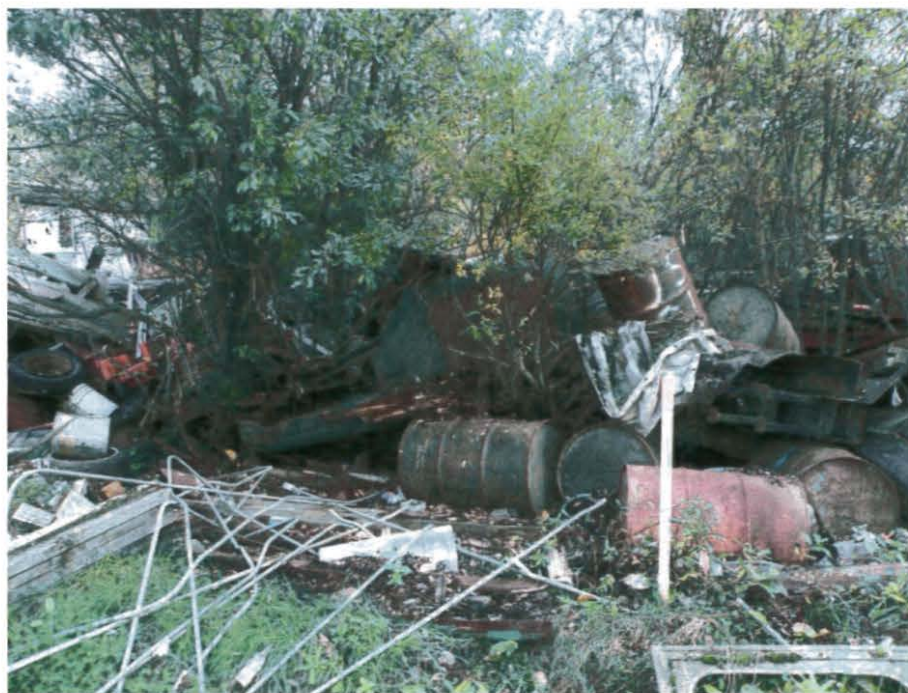
The ROW between Lots 1-8 and Lots 9-15 of Block 4 presented an estimated 40 drums with at least 7 containing significant fluid. (Photo 24) Many washing machines and other non-hazardous debris were encountered. (Photo 25)

Photo 24: Estimated 40 drums with at least seven containing significant fluid and debris located on ROW between Eklutna Inc's and Poirier's property in Block 4

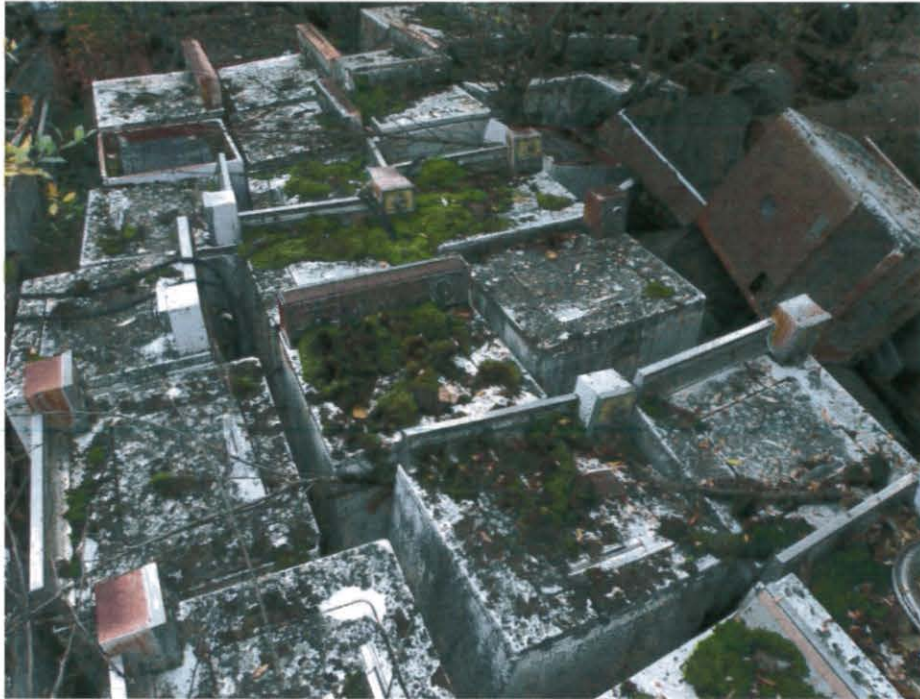
Photo 25: Non Hazardous debris found on ROW dividing Block 4

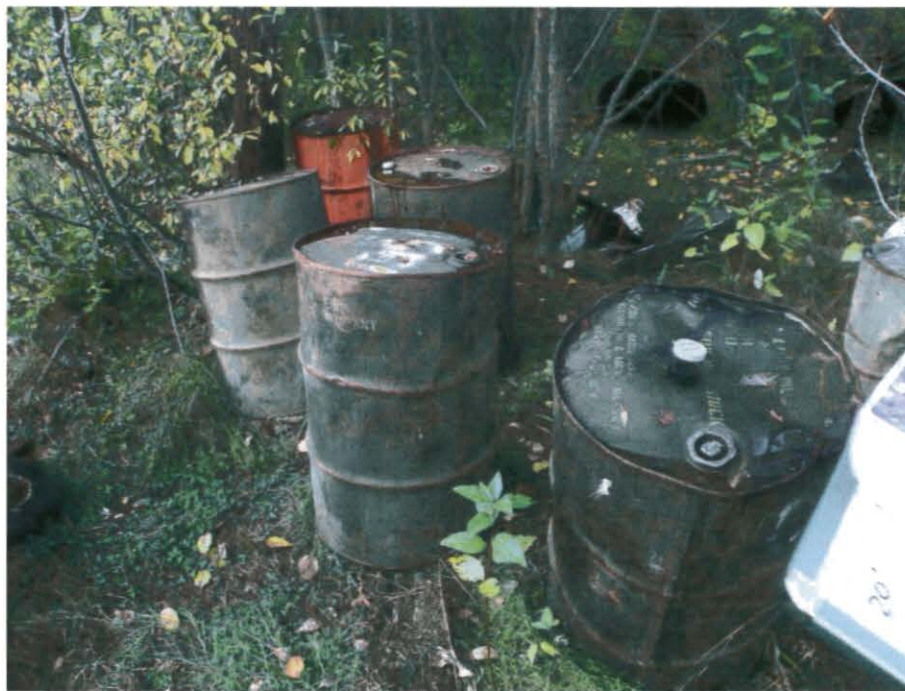
The ROW between Lots 1-8 and 9-14 of Block 2 presented 4 drums of unknown contents with significant free product. (Photo 26) This ROW included limited metal debris and waste wood.

Photo 26: Four drums of unknown contents and containing significant free products located on ROW dividing Block 2

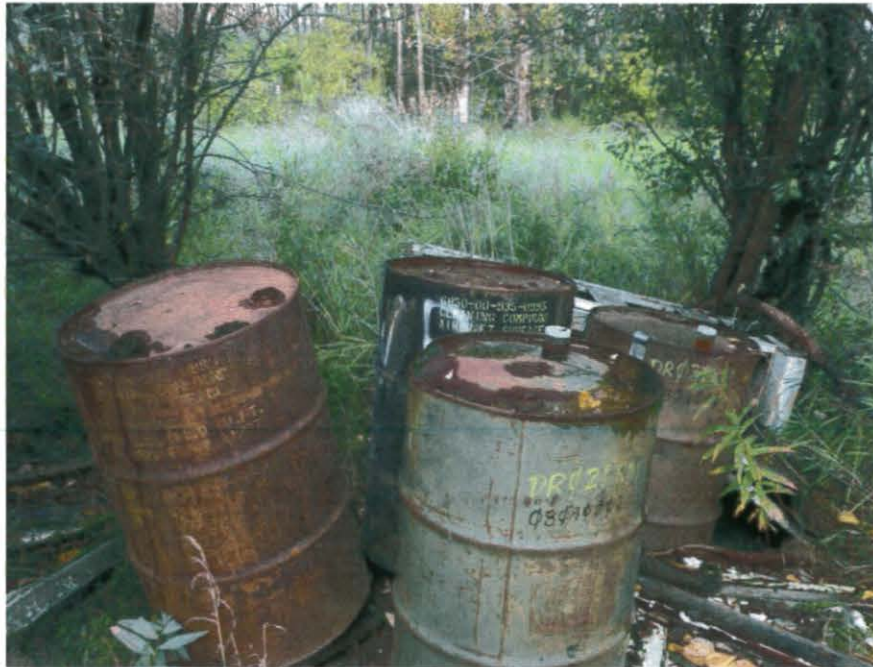
Photo 27: Two Empty and 2 full (with sample jars on top) located on western side of Lot 8 Block 2.

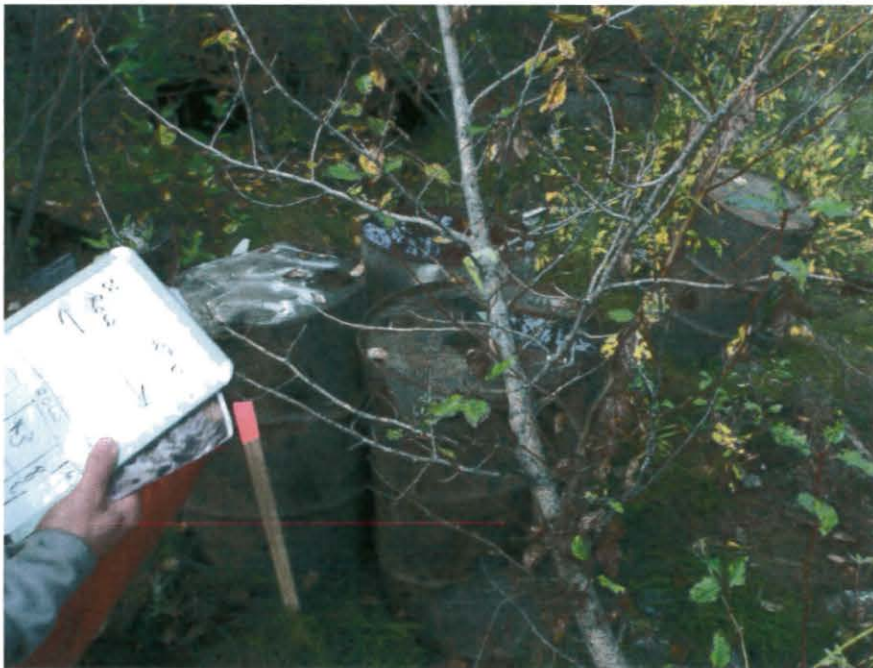
Photo 28: Four full drums located on the SE corner of Lot 8 of Block 2

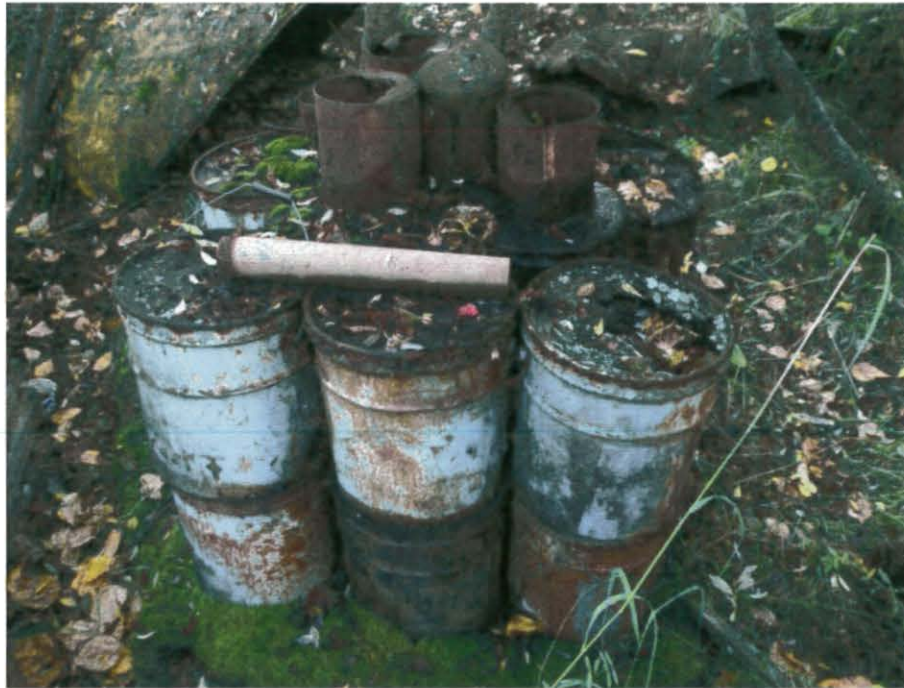
Photo 29: Lot 8 of Block 2 demonstrating actively leaking 5 and 1 gallon metal paint containers.

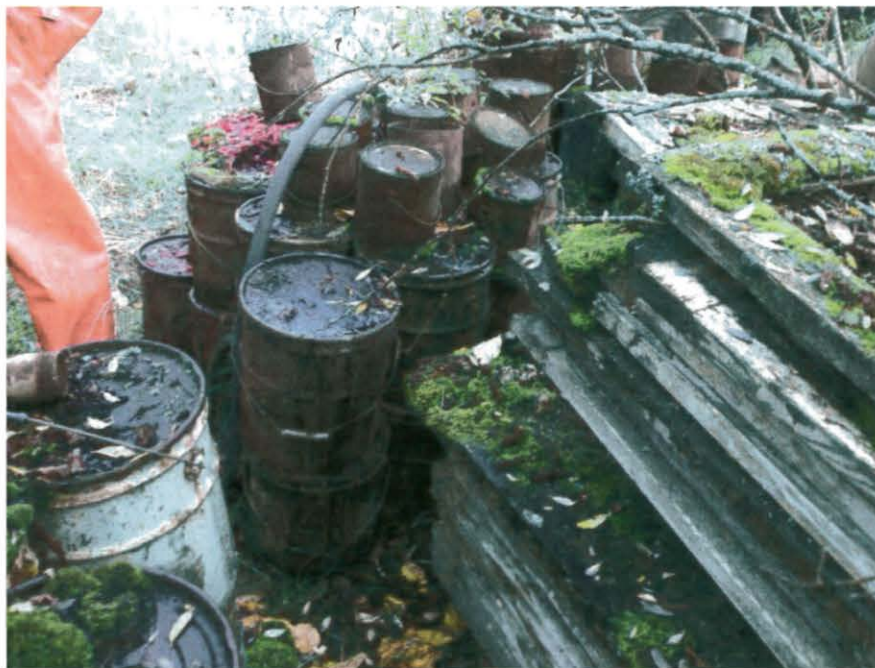
Photo 30: Continuation of previous photo demonstrating large number of 5 and 1 gallon paint cans in this area. Most cans are actively leaking.

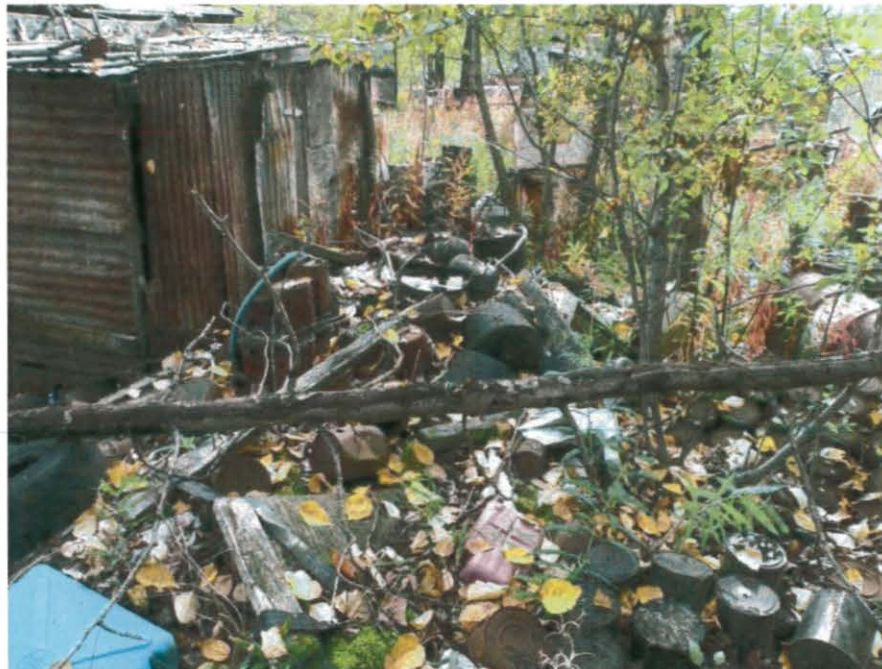
Photo 31: ROW between Blocks 3 and 4 featuring leaking paint cans.

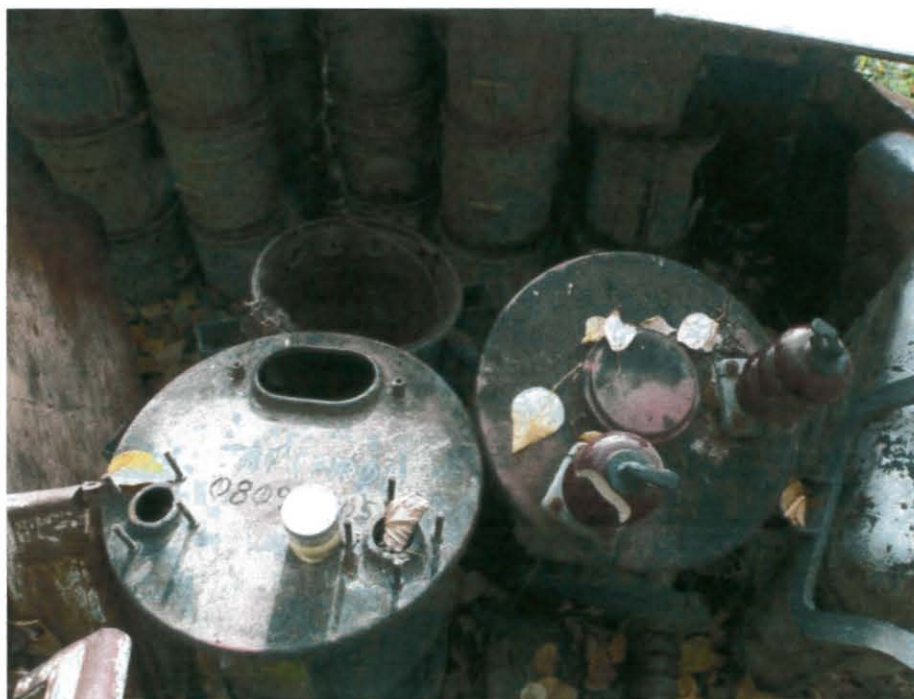
Photo 32: ROW between Blocks 3 and 4 featuring transformer shells and leaking paint buckets

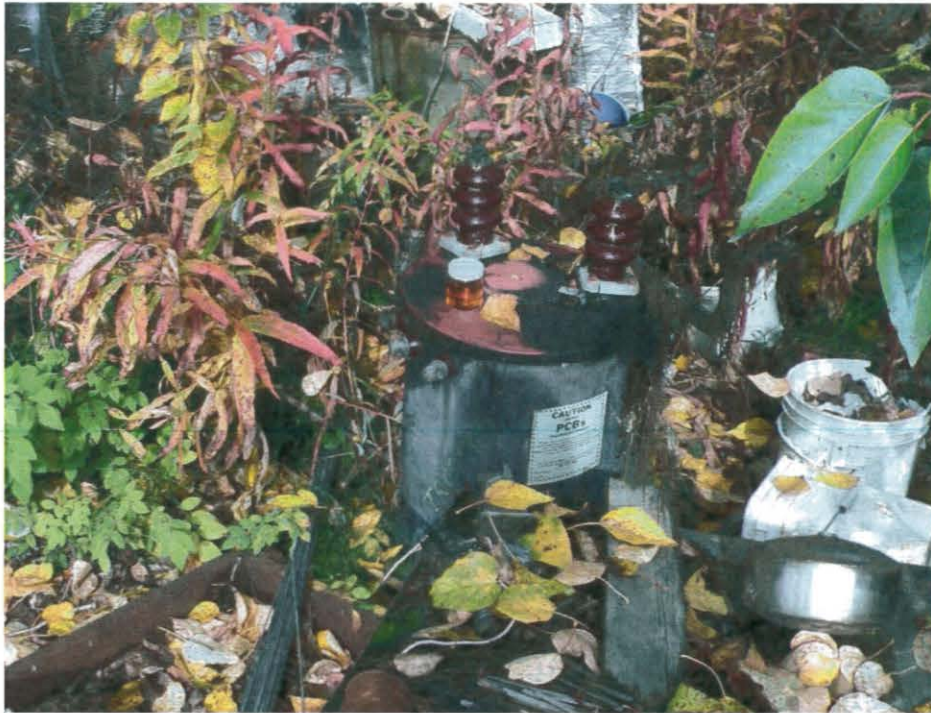
Photo 33: ROW between Blocks 3 and 4 showing one of 3 Transformers containing suspected PCB dielectric oil.

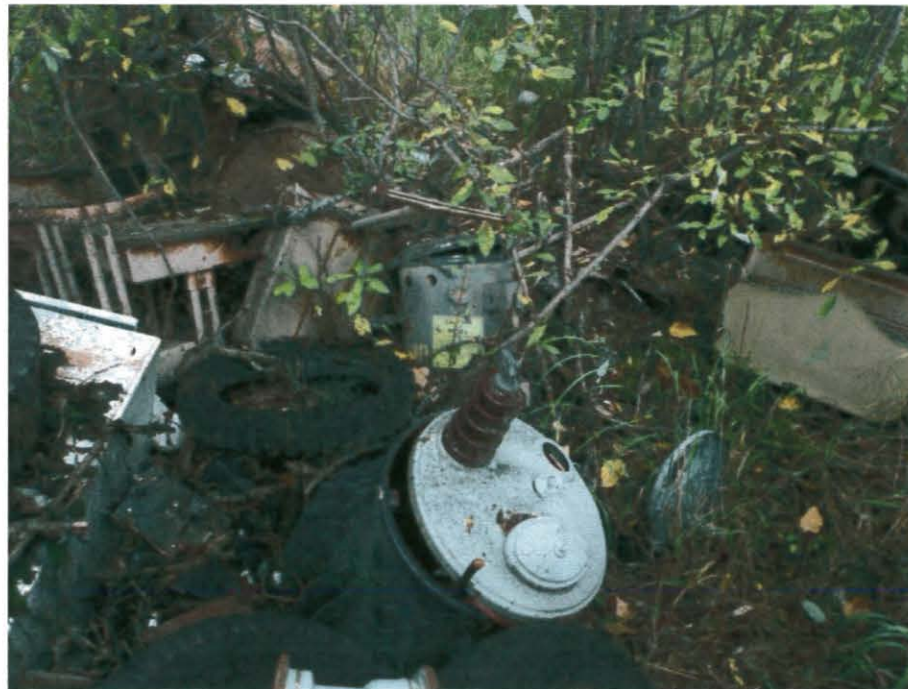
Photo 34: ROW between Blocks 3 and 4 featuring another transformer with suspected PCB dielectric oil.
