## Phase I Environmental Site Assessment

Matanuska Townsite, Lot 15, Block 4, East Matanuska Spur Road,  
Matanuska-Susitna Borough, Alaska.

**March 2009**

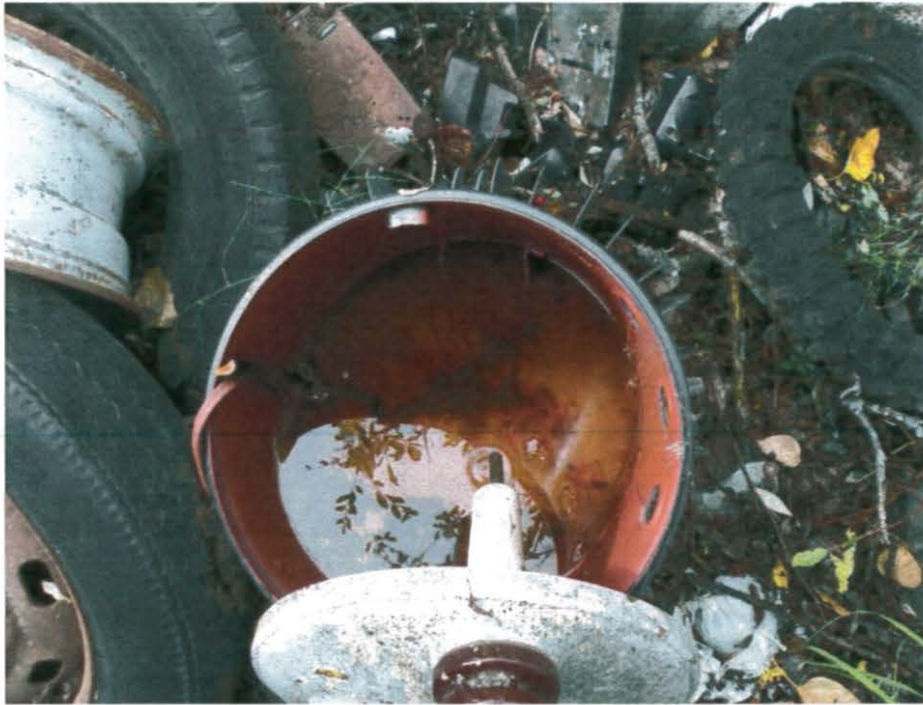
Photo 35: Close-up of transformer shown in above photo demonstrating water and dielectric oil mixture.

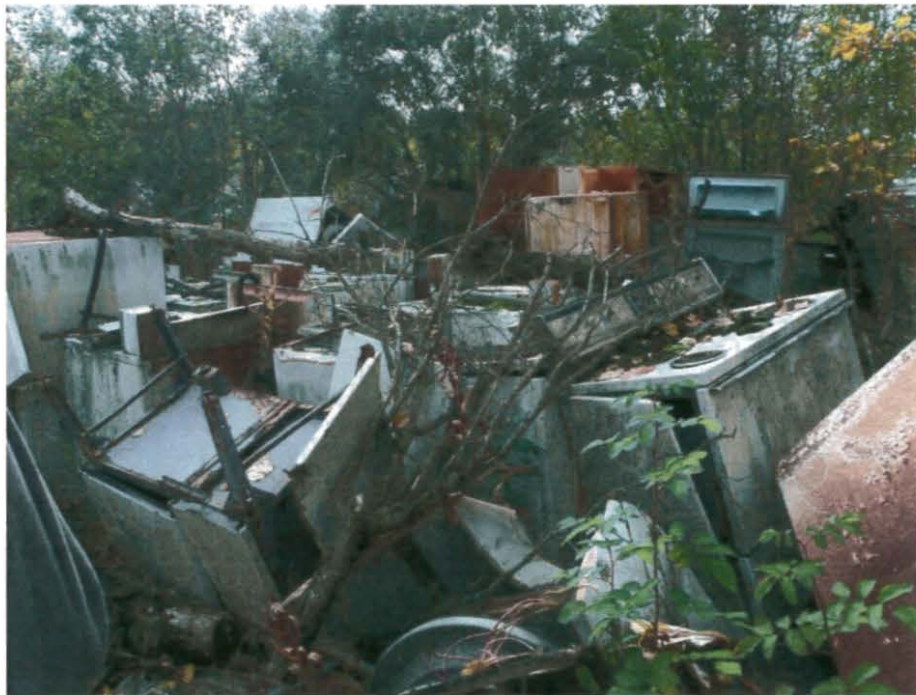
The borough also owns Lots 4-5 of Block 4 featuring 4 vehicles, debris and many appliances (Photo 36).

Photo 36: Lots 4 and 5 of Block 4 owned by the borough featuring appliances

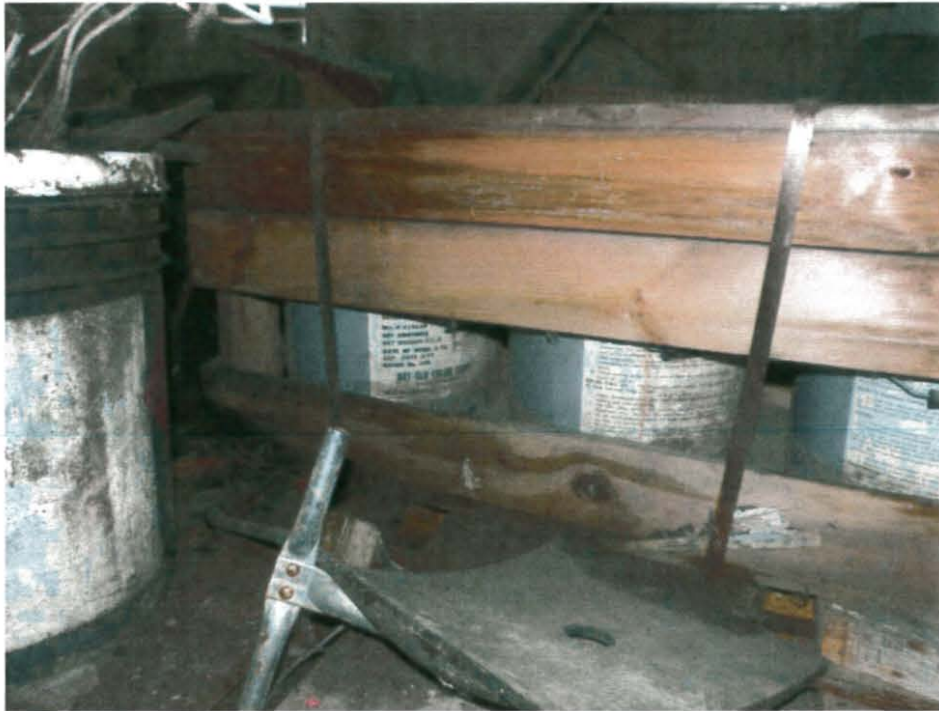
Photo 37: Lot 3 of Block 4 owned by Carl Martin demonstrating 5 gallon paint buckets

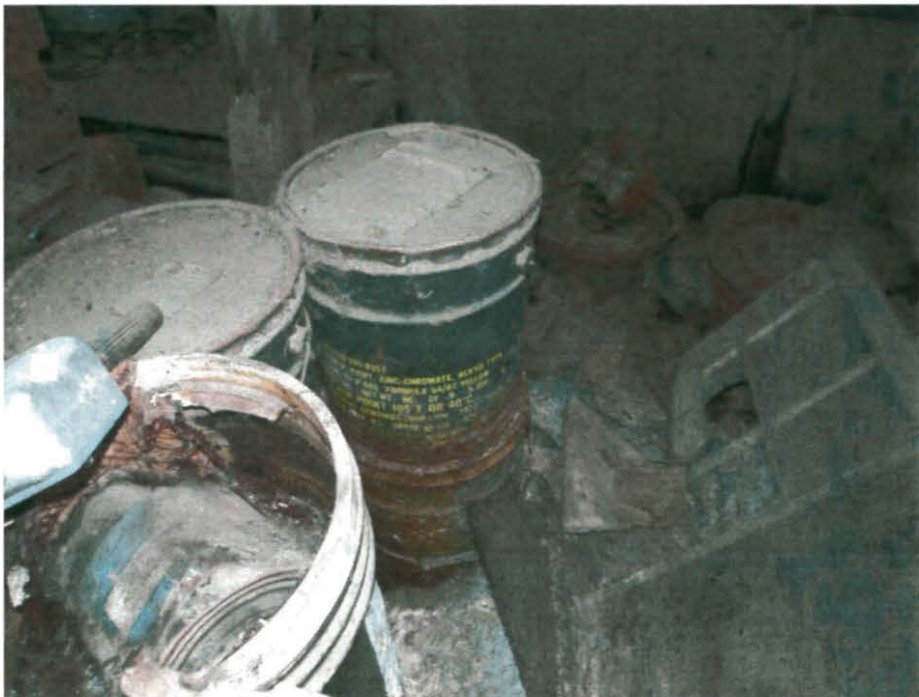
Photo 38: Lot 3 of Block 4 owned by Carl Martin demonstrating 5 gallon buckets

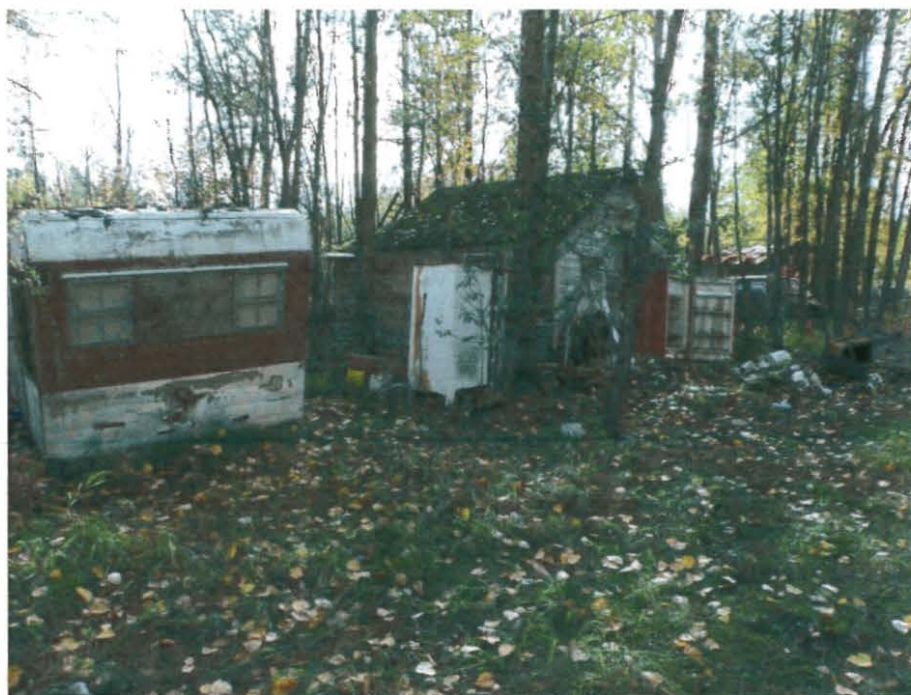
Ms Anne Barnes owns Lots 15-16 of Block 3 which features a camper trailer, vehicle and a small shack. (Photo 39) While most of the debris was non-hazardous, some items were of concern including many cans of leaking hydraulic fluid.

Photo 39: General Debris found on Lots 15 and 16 of Block 3 owned by Anne Barnes.
