TECHNICAL ASSISTANCE TEAM  
ON-SCENE COORDINATOR  
REPORT FOR:

Alaska Husky Battery  
Anchorage, Alaska

TDD T10-8810-039

REPORT PREPARED BY: ECOLOGY AND ENVIRONMENT, INC.  
PROJECT MANAGER: THOMAS ASHLEY  
DATE: DECEMBER 1988

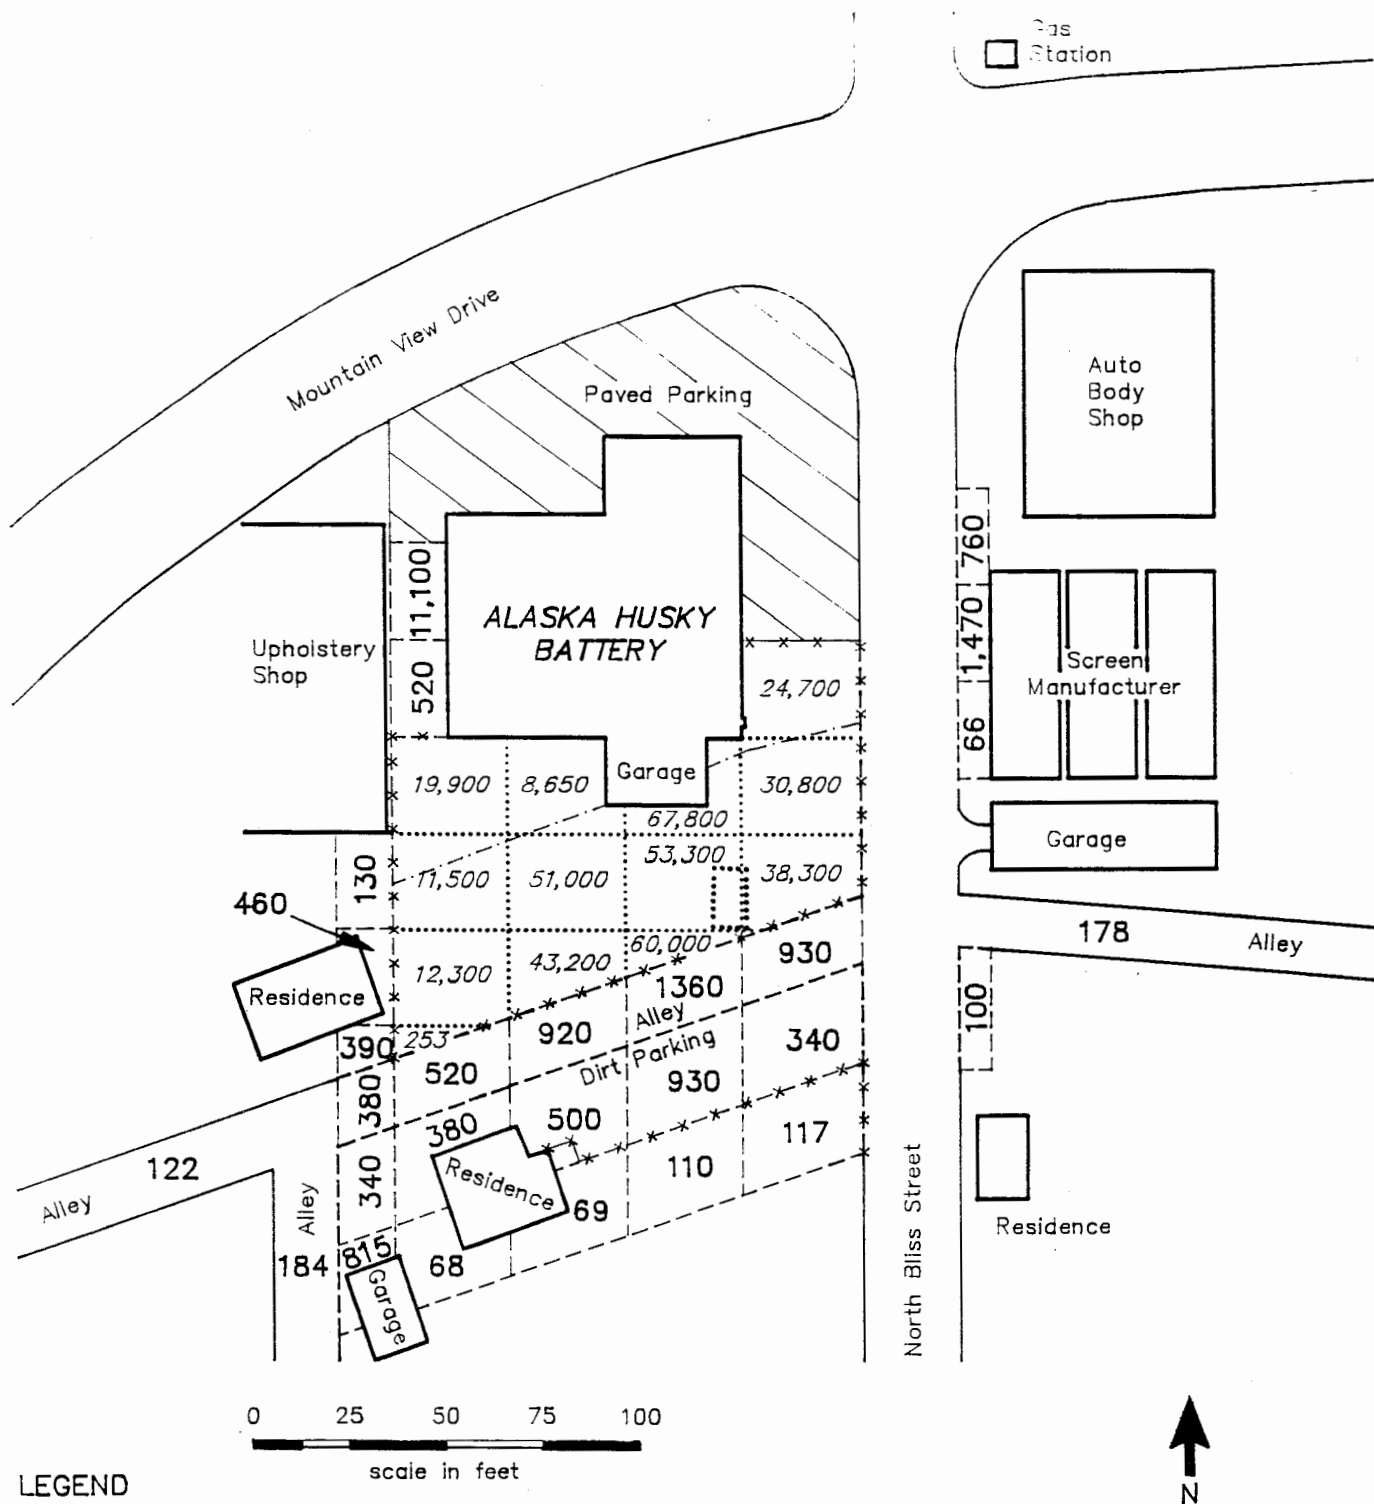
**FIGURE 3**  
**LEAD RESULTS – SURFACE**  
**SOIL, MAY 1988**  
 ALASKA HUSKY BATTERY  
 Anchorage, AK

work yard indicated elevated levels of lead (23,080 ppm to 77,730 ppm) when compared to the background level (633 ppm). Three of the four samples also exceeded the Extraction Procedure Toxicity (EP Tox) hazardous waste criterion for lead of 5.0 ppm (40 CFR 261.24). The report concluded that the site appeared to present a threat to the public health and/or environment and recommended that an extent of contamination survey be performed (Tetra Tech, 1984).

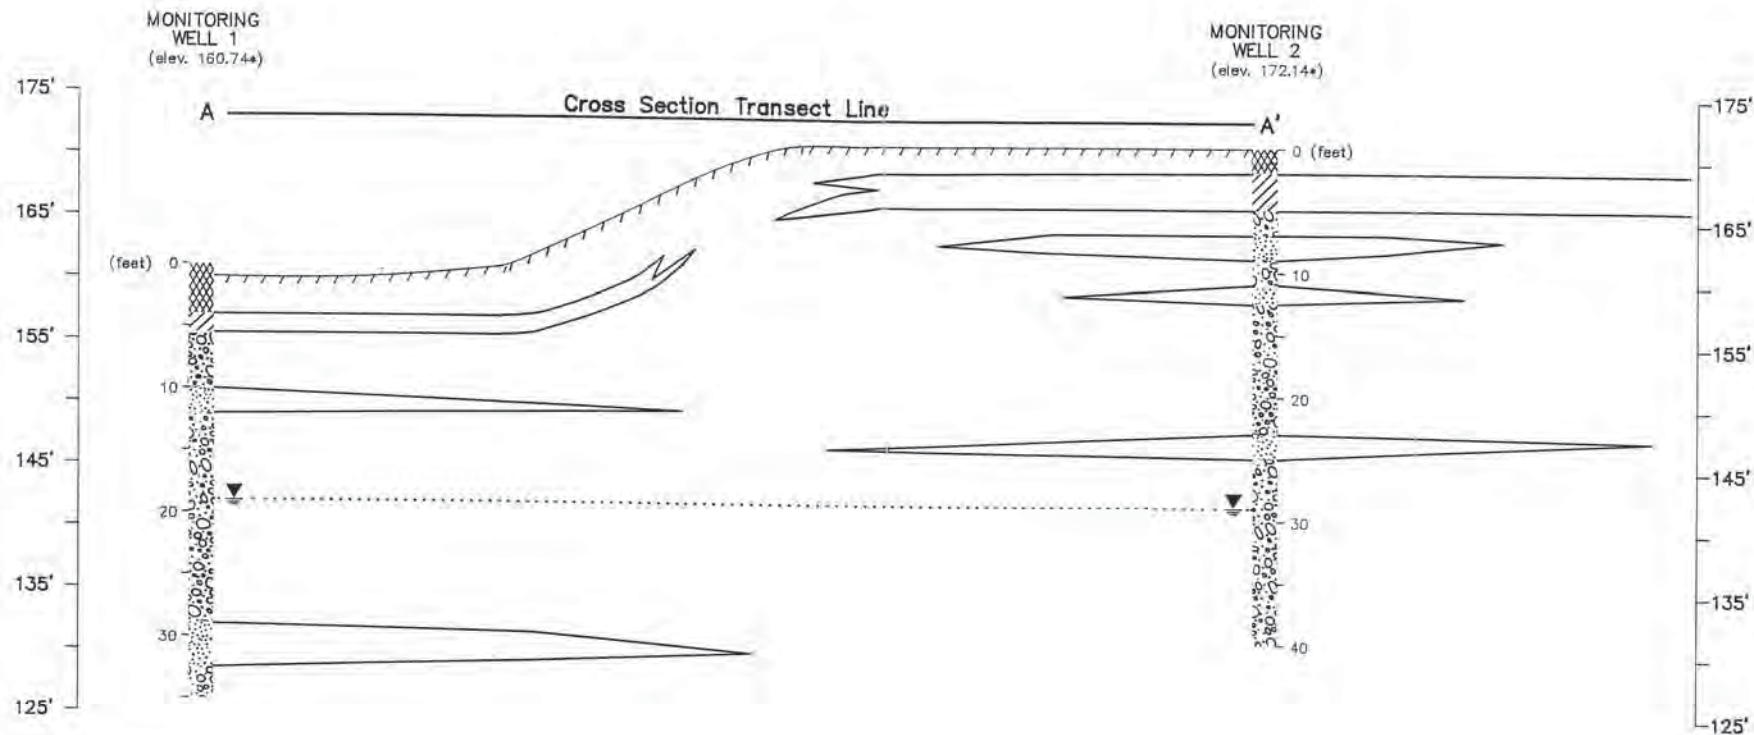
FIGURE 5  
GEOLOGIC CROSS SECTION  
ALASKA HUSKY BATTERY  
Anchorage, AK

The study of site geology and hydrogeology revealed no continuous permeability barriers to a depth of 40 feet bgs (Figure 5). Due to previous site development activities, the pre-development soil profile was not intact across much of the site. The local ground water gradient was found to be 0.005 ft/ft, sloping toward the west (Figure 6)(Ashley, 1988).

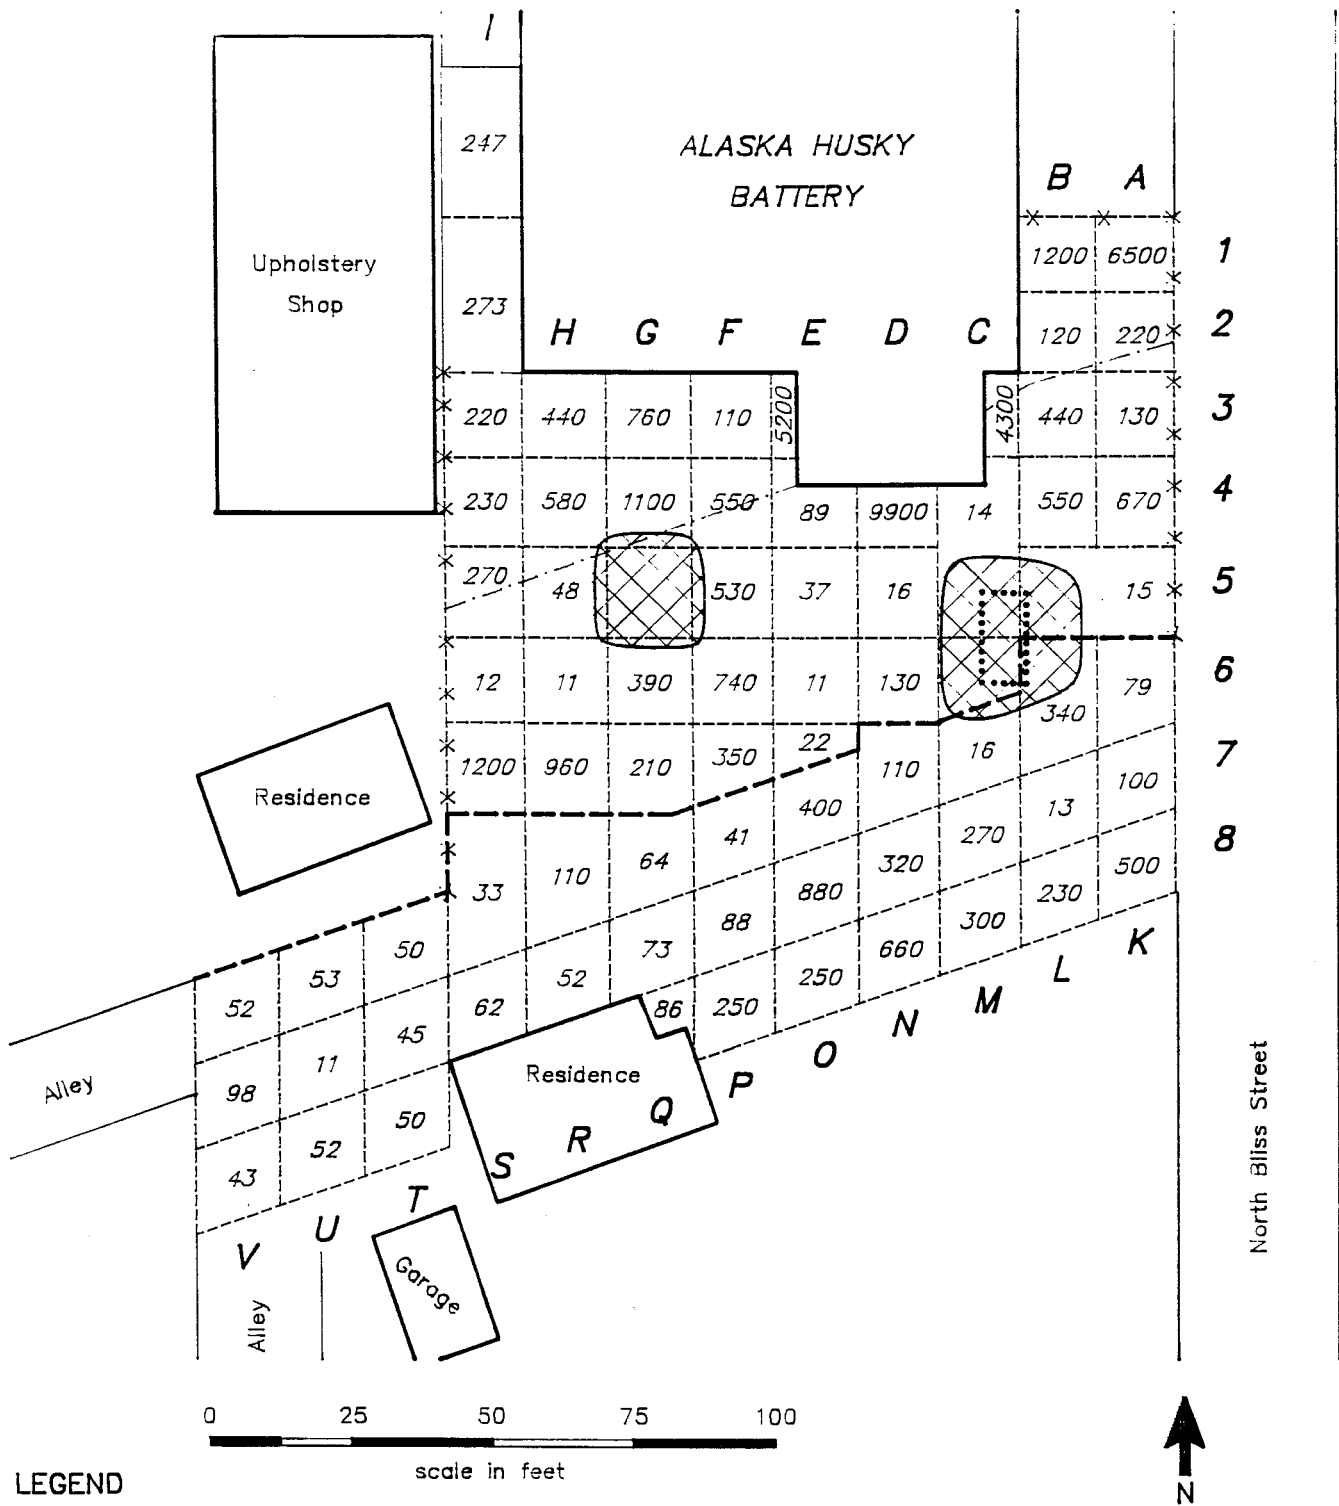
**FIGURE 10**  
**POST REMOVAL LEAD LEVELS**  
**ALASKA HUSKY BATTERY**  
**Anchorage, AK**

Cleanup verification sampling was conducted within the 12 ft x 15 ft grid system shown in Figure 9. Application of this grid system resulted in a 4-fold increase in sampling intensity over the sampling conducted during the May 1988 site assessment. Surface soil samples (i.e., 0-3 inches bgs) were collected from the approximate center of each grid in the absence of visual indications of contamination. If potential visual indications (i.e., staining, saturation) were present, a sample was collected from the area. When analytical results indicated the presence of lead or PCB contamination exceeding the established clean up levels, surface soils were excavated to a depth of 6 inches bgs, and the grid was resampled. Residual (i.e., post removal) surface soil lead and PCB levels are presented in Figures 10 and 11, respectively.
