## 2014 Former Utica Mining Camp Field Work

Structural Shoring of Machinist Shop, 08/25-28/2014

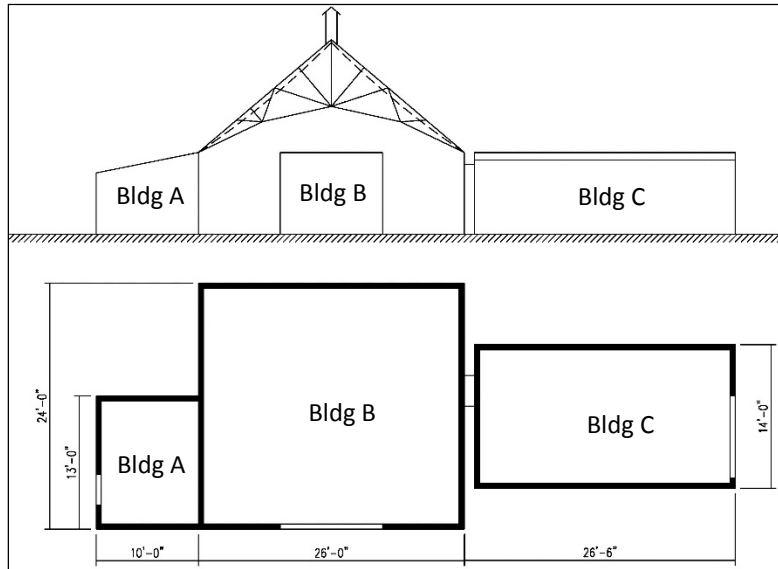
Figure 2: Machinist Shop Layout

The machinist shop is composed of three buildings: A, B, and C. Shoring of Building B (Figure 2) began with a base of two transversely oriented layers of three 2x4s on the floor of the building, followed by installation of a 4x4" column. Additional blocking was added at the top of the column to increase the area of connection and everything was toe nailed in place with screws (Photo 6). Where roof deflection was most apparent four web stiffeners were added to the beams that had been reinforced with the column (Photos 6 & 7). Because a ladder was not available during the previous site visit, some members that were thought to be strong enough for structural shoring were found to be degraded past reliability. Additional beams would have been required to tie into any other trusses.

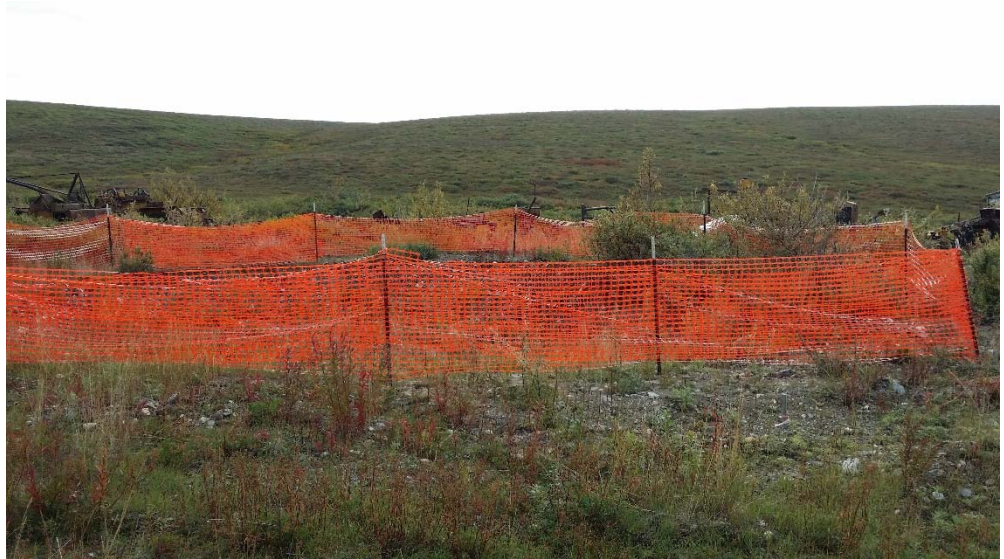
Photo 1:  
Replacement  
orange safety  
fencing around  
perimeter of prior  
powerhouse  
excavation.

Upon arrival at the site the current condition of the machinist shop was assessed. The crew also re-covered three existing wood tent platforms with tarps, and replaced the orange safety fence at the perimeter of the former powerhouse excavation (Figure 1 - AOC 1, Photo 1). Seven lead-acid batteries collected during the 2012 field effort were packaged into three vermiculite filled plastic totes and hauled back to Deering for temporary storage until shipment to an approved recycling facility is arranged.

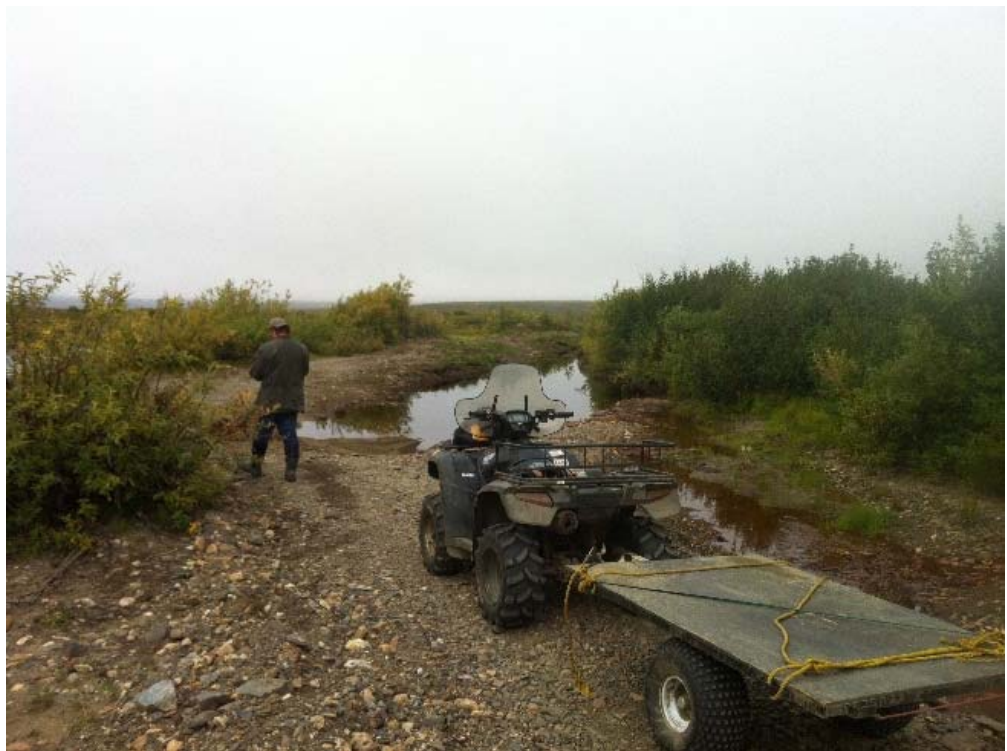
The morning of August 26 the team returned to the Utica machinist shop, while enroute the deteriorating condition of the road between Utica and Deering was documented in several locations. Noteworthy road damage included large puddles (Photo 2), washed out sections (Photo 3) and a displaced culvert (Photo 4).

Photo 2:  
Road Conditions at  
approximately  
mile 7.

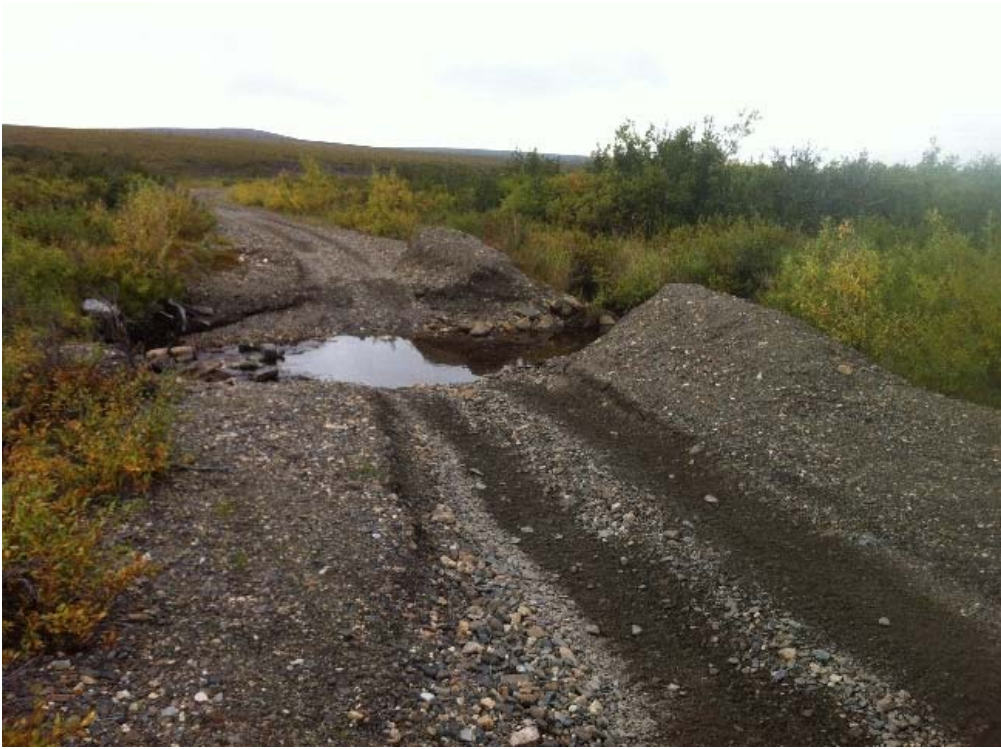
Photo 3:  
Road Conditions at  
approximately  
mile 12.

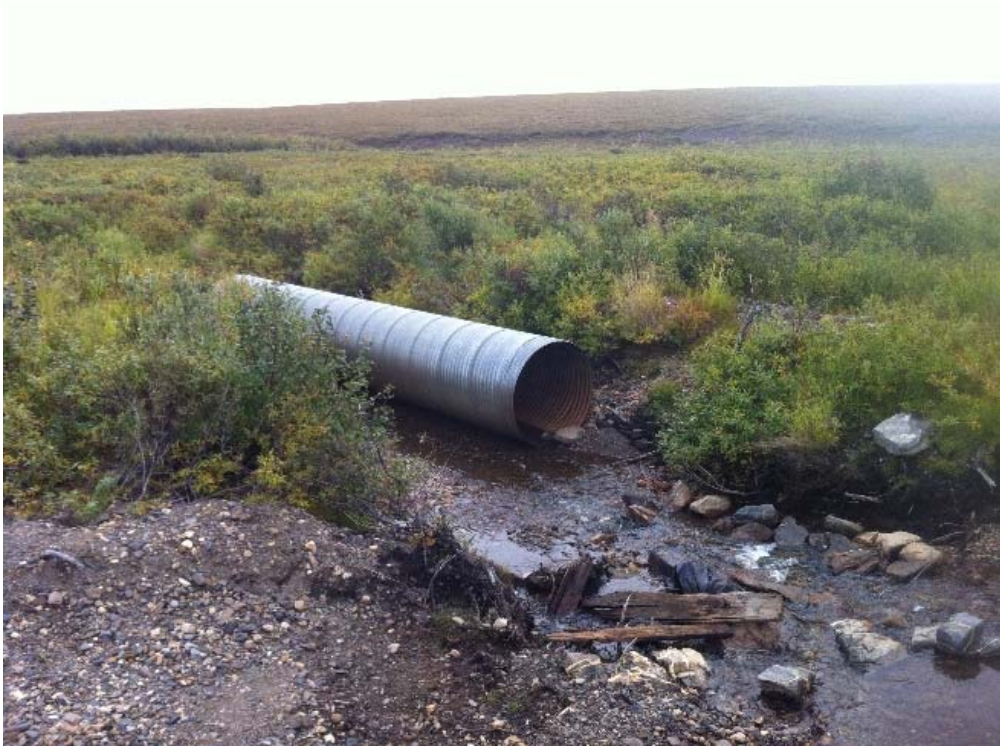
Photo 4:  
Displaced culvert  
at approximately  
mile 12.

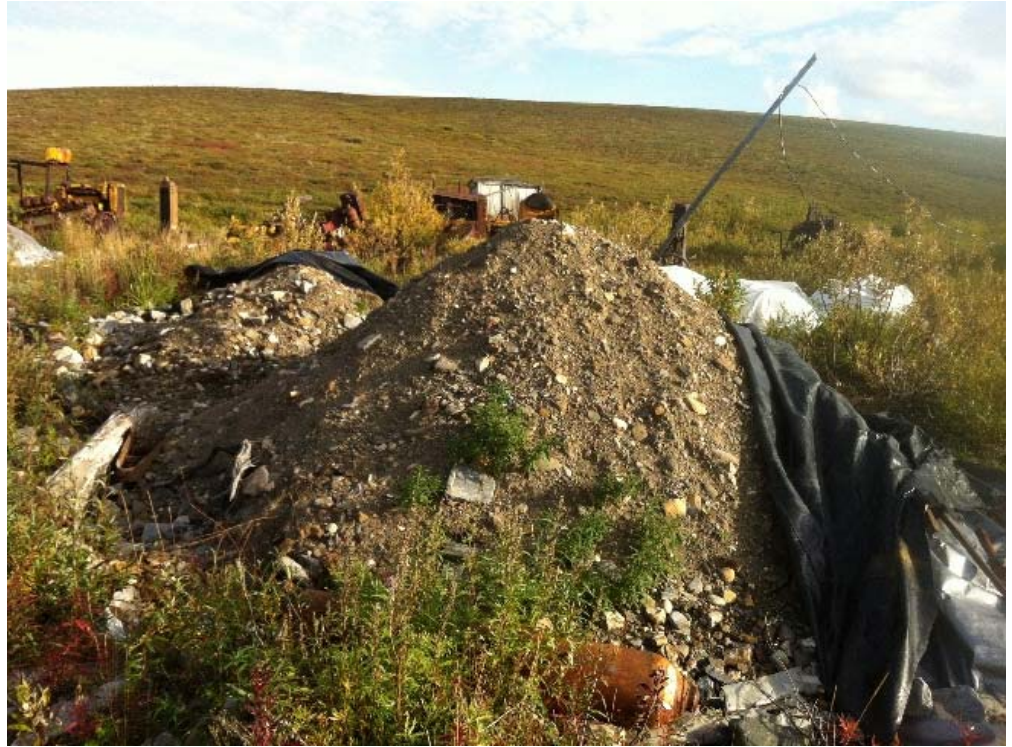
Upon arrival at Utica Troy and Maranda began shoring the existing structure of the machinist shop. A site walk through and inspection of covered soil stockpiles was performed by James and Clayton. Some of the stockpiles were uncovered and several tarps were in need of repair or replacement (Photo 5).

Photo 5:  
Uncovered soil  
stockpile

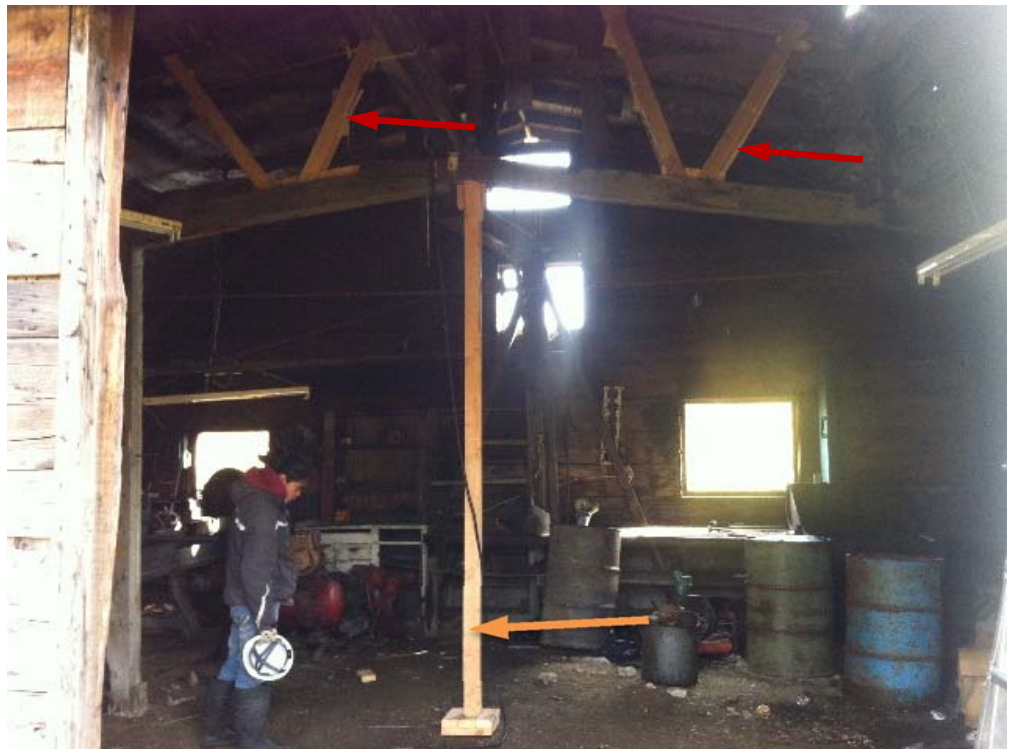
Photo 6:  
Building B new  
web stiffeners  
(red) and column  
(orange).

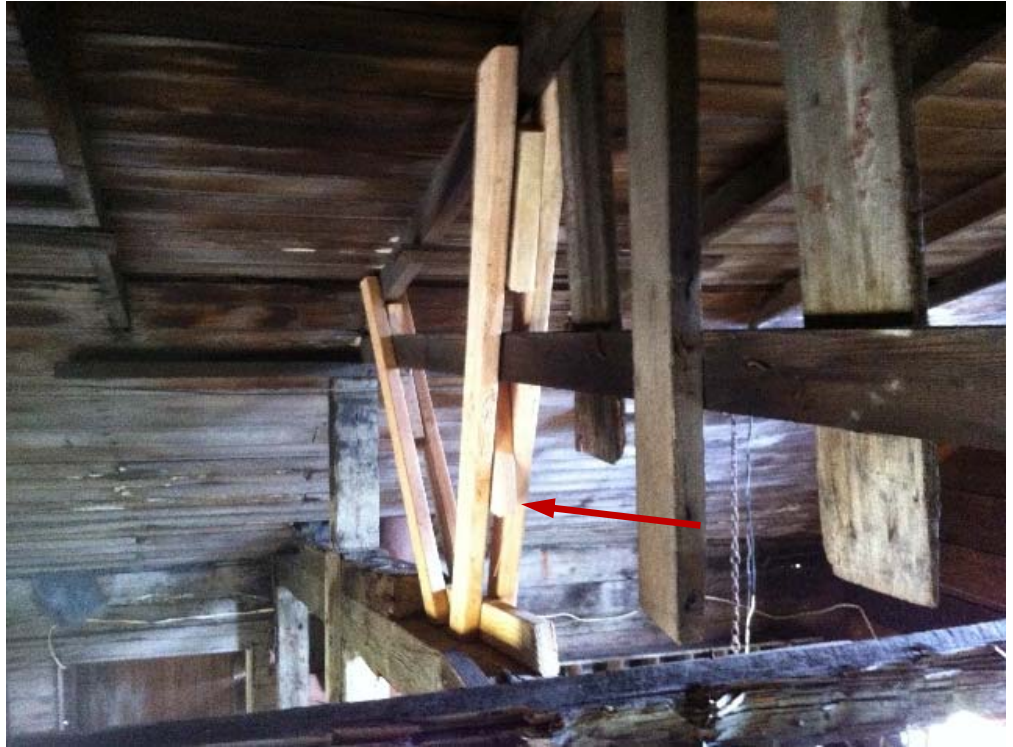
Photo 7:  
Web stiffeners  
installed in  
Building B

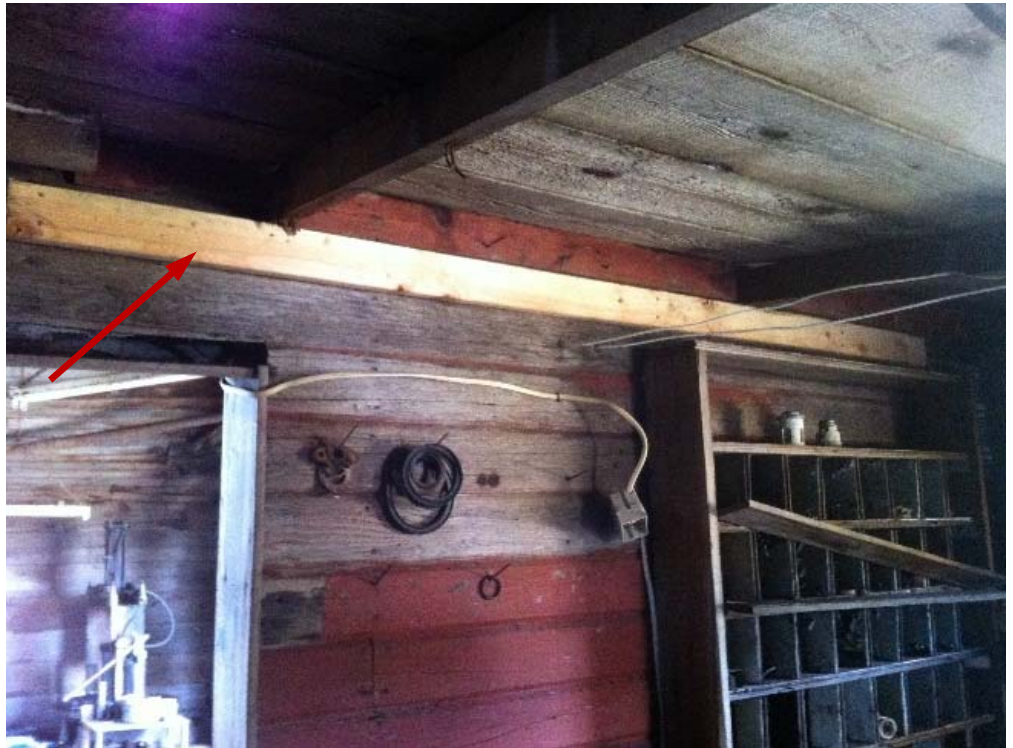
Photo 8:  
Ledger board  
added in building  
section A

In Building A a ledger board was screwed into the studs of the wall (Photo 8) as recommended in the structural investigation report. Building C was left unaltered, as upon further inspection it appeared structurally sound. It previously appeared that cross bracing was missing in Building C, but that was due to additional members being nailed onto non-structural columns.

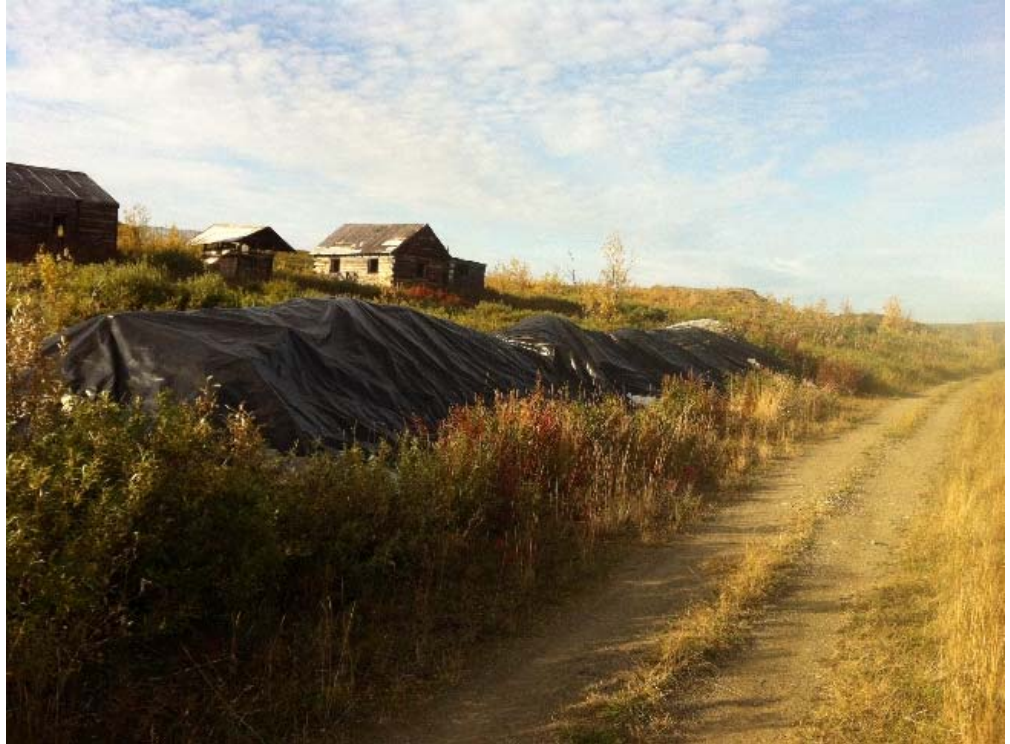
Photo 9:  
Re-covered soil  
stockpiles.

While the work in the machinist shop was being completed, James and Clayton inspected and, as needed, re-covered stockpiles of previously excavated soils around the site (Figure 1 - AOC 8, Photo 9). Once they were satisfactorily covered, the drum staging areas were inspected. The drums near a large tailings pile just outside the eastern site boundary and north of the road remained well covered and the integrity of the cover looked good (Photo 10). One Caterpillar heavy equipment battery was found and removed from this area and one additional battery was discovered and extracted near building 22. Plastic sheeting covering drums on the western side of the machinist shop had begun to degrade and tear from exposure to the environment (Photo 11), replacement should be considered. The condition of cached supplies (poles for wall tent, propane tanks, toilet paper) for future mobilizations was checked, everything appears to be present but some minor disturbance was evident. After shoring of the building was completed, a ladder purchased for this work was secured in the machinist shop (Photo 12). The remaining 5 batteries (12 total) were transported back to Deering and staged for future shipment and disposal.

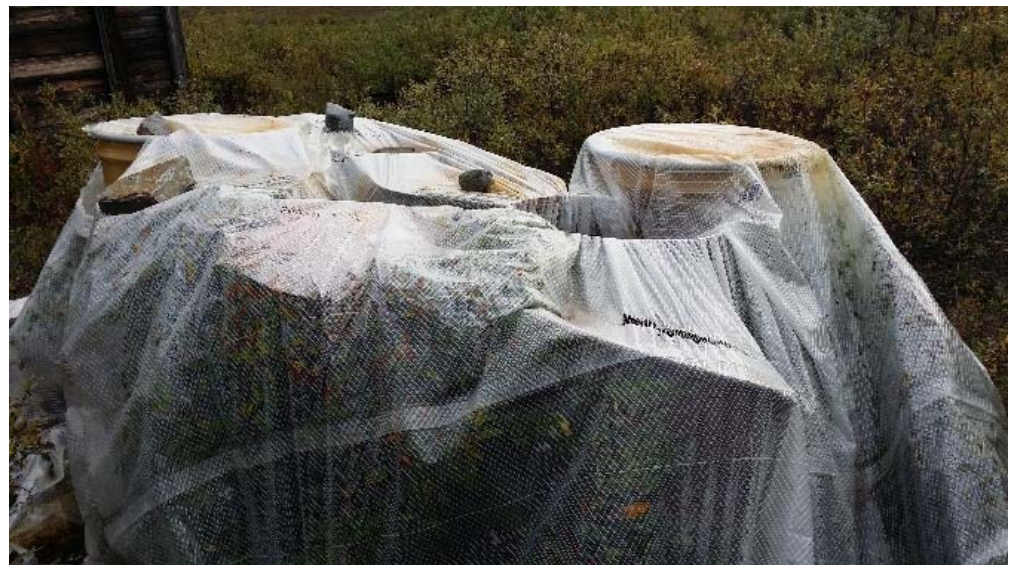
Photo 10:  
Weathered, but  
intact, DuraSkrim  
plastic sheeting  
covering drums.

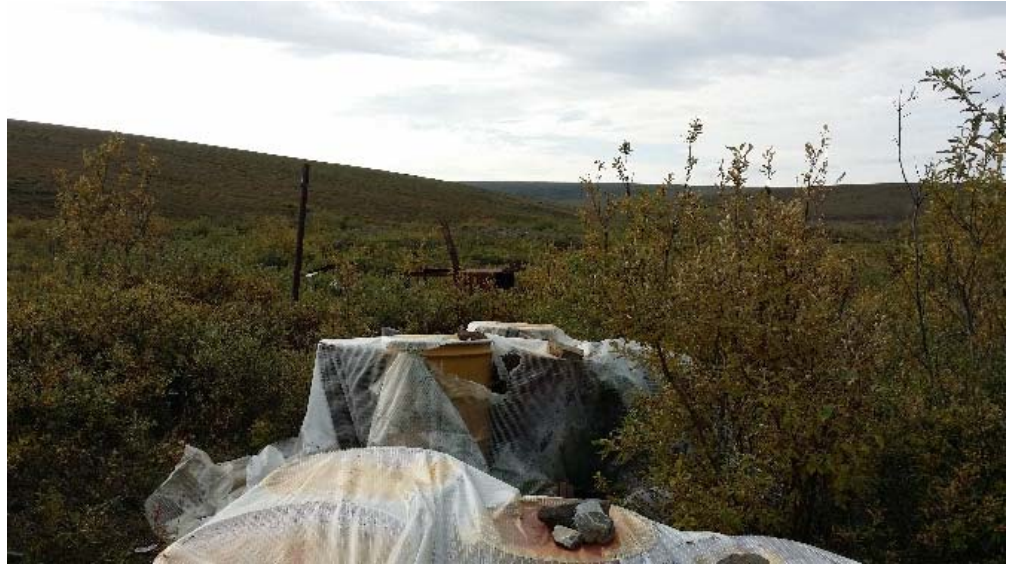
Photo 11:  
Weathered and  
torn DuraSkrim  
sheeting over  
drums.

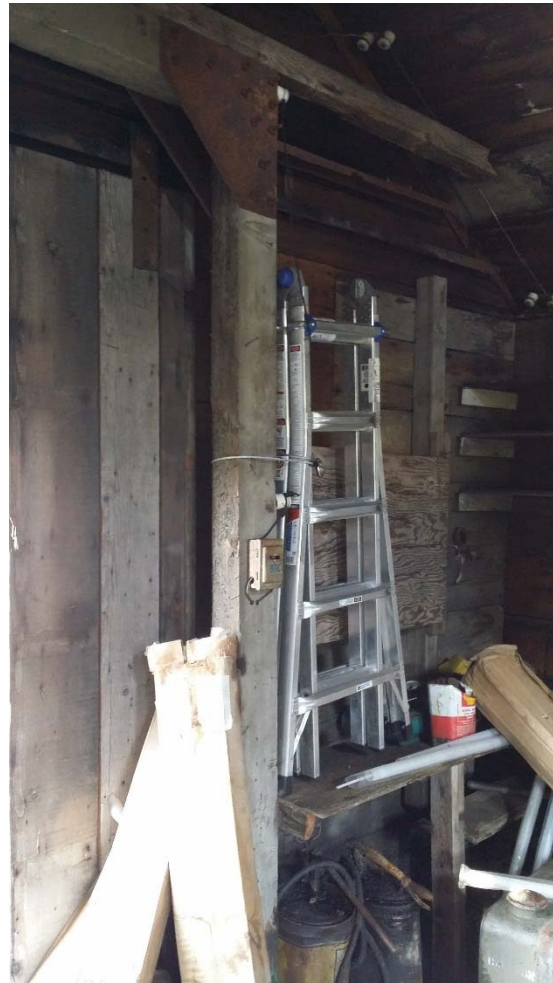
Photo 12:  
Ladder secured in  
machinist shop.
