INSTITUTIONAL CONTROL PERFORMANCE REPORT

PORT HEIDEN RADIO RELAY STATION

PORT HEIDEN, ALASKA

15 November 2011

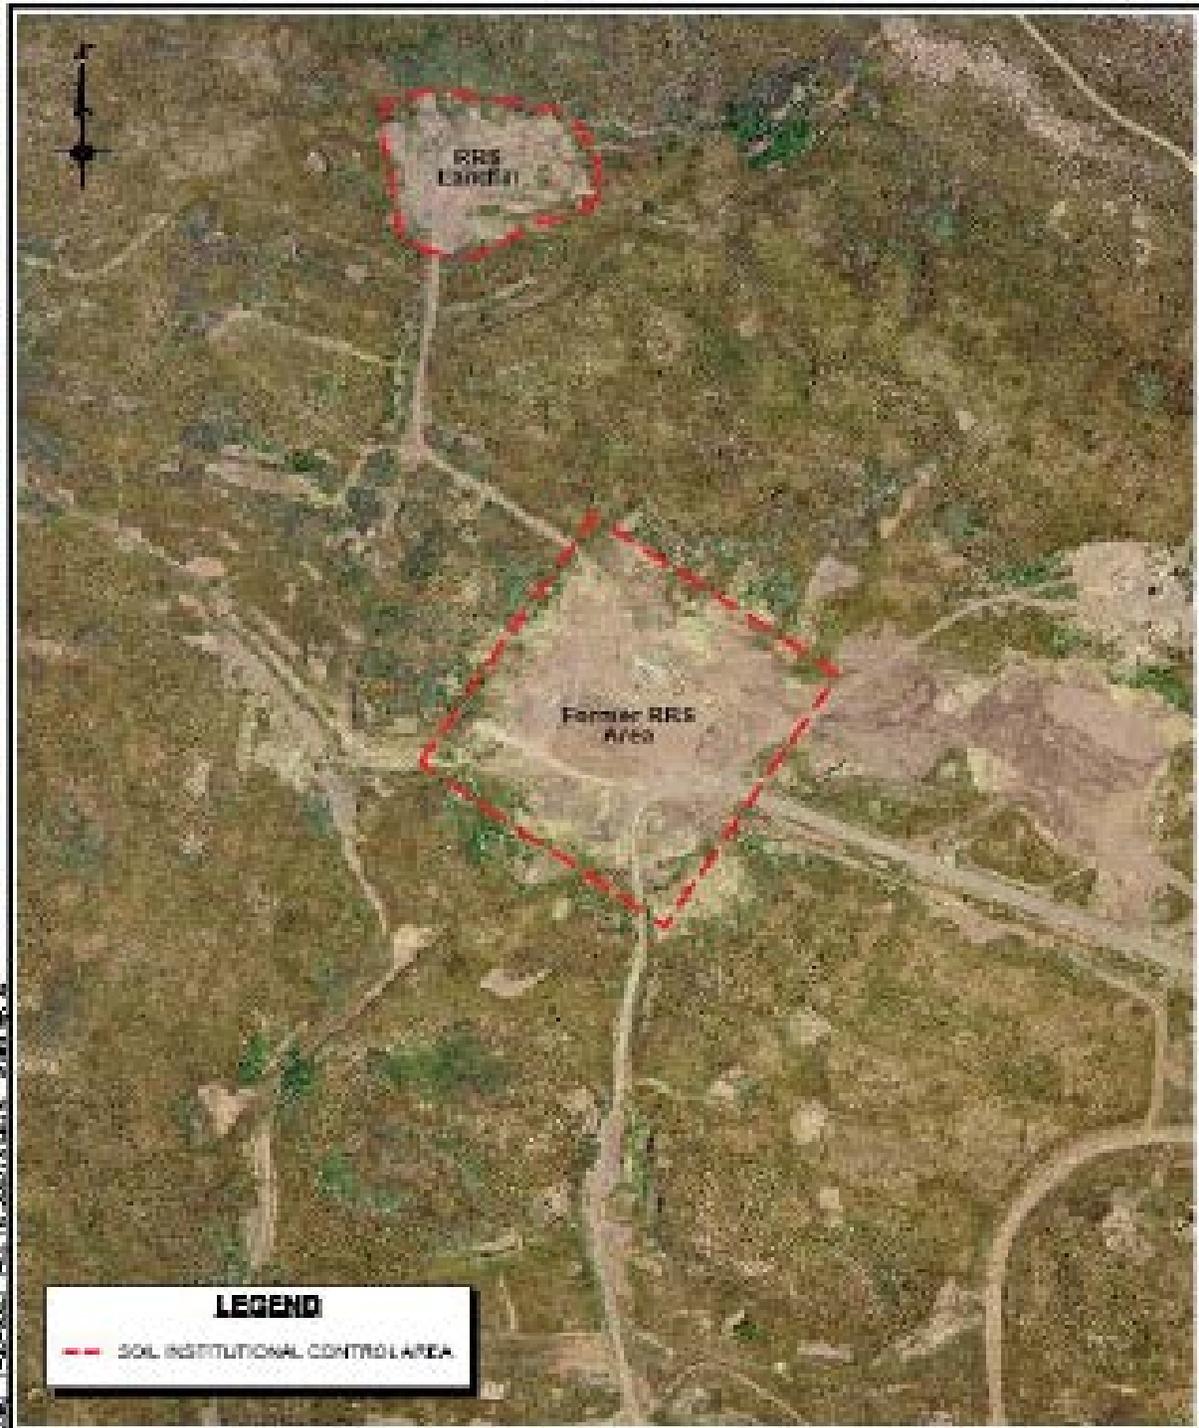
Figure 2-1 AREAS IMPACTED BY INSTITUTIONAL CONTROLS - SOIL

Per the ROD (USAF, 2009), a notice type of institutional control (IC) will be implemented (with the land owners consent) to control the use of soil containing residual concentrations of dieldrin above 0.0076 mg/kg. The location of the institutional control area is depicted on Figure 2-1. This notice will make the Land Owner aware that the Alaska Department of Environmental Conservation (ADEC) approval is required for any disturbance of soil (the goal of this institutional control is to prevent the constant contact of this media with water which could impact groundwater or surface water quality).

If future property use includes disturbance of the institutional control area (see Figure 2-1) such that the remaining pesticide contaminated soil comes in constant contact with water, or other information becomes available which indicates that the site may pose an unacceptable risk to human health, safety, welfare or the environment, the land owner and/or operator are required under 18 AAC 75.300 to notify ADEC and evaluate the environmental status of the contamination in accordance with applicable laws and regulations. Further site characterizations and cleanup may be necessary under 18 AAC 75.325-.390.

As approved by ADEC, the excavations were backfilled to within two feet of the original surface. Edges were contoured to eliminate a sharp drop. Rainwater would from time to time pool in these depressions. As dieldrin was not present, no further steps were taken to eliminate the temporary ponding of water. The Air Force plans to submit a modification to the ROD to eliminate the need for an IC related to dieldrin at the RRS.

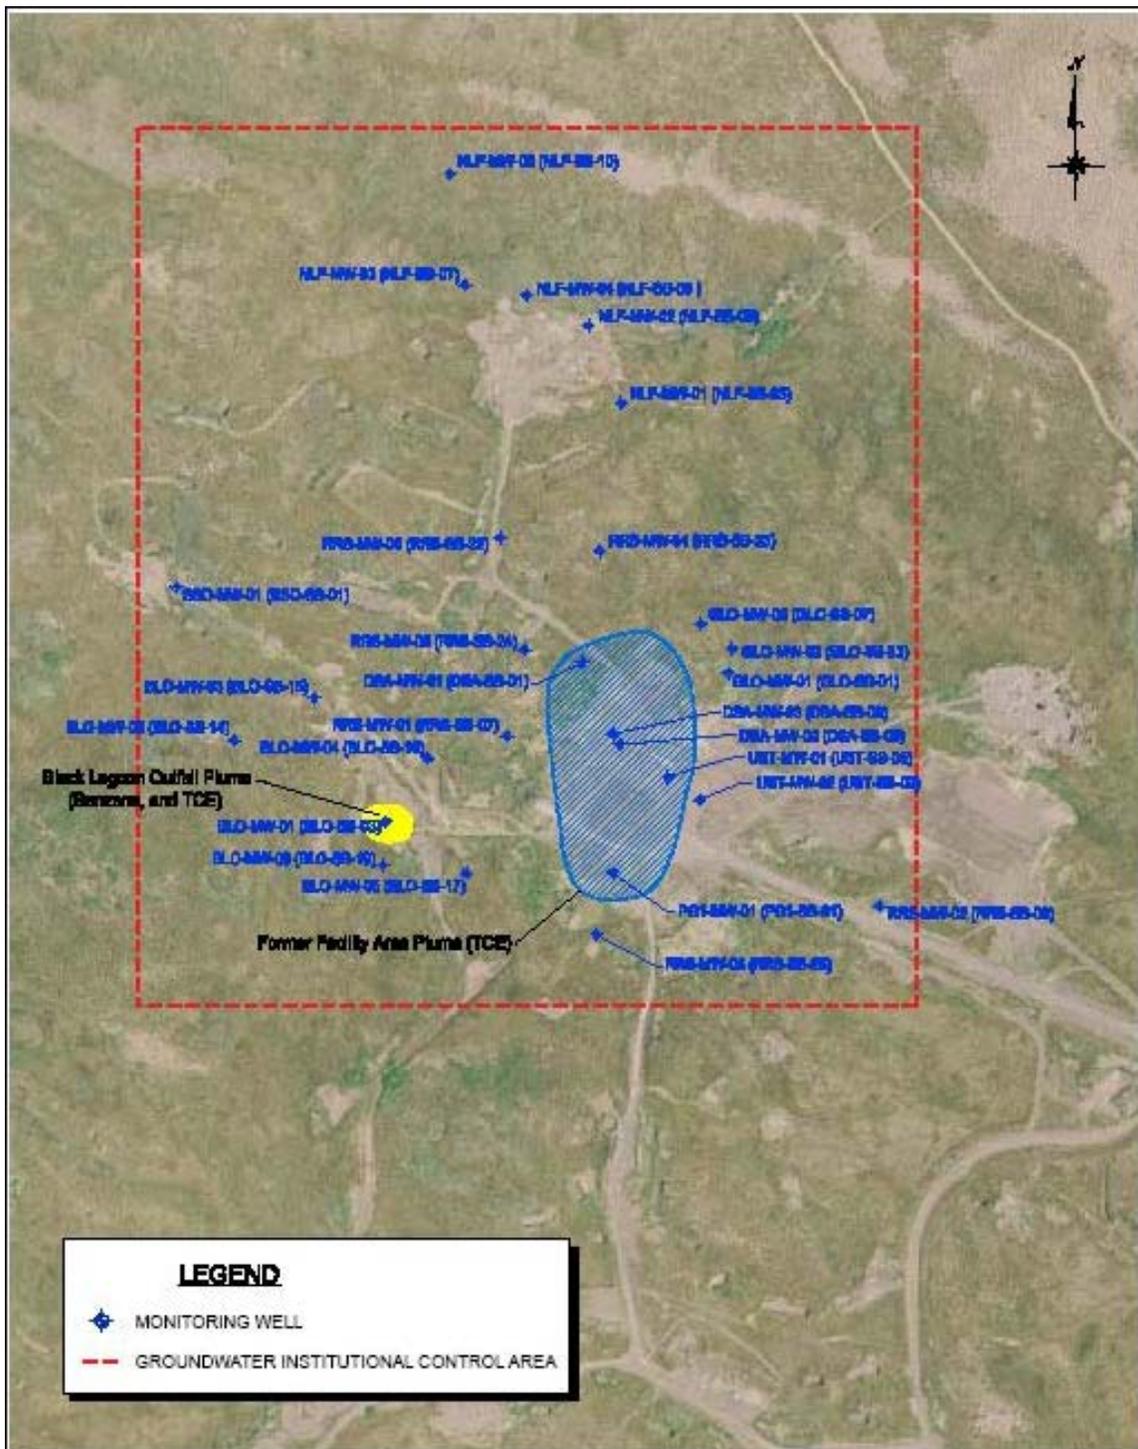
Figure 2-2 AREAS IMPACTED BY INSTITUTIONAL CONTROLS - WATER

Per the ROD, institutional groundwater controls will be implemented to include limitations on groundwater use as approved by ADEC, and notices to the land owner and Village Council of site status. The location of the groundwater institutional control area is depicted on Figure 2-2. These ICs will remain in place until groundwater cleanup levels are achieved through natural attenuation. The objectives of the groundwater ICs are to prevent the drinking of trichloroethylene (TCE) and benzene contaminated water and to prevent its extraction and surface use without treatment.

Other than for sampling purposes, no groundwater was used at the site. The landowner has not accessed the site for any activities beyond a routine site visit. The landowner made no attempt to access/use groundwater. There is no evidence that any other visitor to the site attempted to use groundwater. Sample results will be presented in a separate report.

No additional groundwater contamination was identified. No new contaminants, no new sites, and no new sources were identified. No new exposure pathways were identified. There has been no change of property ownership; no land transfers, sales, or leases.
