**INSTITUTIONAL CONTROL  
PERFORMANCE REPORT**

**PORT HEIDEN RADIO RELAY STATION**

**PORT HEIDEN, ALASKA**

18 November 2010

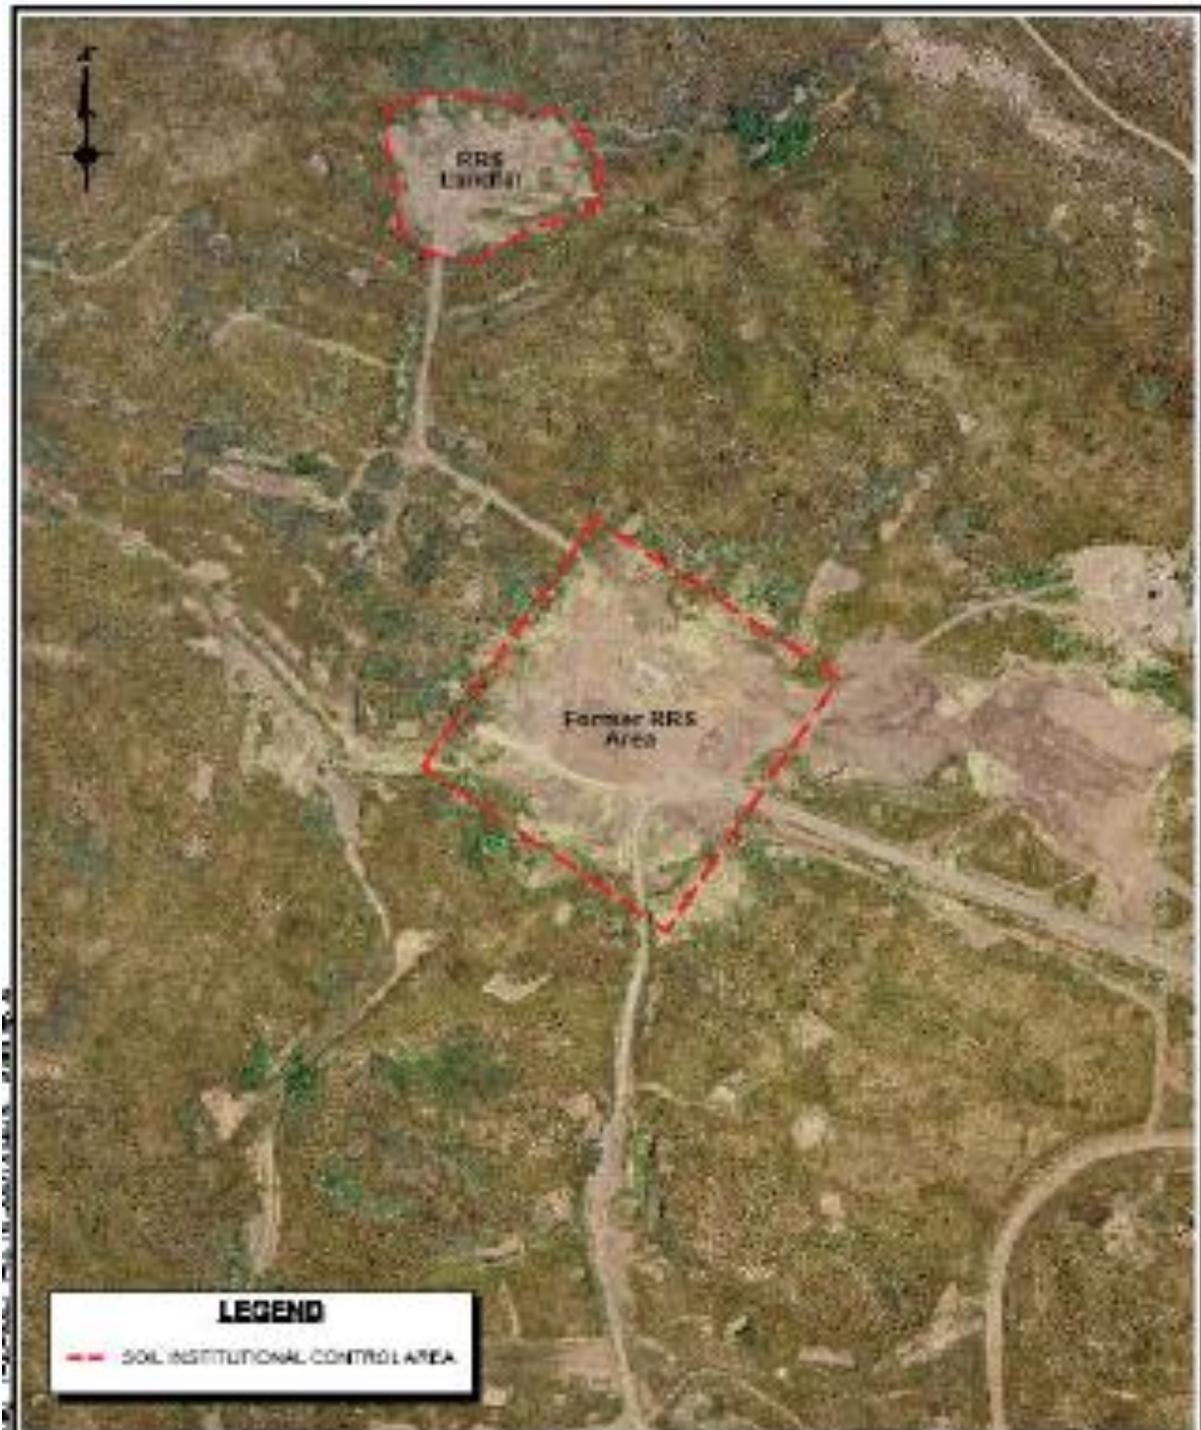
**Figure 2-1 AREAS IMPACTED BY INSTITUTIONAL CONTROLS - SOIL**

Per the ROD, a notice type of institutional control (IC) will be implemented (with the land owners consent) to control the use of soil containing residual concentrations of dieldrin above 0.0076 mg/kg. The location of the institutional control area is depicted on Figure 2-1. This notice will make the Land Owner aware that the Alaska Department of Environmental Conservation (ADEC) approval is required for any disturbance of soil (the goal of this institutional control is to prevent the constant contact of this media with water which could impact groundwater or surface water quality).

If future property use includes disturbance of the institutional control area (see Figure 1-1) such that the remaining pesticide contaminated soil comes in constant contact with water, or other information becomes available which indicates that the site may pose an unacceptable risk to human health, safety, welfare or the environment, the land owner and/or operator are required under 18 AAC 75.300 to notify ADEC and evaluate the environmental status of the contamination in accordance with applicable laws and regulations. Further site characterizations and cleanup may be necessary under 18 AAC 75.325-.390.

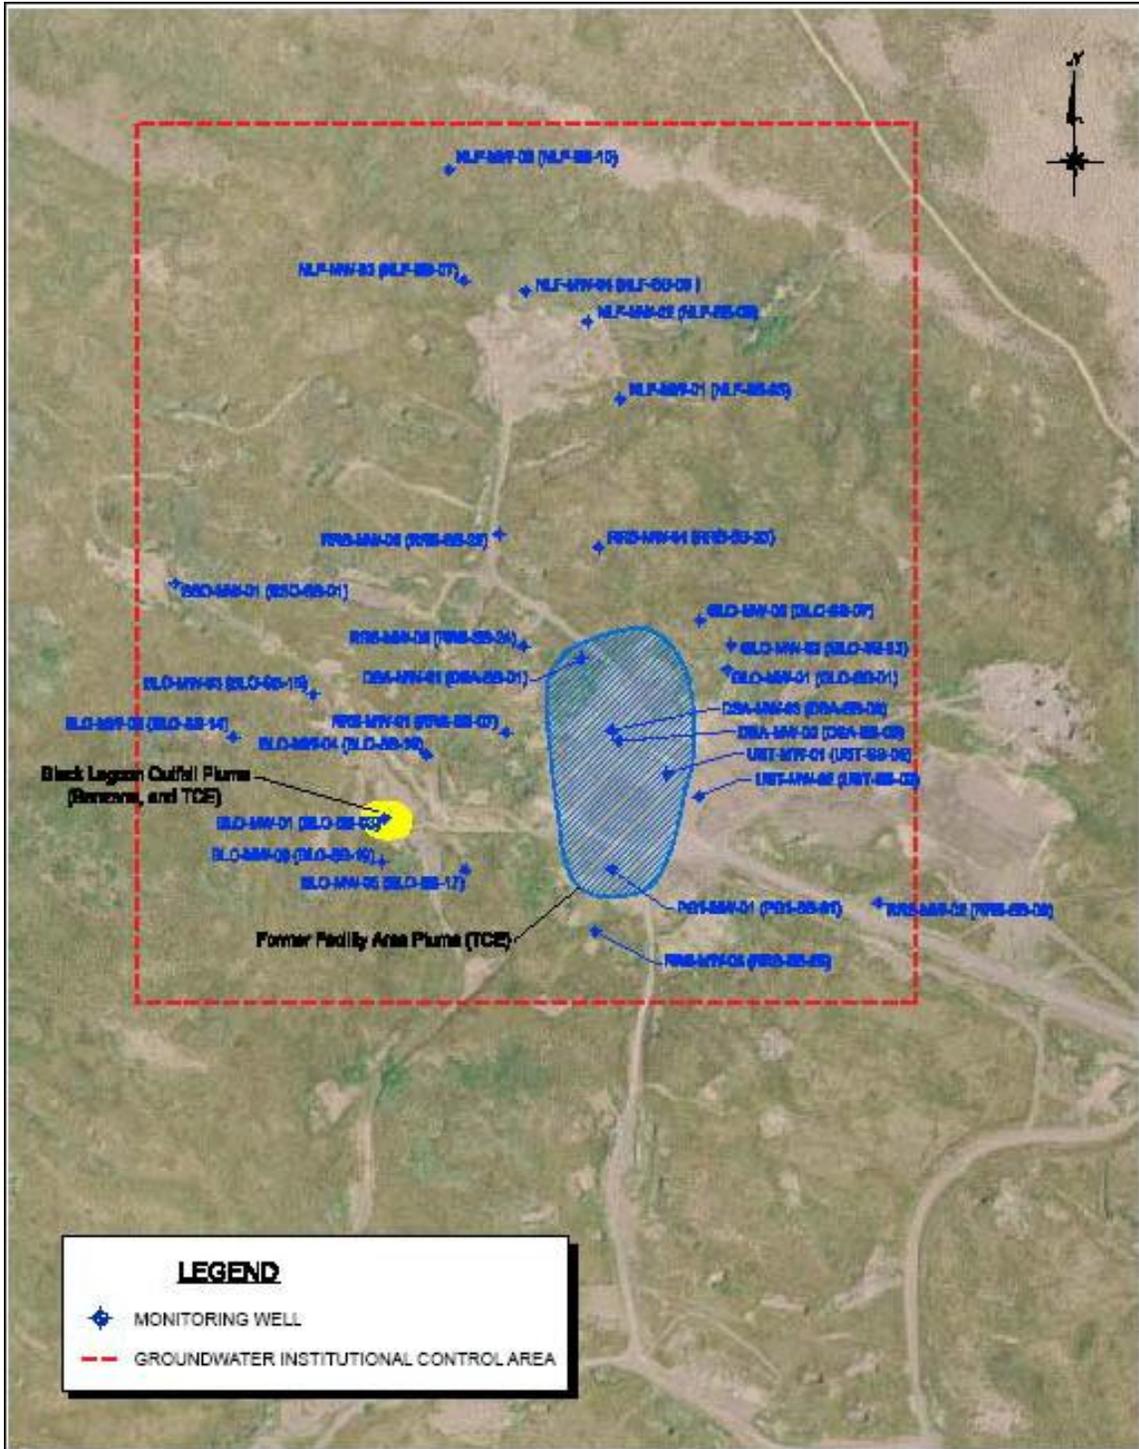
**Figure 2-2 AREAS IMPACTED BY INSTITUTIONAL CONTROLS - WATER**

Per the ROD, institutional groundwater controls shall include limitations on groundwater use as approved by ADEC, and notices to the land owner and Village Council of site status. The location of the groundwater institutional control area is depicted on Figure 2-2. These ICs will remain in place until groundwater cleanup levels are achieved through natural attenuation. The objectives of the groundwater ICs are to prevent the drinking of trichloroethylene (TCE) and benzene contaminated water and to prevent its extraction and surface use without treatment.
