Notice of Environmental Contamination

Grantee: The Corporation of the Archbishop of Anchorage
Tazlina River Dumpsite (Contaminated Sites Database Hazard ID No. 26337)

Re: Decision Documents - Cleanup Complete for *Tazlina Copper Valley School Site*, Hazard ID 25429; and
Cleanup Complete with Institutional Controls for *Tazlina River Dumpsite*, Hazard ID 26337.

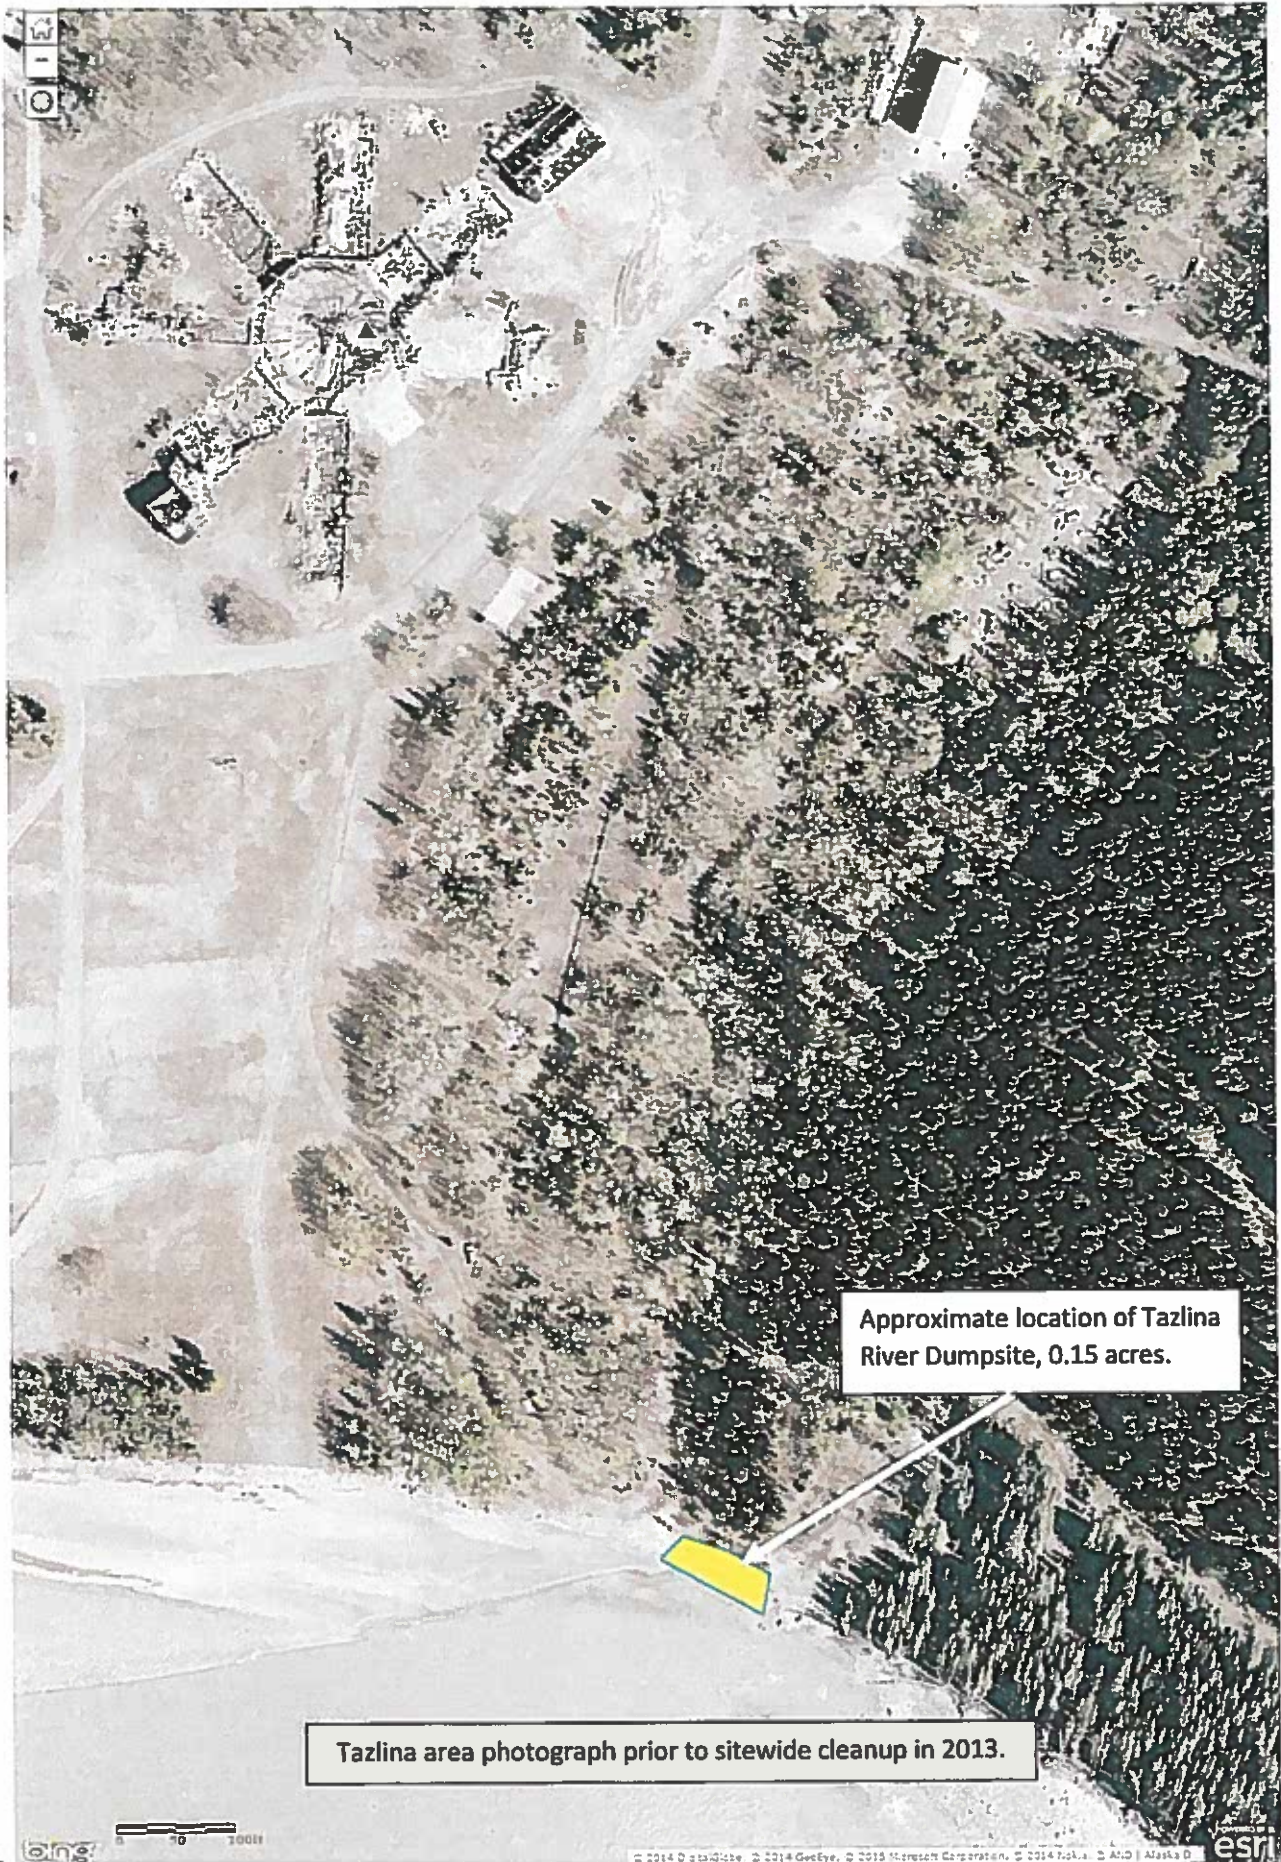
Tazlina area photograph prior to sitewide cleanup in 2013.

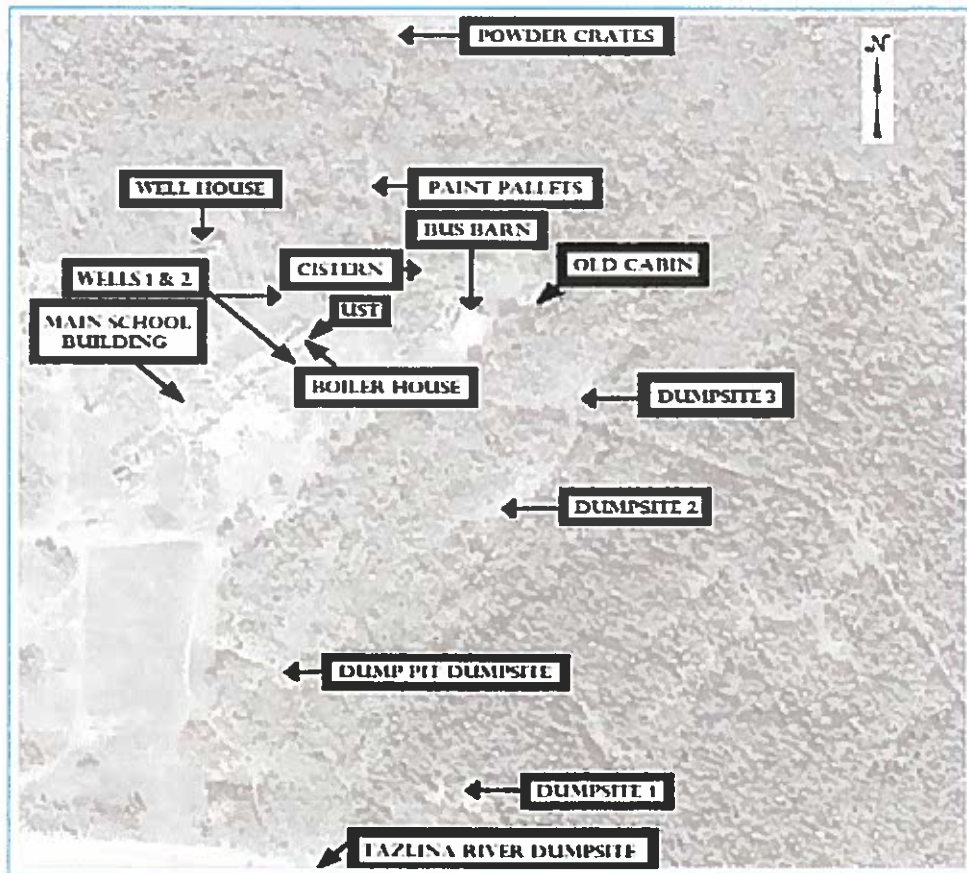
Detailed figure of building locations and hazard locations on former school property.

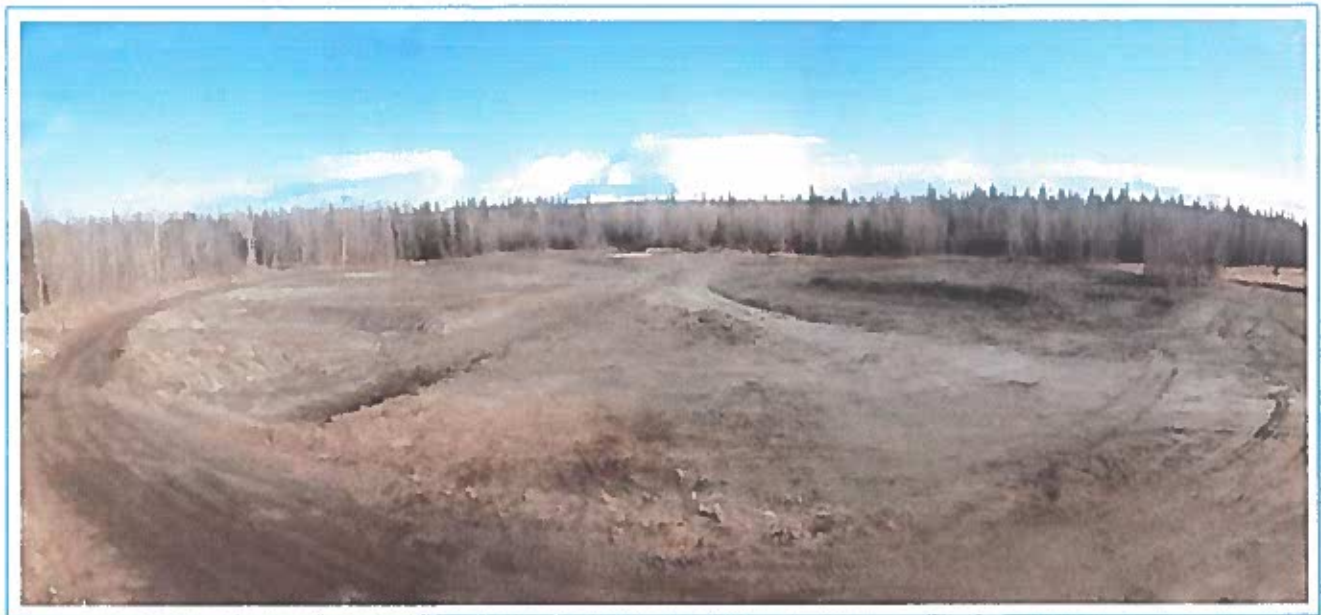
Final picture of school property following cleanup activities.
