Department of Environmental Conservation

RE: Decision Document: Thane Bunker Fuel Tanks  
Cleanup Complete Determination

Thane Bunker Fuel Tanks  
0 Thane Road  
Juneau, Alaska 99801  
Parcel No. 1B0401000030

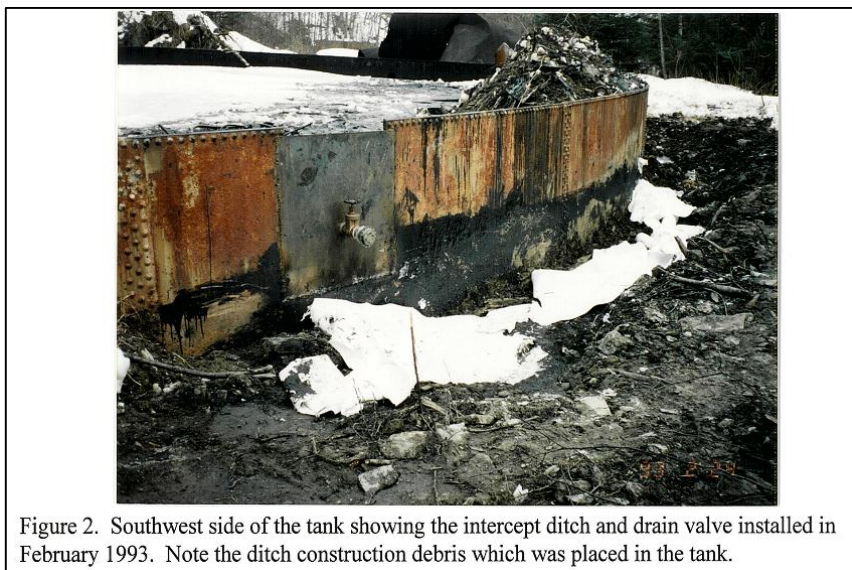
Figure 2. Southwest side of the tank showing the intercept ditch and drain valve installed in February 1993. Note the ditch construction debris which was placed in the tank.

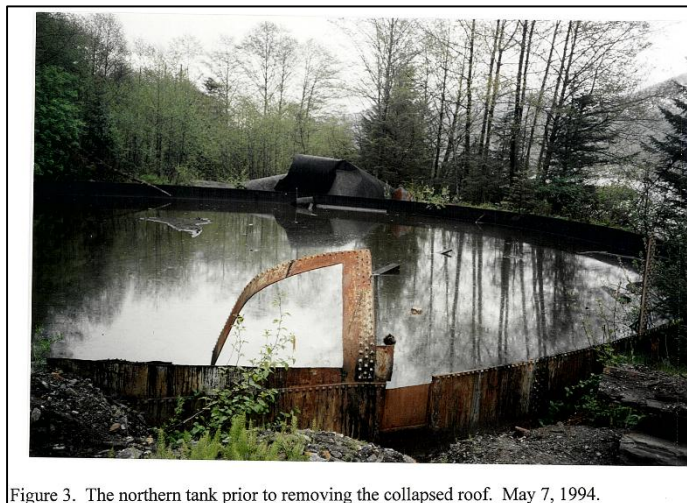
In 1994, DEC and the U.S. Coast Guard initiated a cleanup operation where woodchips were added to the north tank in an attempt to solidify the oil and then incinerate the solid oil wastes. The cleanup was not completed and the north tank was left with a mixture of Bunker-C fuel, water, wood chips, contaminated soil, and other debris.

Figure 3. The northern tank prior to removing the collapsed roof. May 7, 1994.

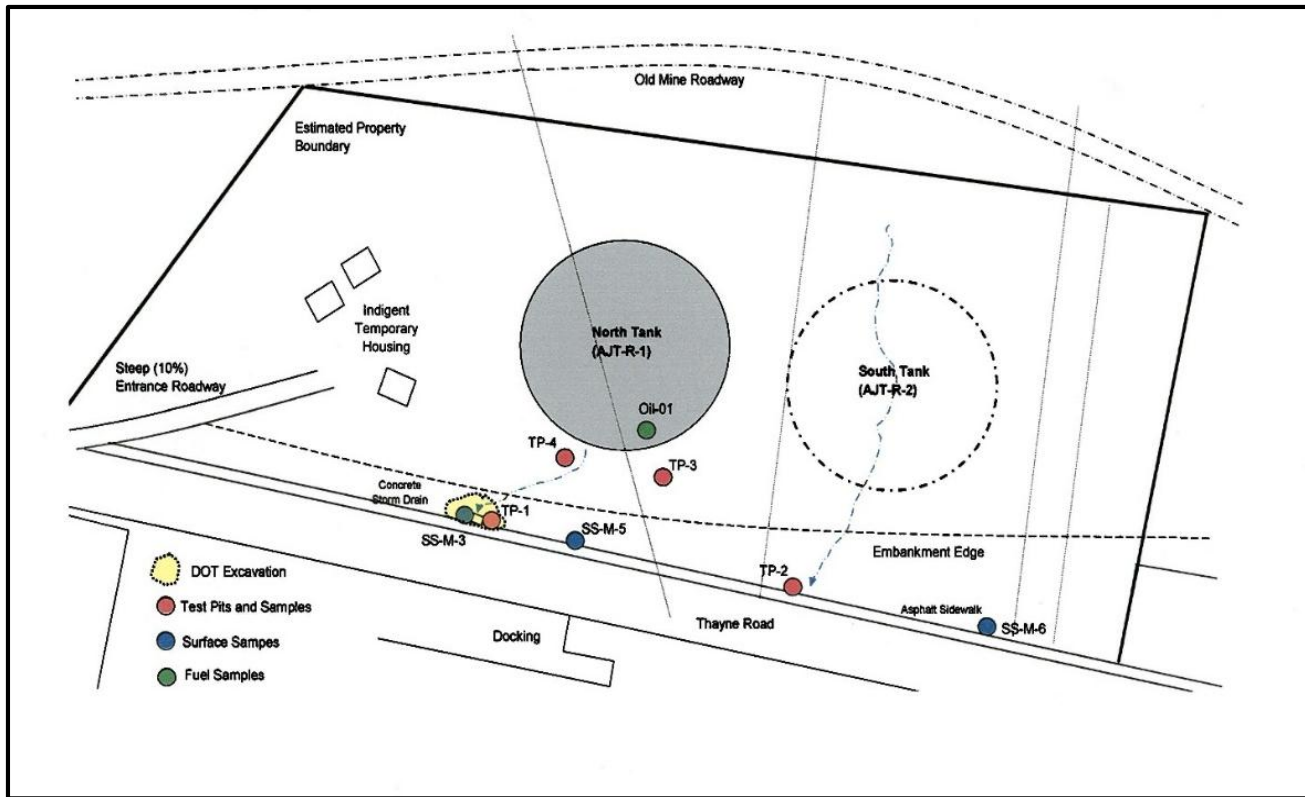
Reconstruction Project. A 1996 Preliminary Site Investigation (PA/SI) was prepared for ADOT&PF in anticipation of the road construction project to determine the extent contaminated soils migrated toward the road and project site. The PA/SI was conducted by Easton Environmental and included the first record of laboratory sampling at the site. Lab results revealed that the petroleum hydrocarbons present were 20 percent (by weight) diesel range and 80 percent residual range. Sample analyses of the product in the north tank were: 140,000 mg/kg Diesel Range Organics (DRO) and 470,000 mg/kg Residual Range Organics (RRO) and the south tank: 130,000 mg/kg DRO and 480,000 mg/kg RRO. Four test pits were excavated; two near Thane Road along an overflow route and two between the north tank and the top of the embankment. Samples were collected at the surface and at 2-foot interval depths to a maximum depth of 8-feet. Test pit locations can be seen in Figure 4. Laboratory analysis indicated areas of petroleum hydrocarbon contamination between the north tank and the top of the embankment leading down toward the road. The contamination appeared to be shallow and decreased with distance from the tank. One of the four test pits (TP1-1) indicated a total petroleum hydrocarbon concentration of 33,000 mg/kg above the DEC Leaking Underground Storage Tank Program cleanup standard of 2000 mg/kg. All other test pit analyses were below the DEC levels of concern. Approximately 65 tons of contaminated soil located in the ADOT&PF project area was removed but its final location is unknown.

Figure 4: Test Pit locations from the 1996 Easton Environmental Report prepared for ADOT&PF

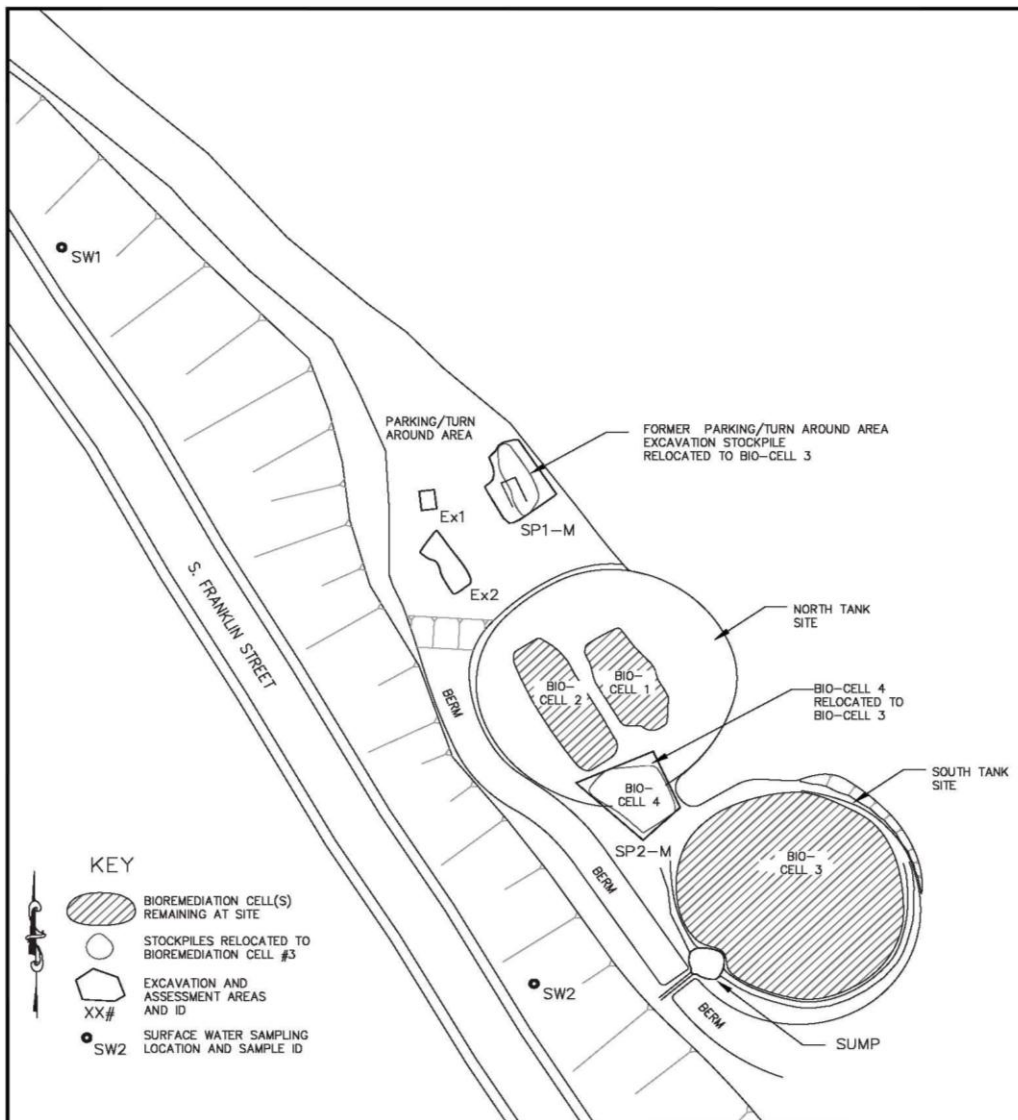
Table 1 shows that bioremediation cells 1 and 2 had contaminant concentrations below DEC cleanup criteria; these were not excavated for further treatment. Bioremediation cell 4 was relocated to the former South Tank footprint where the soil was integrated with bioremediation cell 3 (refer to Figure 5). The parking turnaround stockpile was also relocated to bioremediation cell 3 (bio-cell 3) in addition to two locations within the parking turnaround area (Ex1 and Ex2) that were identified in the SMS Report (2012) as having contamination above cleanup levels. The sediment within the existing sump adjacent to bio-cell 3 was excavated and also placed in the cell for treatment.

Figure 5: Bioremediation Cells locations 2013- Nortech Site Assessment and Remediation Report, 2013

Upon completion of excavation, the sump was field screened and sampled, a new liner was placed in the sump, and sorbent booms were installed at the outfall of the sump. The soil within bio-cell 3 was turned and mixed after assessment activities were completed.
