**Environmental Evaluation of Property  
Summit Prototype Homesite  
Buckland, Alaska**

July 2012

By:  
**Shannon & Wilson, Inc.**  
5430 Fairbanks Street, Suite 3  
Anchorage, Alaska 99518  
Phone: (907)561-2120  
Fax: (907)561-4483  
e-mail: [msh@shanwil.com](mailto:msh@shanwil.com)

32-1-17517

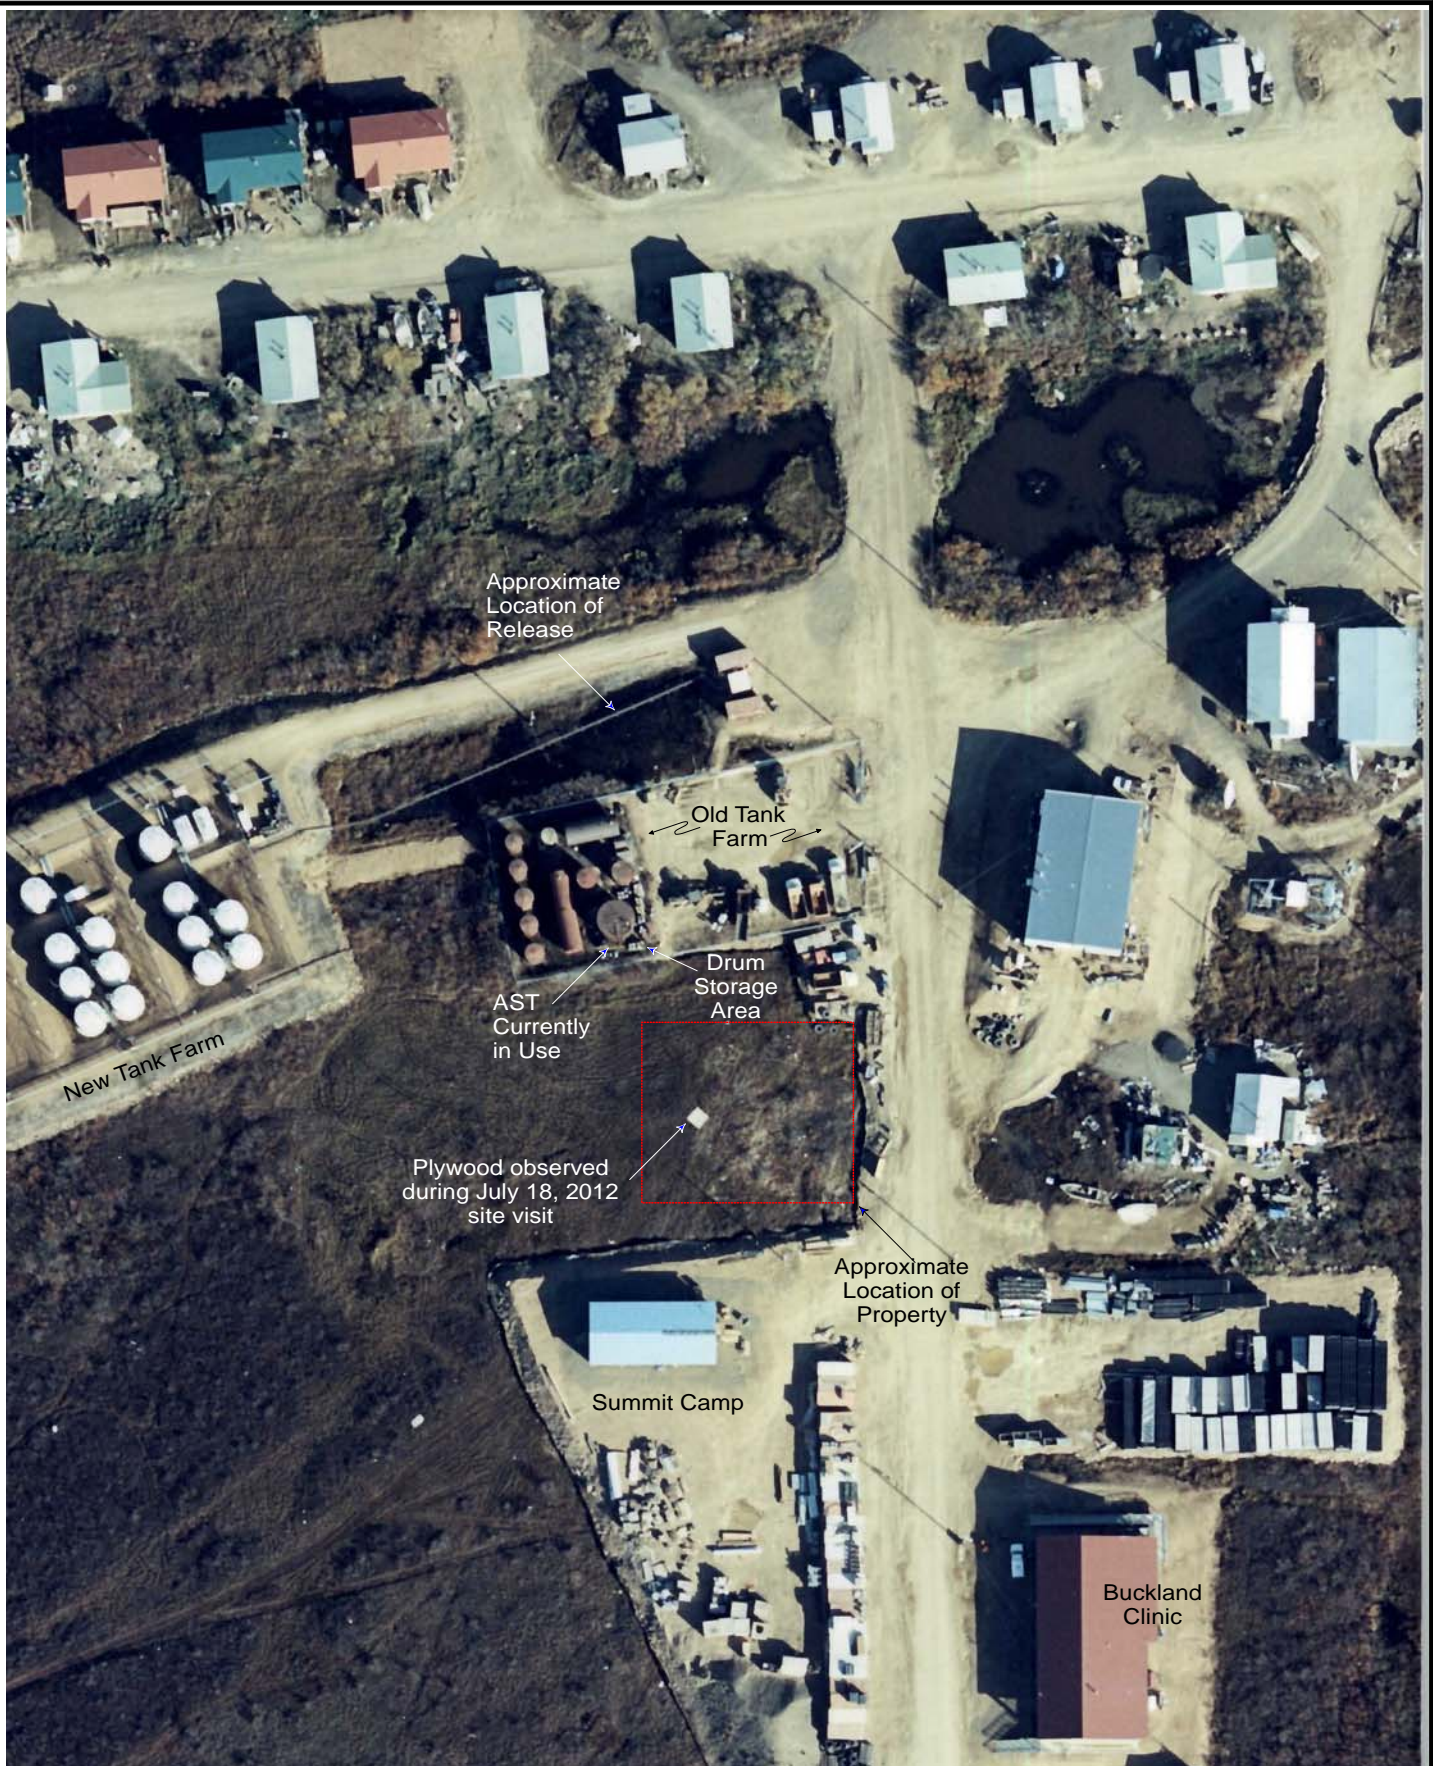
Summit Prototype Homesite Buckland, Alaska		
<b>SITE PLAN</b> (Aerial Photograph Dated September July 2012                      21, 2010)                      32-1-17517		
 	SHANNON & WILSON, INC. Geotechnical & Environmental Consultants	<b>Fig. 2</b>

The September 21, 2010 aerial photograph is included as Figure 2 and is the next most recent photograph after the 1996 aerial. The Property appears much as it did during the July 18, 2012 site visit. A piece of plywood was observed in the central portion of the Property during the July 2012 site visit, and it appears that this piece of plywood is present in the 2010 aerial photograph. The vehicle path is no longer visible on the Property. Additional development has occurred to the north. The vehicle parking/storage area at the Old Tank Farm appears as it did during the July 18, 2012 site visit. The structure observed in this area in the 1996 photo is not evident in the 2010 photo. Additional stored materials are visible in the southeastern corner of the Old Tank Farm. Further north, an access road has been constructed and extends to the New Tank Farm which was constructed to the west of the Old Tank Farm. The New Tank Farm appears to contain approximately 19 ASTs which are segregated into three containment units. The Summit Camp is present to the south of the Property and the Buckland Clinic is visible to the southeast of the Property across the access road. Additional development has been conducted to the east of the Property, east of the access road and one additional building is present to the northeast of the Property east of the access road.

The Old Tank Farm parcel includes a vehicle parking/storage area to the east and a bermed tank farm to the west (see Figure 2 aerial photograph). The Old Tank Farm contains 12 ASTs, 11 of which are reported to be empty. The southeastern tank, indicated on Figure 2, is reportedly currently in use. Signs of surface stains were observed in the central portion of the Old Tank Farm and faint hydrocarbon odors were also noted. Ponded water was observed in the southwest

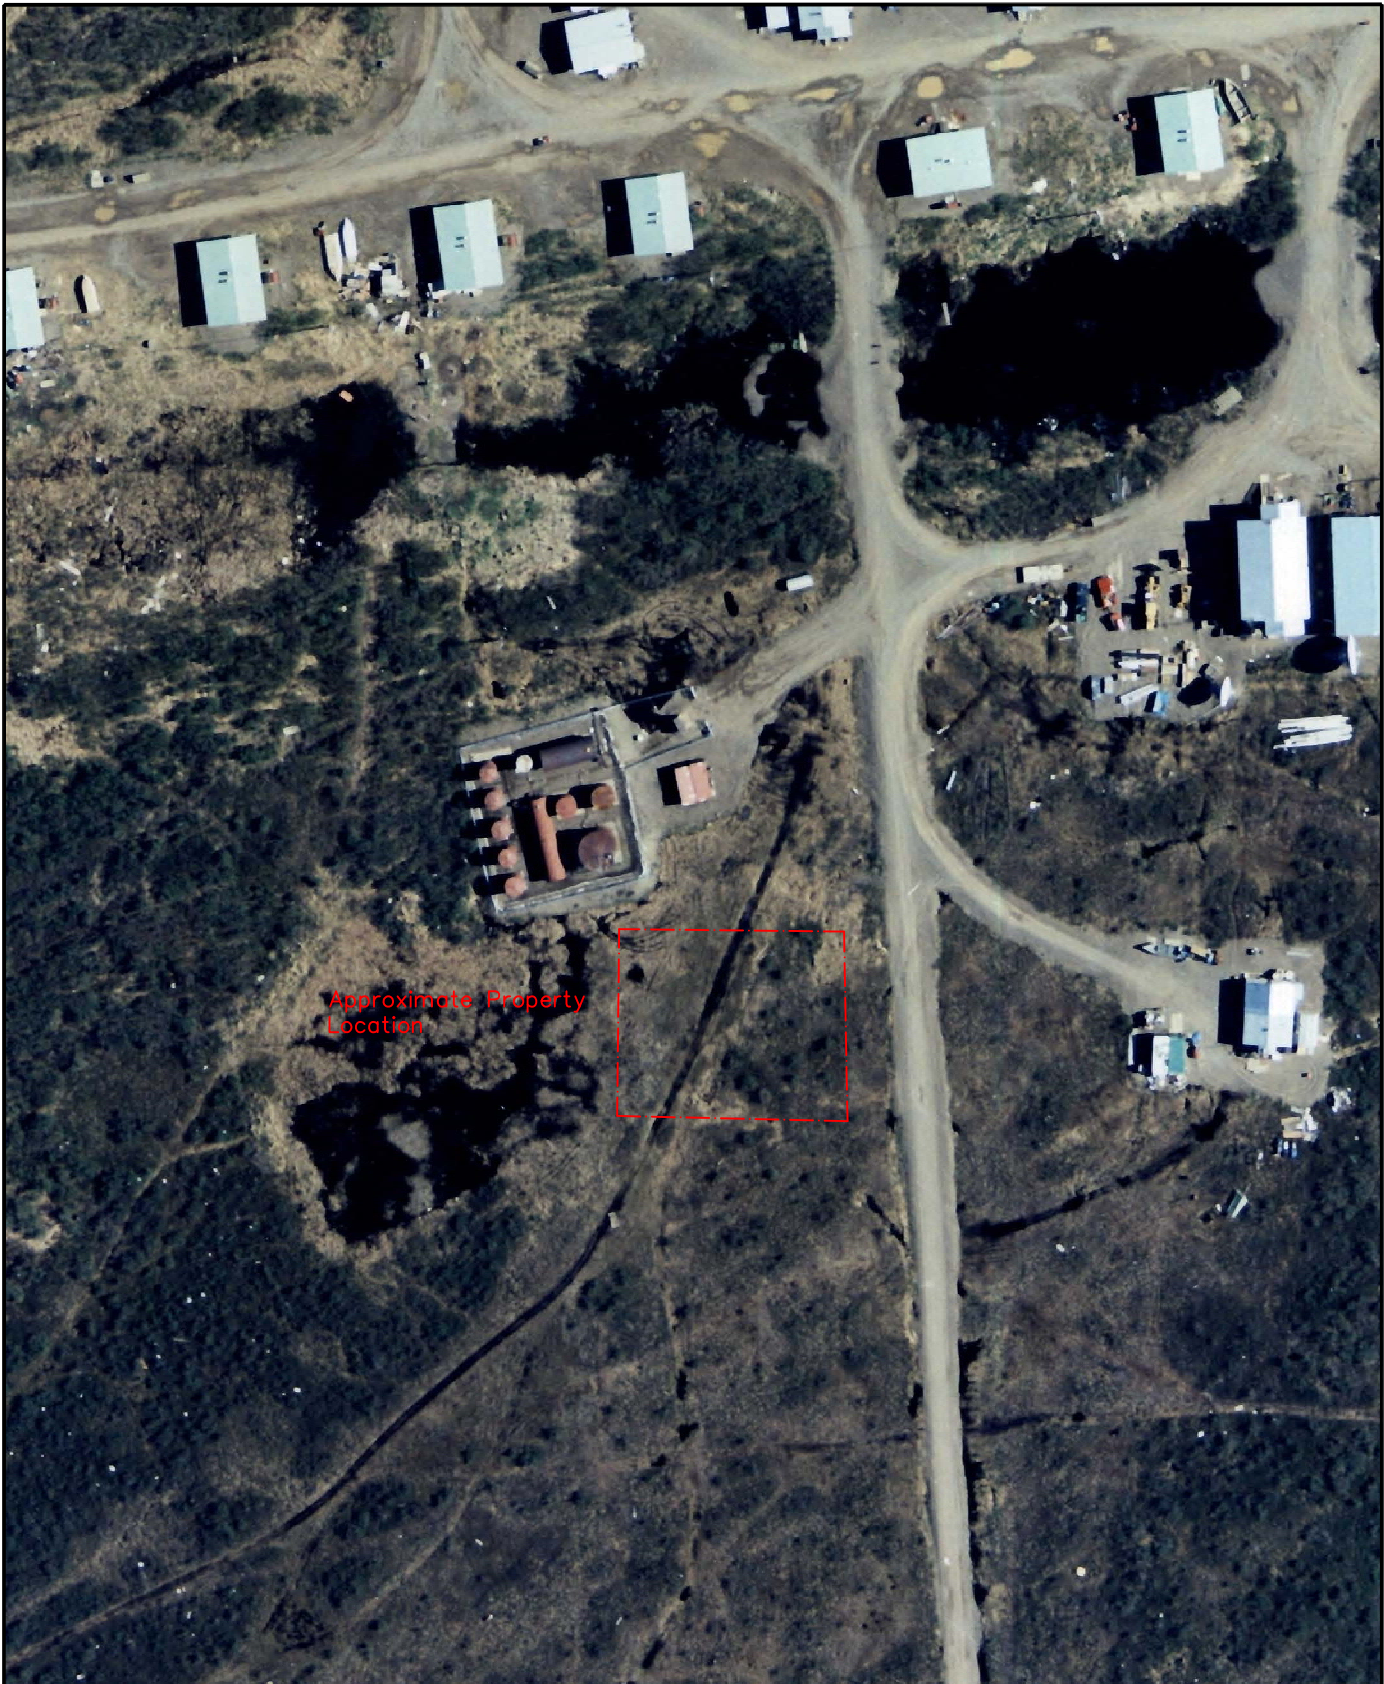
SHANNON & WILSON, INC. Geotechnical & Environmental Consultants	FIG. 3

The June 13, 1996 aerial photograph is included as Figure 3. The Property remains undeveloped and vegetated. The transecting vehicle path is still visible across the Property, but appears to now contain water. The Old Tank Farm is present with a total of 11 aboveground storage tanks (ASTs) visible in the aerial photograph. It appears that fencing is present around the tank farm and a structure to the east of the Old Tank Farm in the cleared area that is used for vehicle parking and storage at the time of the site visit in 2012.

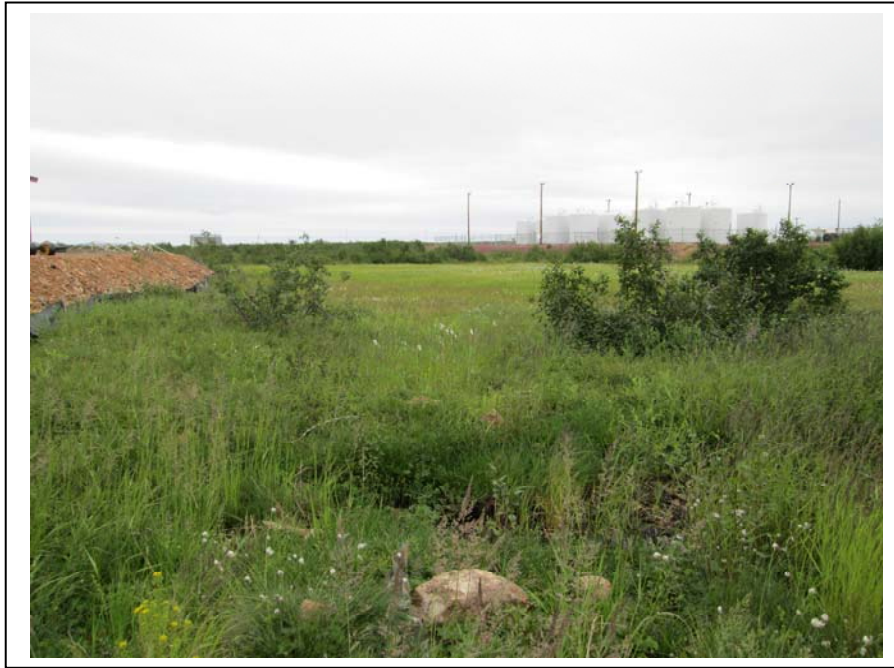
The Property is undeveloped and vegetated with grass and tundra mat, as shown in Photos 1, 2, and 3. Mr. Gavin stated that the property has never been developed that he is aware of. The ground surface was soft and wet, with ponded water visible in at least one location. No hydrocarbon sheen or odor was observed on the ponded water. No signs of distressed vegetation were observed along the portions of the Property bordering the neighboring tank farm. A piece of plywood was observed in the central portion of the Property (visible in the 2010 aerial photograph included as Figure 2). The Property is bordered by the Old Tank farm to the north (Photo 3), an access road to the east with several buildings associated with village maintenance and the Buckland Medical Clinic further east, the Summit Camp site to the south, vegetated tundra to the west, and the New Tank Farm to the northeast (Photo 2).

Photo 1: Looking west, the Property is vegetated with grasses and tundra mat. Fill material for the Summit Camp building parcel is present on the left hand side of the photo. (July 18, 2012)

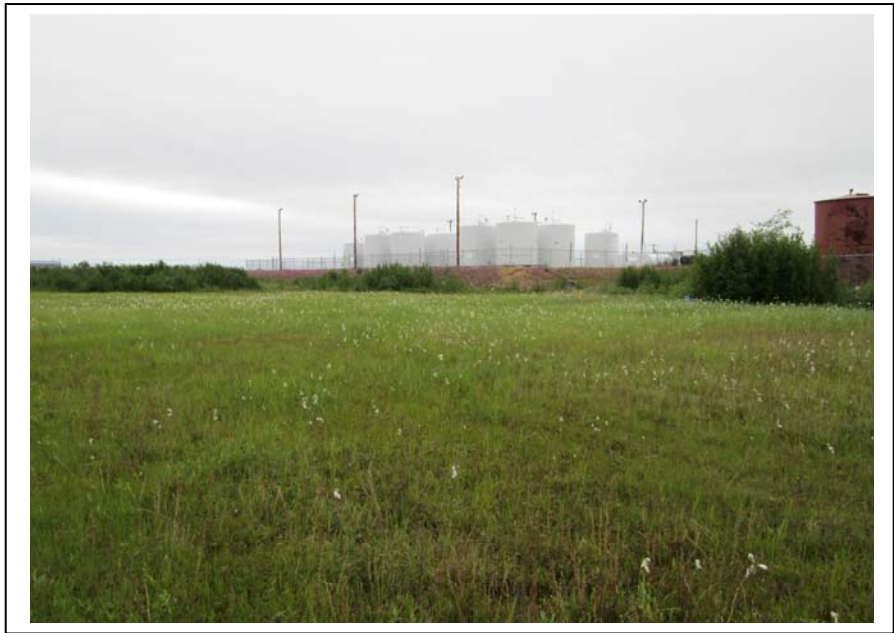
Photo 2: Looking northwest across the Property to the New Tank Farm. (July 18, 2012)

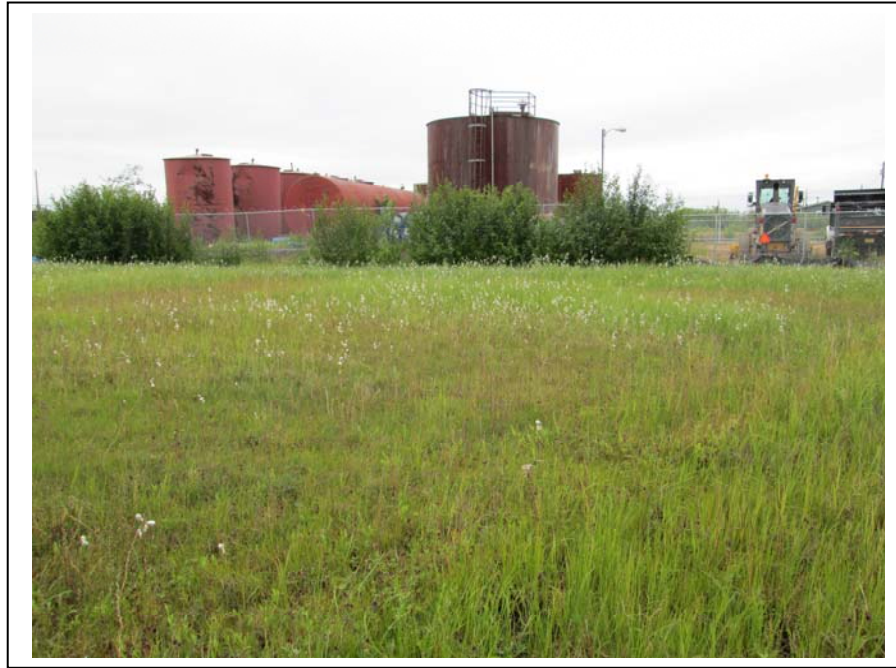
Photo 3: Looking north across the Property to the Old Tank Farm. The portion of the vehicle storage area is visible on the right hand side of the photo. (July 18, 2012)

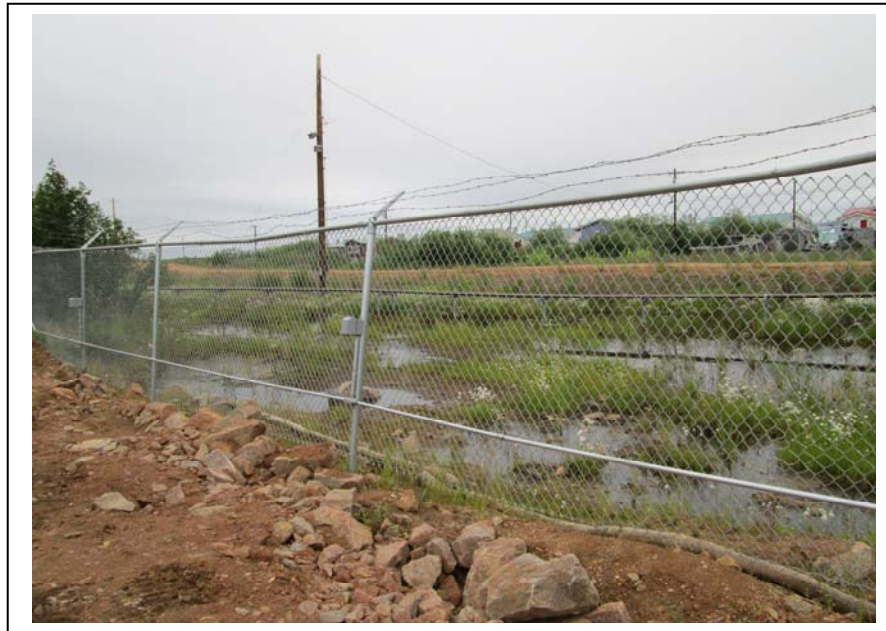
The parcel north of the Property is the site of the Old Tank Farm which reportedly had a release in 2008. Mr. Gavin indicated that the release was due to a leak in the piping which fed the tank farm. The release location indicated by Mr. Gavin was to the northeast of the Old Tank Farm, as shown on Figure 2. The release occurred in a low lying area while there was still snow on the ground. At the time of our site visit, ponded water was present in the area of the release, as shown in Photo 4. A sorbent boom was placed at the edge of the ponded water on the north side of the northern fence boundary of the Old Tank farm (Photo 4). Mr. Gavin indicated that this was placed as a precautionary measure each year.

Photo 4: Looking north from the Old Tank Farm to the low lying area where the spill occurred. A sorbent boom is visible in the foreground of the photo. (July 18, 2012)

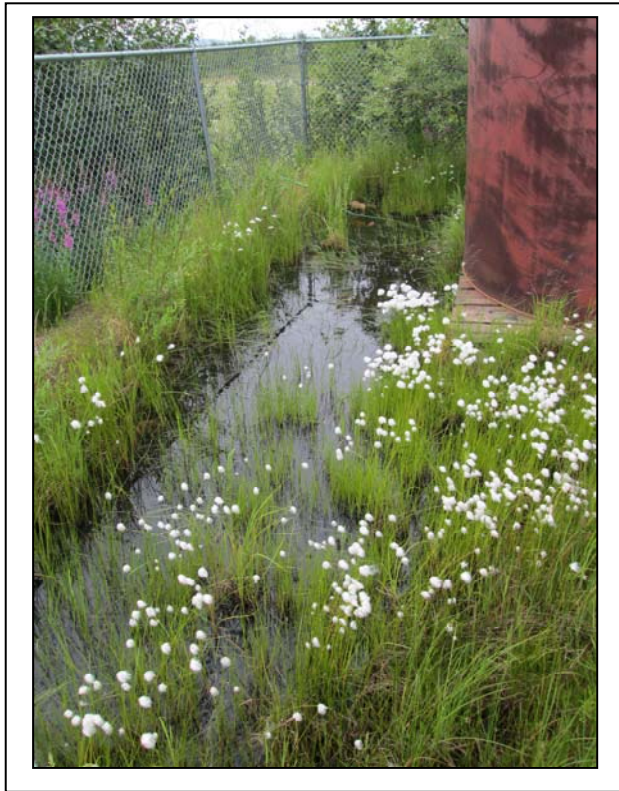
corner of the Old Tank Farm (Photo 5). No hydrocarbon odor or sheen were noted on or in the vicinity of the ponded water. The berm of the tank farm was observed and appeared to be continuous around the Old Tank Farm tanks. A black liner was evident in both the southern and northern berms (Photos 6 and 7).

Photo 5: Looking west, ponded water was observed within the bermed area of the Old Tank Farm. No hydrocarbon odor or sheen was observed at the time of our site visit. (July 18, 2012)

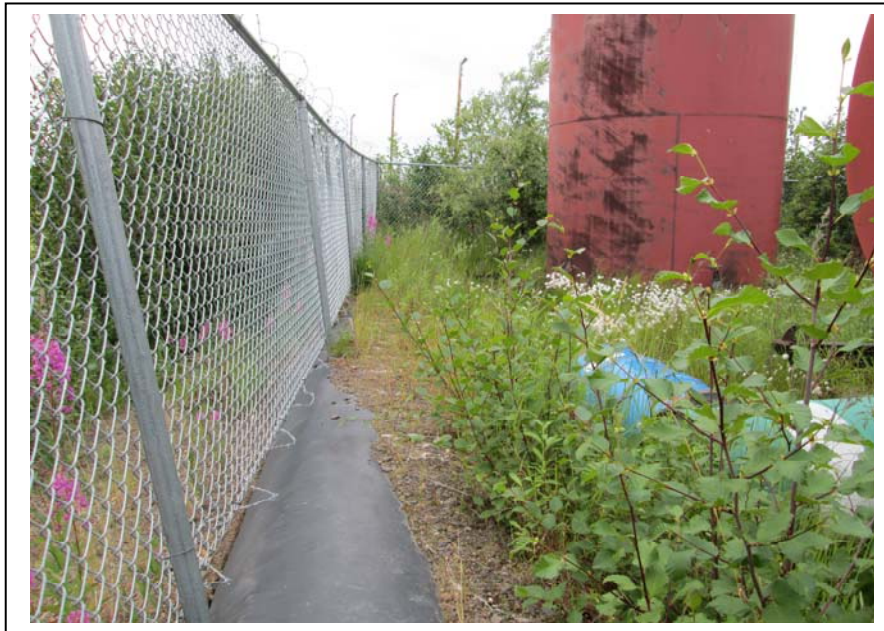
Photo 6: Looking west along the southern fence of the Old Tank Farm. Black liner was observed along the top of the southern berm. (July 18, 2012)

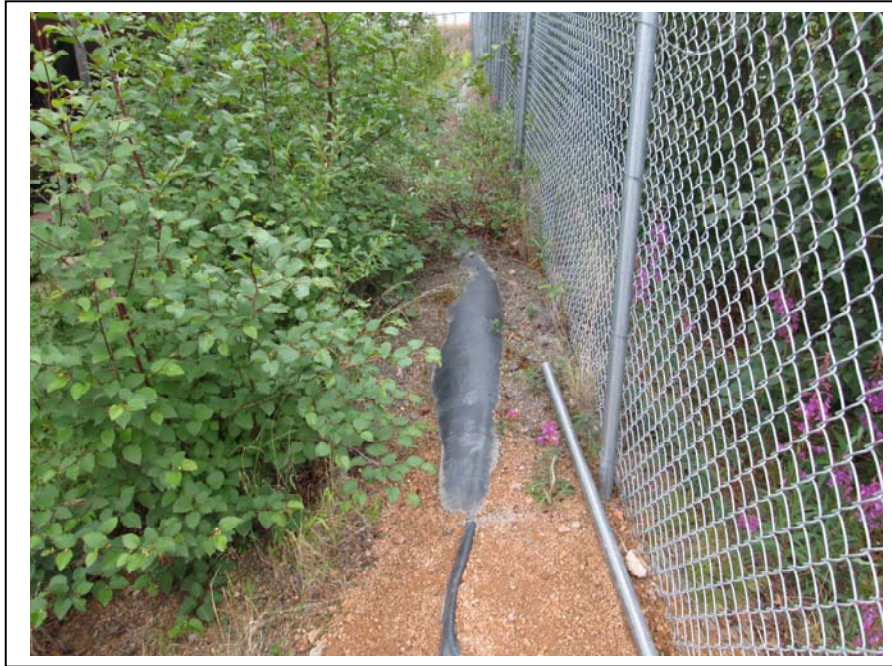
Photo 7: Looking west along the northern fence of the Old Tank Farm. Black liner was observed along the northern berm of the Old Tank Farm. (July 18, 2012)

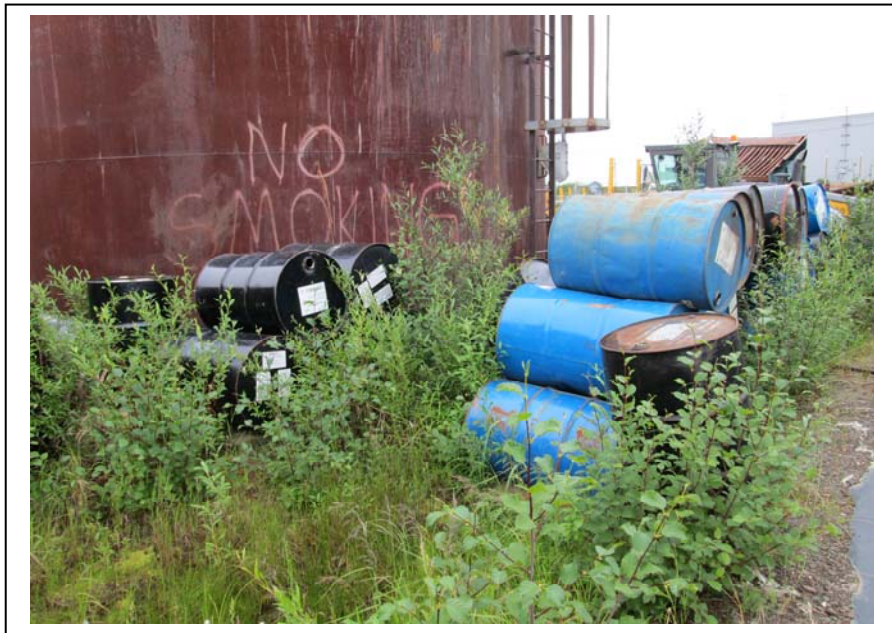
Numerous drums were stored in the southeast portion of the Old Tank Farm within the berms (Photo 8). Most of the drums appeared to be empty; however, several drums labeled as either fuel or lubricant still contained liquid (Photo 9). No leaking or damaged drums were observed at the time of our site visit.

Photo 8: Looking east toward the AST still in use at the Old Tank Farm. Numerous empty drums are stored within the bermed portion of the Old Tank Farm. (July 18, 2012)

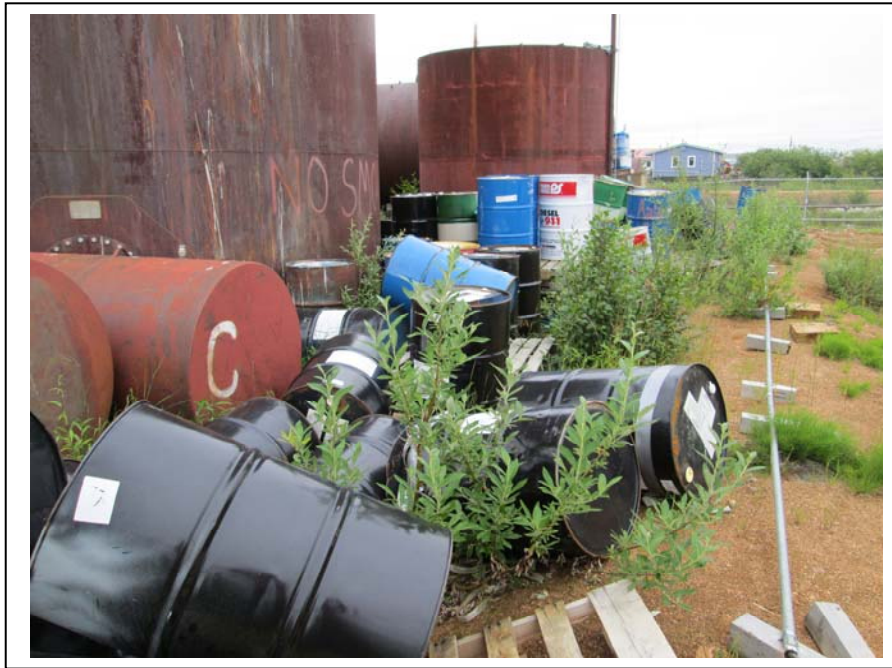
Photo 9: Looking north, numerous drums were stored within the Old Tank Farm berms. Some of the drums stored upright in the background contained liquid. (July 18, 2012)

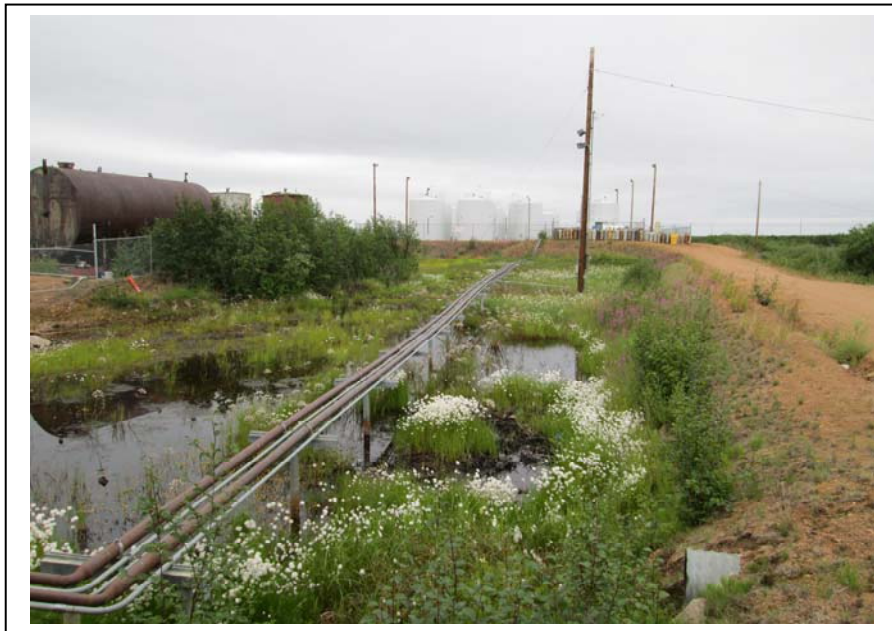
A gravel access road extends along the north site of the Old Tank farm to the New Tank Farm as shown in Figure 2. Mr. Gavin indicated that the low lying spill area had been excavated during cleanup activities and that was part of the reason that this area was lower than the surrounding area (Photo 10). As shown in Figure 2, fuel lines are visible crossing this area and Mr. Gavin indicated that one of these lines was the source of the release.

Photo 10: Looking west across the low lying area in the foreground toward the New Tank Farm in the background. The low lying area was reportedly excavated during cleanup activities. (July 18, 2012)

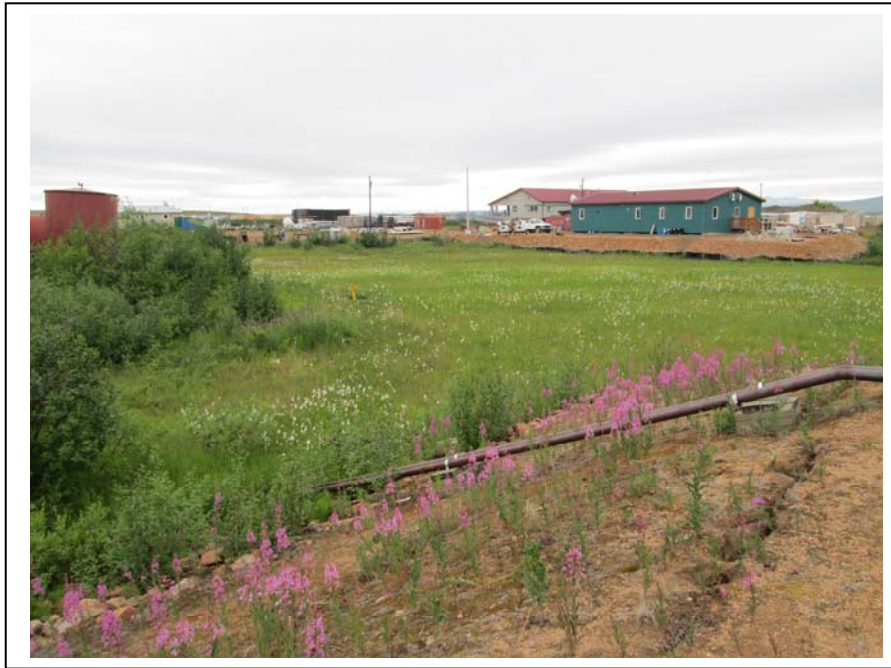
Photo 11: Looking southeast toward the Property from the New Tank Farm. The Summit Camp Building (blue) is present in the upper right hand corner of the photo. (July 18, 2012)

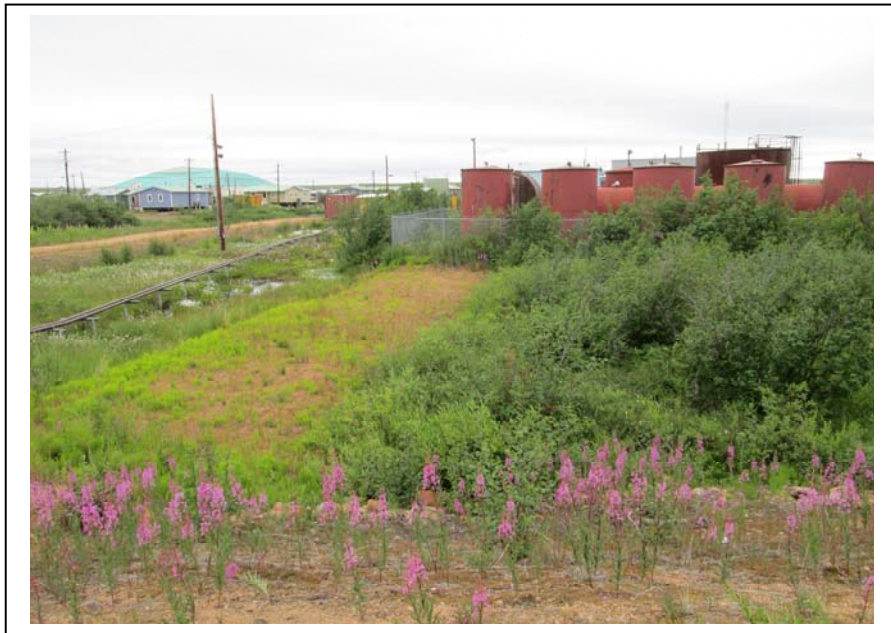
The New Tank Farm is located approximately 200 feet northwest of the Property and around 120 feet west of the Old Tank Farm (Photos 11 and 12). An old road is visible extending from the Old Tank Farm to the New Tank Farm (Photo 12). The New Tank Farm contains tanks for three different entities according to Mr. Gavin; the IRA Fuel Project, the City of Buckland, and the school. No surface staining or odors were observed in the New Tank Farm at the time of the site visit.

Photo 12: Looking east from the New Tank Farm to the Old Tank Farm. A former road is evident extending from the Old Tank farm toward the bottom left hand corner of the photo. (July 18, 2012)
