# JUNEAU STORMWATER HYDROGRAPHY REPORT

ACWA GRANT # 14-06

Organization Name: Juneau Watershed Partnership

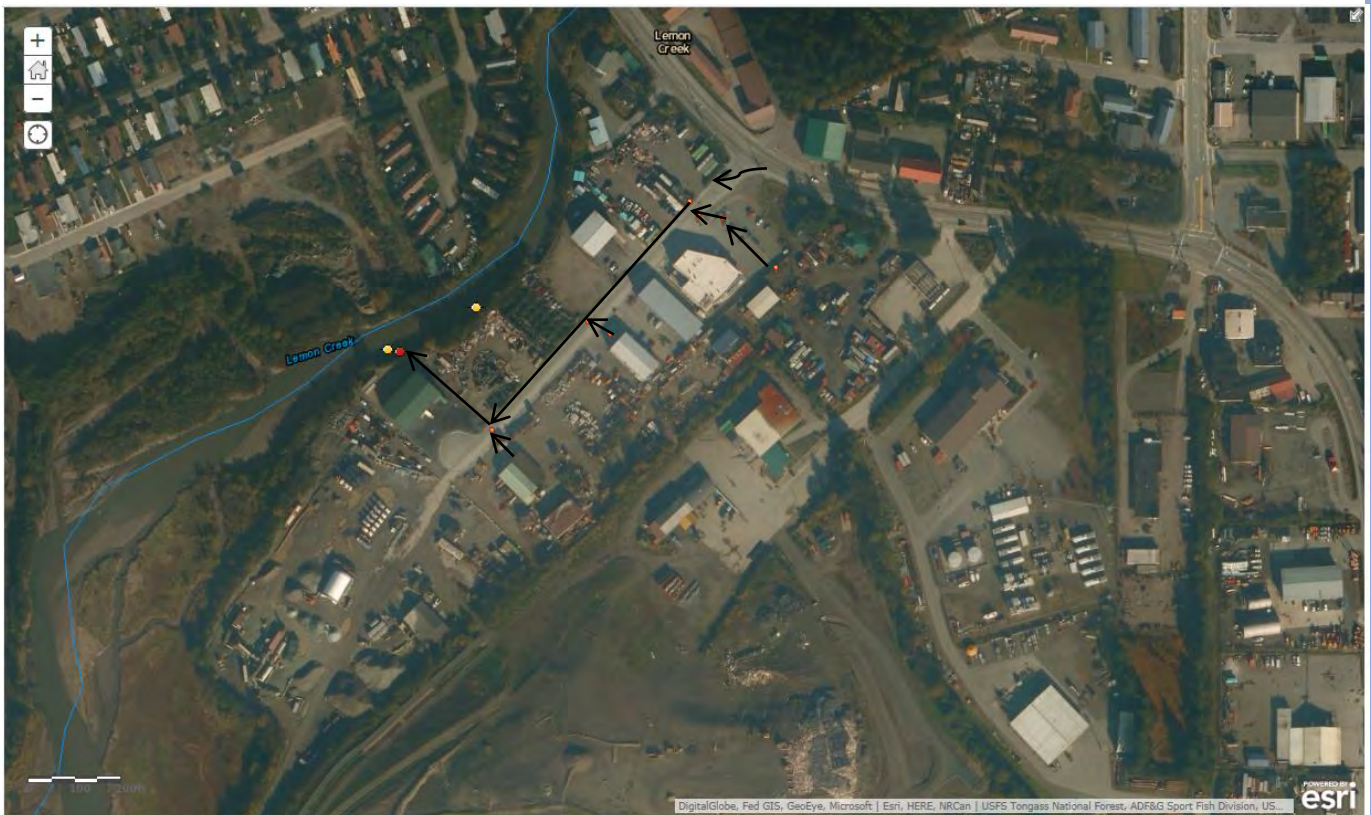
The commercial – industrial sites located on Commercial Boulevard encompass a sub-drainage of approximately 18 acres in the JRM Subdivision. Stormwater in this subdrainage is primarily conveyed through a storm sewer system. The stormwater from this area is directed southwest and discharges into Lemon Creek at an outfall located in between lots JRM LT8B (5760 Concrete Way) and JRM LT 9A (5750 Concrete Way) on riprap embankment (Figure 2). This outfall coincides with the outfall labeled LCOUTF001 in the CBJ outfall data from 2008. According to this data, this outfall was a ditch that discharged to the creek at this location and a pipe outfall, LCOUTF002, was located upstream. During our mapping effort, JWP attempted to locate the LCOUTF002 outfall; however, LCOUTF002 appears to have been decommissioned.

Figure 2. Map of the Concrete Way sub-drainage, showing the mapped stormwater structures (orange dots) and the outfalls identified during CBJ's 2008 inventory (yellow dots). The subdrainage discharge point to Lemon Creek is shown in red.

There are some best management practices occurring in this sub-drainage. Catch basins are used in the storm sewer system, providing some treatment. Some of the industrial sites in this sub-drainage are

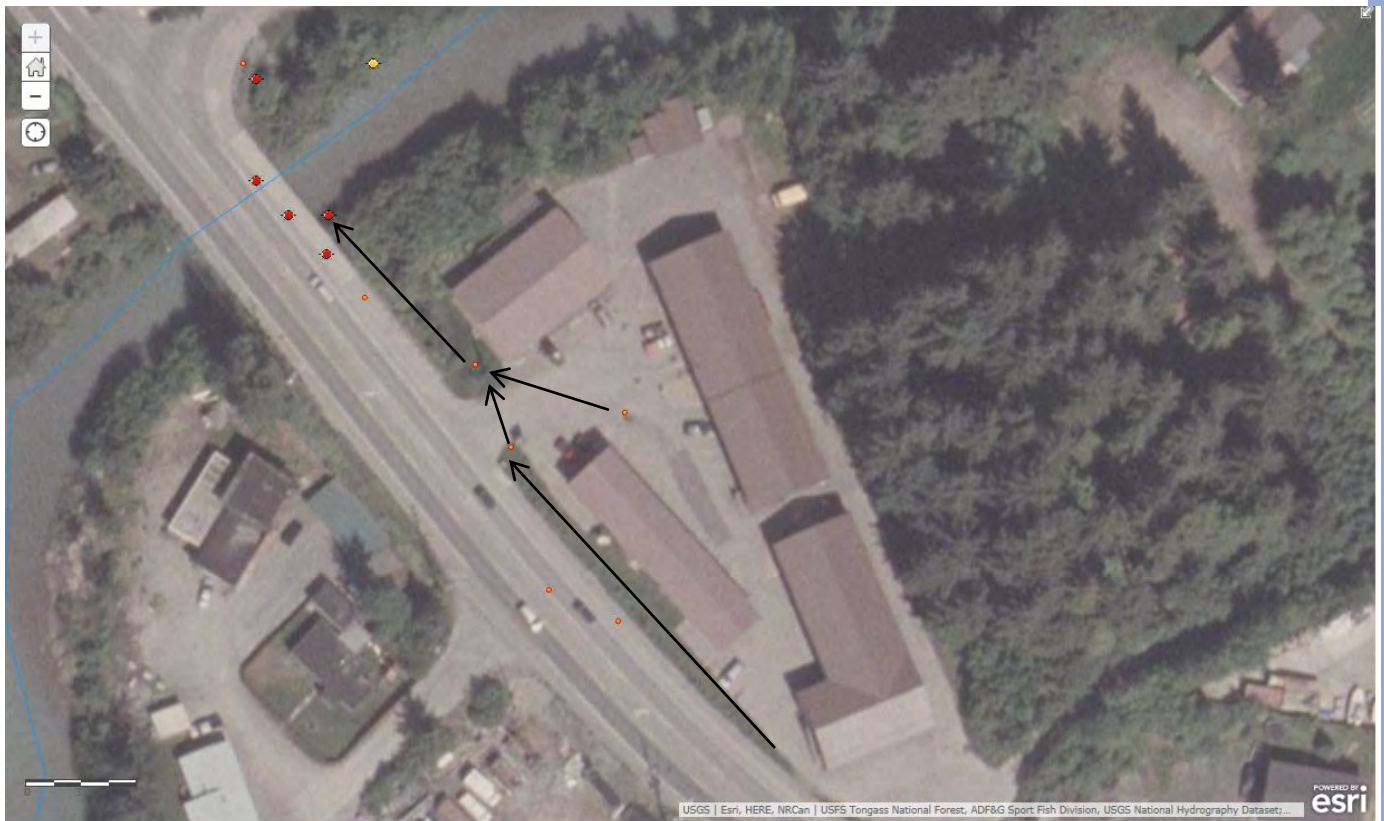
The Space Unlimited, Inc. Business Center Sub-drainage is relatively small, only approximately 1.5 acres. It encompasses the business center and a portion of Glacier Highway (Figure 3). Most of the parking lot drains toward a storm drain inlet located in the parking lot. A vegetated roadside ditch captures stormwater runoff from Glacier Highway and the rest of the business center's parking lot. The ditch flow is conveyed under the entrance driveway to the business center via a culvert where it combines with the stormwater from the parking lot storm drain into a series of vegetated ditches and culverts located on the northwest end of the business center. This provides some treatment of the stormwater prior to it discharging into Lemon Creek.

Figure 3. Map of the Space Unlimited and Lemon Creek Bridge sub-drainages, showing the mapped stormwater structures (orange dots). Outfalls to Lemon Creek are shown in red. Flow through the Space Unlimited subdrainage is shown by the arrows. The entire Lemon Creek Bridge subdrainage consists of overland flow to the outfalls on the bridge.

The Lemon Creek Bridge Sub-Drainage is quite small, only 0.2 acres. It consists of the Lemon Creek Bridge and an adjoining portion of Glacier Highway. Though a sub-drainage, for the purpose of this report, is defined as an area in which all the stormwater run-off is collected and transported to a single discharge point on the waterbody, this sub-drainage is an exception. Stormwater flows into three drain inlets located on the east side of the bridge that discharge directly to the creek below and another inlet on the corner of Davis Avenue and Glacier Highway that discharges to the vegetated hillside just upstream of the bridge (Figure 3).

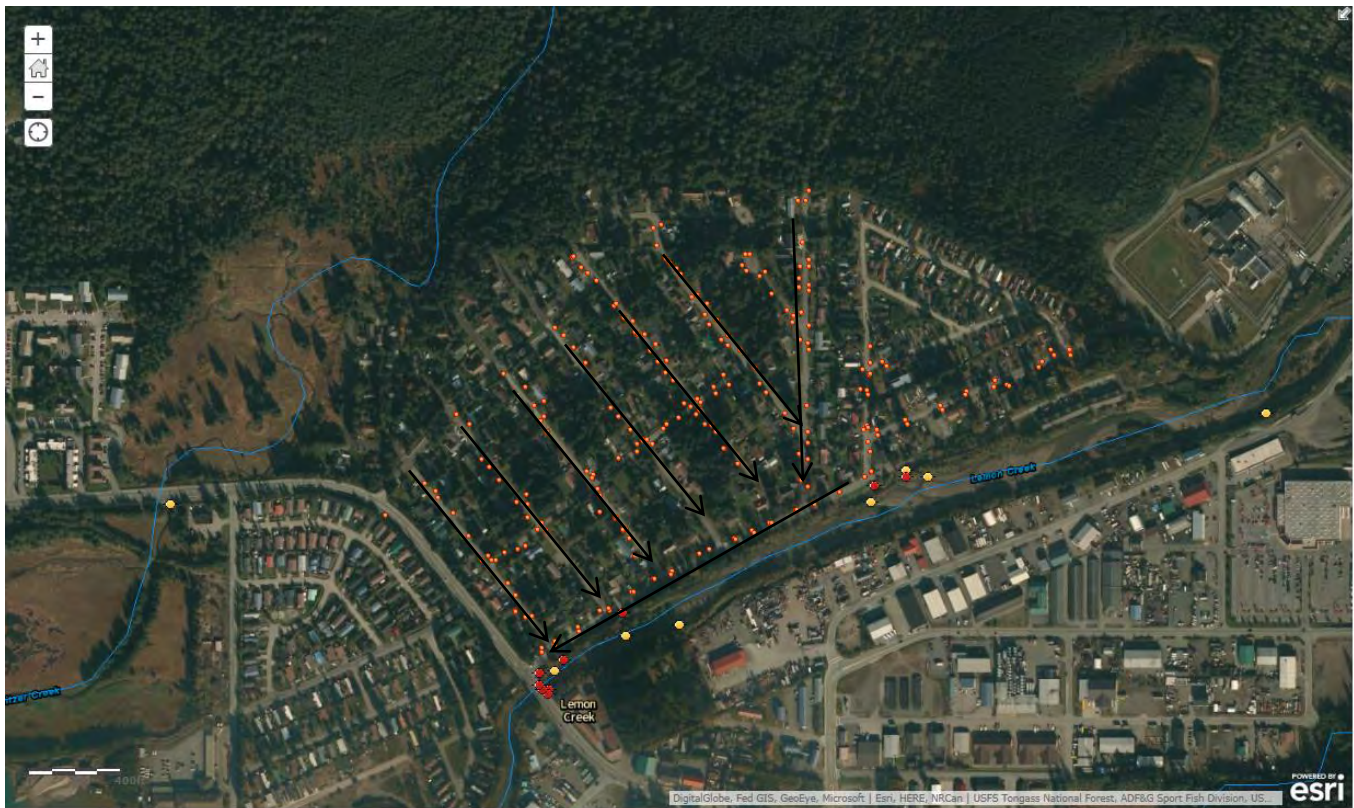
This residential area is designated for mid to high density residential use, and is currently zoned as D-5 and D-10 (five and ten units per acre, respectively). The stormwater conveyance system in this sub-drainage generally consists of vegetated ditches with cross-culverts that capture and transport run-off from yards and the smaller neighborhood roads. The vegetated ditch network works like a swale, allowing stormwater to slow and sediment to settle in the ditch rather than discharging directly into the storm sewer system. These ditches appear to work quite well, as stormwater was observed moving very slowly through the roadside ditch system. It appears that the water moves slowly southeast, where the ditch network connects to the storm sewer system at each street's intersection with Davis Avenue (Figure 4).

Figure 4. Map of the Pinewood Park Residential sub-drainage, showing the mapped stormwater structures (orange dots). Outfalls to Lemon Creek are shown in red. The outfalls identified during CBJ's 2008 inventory (yellow dots). The general flow through this sub-drainage is shown by the arrows.

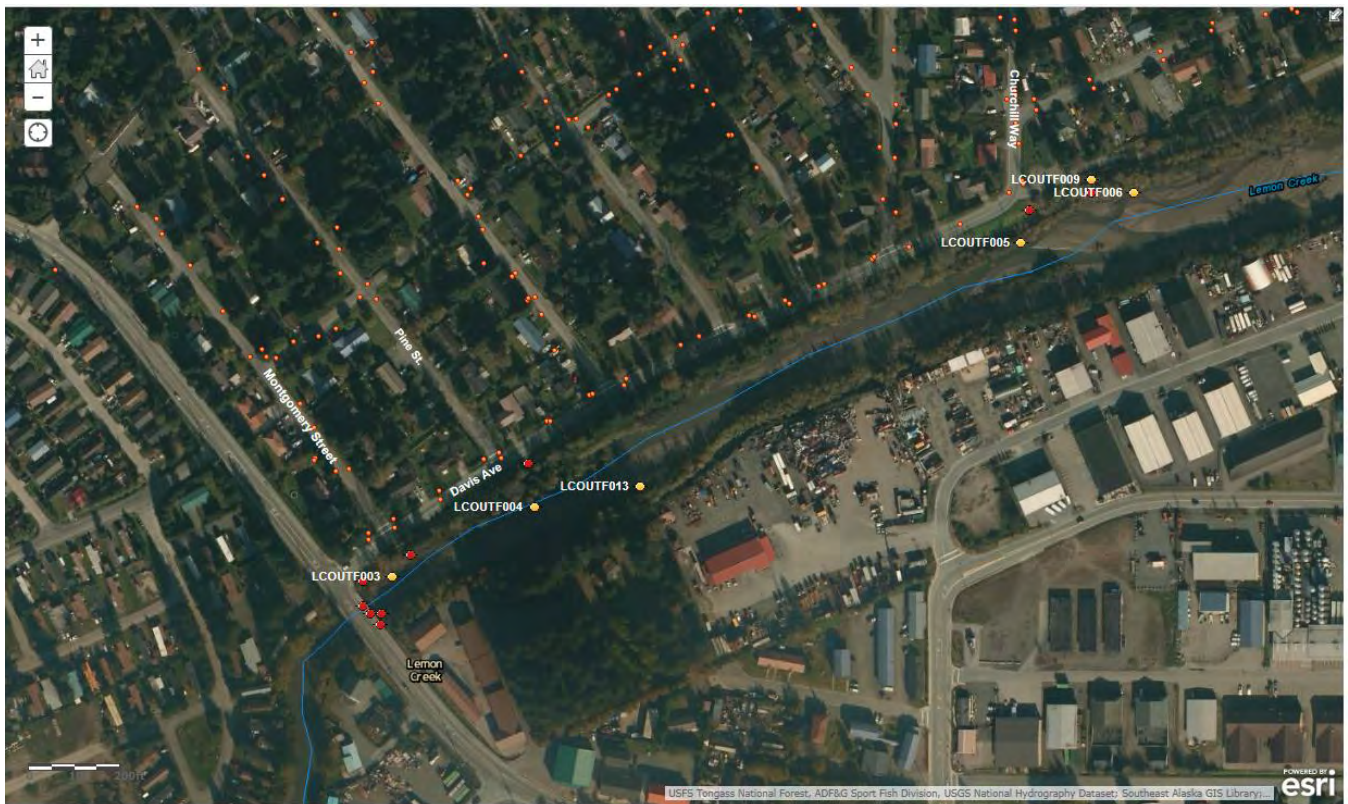
Davis Avenue, which is a main neighborhood access road from Glacier Highway, includes a storm sewer/curb and gutter system, which quickly conveys stormwater from the roadway. Another feature along Davis Avenue is a shallow, vegetated swale located between the sidewalk and residences on the north side of the street. The swale intercepts run-off from the yards and sidewalk. Drain inlets are located along the bottom of the swale to convey stormwater from the swale into the storm sewer system located along Davis Avenue. This whole system discharges into Lemon Creek at an outfall located across from Montgomery Street upstream from the Lemon Creek bridge on Glacier Highway. This outfall discharges to riprap velocity dissipater (or rock apron) before entering the creek, preventing erosion at the site of the discharge. This outfall coincides with LCOUTF003 in the CBJ outfall data (Figure 5).

Figure 5. Close up of Pinewood Park Residential sub-drainage along Davis Avenue showing the outfalls to Lemon Creek in red and the outfalls identified during CBJ's 2008 inventory (yellow dots).

JWP was unable to locate these drain inlets, but was able to locate both outfalls. The outfall located across from the Davis Avenue – Pine Street intersection, or LCOUTF004 in the CBJ data, after two days of rain. No water was discharging from the outfall. Very little water was observed in the swale at this time. This suggests the inlet is either buried or overgrown with vegetation to the point that the water present cannot enter the drain, or perhaps the inlet is no longer there. The CBJ outfall data outfall indicates that LCOUTF004 was discharging water when observed by CBJ staff in 2008, so it was at least operational then. Since the storm sewer system drains to the outlet across from Montgomery Street (or LCOUTF003), water was observed discharging from this outfall, but this is not an indication whether stormwater is entering an inlet in the trailside swale. It is recommended to revisit this area in the fall or early winter, after the vegetation has died down, to see if the inlets can be located to get a better picture of how the stormwater is being conveyed in this area.

There are also two outfalls on the eastern end of Davis Avenue, coinciding with LCOUTF005 and LCOUTF009, but no stormwater was observed discharging from these outfalls (Figure 5). It is unclear if the residential areas to the north of these outfalls contribute stormwater to the storm sewer system that discharges across from Montgomery Street or if this area discharges at these outfall locations. Construction was occurring during field work, and improvements were being made to the storm sewer system in the area. This may have affected the observations. It is recommended to revisit this area to get a better picture of how the stormwater is being conveyed.

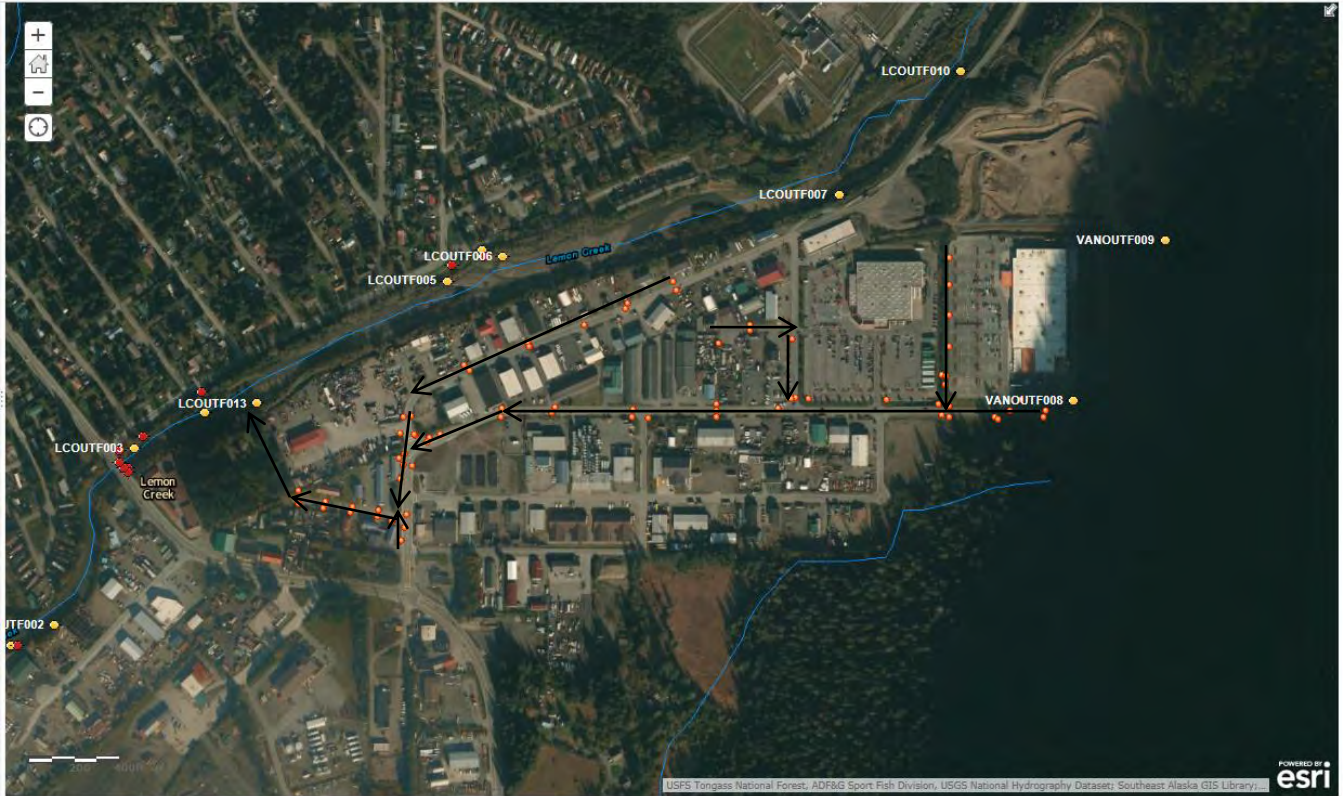
The Aisek Street Sub-drainage encompasses approximately 96 acres of commercial and industrial development. The contributing area includes Anka Street, Commercial Boulevard, as well as adjoining lots. The stormwater in this sub-drainage is conveyed through a storm sewer system, which discharges to Lemon Creek from an outfall on the streambank to the northwest of Aisek Street, at the edge of the Skookum Sales and Recycling lot. This outfall coincides with the outfall LCOUTF013 in the CBJ outfall data from 2008 (Figure 6).

Figure 6. Map of the Aisek sub-drainage, showing the mapped stormwater structures (orange dots). The outfall LCOUTF013 identified during CBJ's 2008 inventory (yellow dot) is the discharge point for this subdrainage. The general flow through the storm sewer system is indicated by the arrows.

There are two storm drain inlets located on the south lot of Home Depot adjacent to the Commercial Boulevard cul-de-sac that collect stormwater from a small area of the parking lot. These drains connect to the storm sewer system at Commercial Boulevard. Debris and pallets were observed around these inlets and it is likely that smaller pieces could be entering the storm sewer system at these locations.

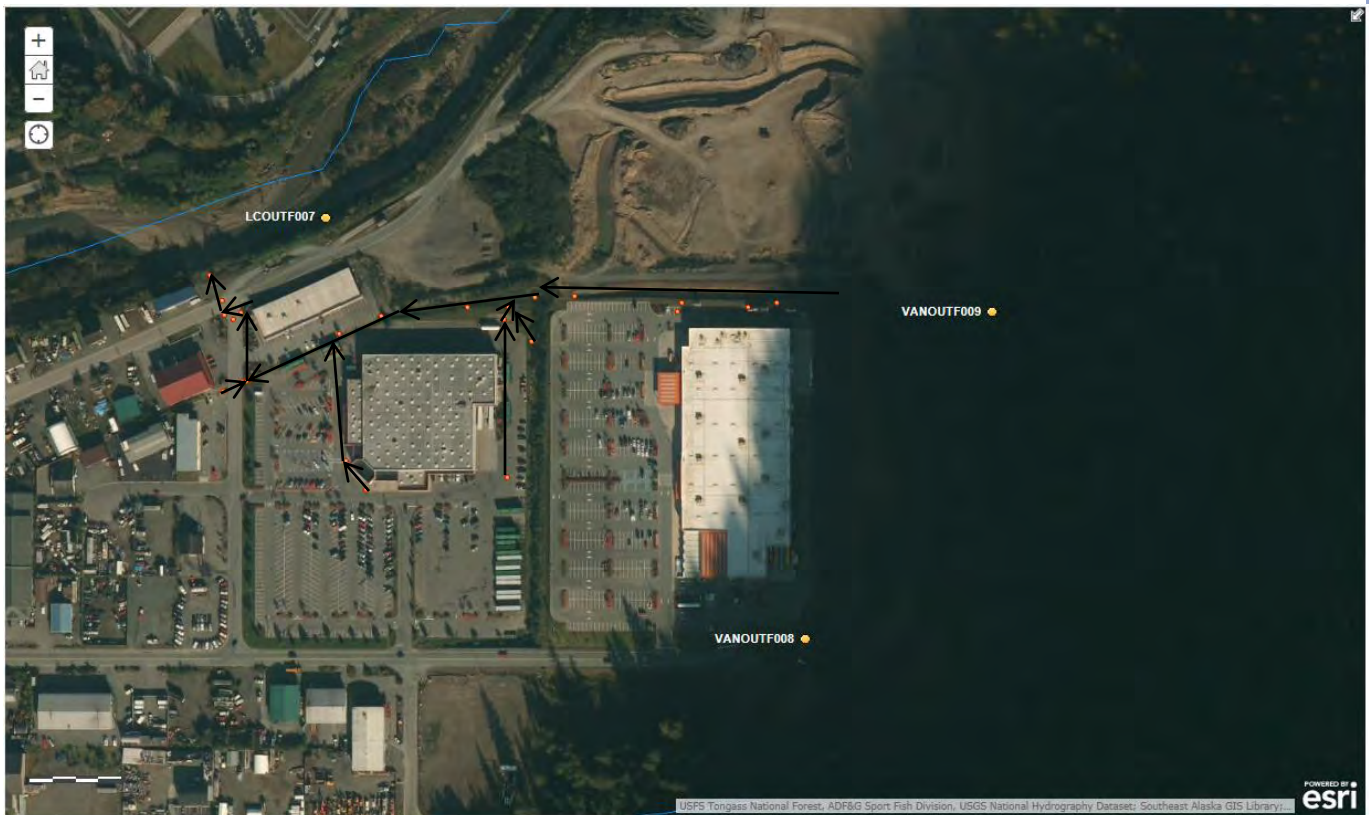
The Costco – Home Depot sub-drainage in the Lemon Creek watershed encompasses approximately 9 acres of commercial and industrial development, with Costco and Home Depot being the most notable developments in the sub-drainage. The northern half of the Costco lot and a small portion along the northern edge of the Home Depot lot is included in this subdrainage. Stormwater from this sub-drainage discharges to Lemon Creek from an outfall located on riprap embankment across from the Anka Street – Ralph’s Way Intersection, which corresponds to the outfall LCOUT007 from the 2008 CBJ Inventory (Figure 7).

Figure 7. Map of the Costco-Home Depot sub-drainage, showing the mapped stormwater structures (orange dots). The outfalls identified during CBJ’s 2008 inventory (yellow dots). The general flow through the subdrainage is shown by the arrows.

A large swale constructed of vegetated, large rock is located on the north end of the lot between the Home Depot and CBJ gravel pit; this is primary stormwater conveyance in the subdrainage from the Home Depot lot. Two inlets in the northeast end of the Home Depot parking lot also convey stormwater into the swale and the CBJ gravel pit has at least one outfall into the swale. This swale is designed to handle a substantial amount of stormwater. The outlet to the swale has a grate to keep debris from leaving. This is beneficial as garbage and debris was observed in the swale, adjacent to

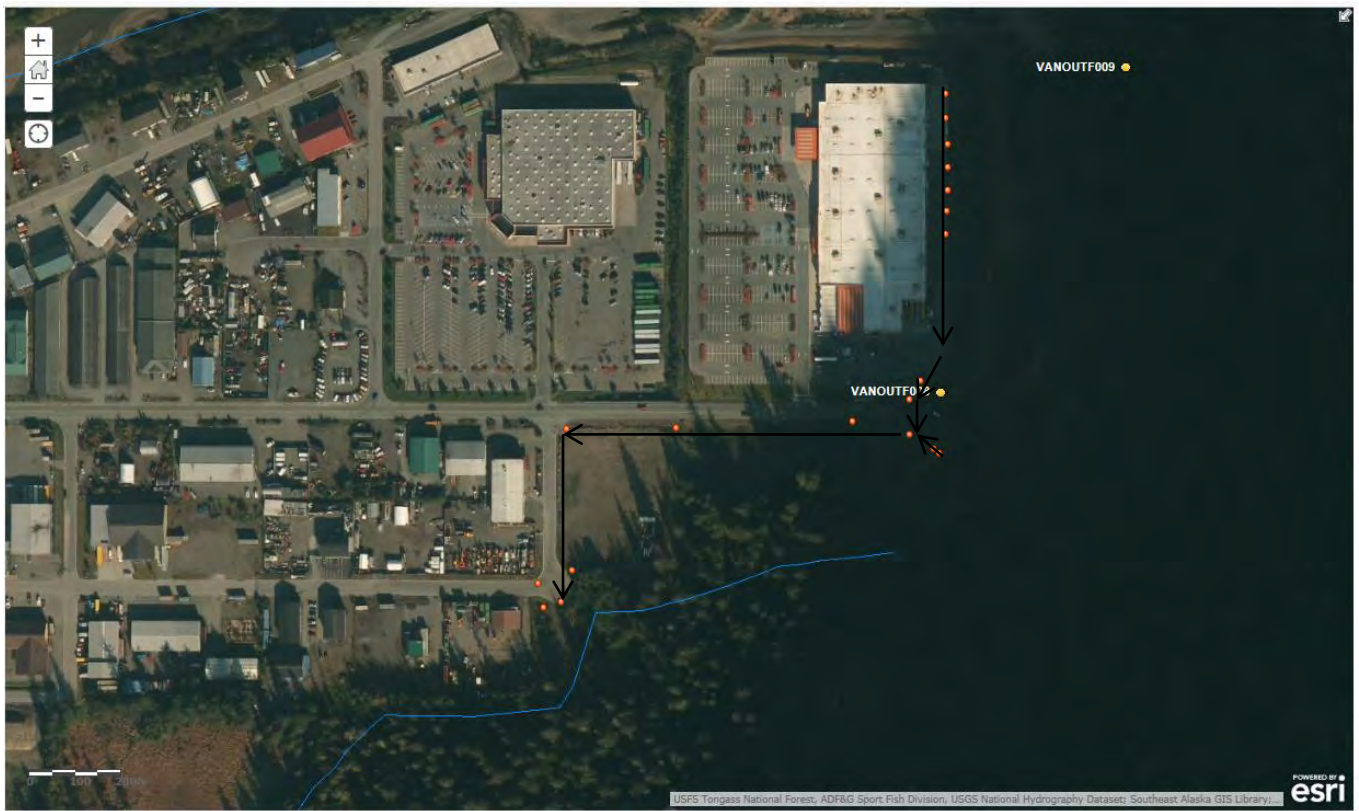
The Shaune Drive sub-drainage consists of run-off from the vegetated hillside/Lemon Creek Trail as well as an undeveloped commercial/industrial lot. Stormwater in this subdrainage is conveyed through a combination of storm sewer system and a network of drainage ditches. Stormwater from this sub-drainage discharges from an outfall at the Charles Way – Shaune Drive cul-de-sac to wetlands that drain into the upper reaches of Vanderbilt Creek. The area of this subdrainage is difficult to measure because the drainage area consists largely of undeveloped areas.

Figure 8. Map of Shaune Drive sub-drainage, showing the mapped stormwater structures (orange dots). The outfalls identified during CBJ’s 2008 inventory are indicated by yellow dots.

The drainage from the hillside/trail bench behind Home Depot is routed around the impermeable surfaces of Commercial Boulevard through separate drainage ditches and structures from those that convey stormwater from the roadways and parking lot (Figure 8). The backside of the Home Depot lot drains into a swale that parallel’s the paved edge of the lot. The swale is constructed of large rock and is vegetated. Seven roof drains, which connect to underground piping, also discharge to this swale via culvert outlets. The swale outlet is located adjacent to the Commercial Boulevard cul-de-sac. Here stormwater is conveyed into the storm sewer system along Commercial Boulevard, Charles Way and Shaune Drive (Figure 8). The intention was to supply additional water to the creek, which has been historically cut off from its headwaters, but to route the stormwater in a manner that it discharges into Vanderbilt Creek in a “clean” state. Since this water is draining from a vegetated area rather than impermeable surfaces, the quality of this water is going to be higher than that from the paved surfaces.

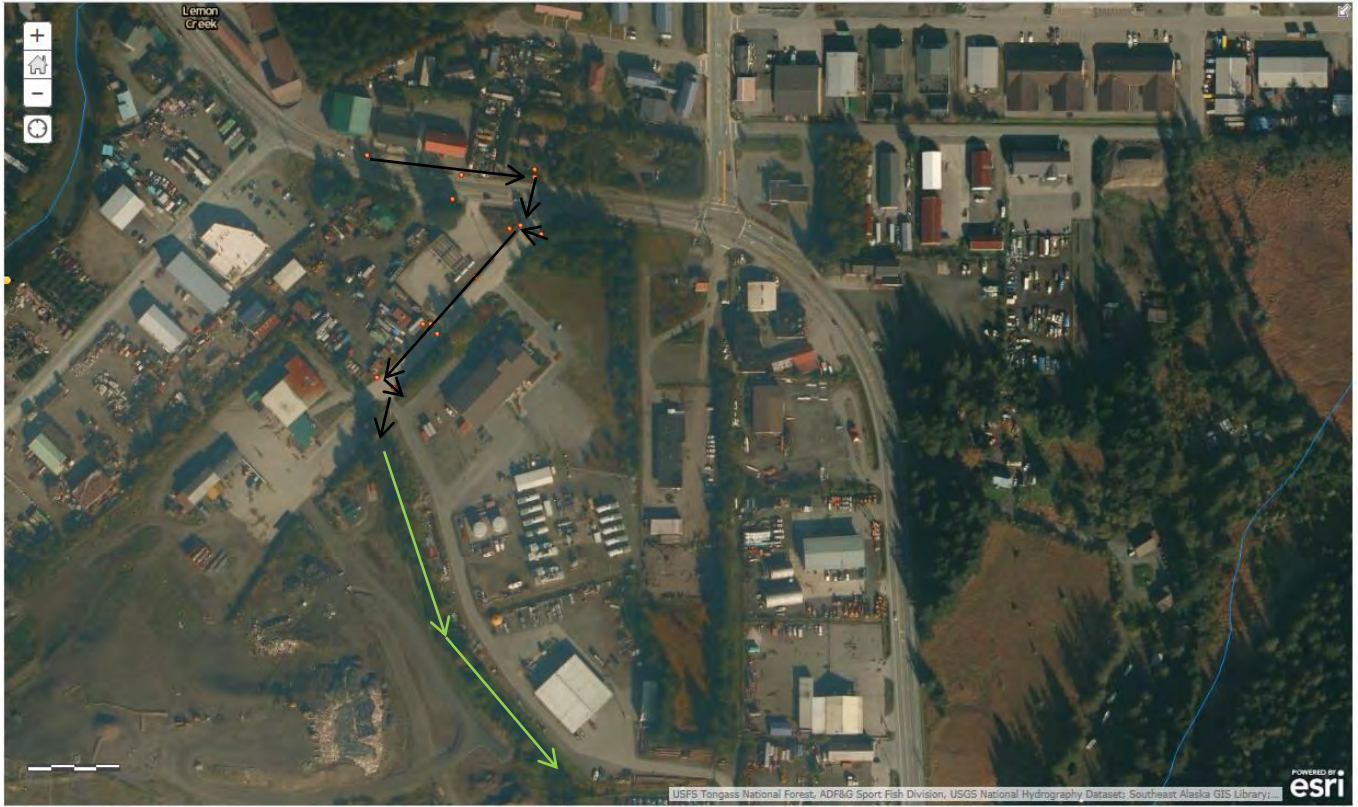
The Glacier Highway – Tonggard Court sub-drainage contains 5 acres of commercial/industrial development. The stormwater in this sub-drainage is transported through a combination of storm sewer system and roadside ditches along Glacier Highway, Tonggard Court and private property (Figure 9).

Figure 9. Map of Glacier Highway – Tongsgard Court sub-drainage, showing the mapped stormwater structures (orange dots). The observed flow through the storm sewer system in this subdrainage is indicated by the black arrows. The green arrow shows the hypothesized flow through the swale that borders the landfill, which is based on the landfill’s plan sets.

A storm drain inlet located in a grassy swale on the north side of Glacier Highway, as well as a nearby storm drain inlet in the roadway, transport stormwater under Glacier Highway to the storm sewer system under Tongsgard Court. The storm drain inlet in the swale on Glacier Highway does not seem to provide much treatment of the water prior to it entering the storm sewer system. The stormwater flowing into this drain is coming from a building lot that seems to be serving commercial/industrial uses, as a storage area for equipment.

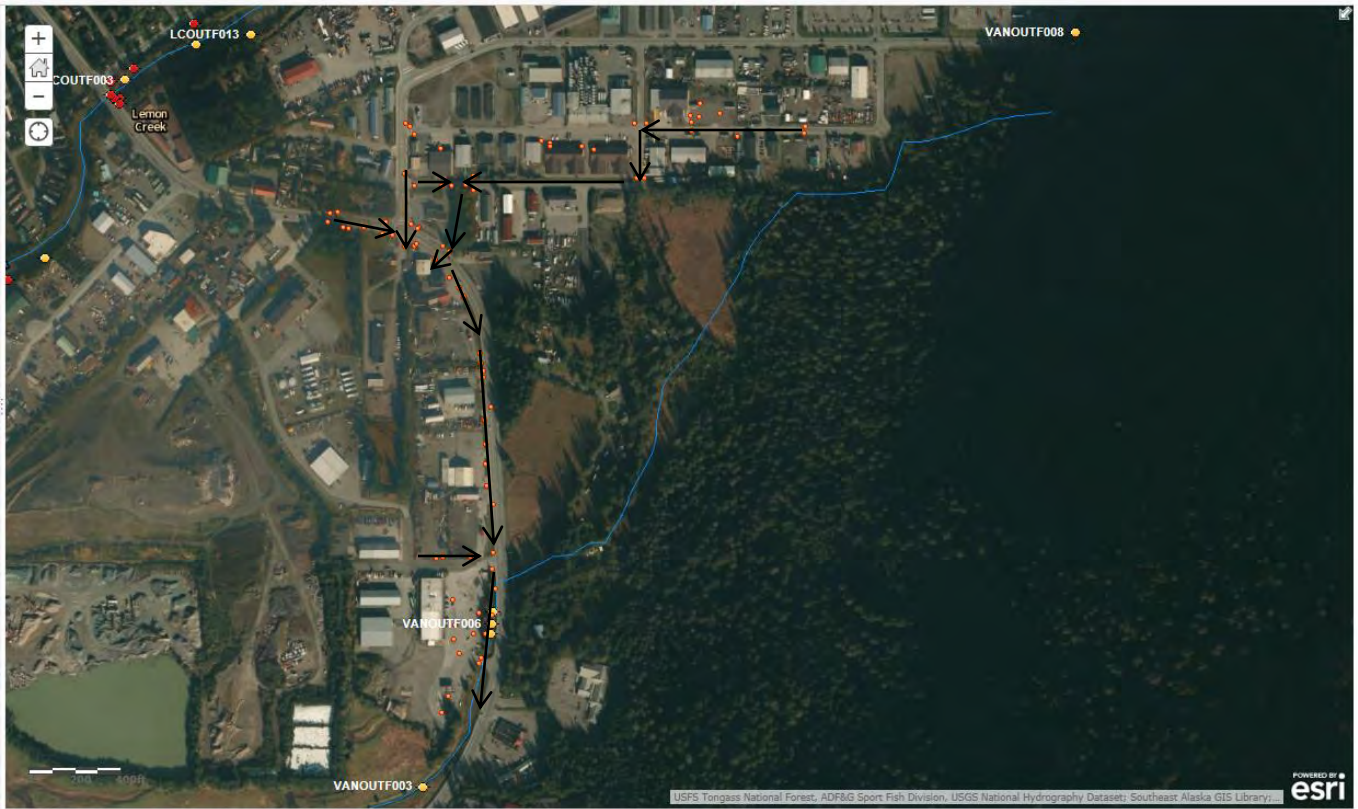
it is connected to the west ditch. The stormwater in the entire ditch-line was extremely turbid during the June 14, 2014 rain event. Sheen was observed in stormwater sheet flowing in Grant's Plaza.

Figure 10. Map of the West Ditch and East Ditch sub-drainages, showing the mapped stormwater structures (orange dots) and the outfalls identified during CBJ's 2008 inventory (yellow dots). The general flow through the subdrainage is shown by the arrows.

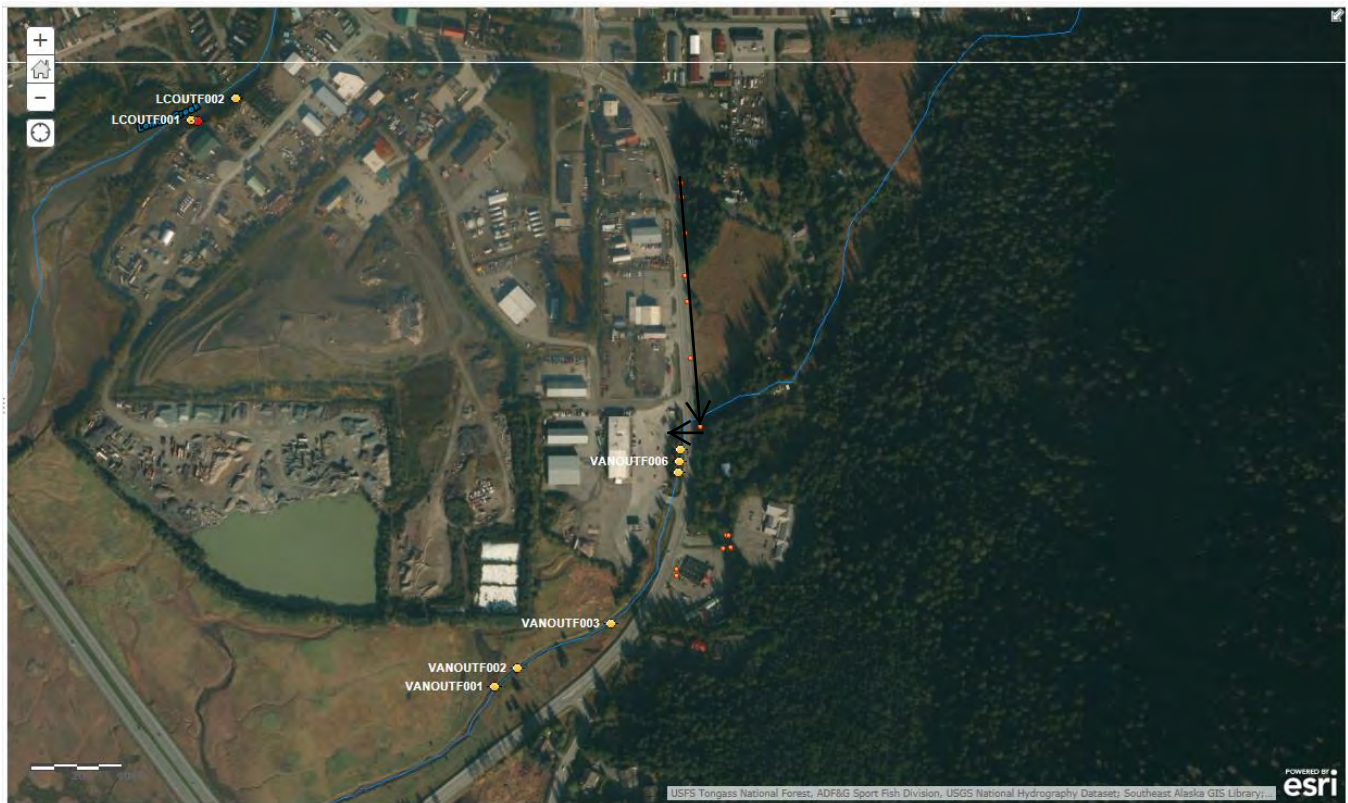
designed to convey high flows of stormwater during storm events, but is also experiencing erosion that is contributing sediment to the stormwater. The ditch flow from the east ditch eventually discharges directly into Vanderbilt Creek just upstream of where a culvert routes Vanderbilt Creek under Glacier Highway and into the west ditch.

Figure 11. Map of the East Ditch sub-drainages, showing the mapped stormwater structures (orange dots) and the outfalls identified during CBJ's 2008 inventory (yellow dots). The general flow through the subdrainage is shown by the arrows.

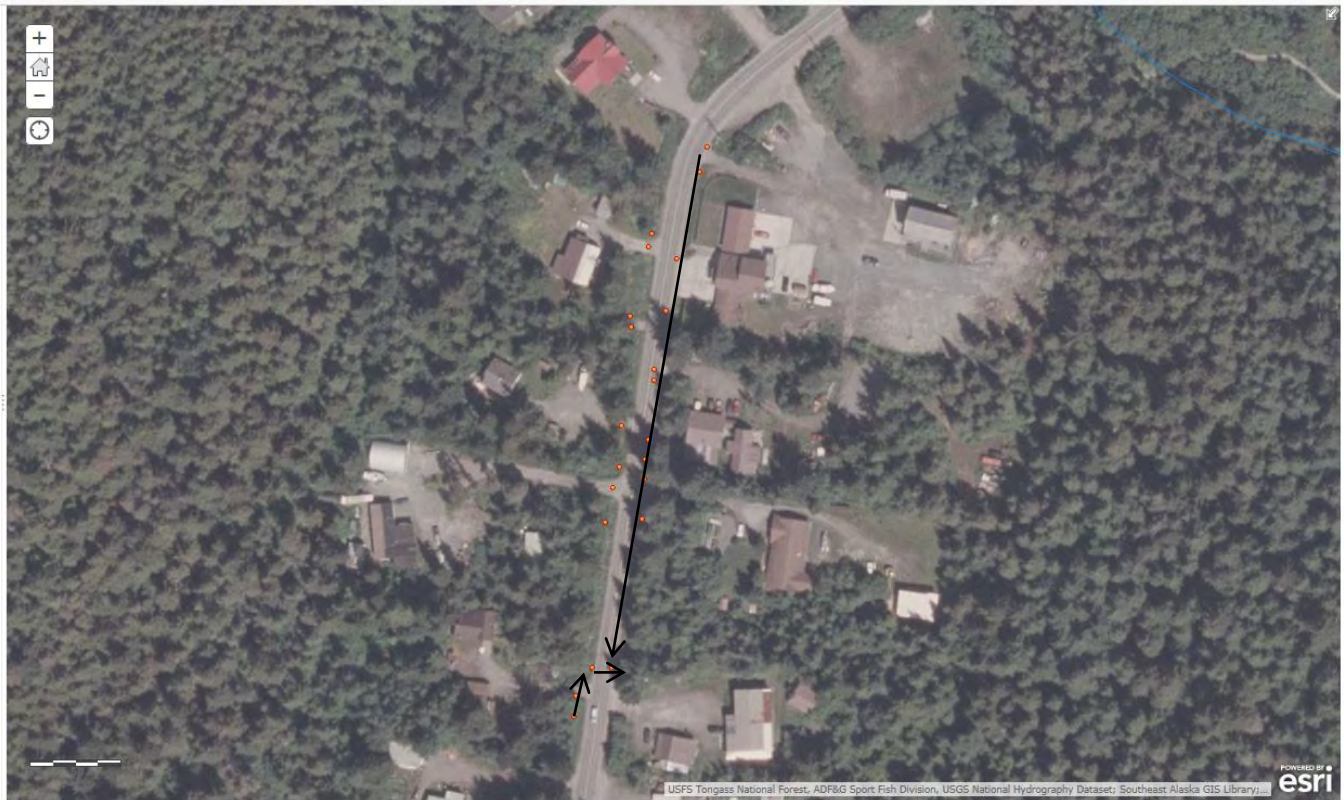
The Lower Engineer’s Cut-Off – West Fork sub-drainage contains approximately 14 acres of residential development. The land use designation for this sub-drainage is Urban Low Density Residential (ULDR). The stormwater in this sub-drainage is conveyed solely through vegetated roadside drainage ditches with cross-culverts to allow the stormwater to flow under driveways. The flow for this sub-drainage begins in near the bend in the road and heads south in the roadside ditches along Engineer’s Cut-Off. The roadside ditches in this sub-drainage discharge into Pederson Hill Creek where the west fork of the creek is directed under Engineer’s Cut-off in culverts. In these locations, the ditch flow directly enters the creek.

Figure 13. Map of the lower Engineer's Cut-off subdrainage, showing the mapped stormwater structures (orange dots). The general flow through the subdrainage is shown by the arrows.

The ditches along Engineer's Cut-off are steeply sloped, relatively deep, and vegetated. They are designed to convey substantial amount of stormwater, and they intercept run-off from both the road and adjacent yards. Iron flocculate is present in locations, indicating that groundwater flow is entering the system. It should be noted that the residential area along this length of Engineer's Cutoff still utilizes septic systems.

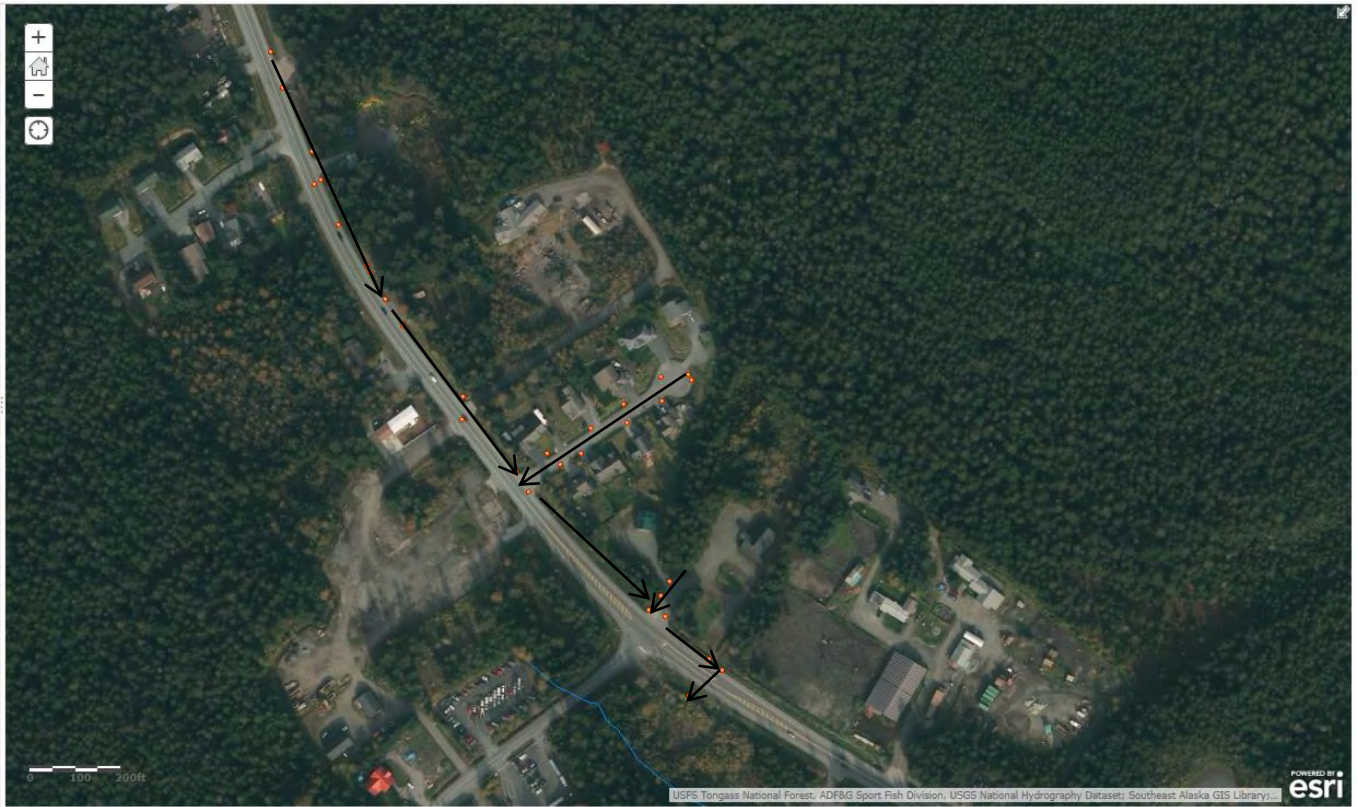
In the Upper Glacier Highway sub-drainage the stormwater is conveyed through a series of roadside ditches from residential and road run-off. This sub-drainage begins at the top of Glacier Highway in the north side ditch and flows southeast in the ditch until it discharges into a tributary of Pederson Hill Creek where the natural creek flow is conveyed under Glacier Highway in a culvert (Figure 15). The north side ditch collects stormwater run-off from the areas north of Glacier Highway as well as the road itself. The stormwater in the Glacier Highway ditches moves relatively slow and may not necessarily make it to Pederson Hill Creek before infiltrating into the ground.

Figure 15. Map of the Glacier Highway subdrainage in Pederson Hill Creek watershed, showing the mapped stormwater structures (orange dots). The general flow through the stormwater system is shown by the arrows.

The ditches along Glacier Highway are steeply sloped, relatively deep, and vegetated. They are designed to convey substantial amount of stormwater. Iron flocculate is present in locations, indicating that groundwater flows are entering the system.

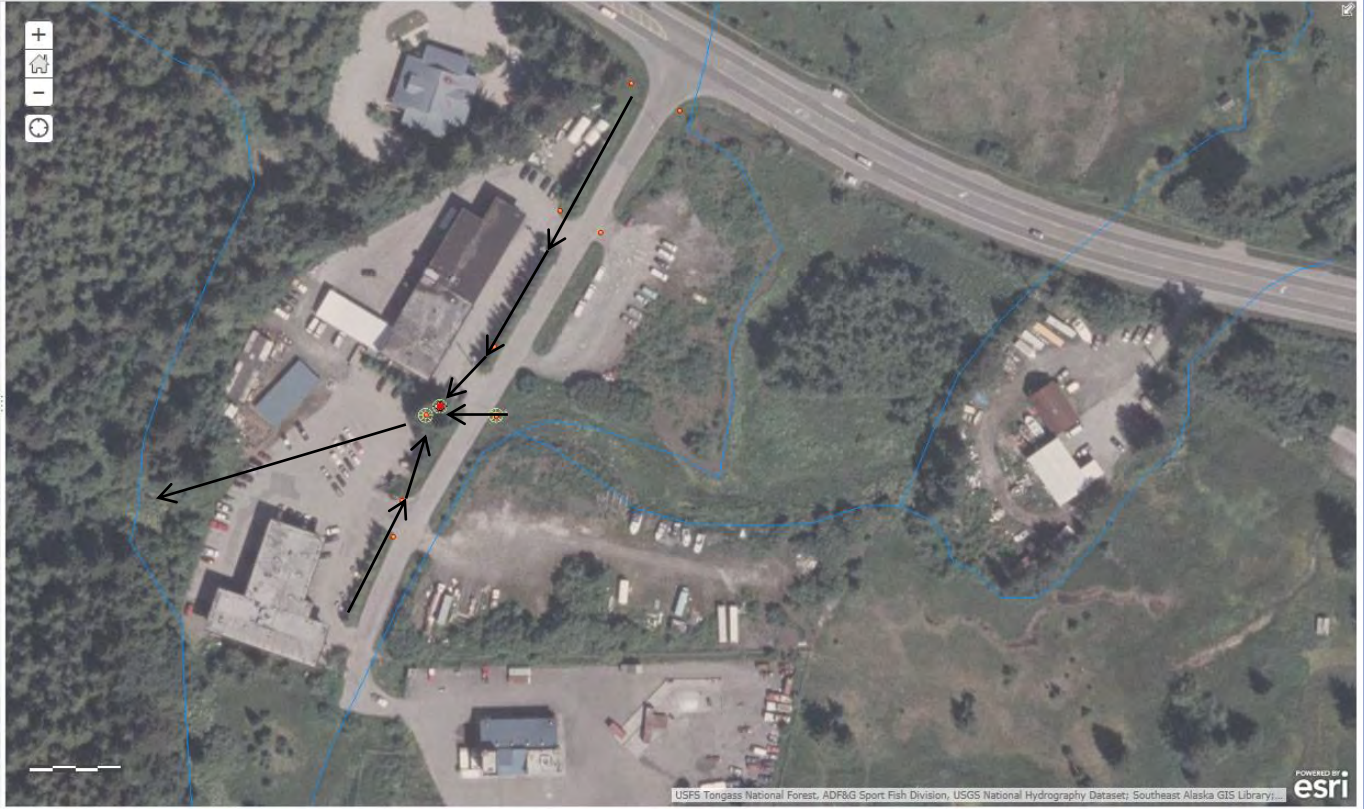
of stormwater. It appears that the lots on Sherwood Lane drain toward the road and into the ditch network. However, since many of the lots on the eastern side of Sherwood Lane are privately owned, they were not accessed to determine whether there were additional drainage structures or patterns.

Figure 16. Map of the Glacier Highway subdrainage in Pederson Hill Creek watershed, showing the mapped stormwater structures (orange dots). The outfall to Peterson Hill Creek is shown in red. The general flow through the stormwater system is shown by the arrows.

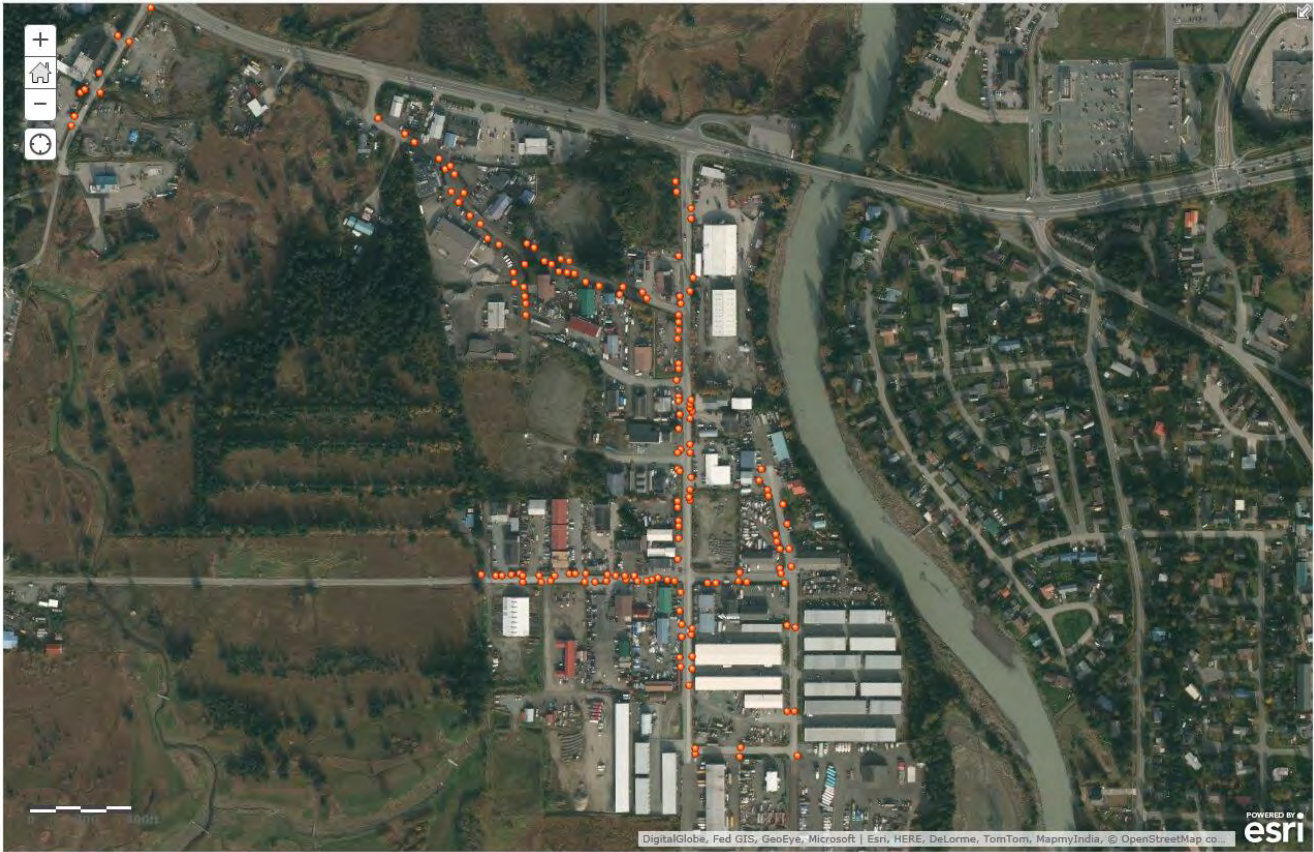
Figure 17. Map of the Industrial Boulevard area. Stormwater mapping revealed that this area does not drain to the Pederson Hill Creek watershed; it appears that this area either slowly drains or flows toward the Mendenhall River. The mapped stormwater structures appear as orange dots.

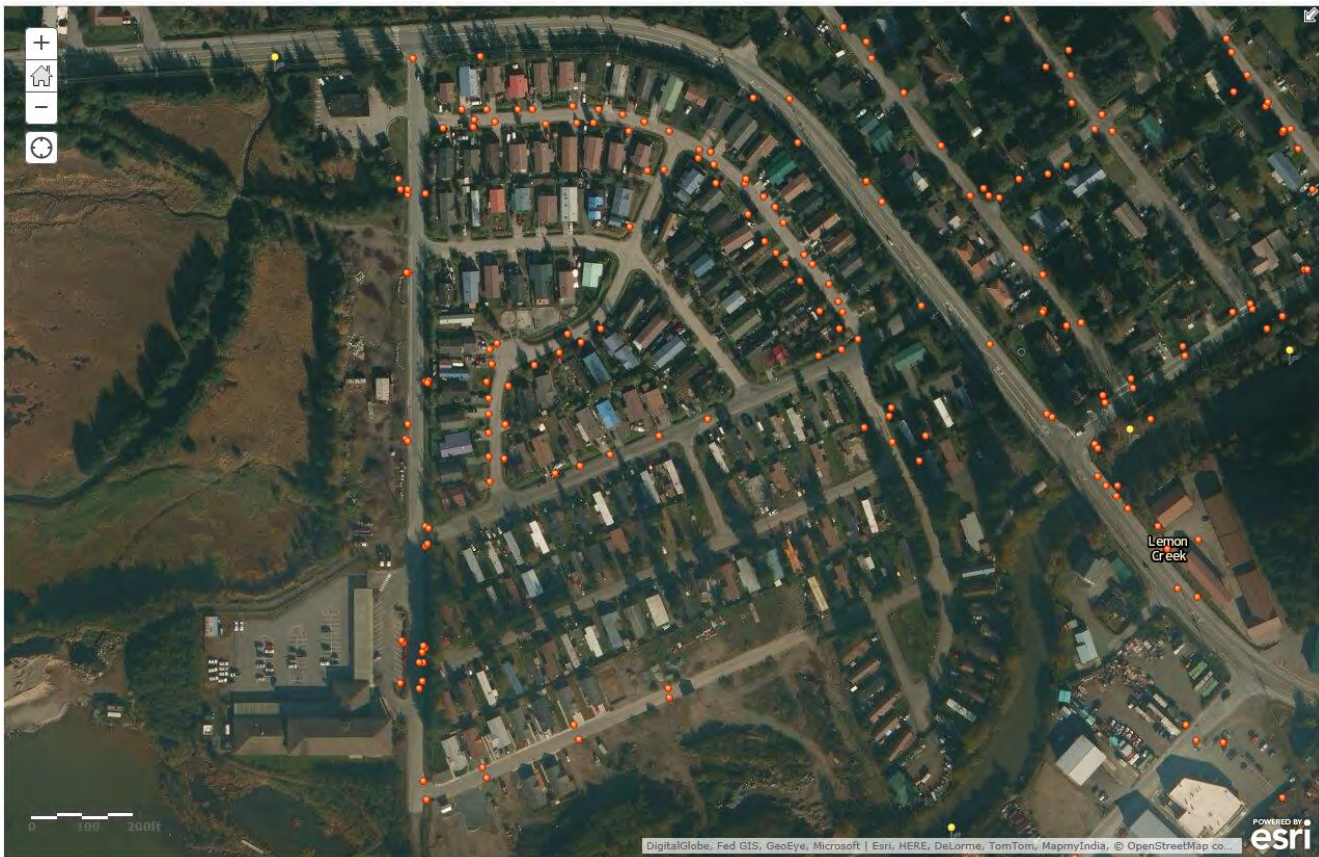
Figure 18. Map of residential area near Switzer and Lemon Creeks. Stormwater mapping revealed that this area does not drain to the Lemon Creek watershed, but to the Switzer Creek watershed. The mapped stormwater structures appear as orange dots.
