**FINAL
MATANUSKA RIVER
DEBRIS REMOVAL ASSESSMENT
PALMER, ALASKA**

**Alaska Department of Environmental Conservation
555 Cordova Street
Anchorage, Alaska, 99501**

**OASIS Environmental, Inc.
807 G Street, Suite 250
Anchorage, Alaska 99501**

30 August 2004

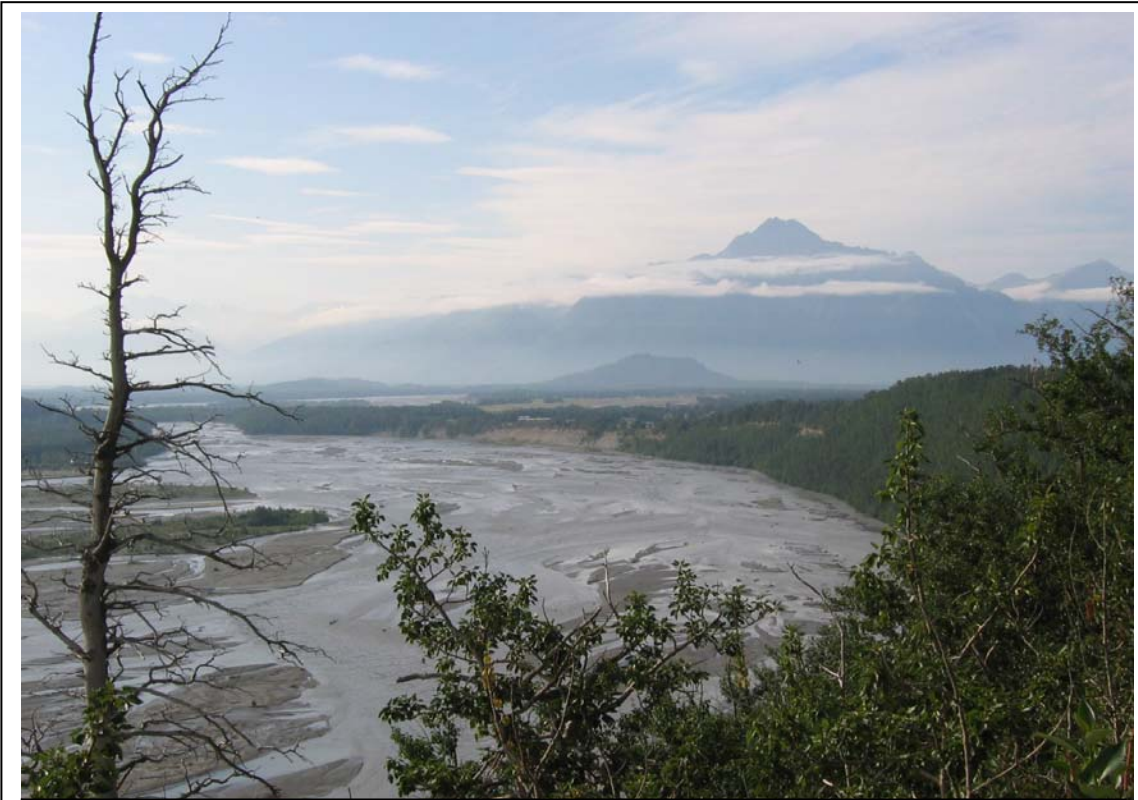
View overlooking the Matanuska River looking towards the debris disposal area. (7/16/04)

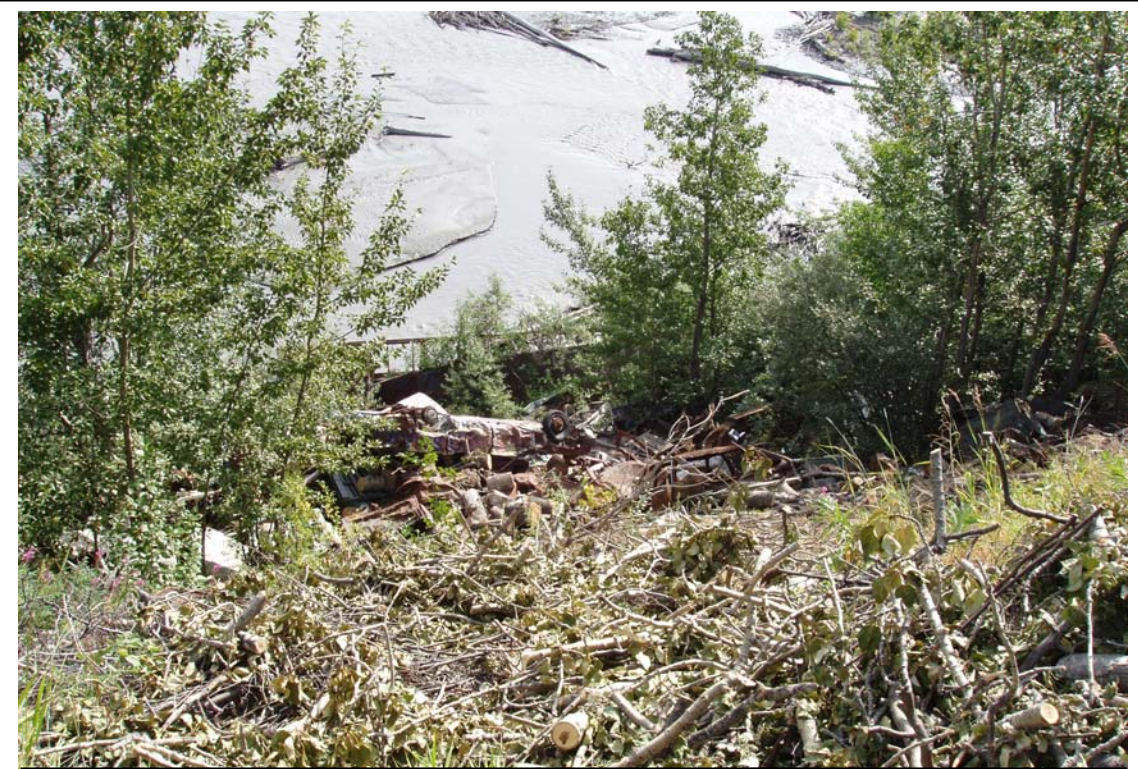
On our arrival at the debris disposal site it was observed that active dumping is still occurring at the site as evidence of recent disposal of tree cuttings (Photo Page 1) and tire tracks on the hiking trail (Photo Page 8) were observed.

Once a debris pile is created it tends to attract the disposal of additional debris. During our July 16 site visit we observed tree cuttings that had been recently placed at the top of the debris pile. Removal of the debris pile would eliminate, and at a minimum reduce, the desire to dump additional debris at this site.

View looking down at the debris disposal area from the hiking trail. Notice new tree cuttings that have been dumped here since the 5/26/04 site assessment. (7/16/04)

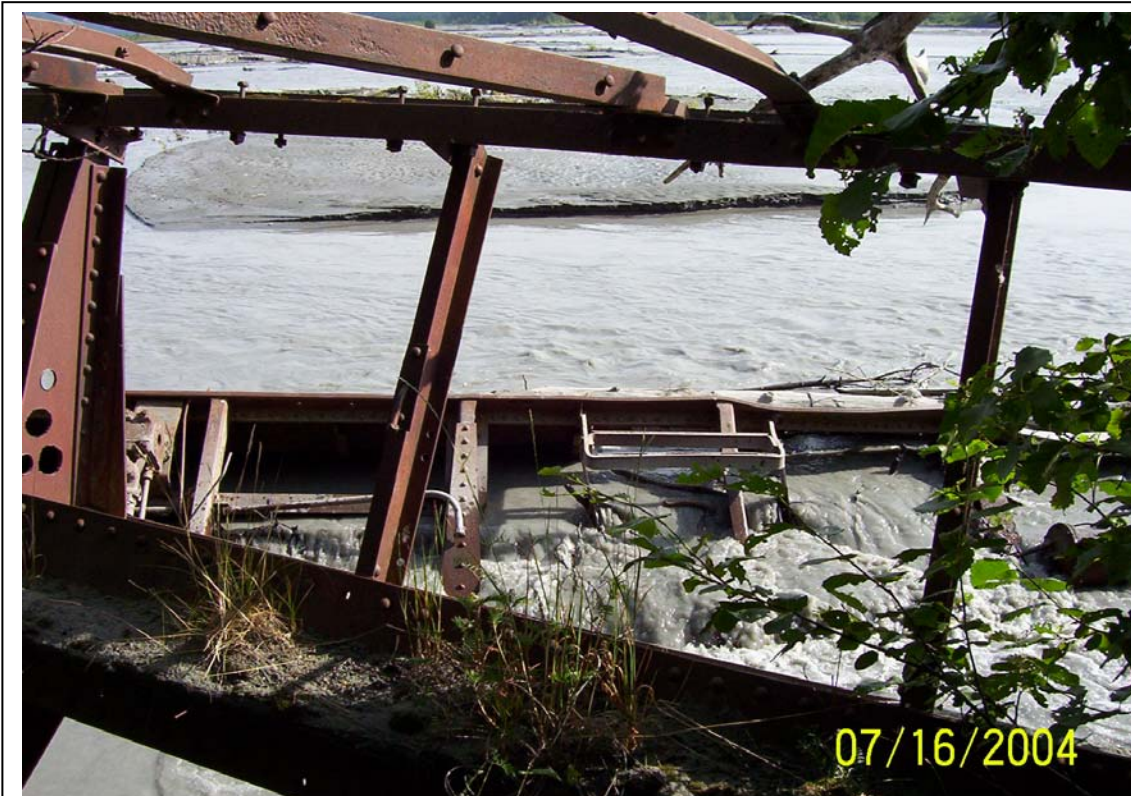
Photo showing bottom section of railroad car sitting in the Matanuska River. (7/16/04)

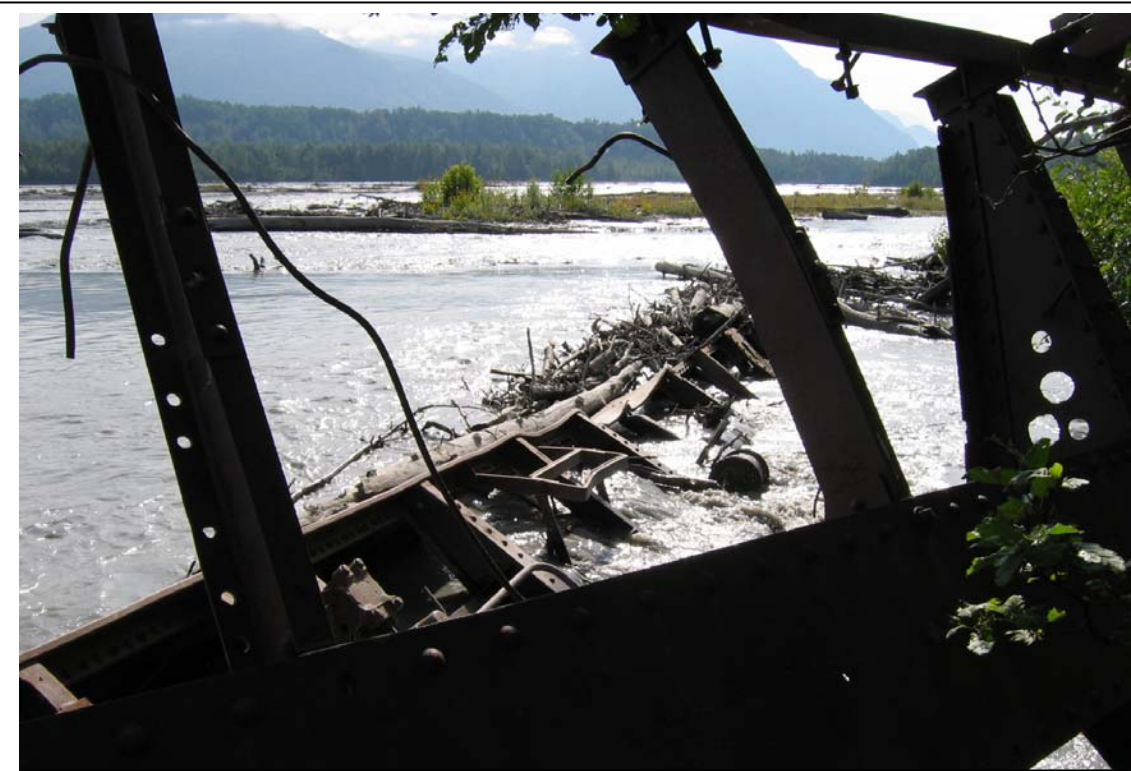
- It is the team's assessment that based on the haphazard and disorganized arrangement of the railcar and other railroad debris that little attempt was made to place the disposed equipment in a manner to maximize the erosion reduction potential. However, some of the railcar debris does appear by a fortuitous nature to offer effective protection against active erosion by the Matanuska River (Appendix A – Photo Page 2).

Another view looking at the railroad car section that shows how it provides some bank erosion protection from the Matanuska River. (7/16/04)

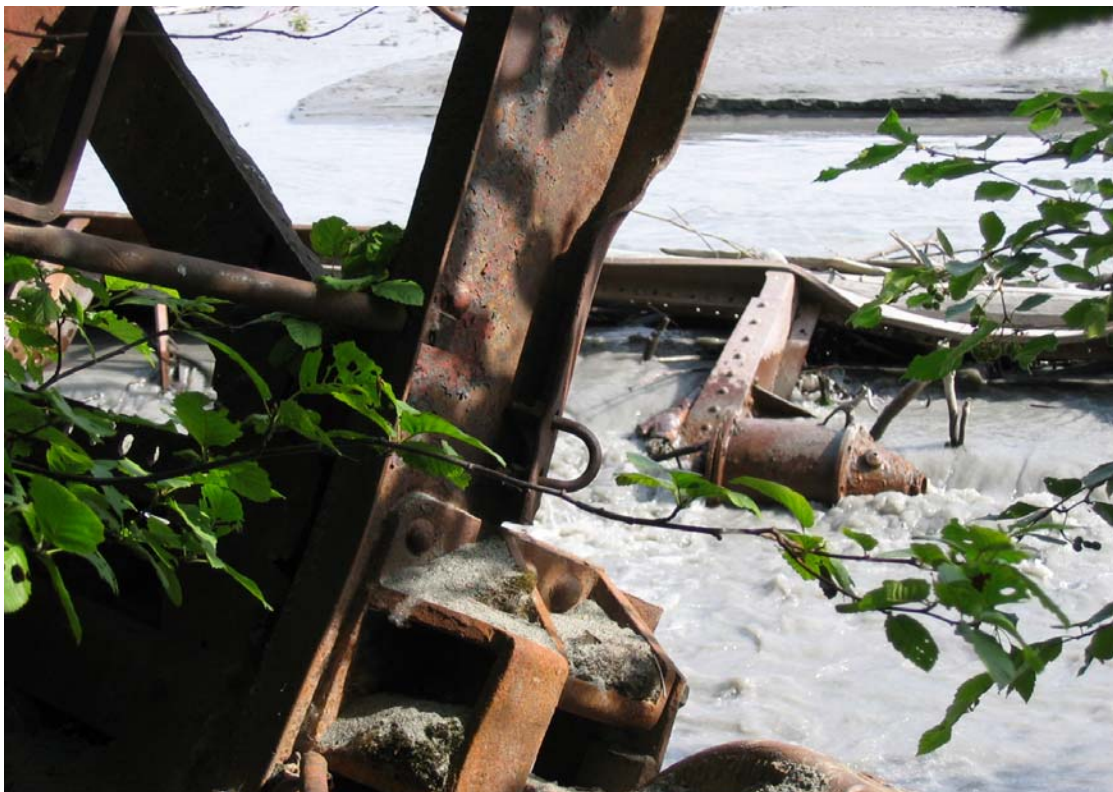
Additional rail car debris laying in a channel of the Matanuska River. (7/16/04)

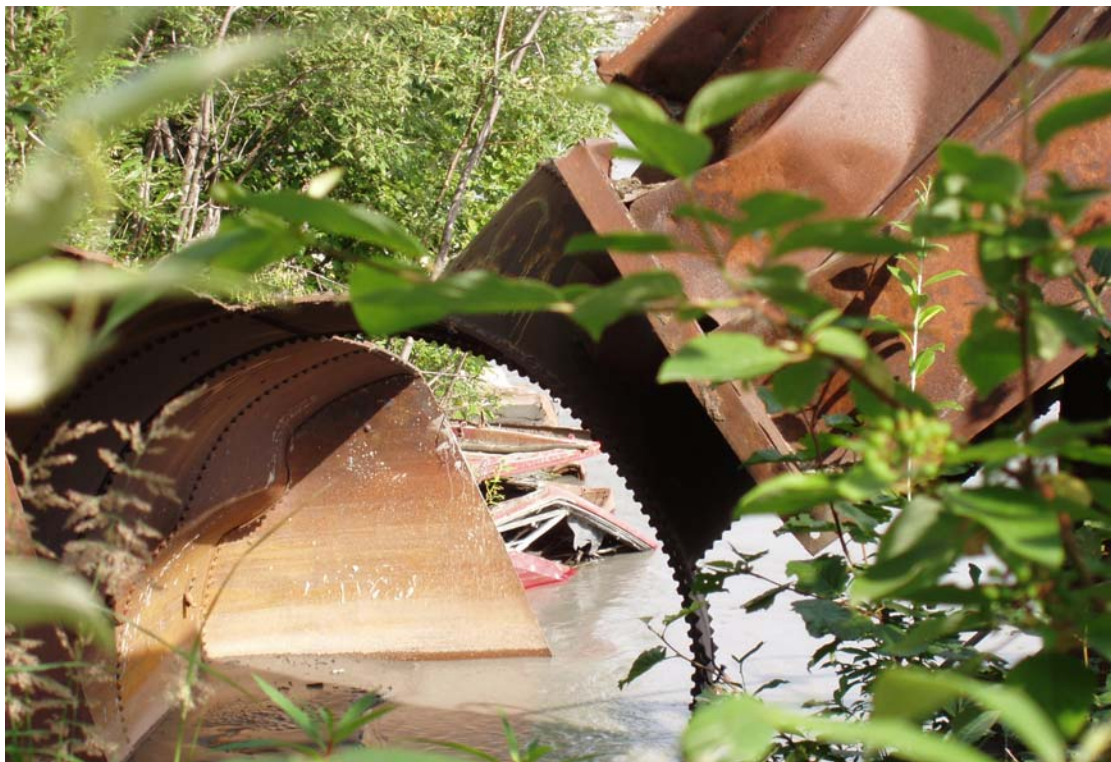
Photo looking upstream at auto and rail car debris located below the water level of the Matanuska River. (7/16/04)

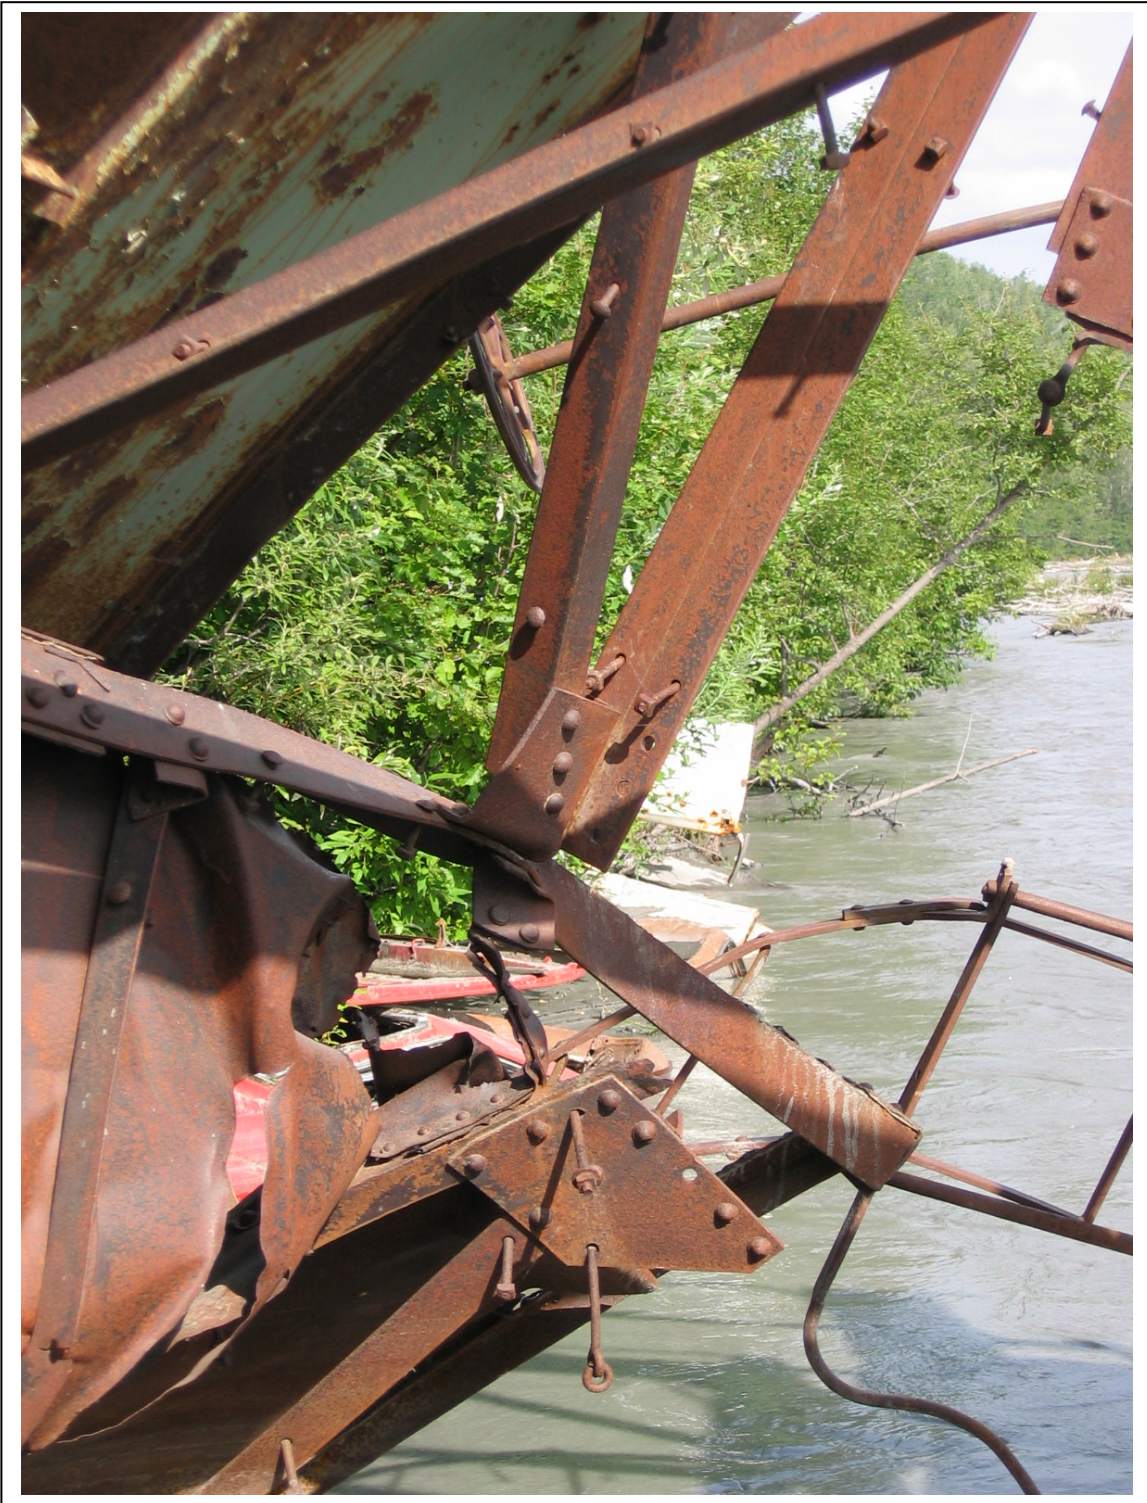
Photo looking upstream along the edge of the Matanuska River from the debris disposal area. (7/16/04)

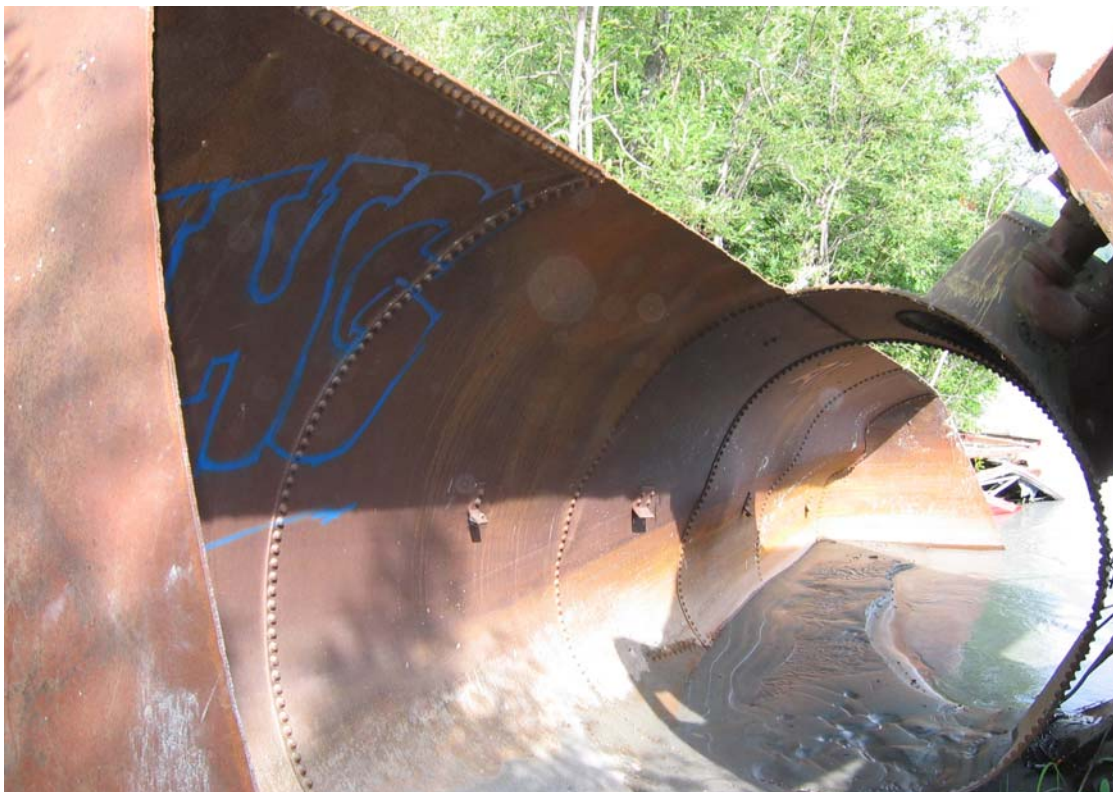
The debris in particular the main debris pile represents a public safety hazard. The instability of piled debris could trap or crush someone that is crawling around or over the debris. Sharp metal edges are also present all over the debris pile. The public hazard represented by the debris pile is further compounded by the fact that it is located on a steep and slippery slope. During our site visits we observed several occasions where children were playing and walking around in the debris pile. Graffiti was also observed at the debris pile on the July 16 site visit (Appendix A – Photo Page 5). Removal of the debris pile would eliminate this public safety hazard.

Photo showing new graffiti that was not present during the May 26, 2004 site assessment. (7/16/04)

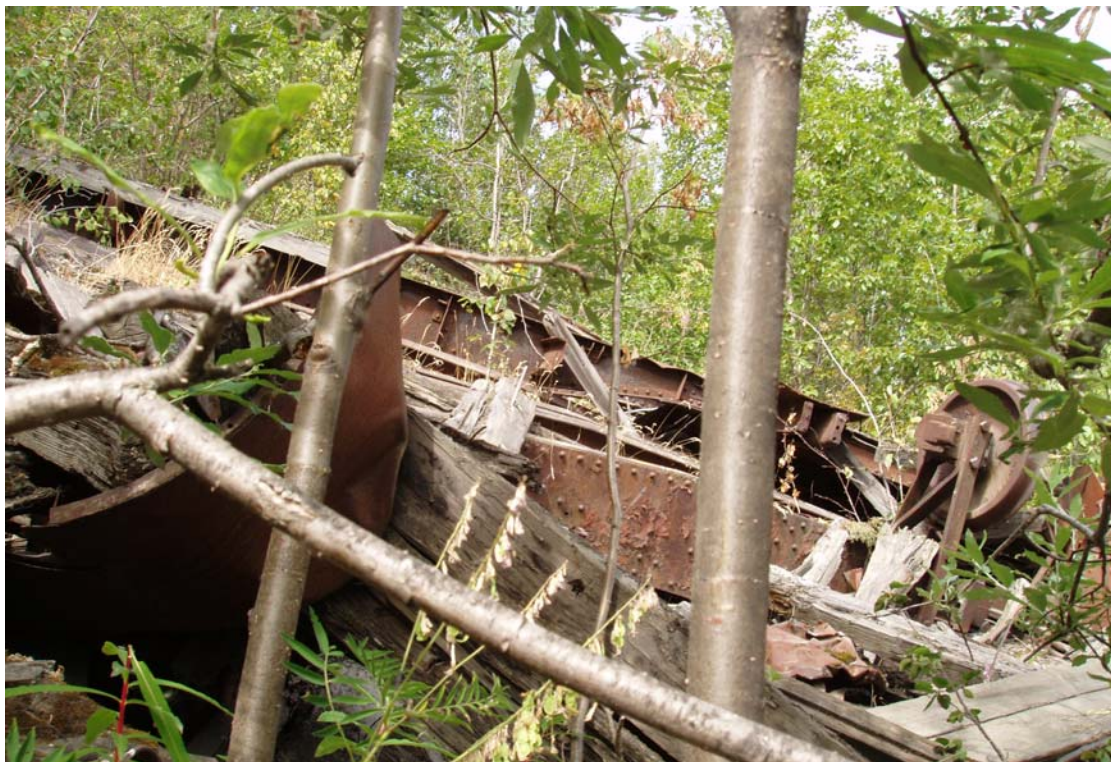
Photo showing rail car debris intermingled with trees and other vegetative growth. (7/16/04)

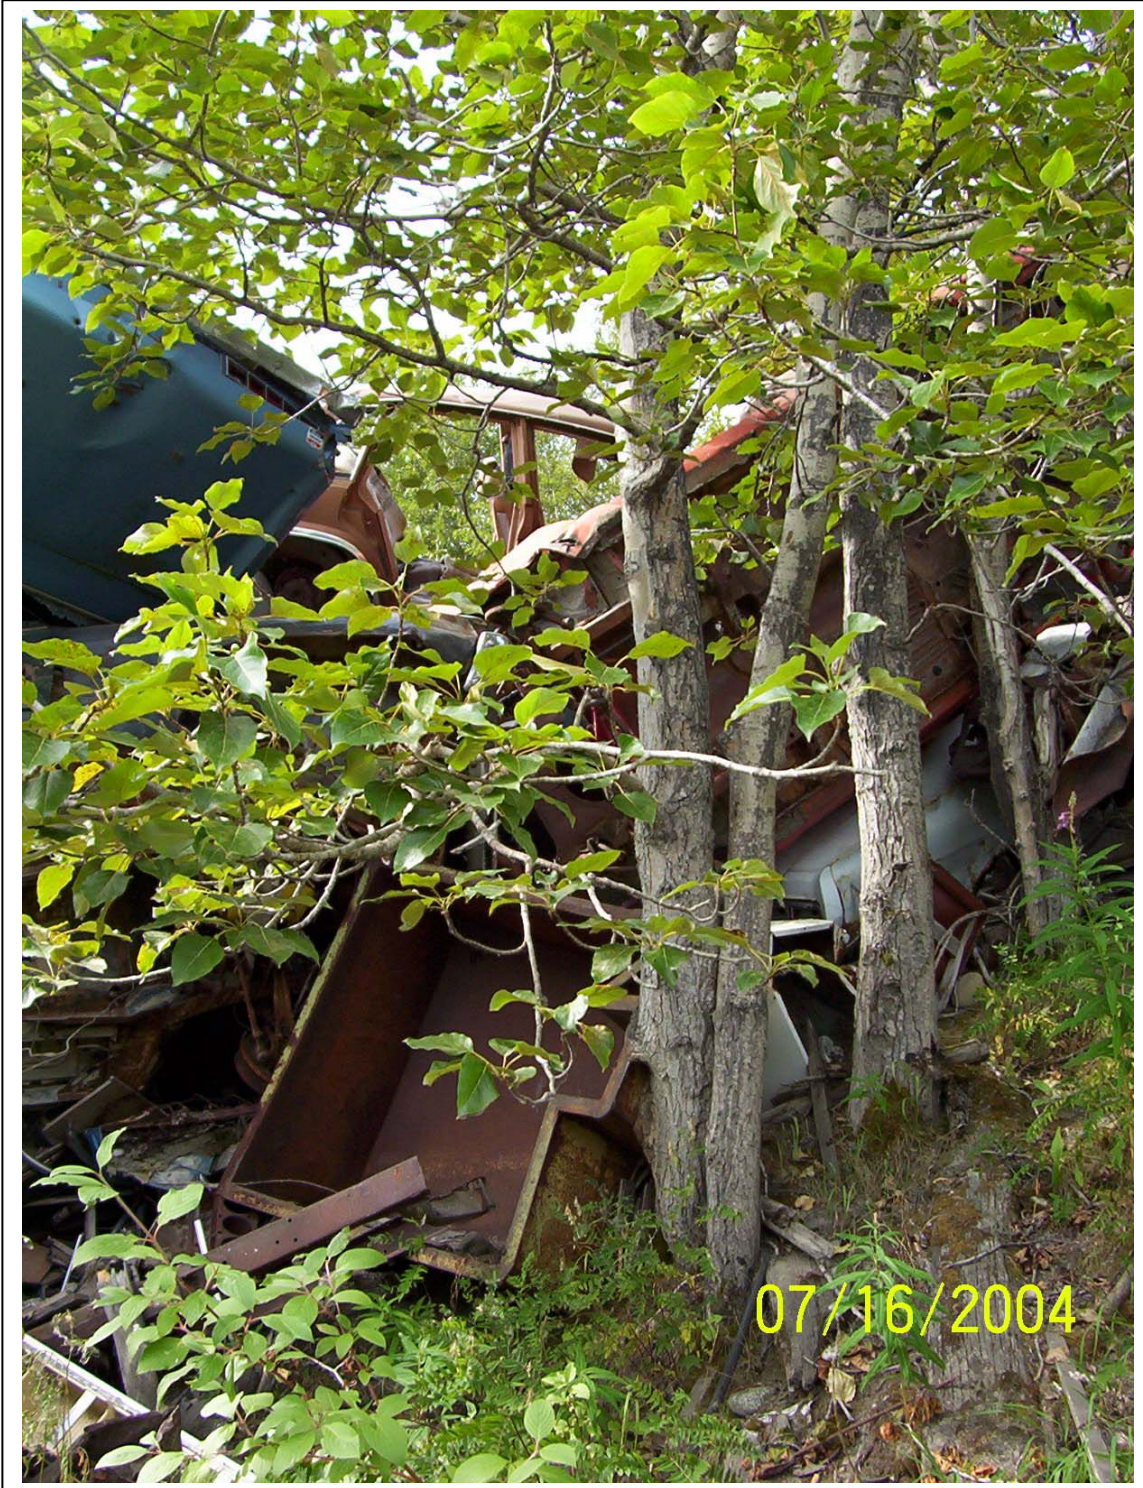
Car bodies and other debris near northern edge of the main debris pile showing how trees are supporting the debris. Also indicates the relatively recent dumping in comparison to the railroad car debris items (7/16/04)

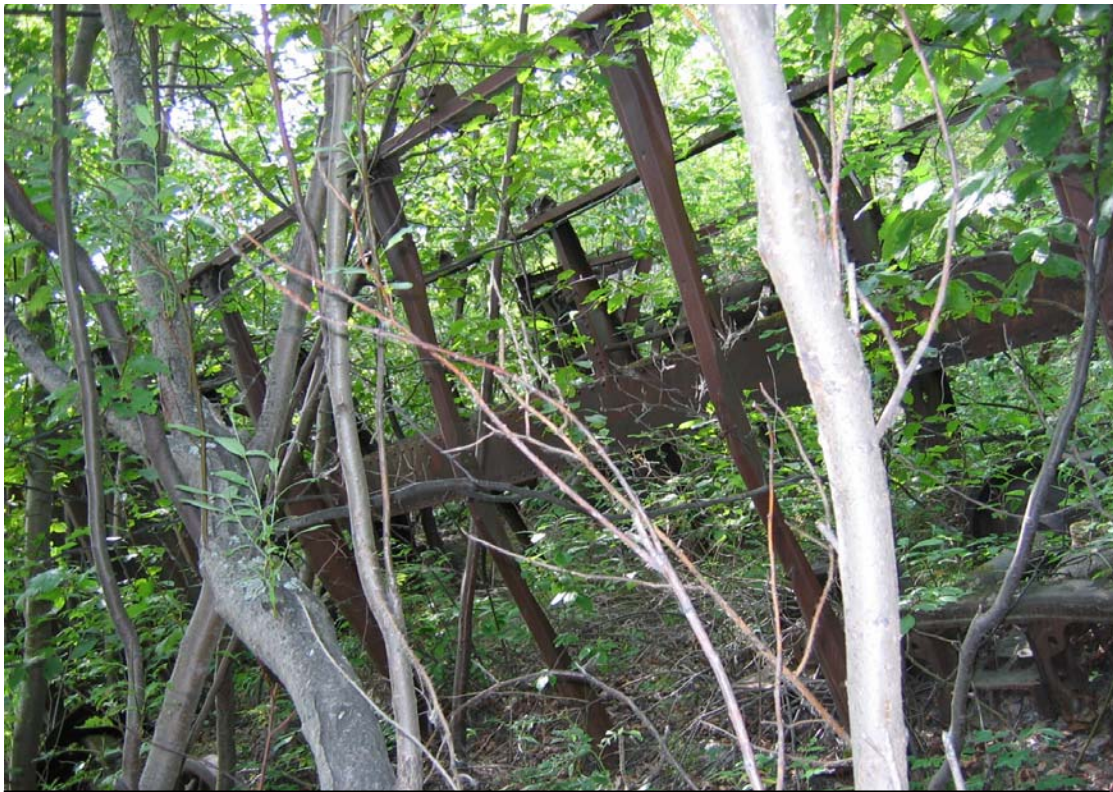
Photo showing vegetative growth around the frame of an old railroad car. (7/16/04)

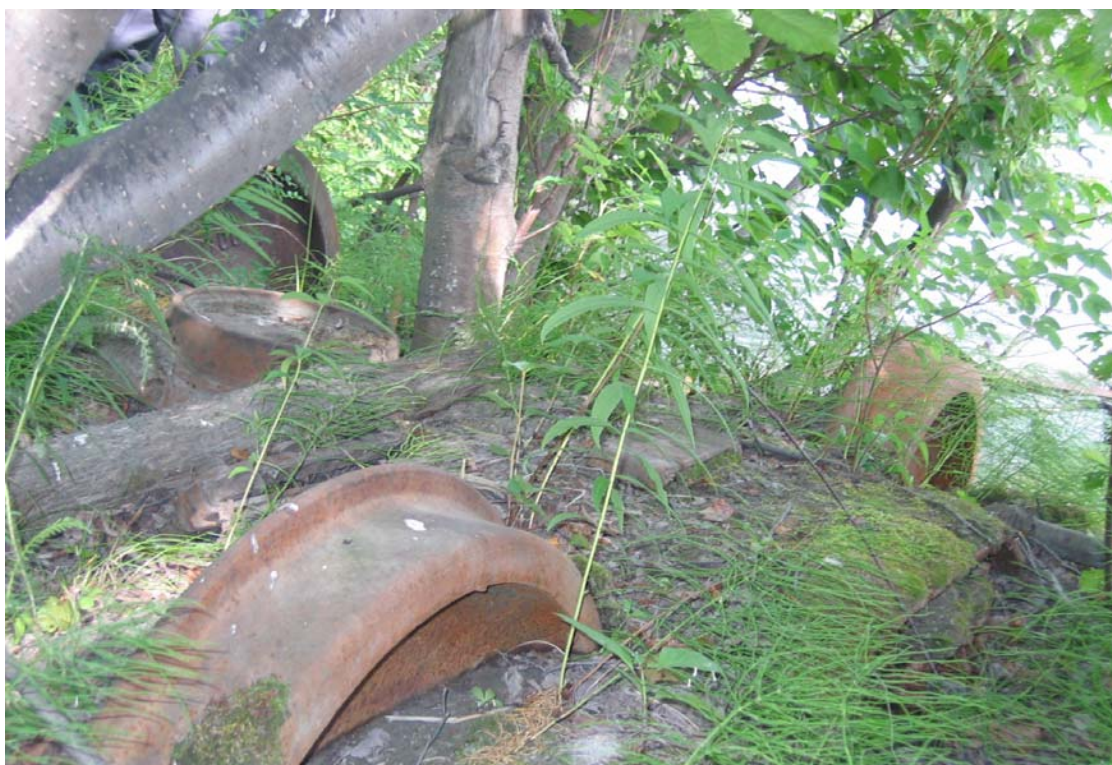
Partially buried rail car wheels and axels located near the base of the bluff and next to the Matanuska River. (7/16/04)

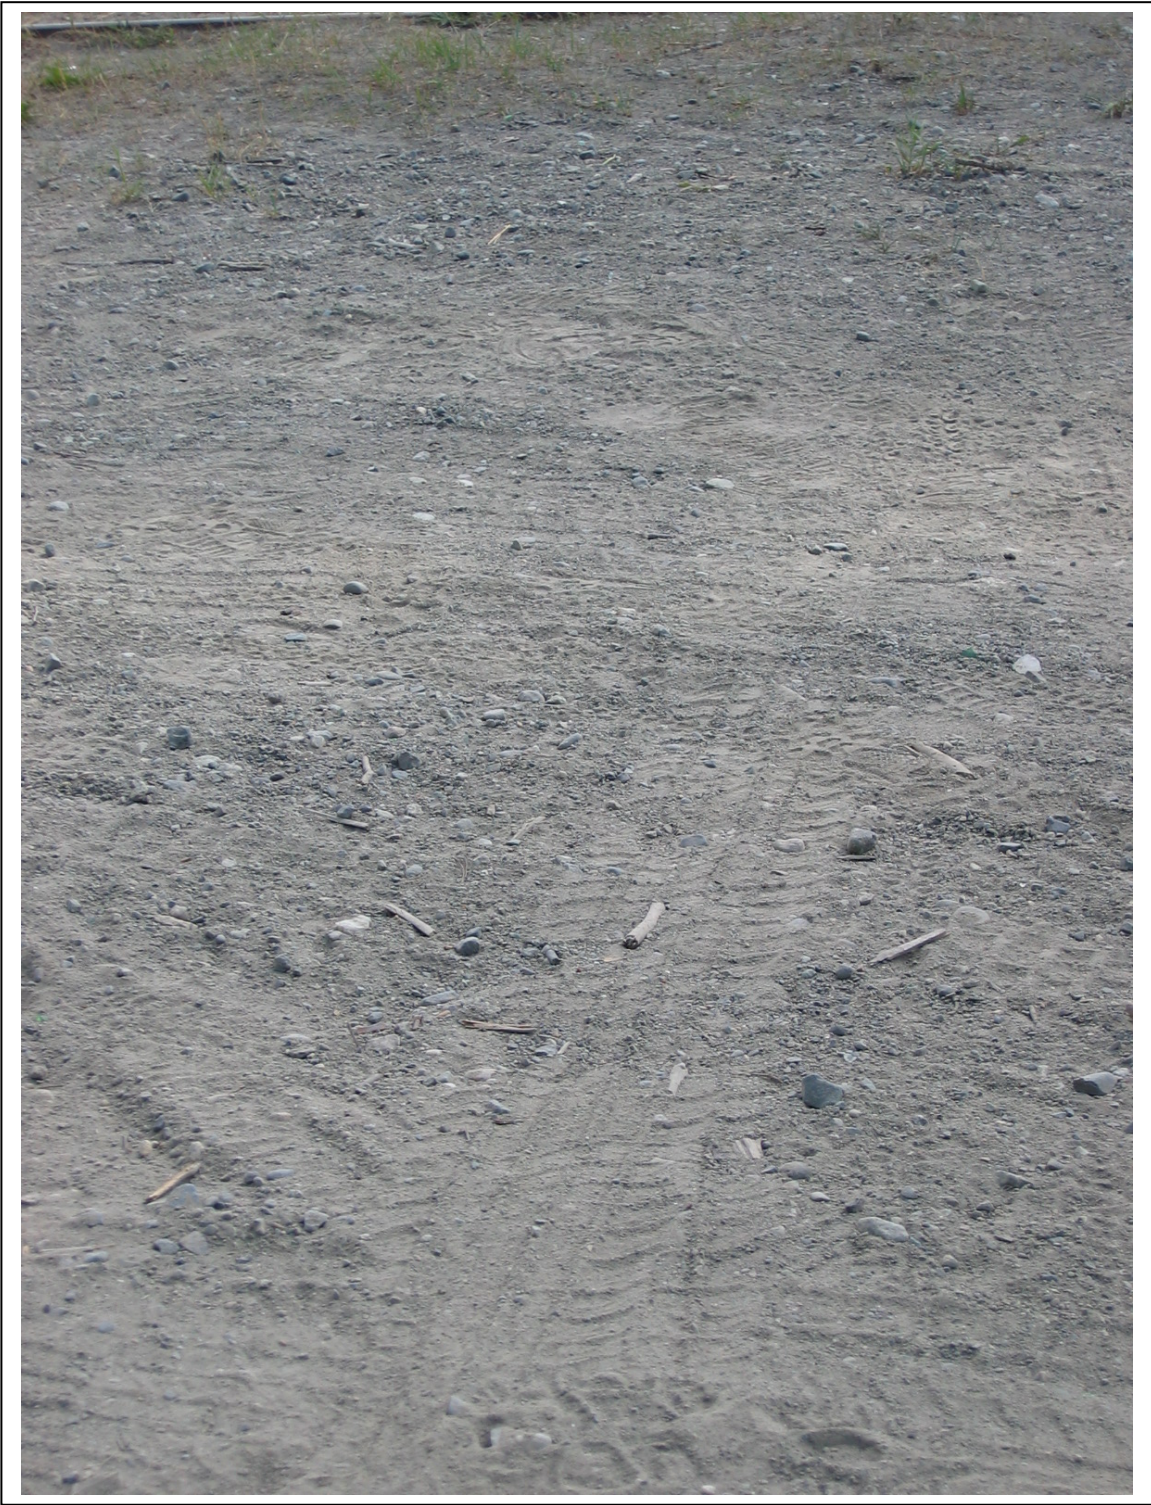
Tire tracks in dirt at top of debris disposal area showing evidence of vehicles driving on the hiking trail.
(7/16/04)

- Install bollards or another suitable barrier to prevent vehicular access to the dump site by the hiking trail at the Eagle Avenue access point and any other points of public access.
- The debris site presents a potential public hazard for children and steps should be taken to minimize the potential for harm. Debris removal is the preferred alternative for minimizing risk but may be cost prohibitive. Other alternatives may include installation of a fence around the debris area to restrict public access.

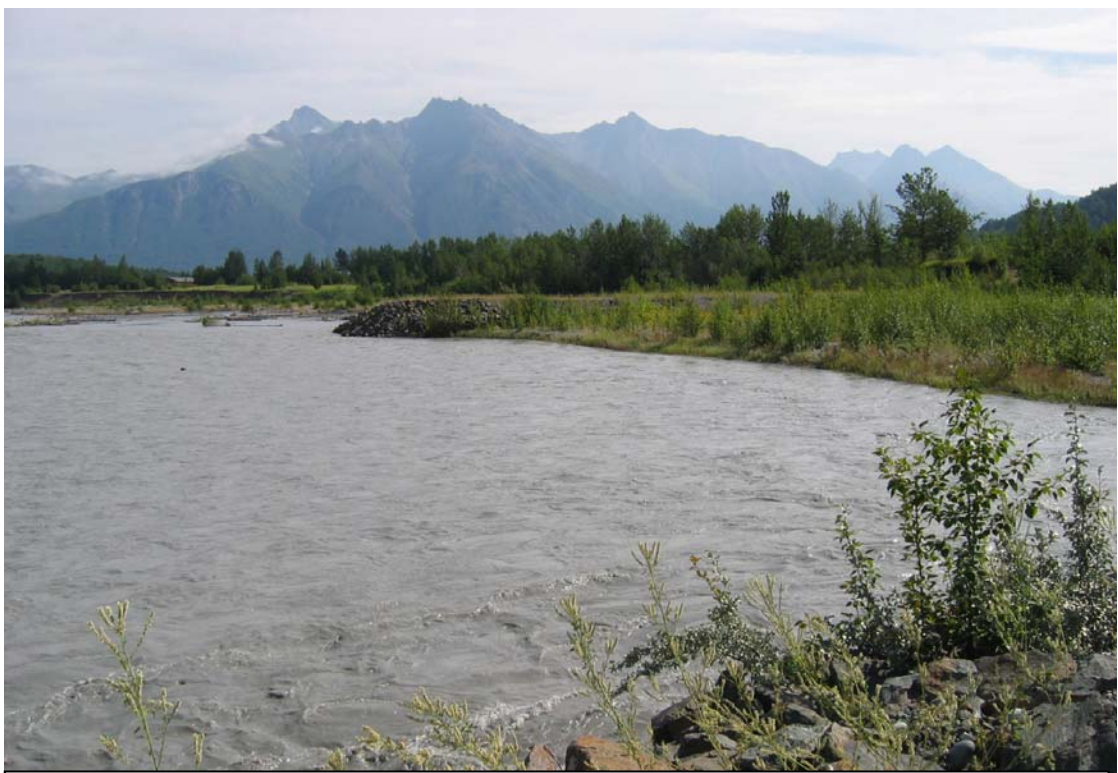
Matanuska River bank stabilization efforts in the Bodenbug Butte area. These large rock finger dikes were constructed in 1992 to prevent further bank erosion. (7/16/04)

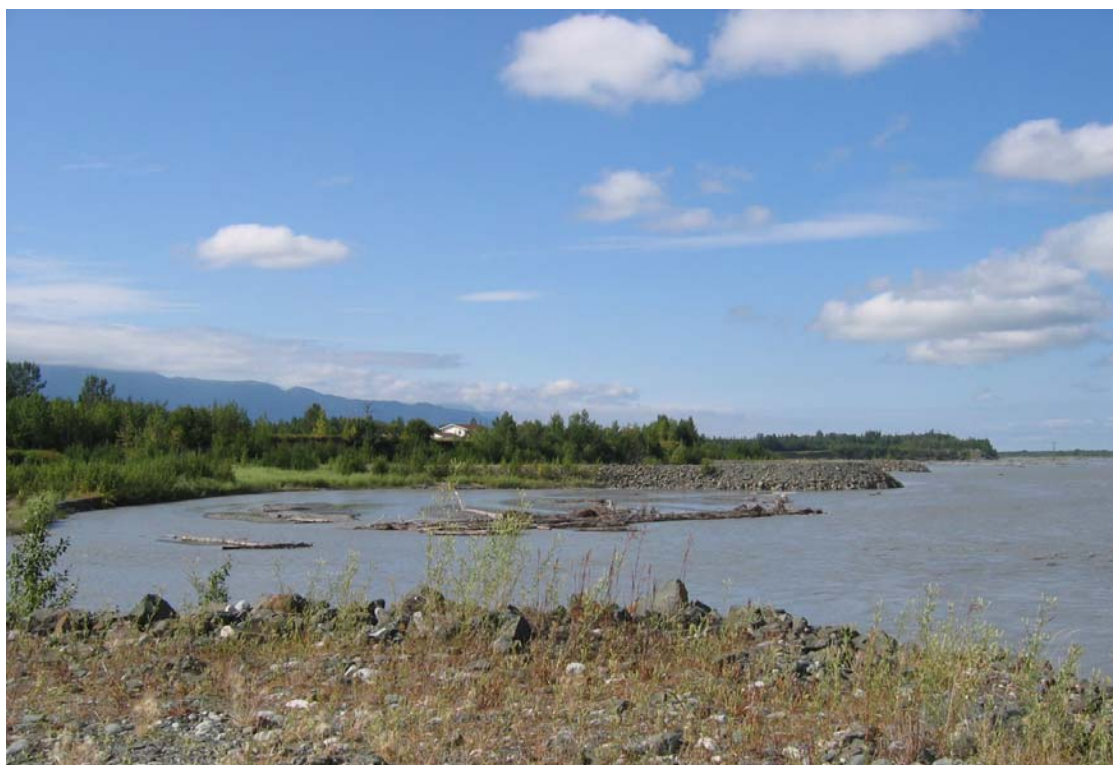
Looking downstream at additional rock finger dikes in the Bodenbug Butte area. Notice that some bank erosion has occurred between the two closest dikes. (7/16/04)

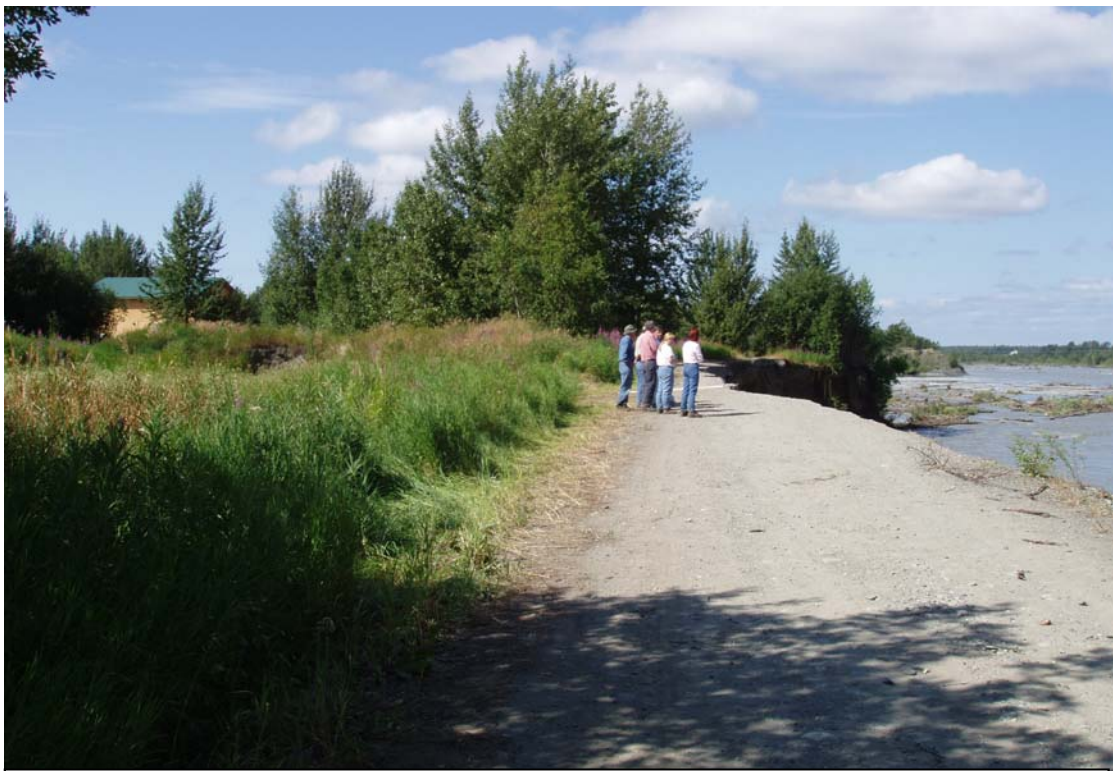
Active Matanuska River bank erosion is occurring in the Circle View Estates subdivision just downstream from protective dikes. (7/16/04)

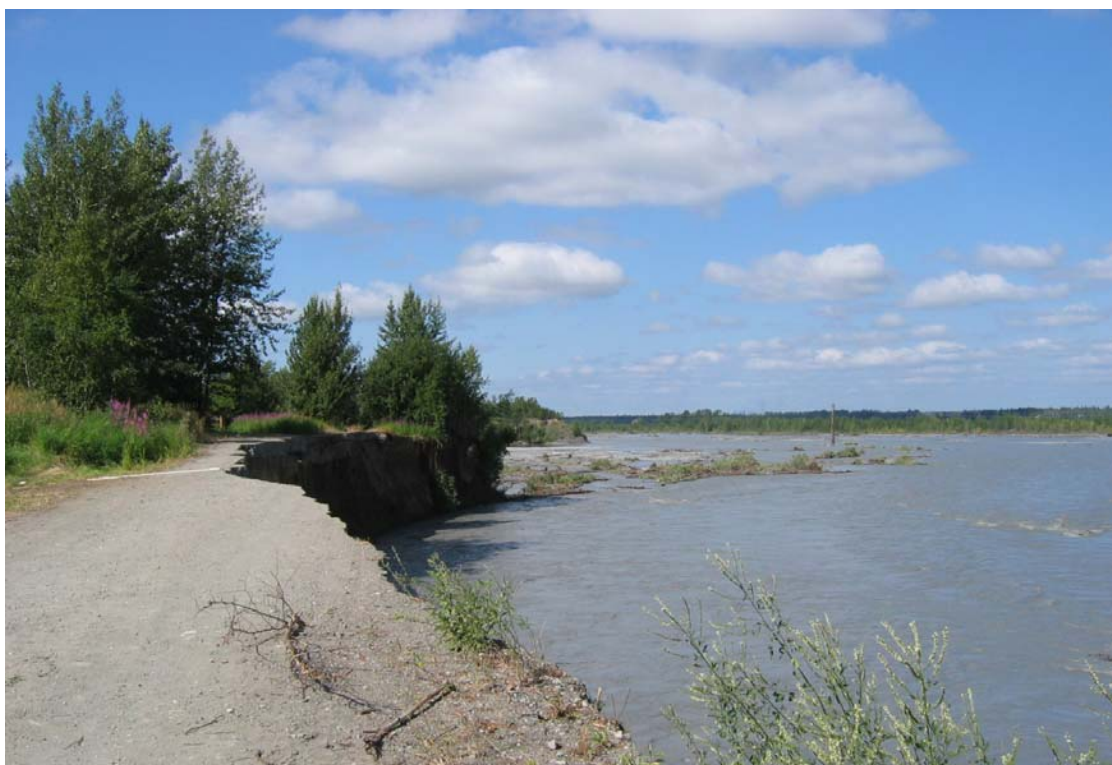
The bank erosion has started to impact the local roadway. Notice the trees that have fallen into the Matanuska River just downstream of the cut bank. (7/16/04)

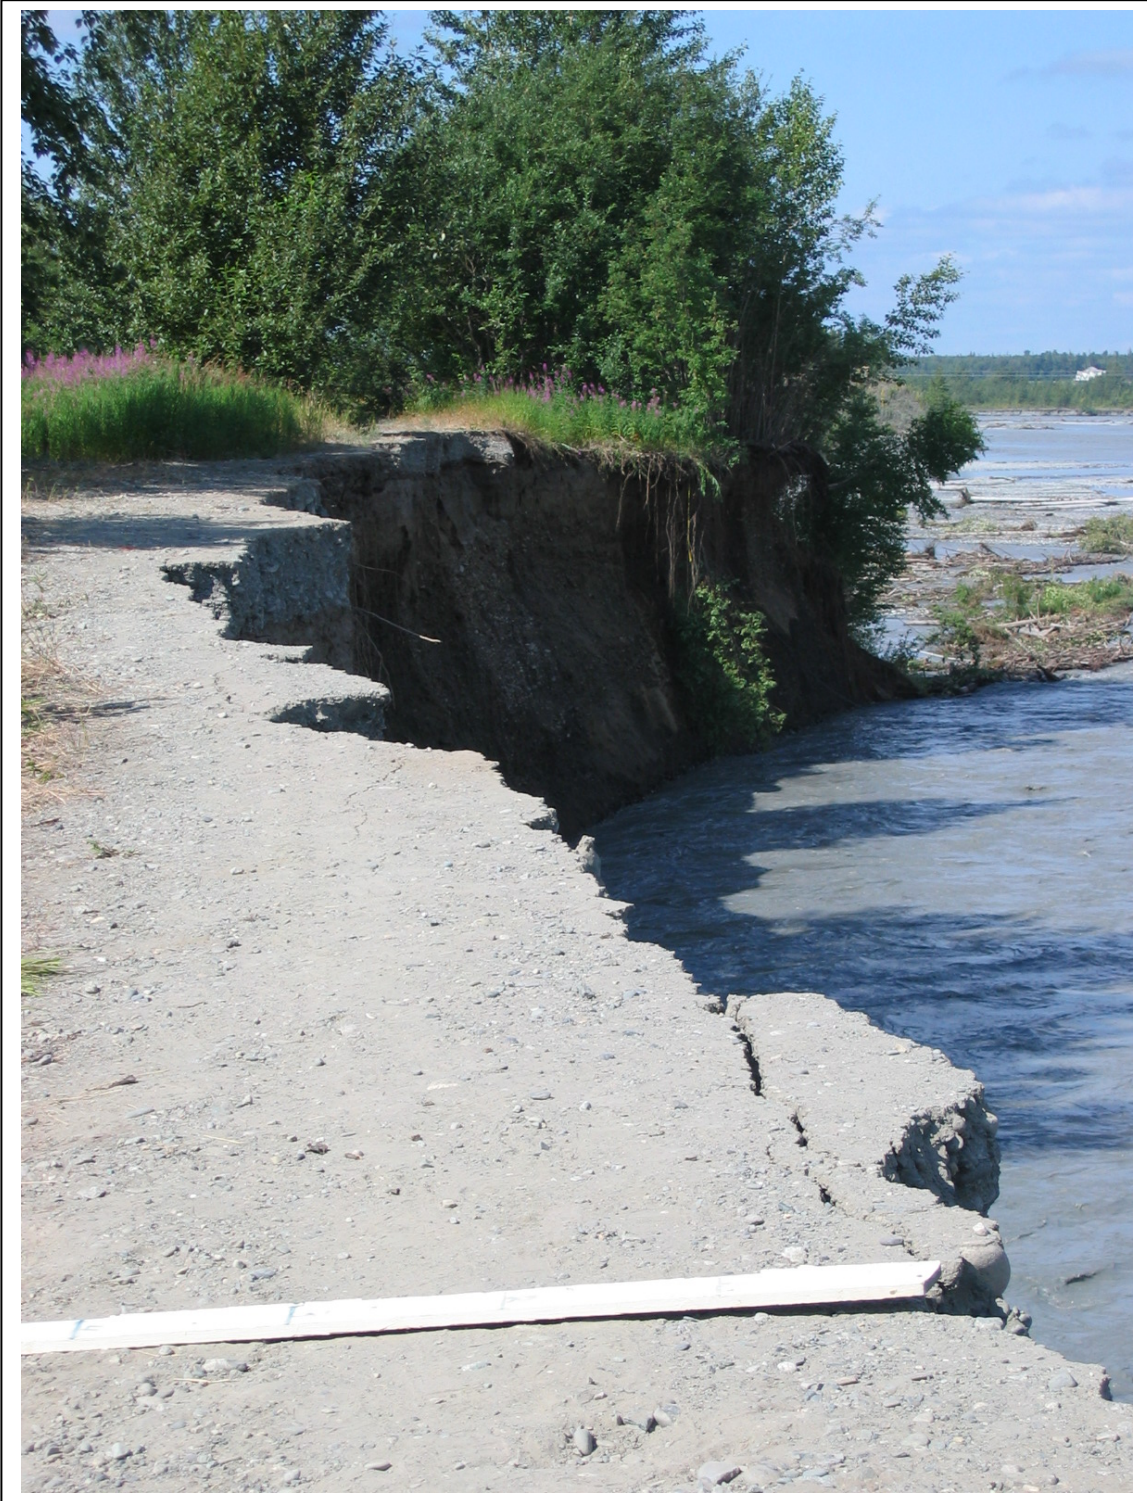
Close up photograph of the bank erosion area. Notice stress cracks along bank edge and could also hear a steady fall of the gravelly bank material falling into the river. (7/16/04)

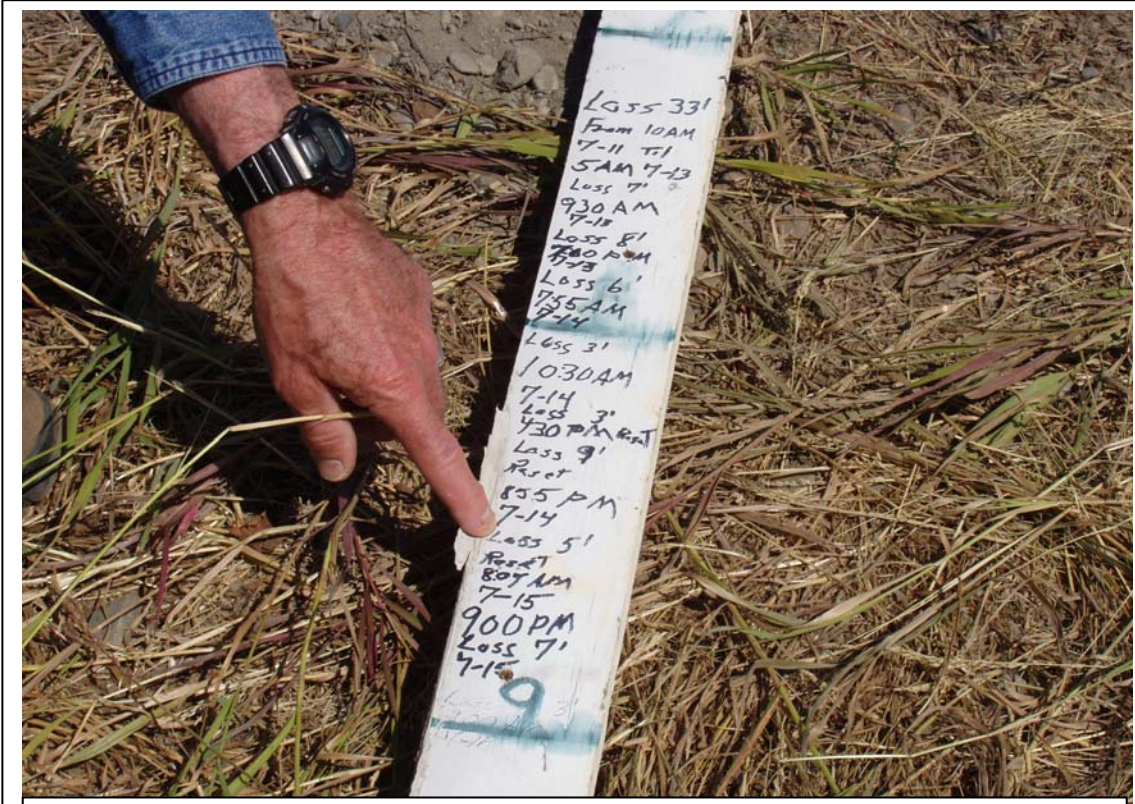
Marker indicating that over 80 feet of the bank has eroded from July 11 though July 16. (7/16/04)

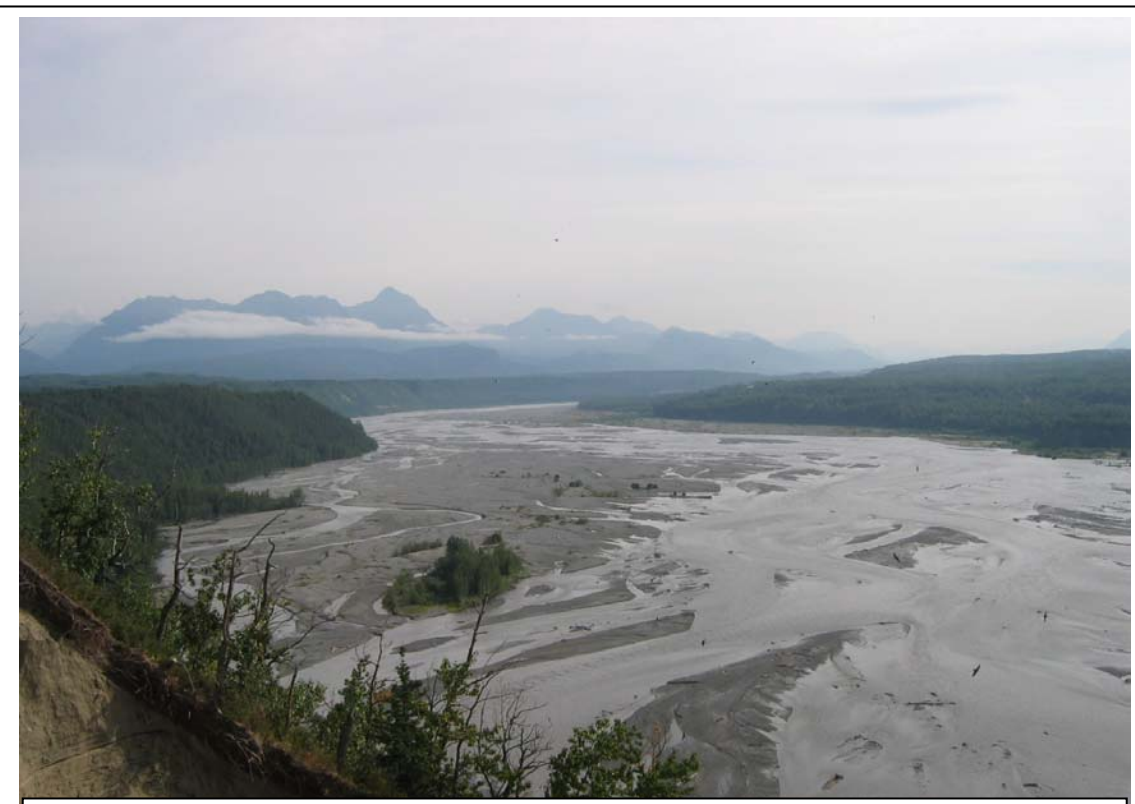
Photo showing the braided channel flow present in the Matanuska River. (7/16/04)
