## **Holgate (Onemile) Creek Field Recon Report, 4/26/05**

Location: south of Haines

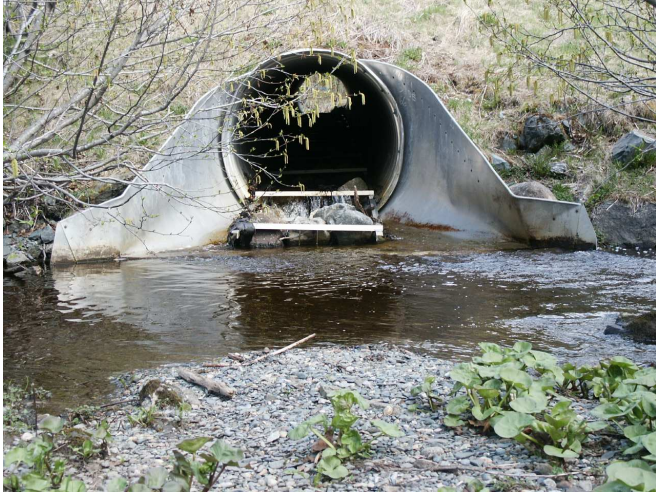
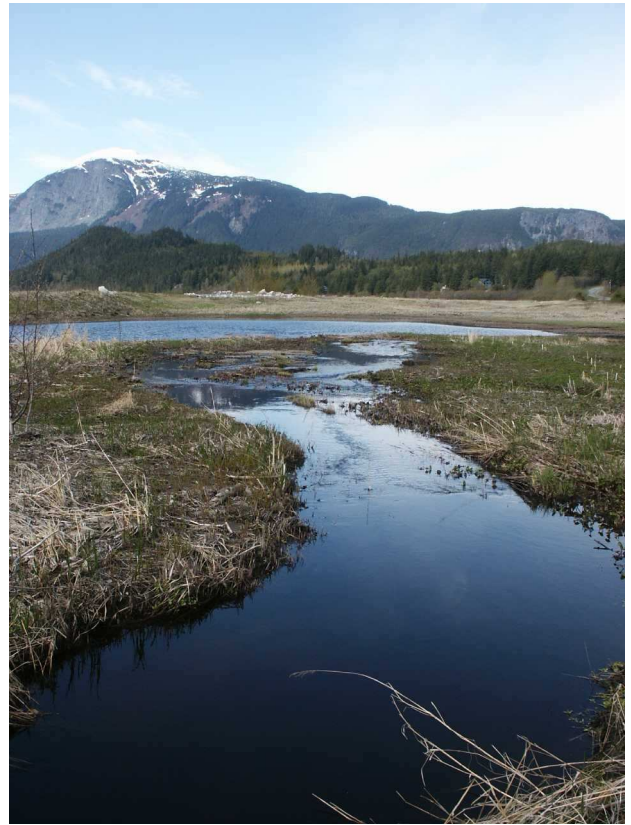
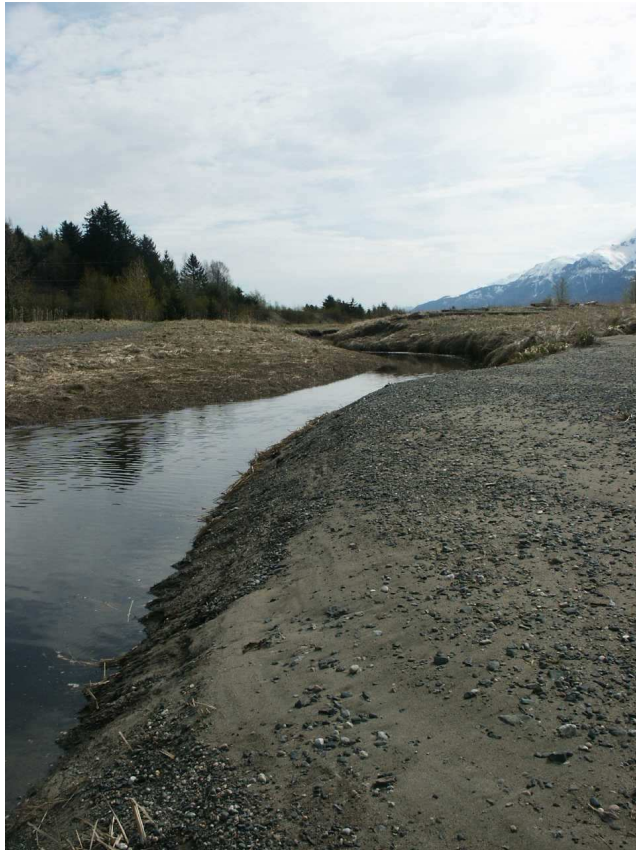
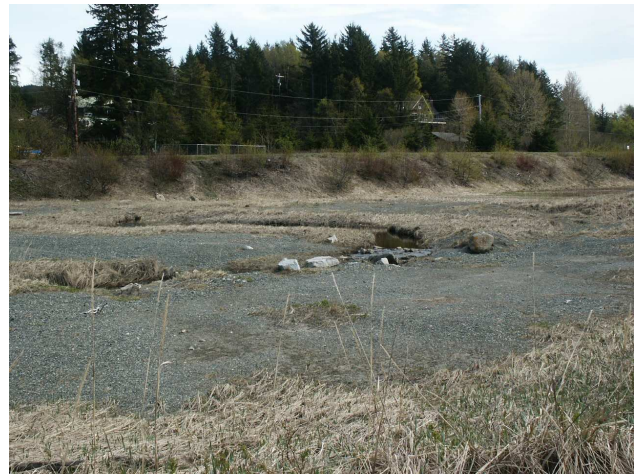
**Lower reaches of Holgate (Onemile) Creek.** *Top left* Photo of culvert on Mud Bay Road with habitat structure inside. *Bottom right* Unvegetated area, formerly site of ATV use.

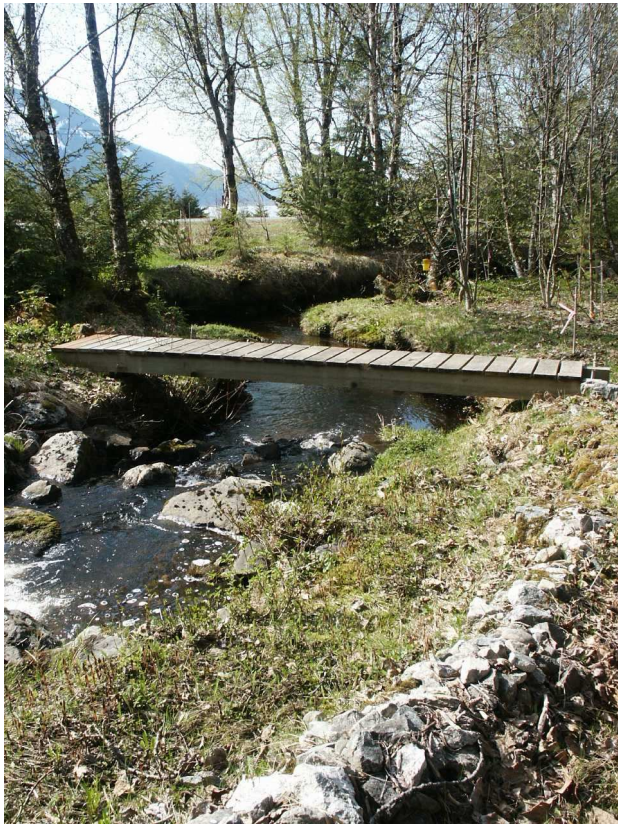
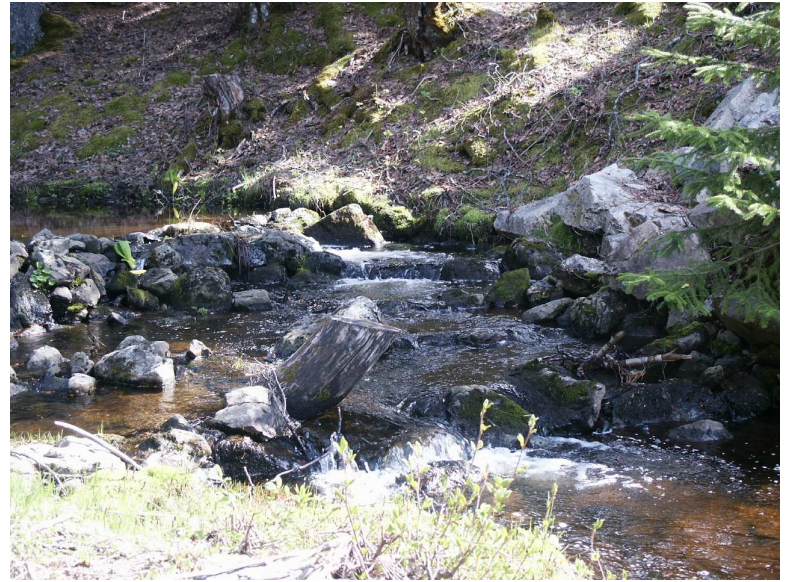
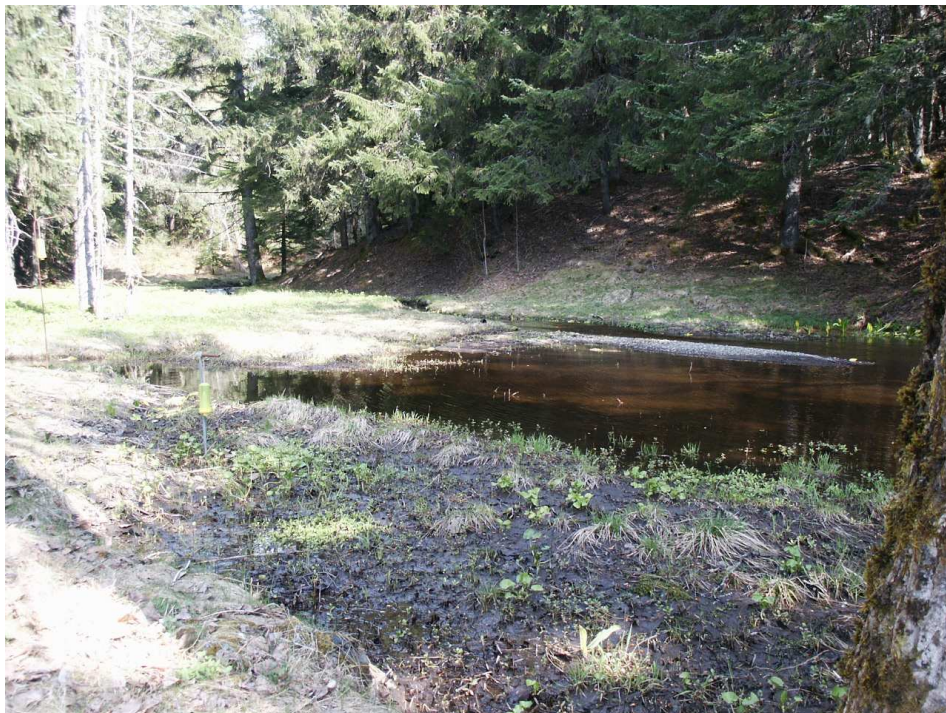
Spoke with Betty Holgate, whose property encompasses both sides of the creek upstream from Mud Bay Road (See plat map attached). She gave us permission to be on their property. The Holgates have a pond on their property that acts as a sediment trap/settling pond. This pond used to be 4 foot deep, but has filled up completely since Small Tracts Road was constructed. Pulses of very turbid water have come through in the past. They would like to be able to dredge the pond periodically. They have done some stone work to improve habitat and fish passage ability as well.

**Photos of Holgate Creek on the Holgate family's property.** *Top right* Stone steps were added to the stream to improve habitat. *Bottom* Pond that has recently (over the last couple of years) filled in.

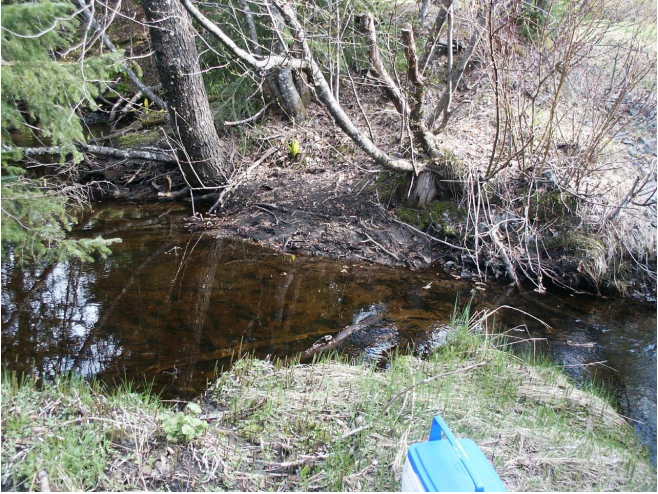
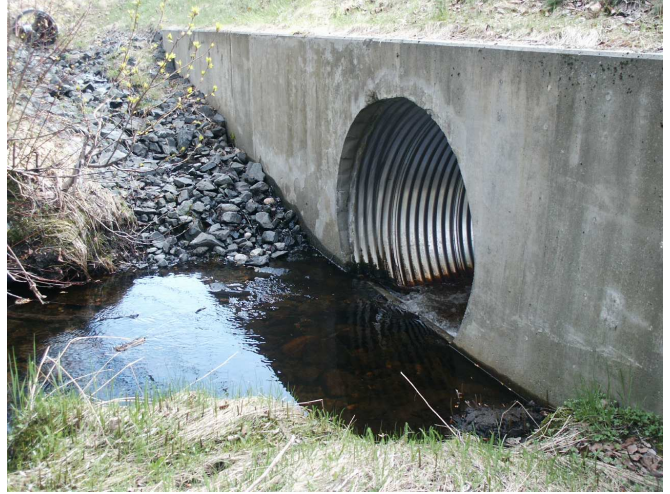
**Sample location: Small tracts Road culvert.** Most upstream sample taken on Holgate Creek,
