**FINAL REPORT
MATANUSKA RIVER DEBRIS SITE ASSESSMENT
PALMER, ALASKA**

**Alaska Department of Environmental Conservation
555 Cordova Street
Anchorage, Alaska, 99501**

**OASIS Environmental, Inc.
807 G Street, Suite 250
Anchorage, Alaska 99501**

25 August 2004

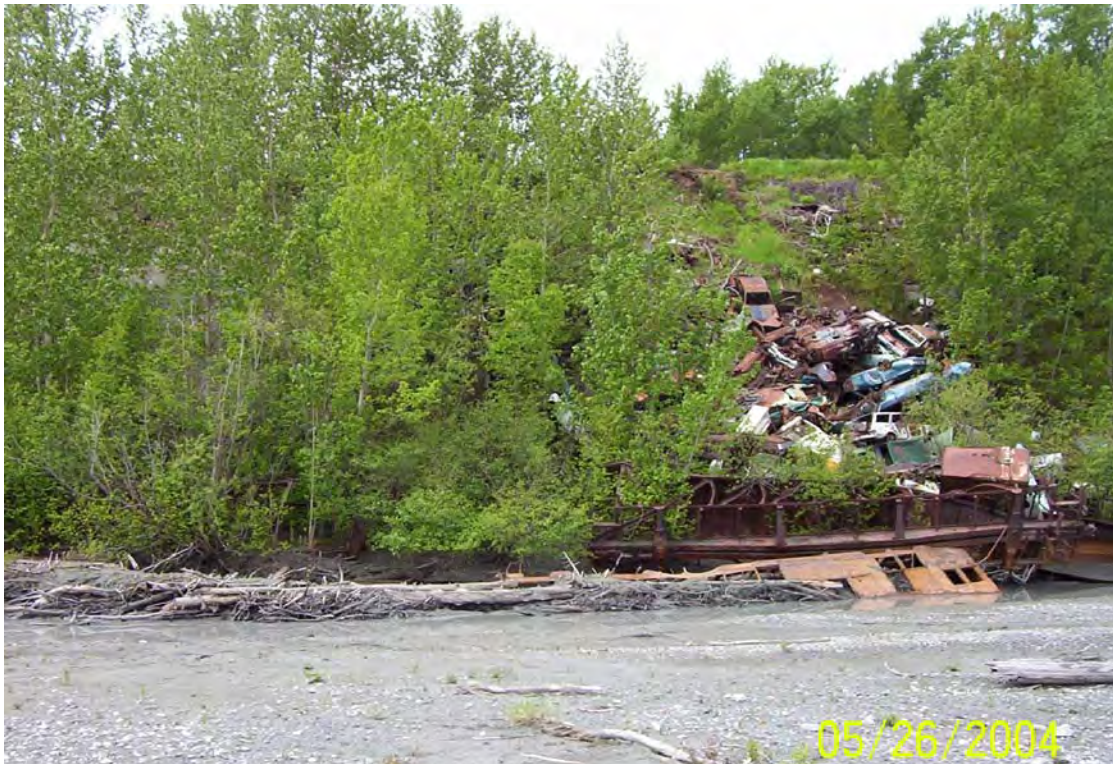
Photo # 1 - Looking west at southern edge of debris disposal area from Matanuska River.
(5/26/2004)

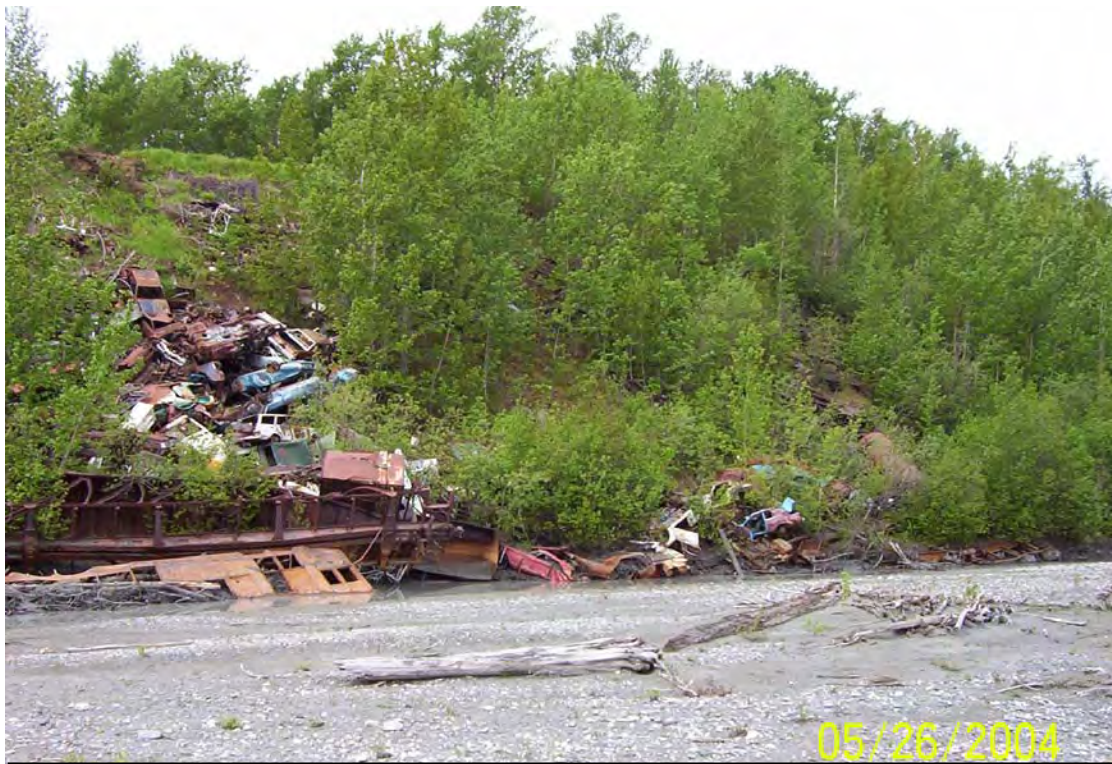
Photo # 2 - Looking northwest at north side of main debris disposal area. (5/26/2004)

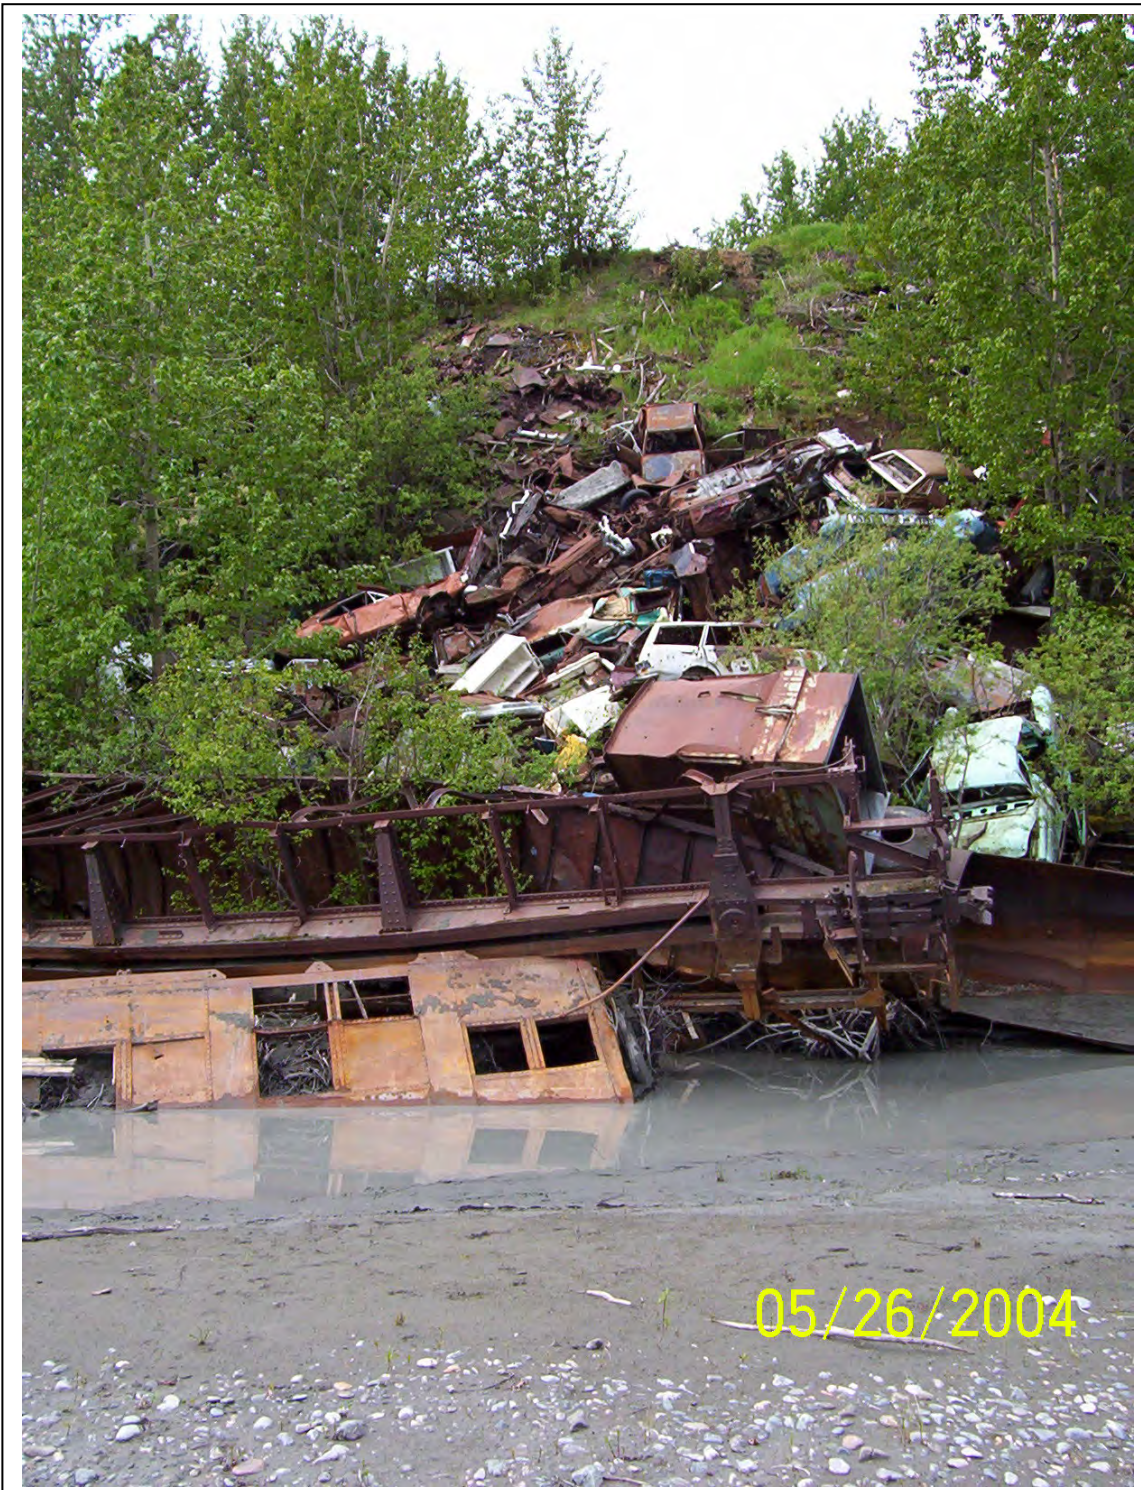
Photo # 3 - Looking at main debris pile area from the Matanuska River. Note railroad cars in the foreground and automobiles and other miscellaneous debris in background. (5/26/2004)

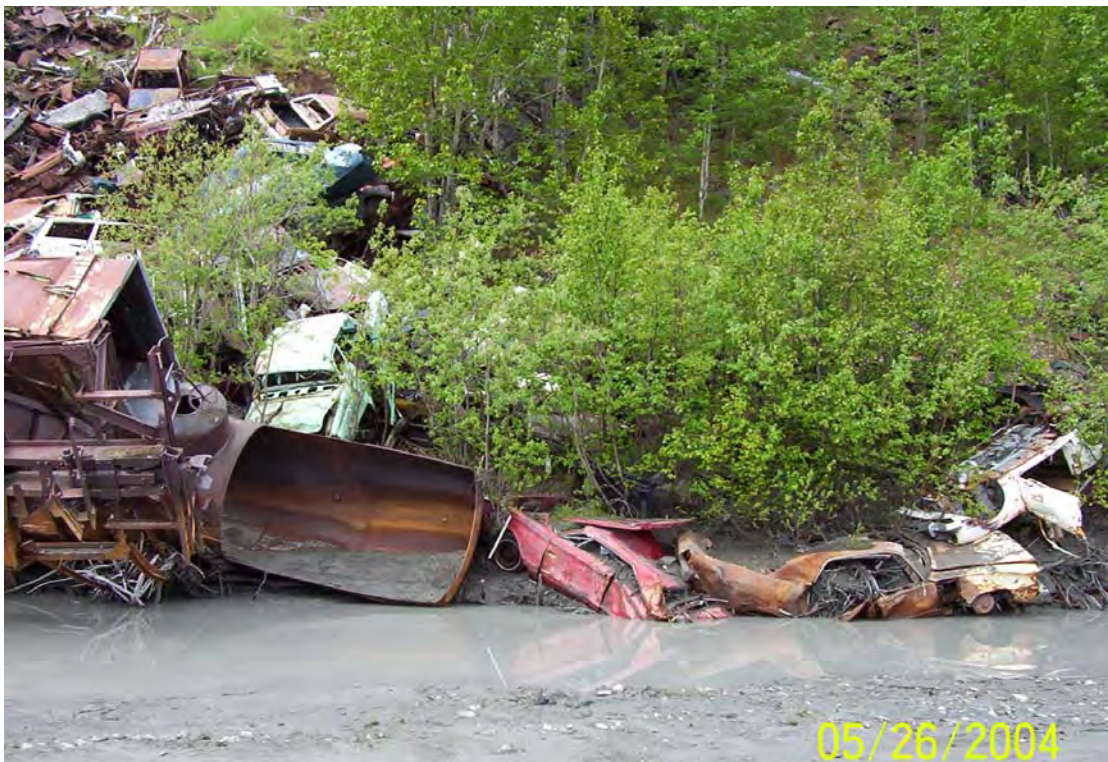
Photo # 4 – Looking west at northern edge of main debris disposal area. (5/26/2004)

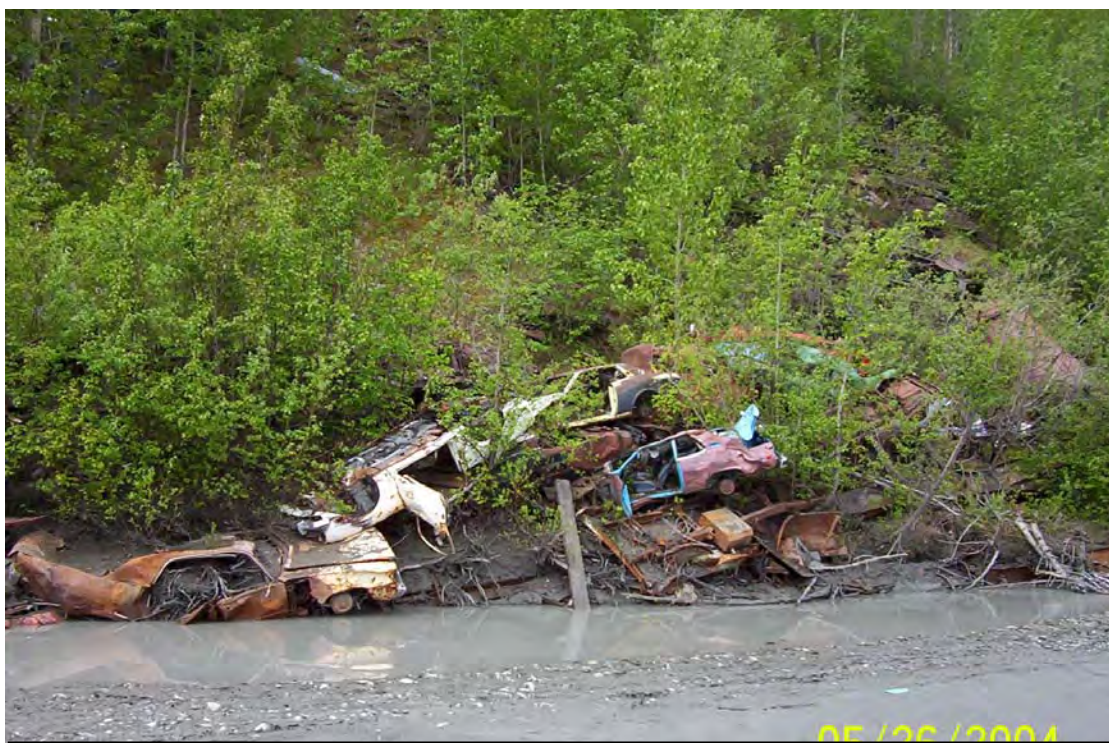
Photo # 5 – Looking west just north of main debris area at additional automobile bodies near the Matanuska River. (5/26/2004)

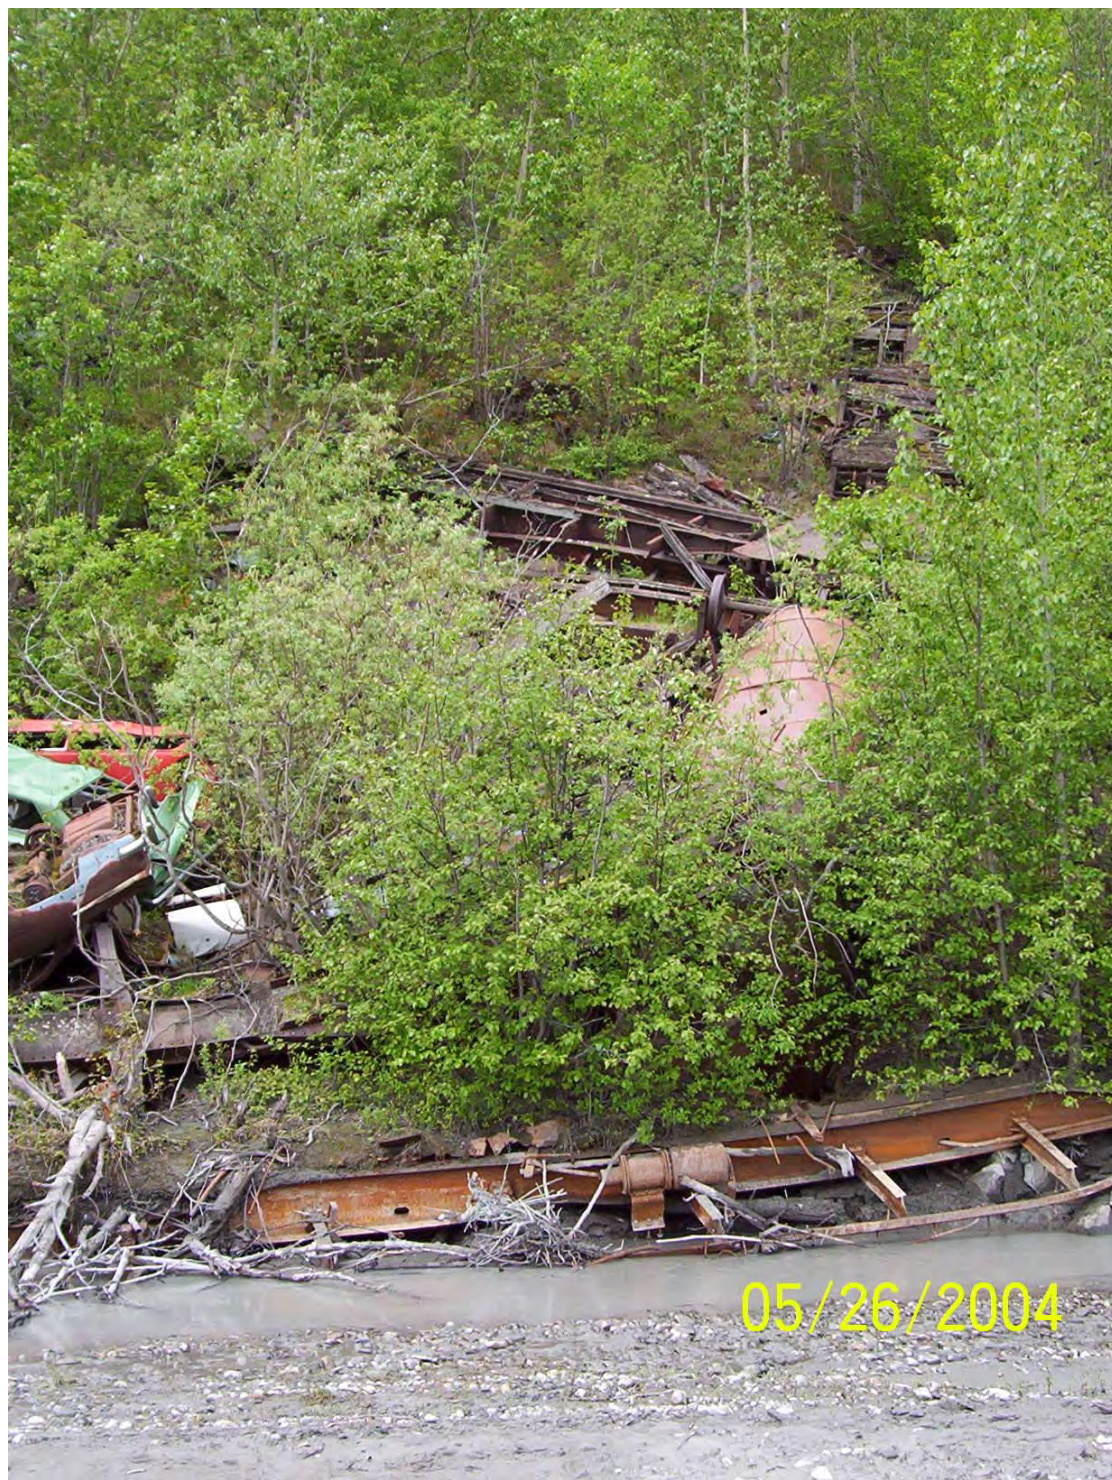
Photo # 6 – Further north looking west at railroad cars and automobile bodies. Note railroad ties and rails on upper portion of bluff in the trees. (5/26/2004)

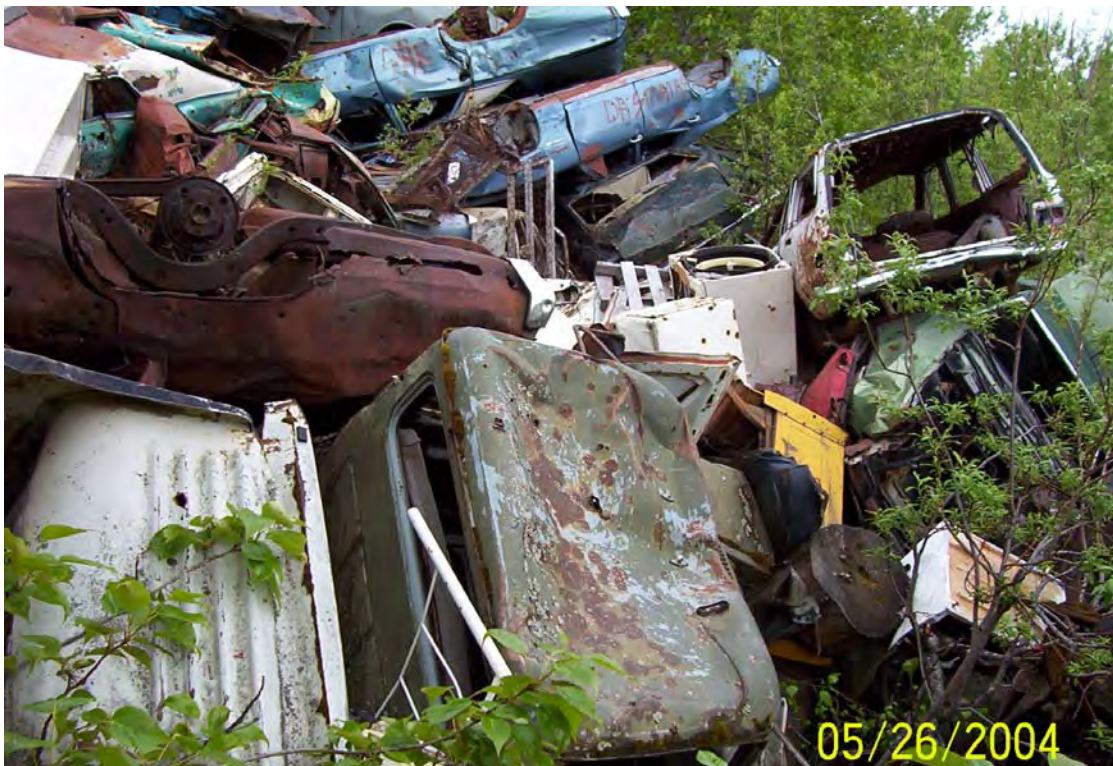
Photo #7 – Close up view of automobiles near center of main dump area. (5/26/2004)

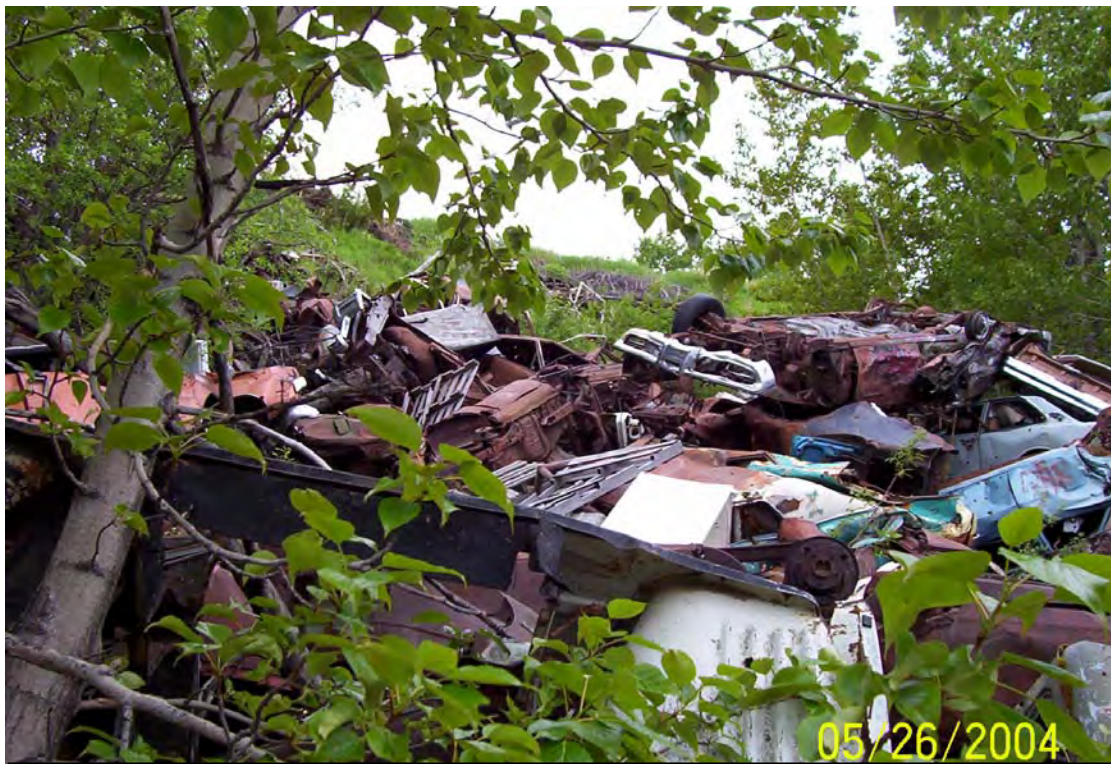
Photo #8 – View of metal automobile debris looking west toward top of dump area. (5/26/2004)

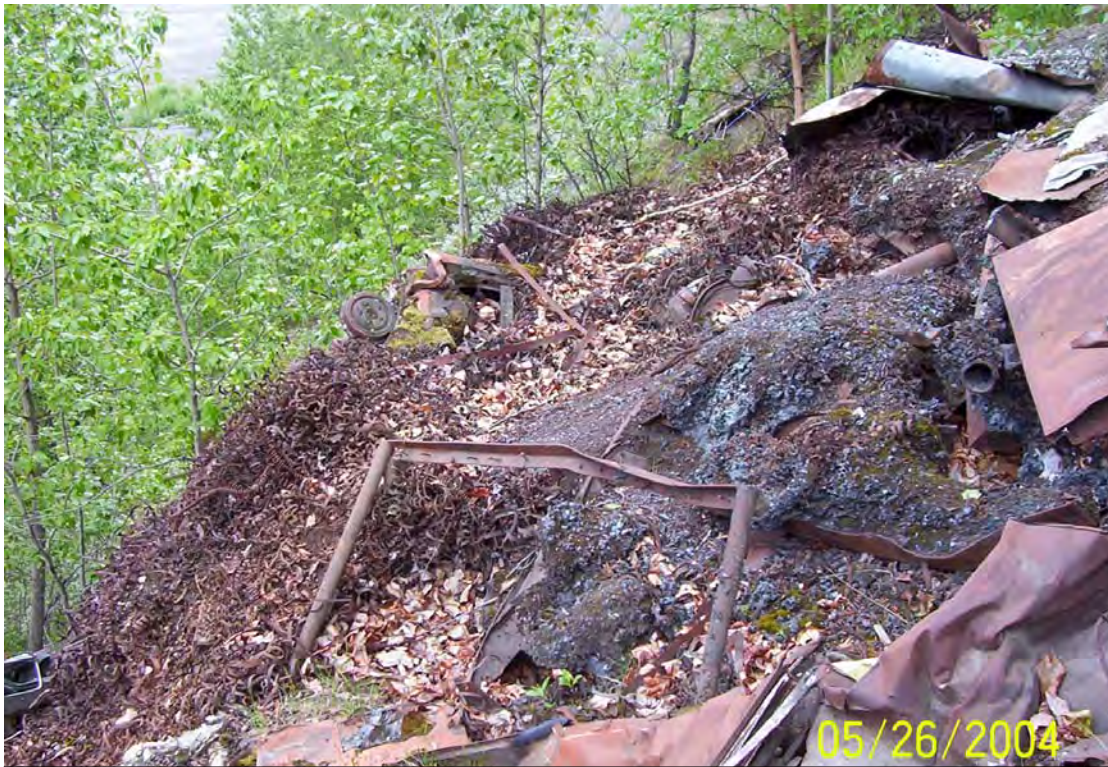
Photo #9 - Coiled metal debris present at the upper portion of the dump site. Note this debris appears to be from metal lath and other machine shop operations. (5/26/2004)

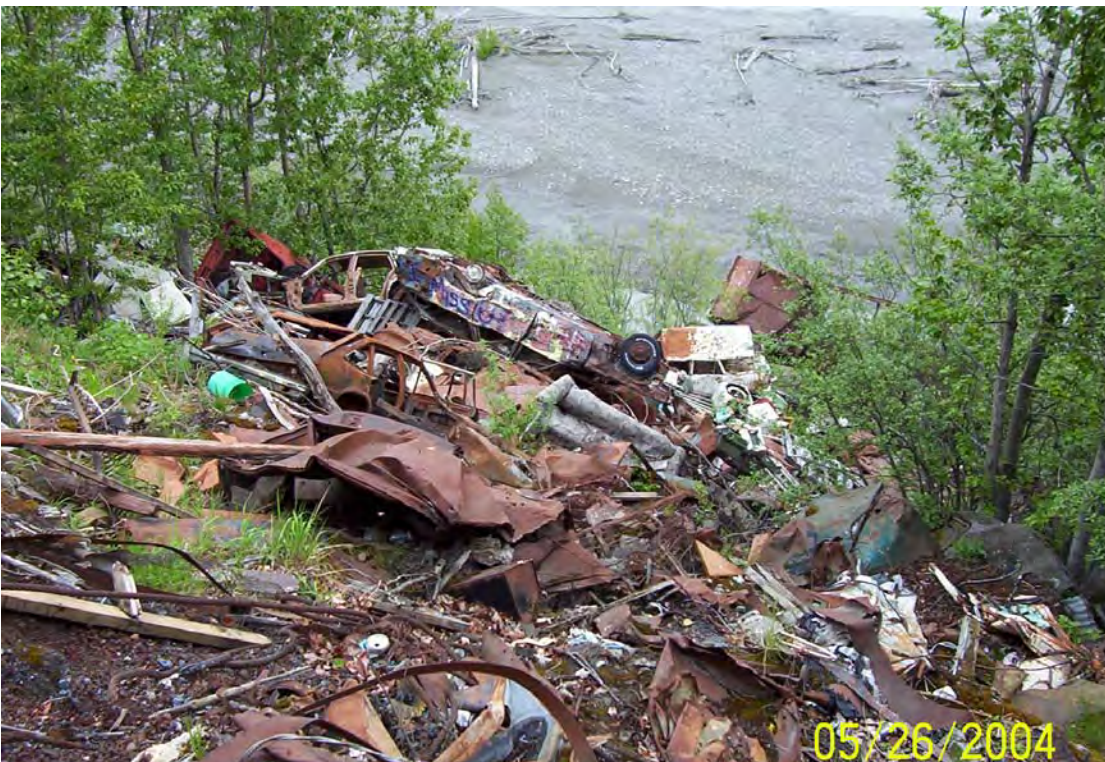
Photo #10 - View of the metal debris from the top of the dump looking east towards the Matanuska River. (5/26/2004)

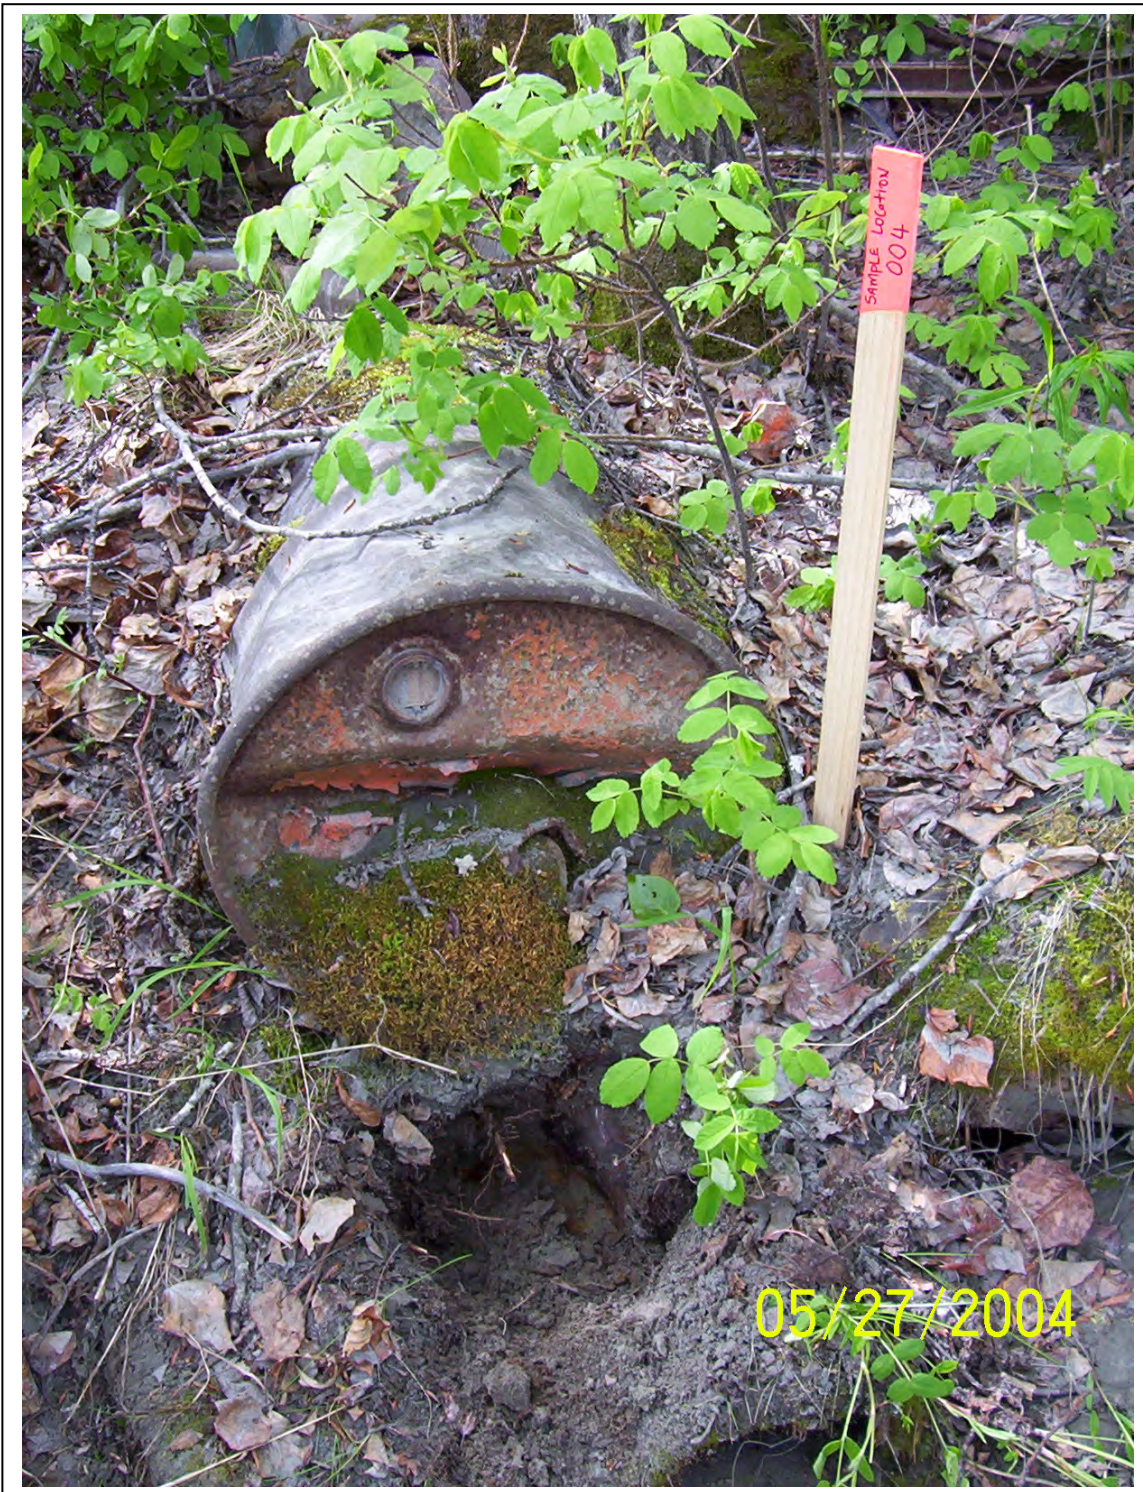
Photo #11 - Close up view of soil sample location MD-04. (5/26/2004)

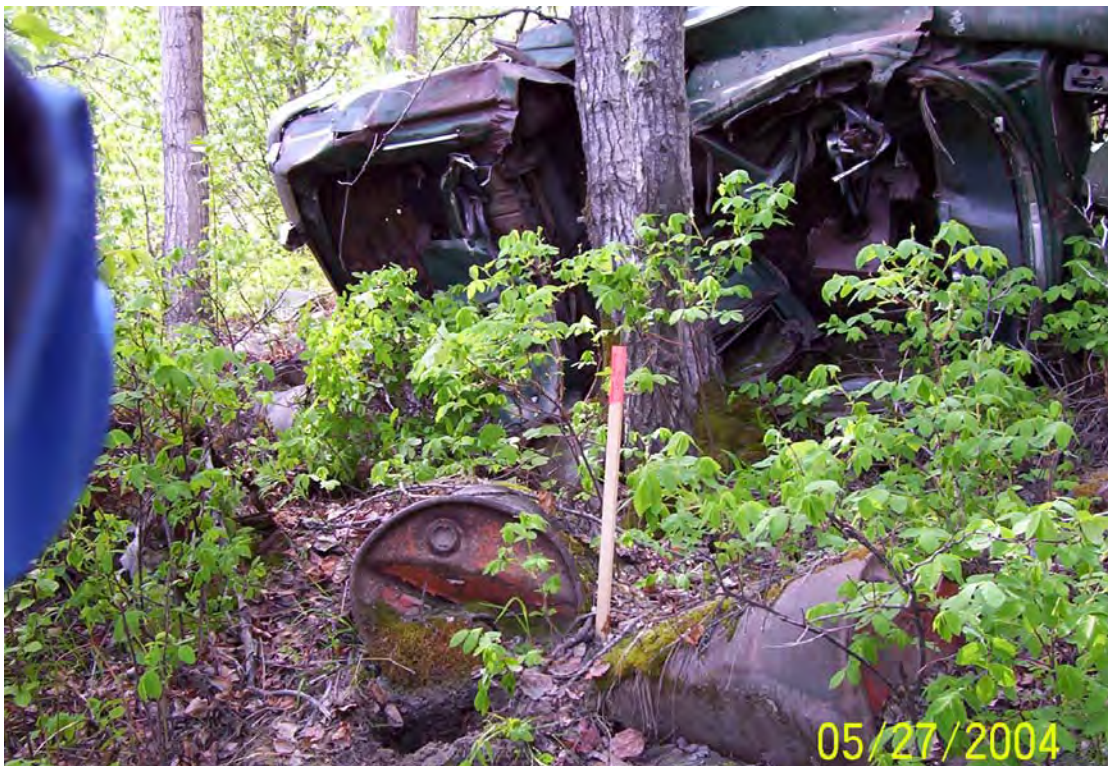
Photo #12 - General overview of soil sample location MD-04 (5/27/2004)

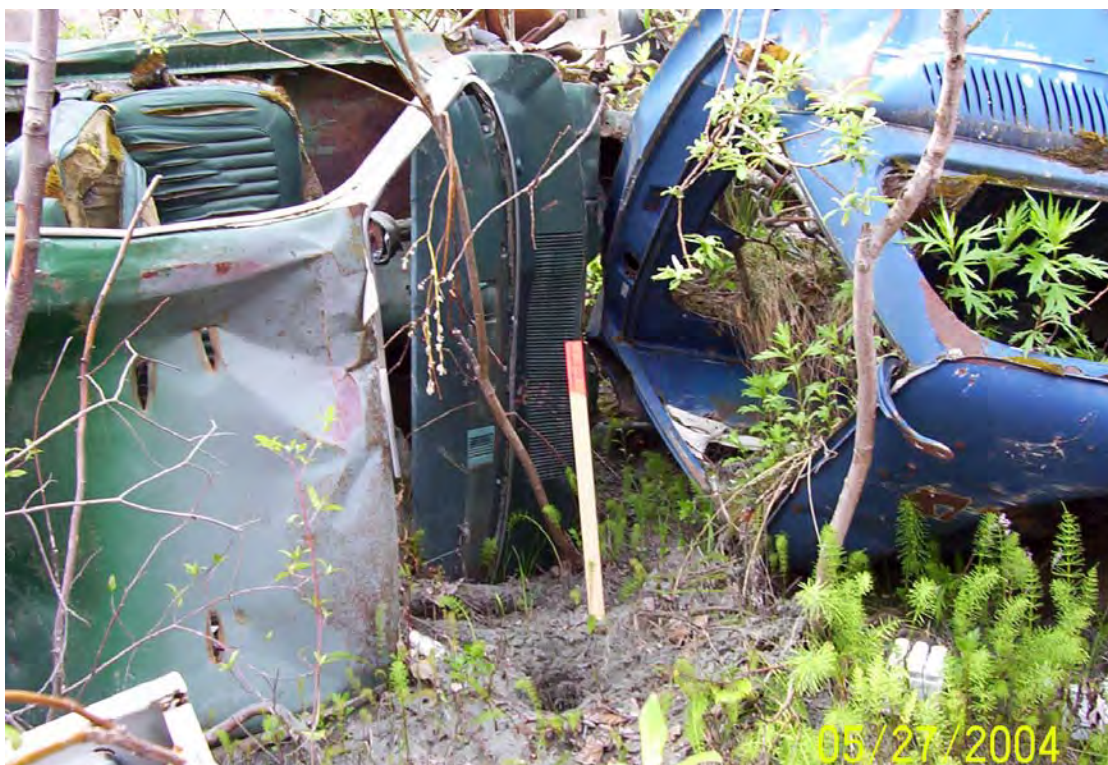
Photo #13 – View of soil sample location MD-05. Note this location is a drainage area near the bottom of the main dump site. (5/27/2004)

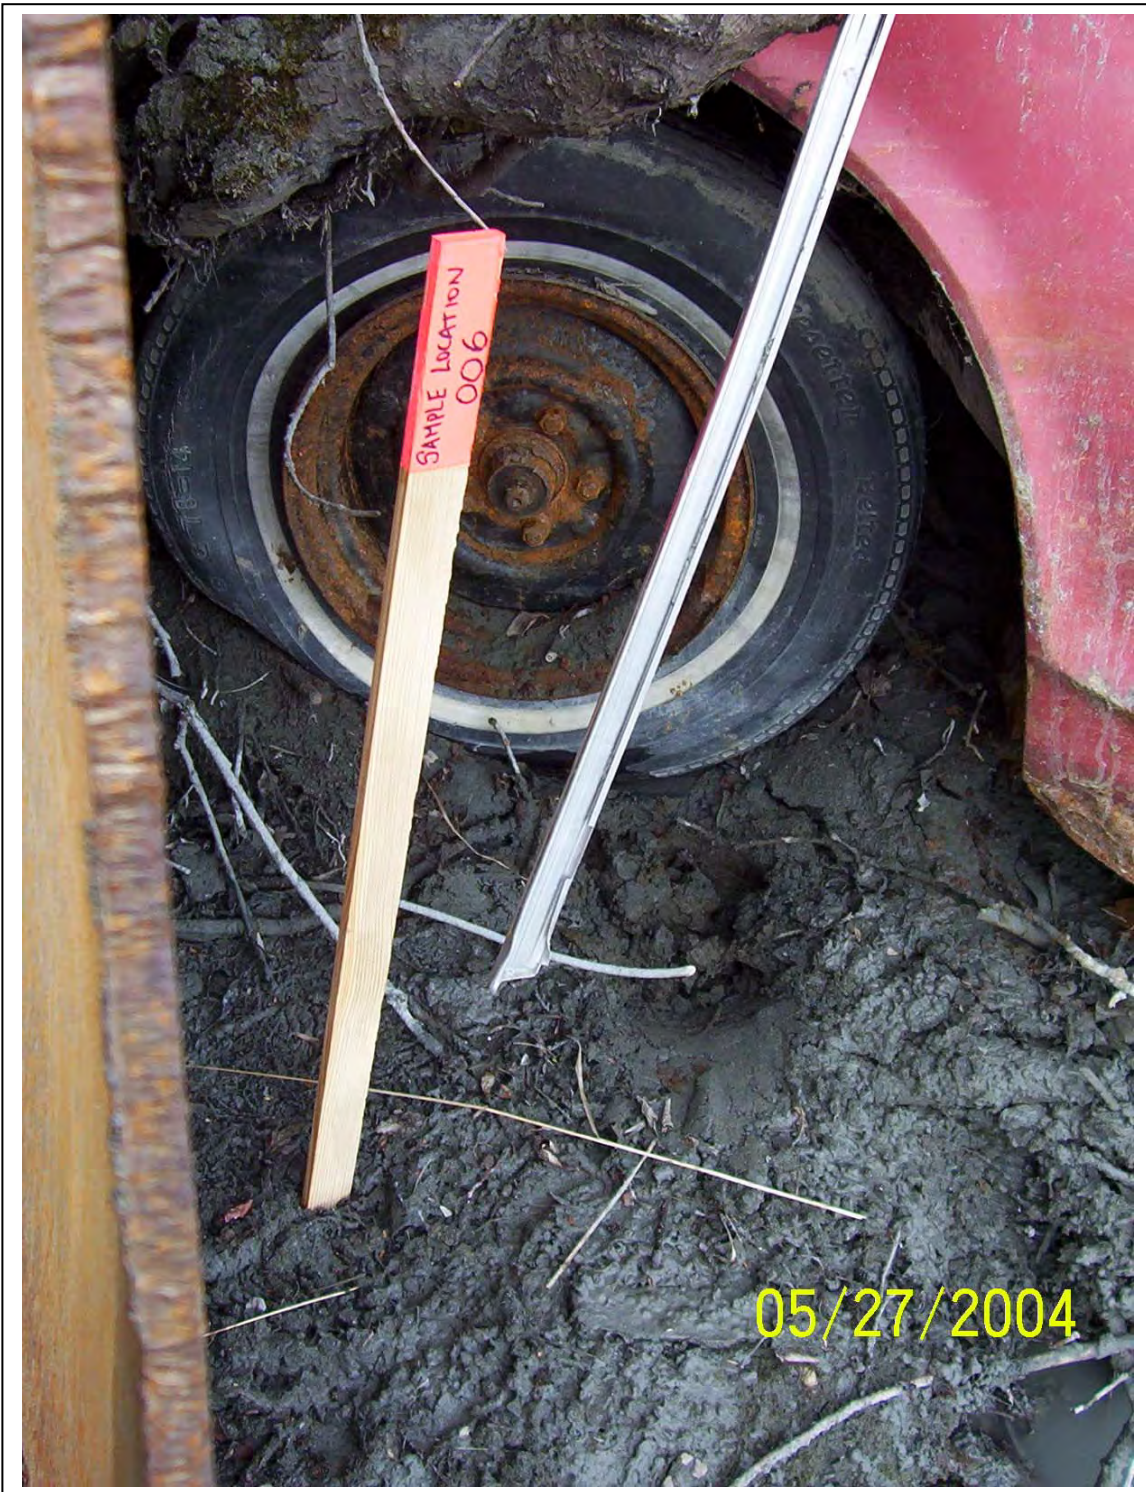
Photo #14 – Close up view of soil sample location MD-06. Note that this sample location is adjacent to the surface water and sediment location MD-02. (5/27/2004)

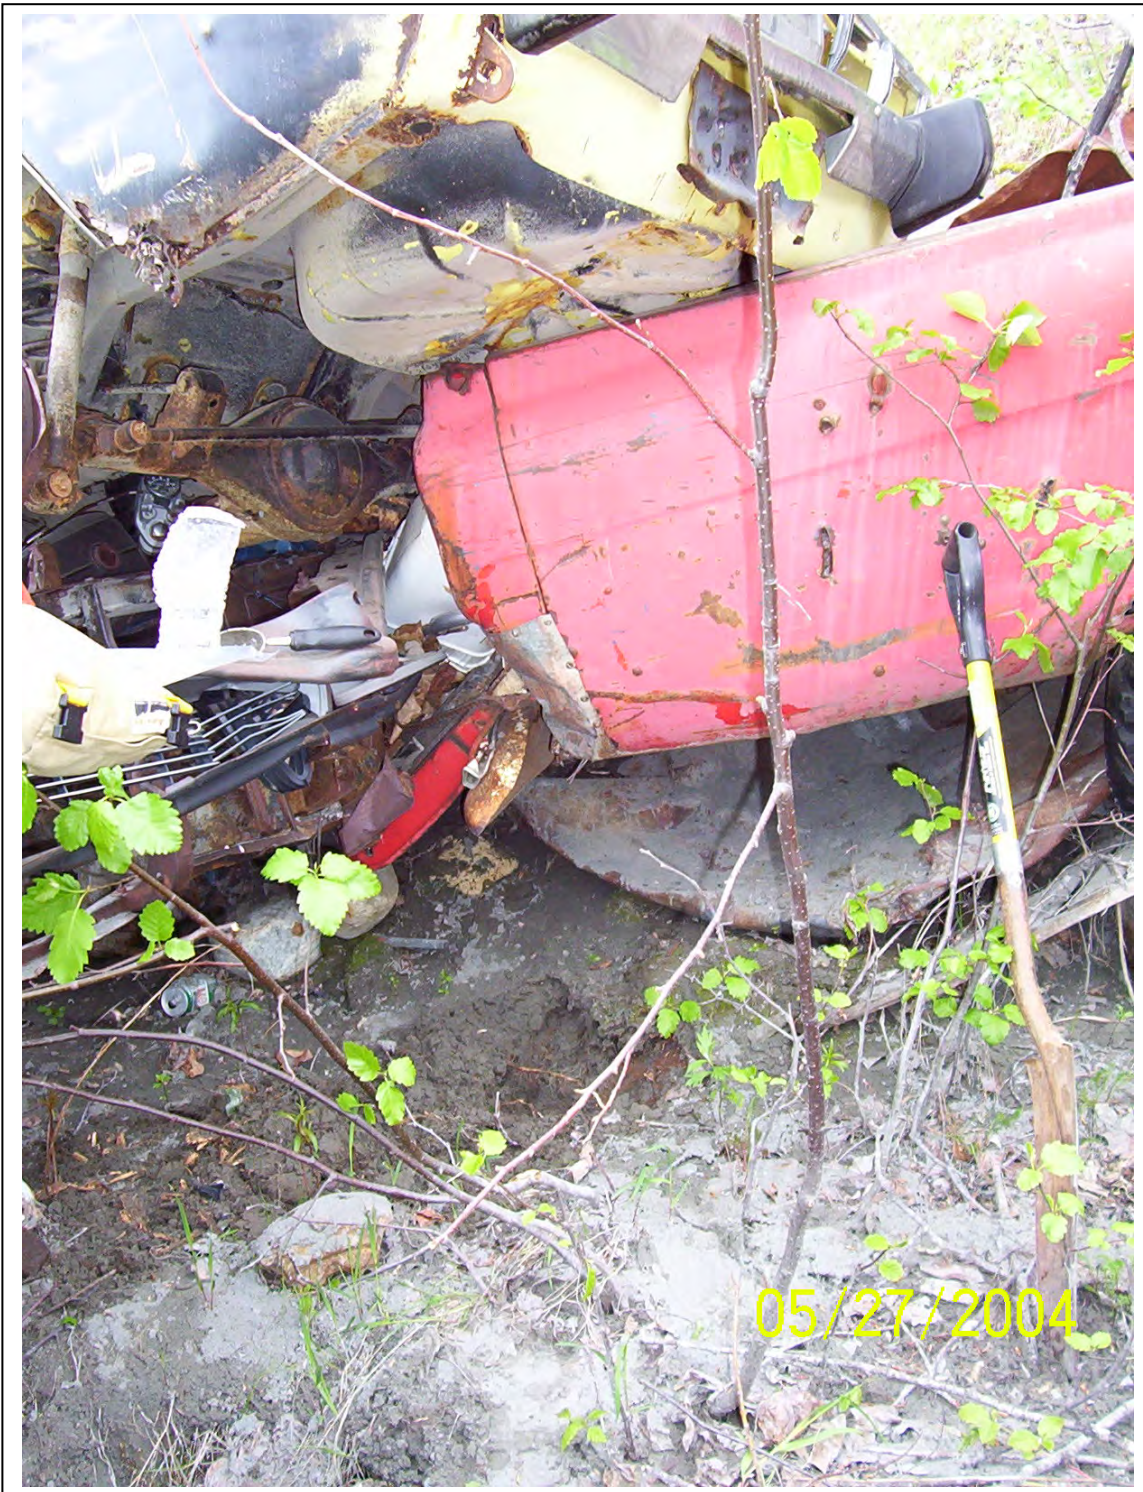
Photo #15 – View of soil sample location MD-07 within the northern portion of debris area along Matanuska River. Note that sample location is underlain by sheet metal. (5/27/2004)

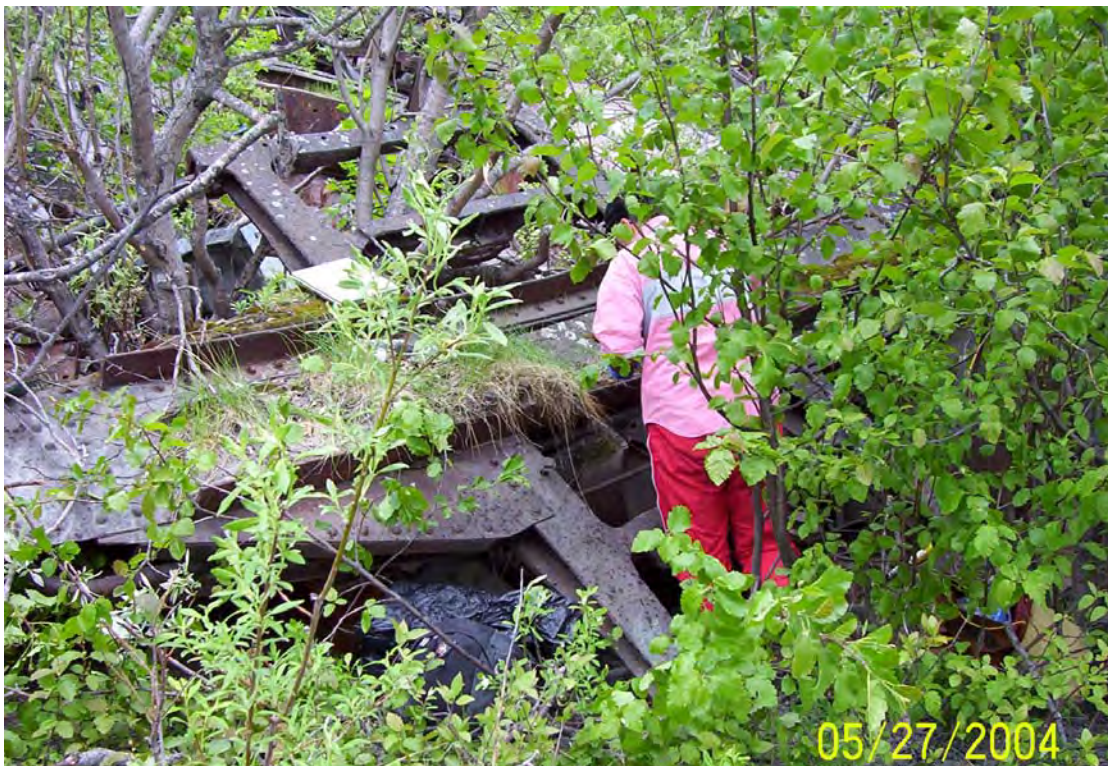
Photo #16 – Overview of soil sampling location MD-08 showing metal debris from old railroad car. (5/27/2004)

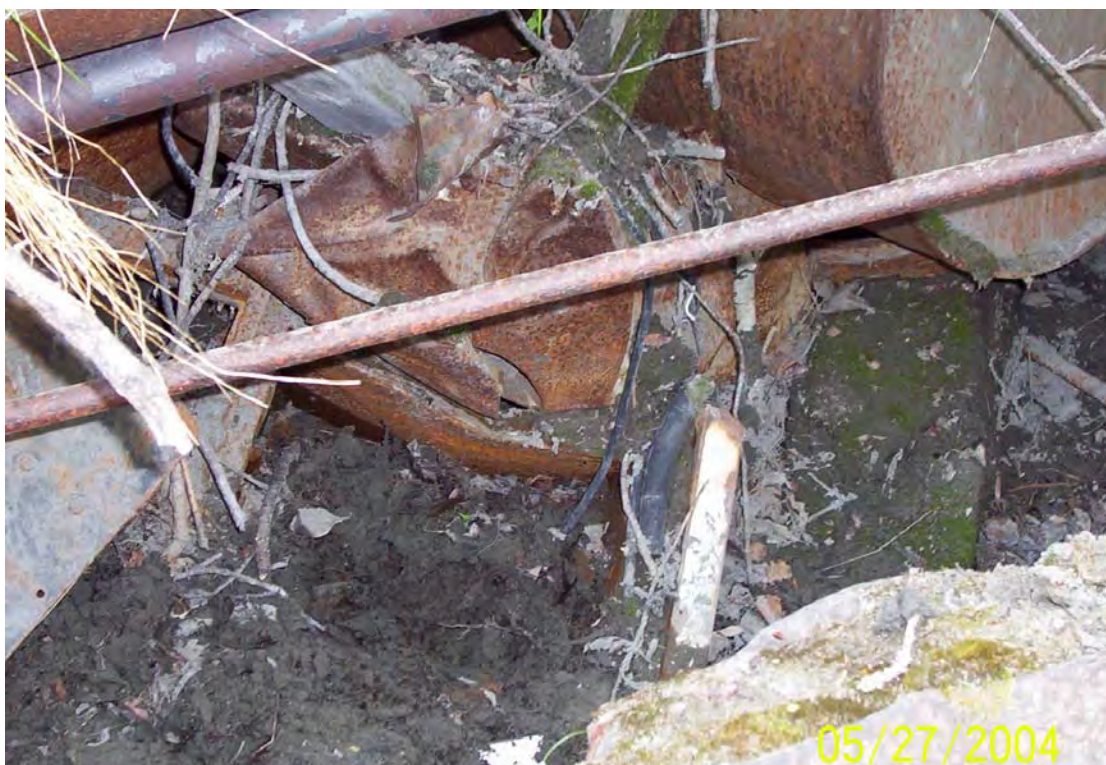
Photo #17 – Close up view of soil sample location MD-08. Note old drums in the upper portion of photograph. (5/27/2004)

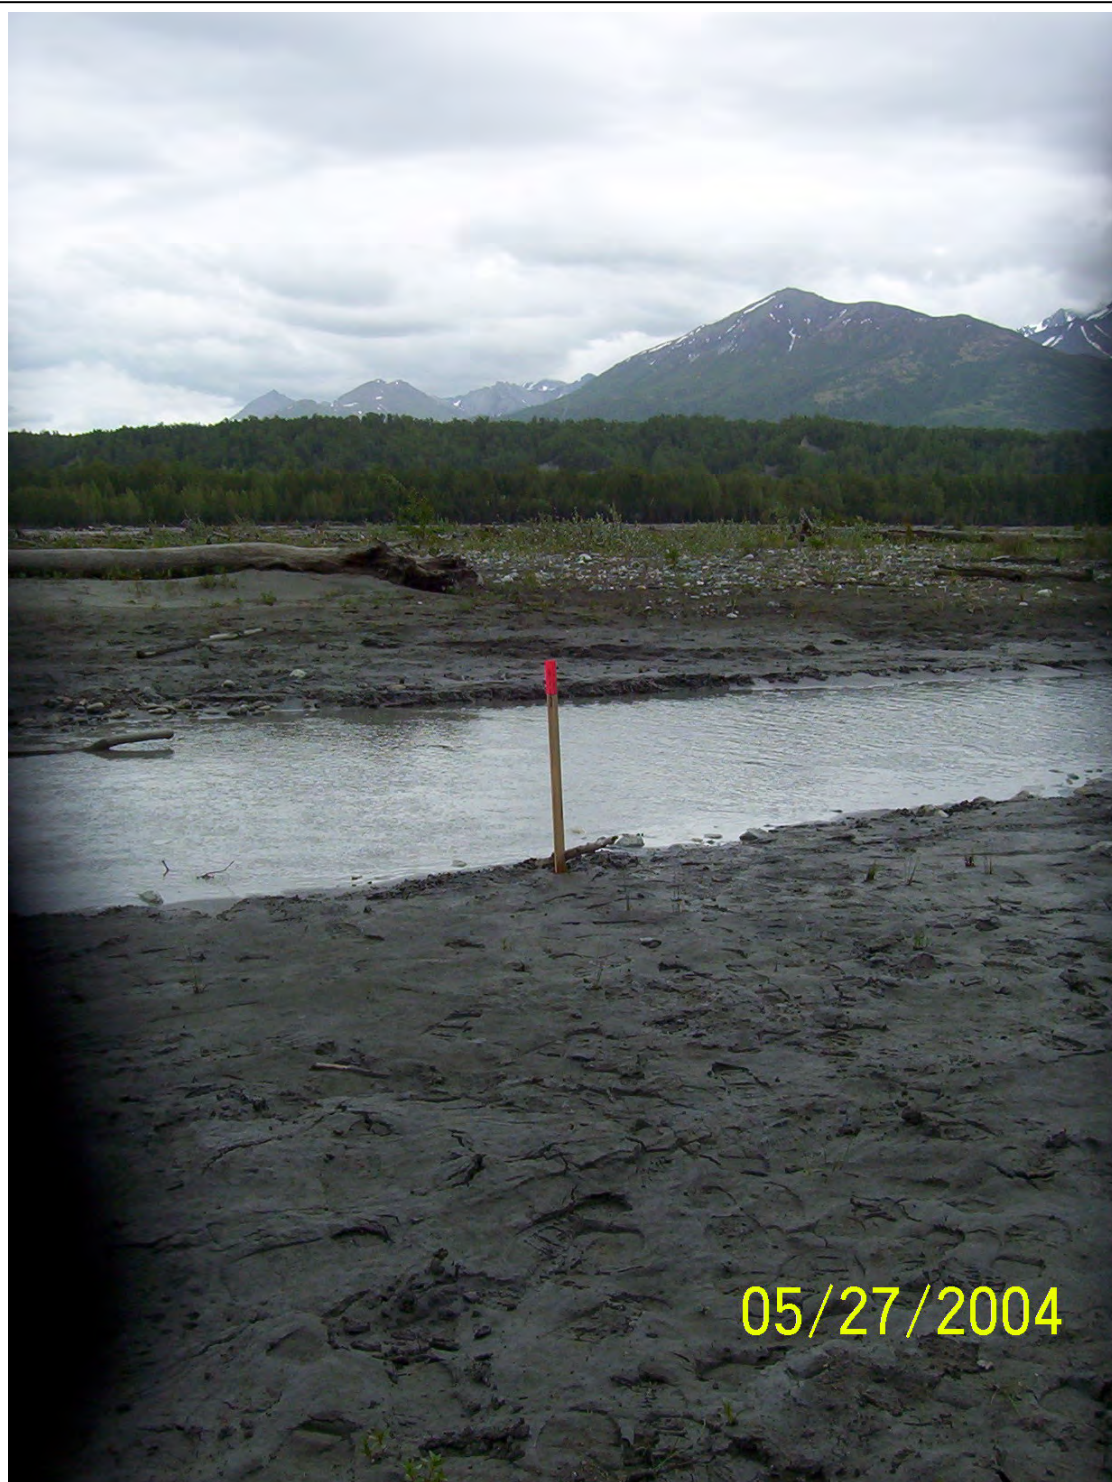
Photo #18 – Looking southeast at the downstream surface water and sediment sample location MD-01.
(5/27/2004)

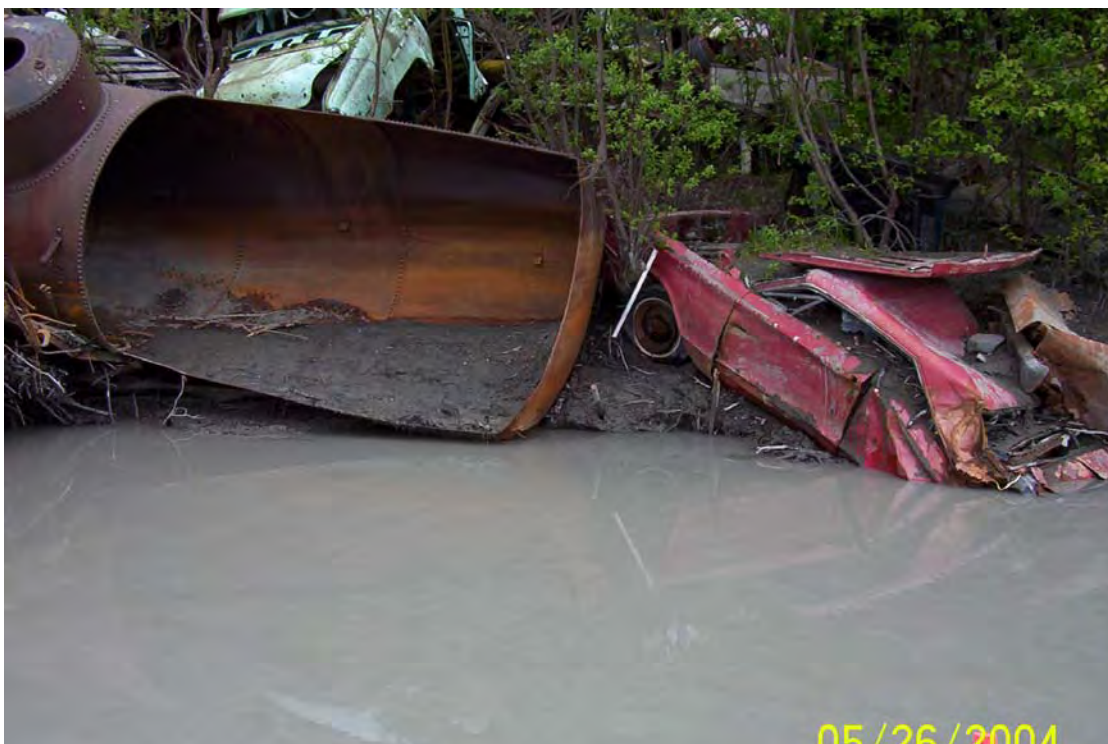
Photo #19 – Looking east at surface water and sediment sample location MD-02. Samples were collected on the far side (debris site) of the Matanuska River. (5/26/2004)
